# The catastrophic landfill flowslide at Hongao dumpsite on 20 December 2015 in Shenzhen, China

Abstract. A catastrophic flowslide occurred at the Hongao dumpsite on 20 December 2015 in the Guangming New District of Shenzhen, China. The flowslide caused 77 causalities and damaged 33 buildings. In the absence of extreme weather conditions and seismic activity, the causes of the failure were analyzed on the basis of multi-temporal remote-sensing images, site investigation, in situ tests, laboratory tests, and numerical analyses. Site investigations showed that the volume of the displaced material was  $2.32 \times 10^6$  m<sup>3</sup> and the volume of the pre-failure waste filling was  $6.27 \times 10^6 \text{ m}^3$ . The flowslide was characterized by high travel velocity and long runout distance. The displaced material was primarily a mixture of silty soil and construction and demolition waste with water content of 17.3-42.4 %. The primary causes of the failure were concluded to be the following: (1) groundwater flow had stagnated in the dumpsite due to drainage system failure and the underlying impermeable granite stratum; (2) the accumulation rate and total volume of the waste

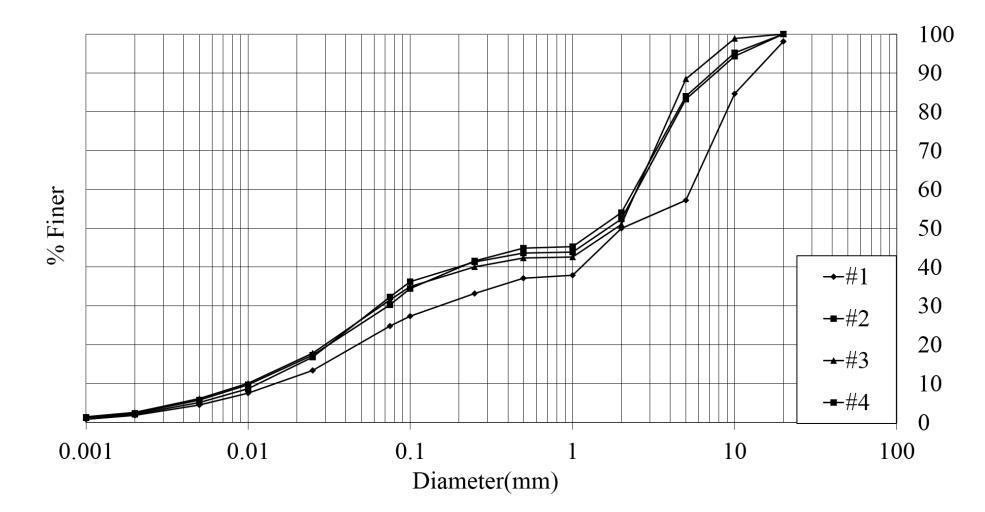
Figure 3. Particle size distribution of the waste filling (with sieve sizes of 20, 10, 5, 2.0, 1, 0.5, 0.25, 0.10, 0.075, 0.025, 0.01, 0.005, 0.002, and 0.001 mm).

Basic material properties were obtained from in situ and laboratory tests. The dry density of the waste filling was 1.25– 1.48 g cm<sup>-3</sup> with a void ratio of 0.83–1.31. Standard compaction tests suggested an optimal water content of 15.3 % with a highest dry density of 1.79 g cm<sup>-3</sup>. The surface of the filling was in a loose state with compaction of 69.8–82.7 %. Based on the undrained shear test, the *c* and  $\phi$  of the filling were 4.7 kPa and 31.9°, respectively, so the friction angle was considerably higher than the gradient of the retaining slope (ave. 20°). No strain softening was observed in the saturated specimen under triaxial tests.

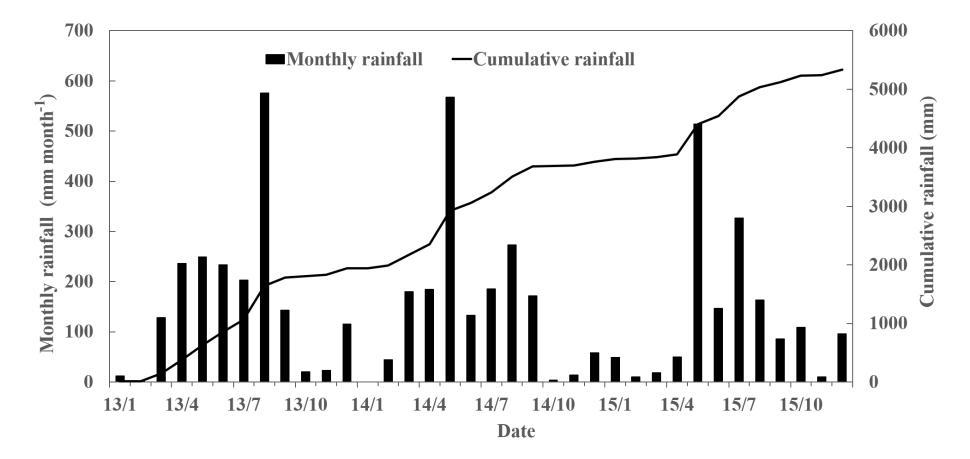
Figure 4. Monthly rainfall and cumulative precipitation between January 2013 and December 2015.

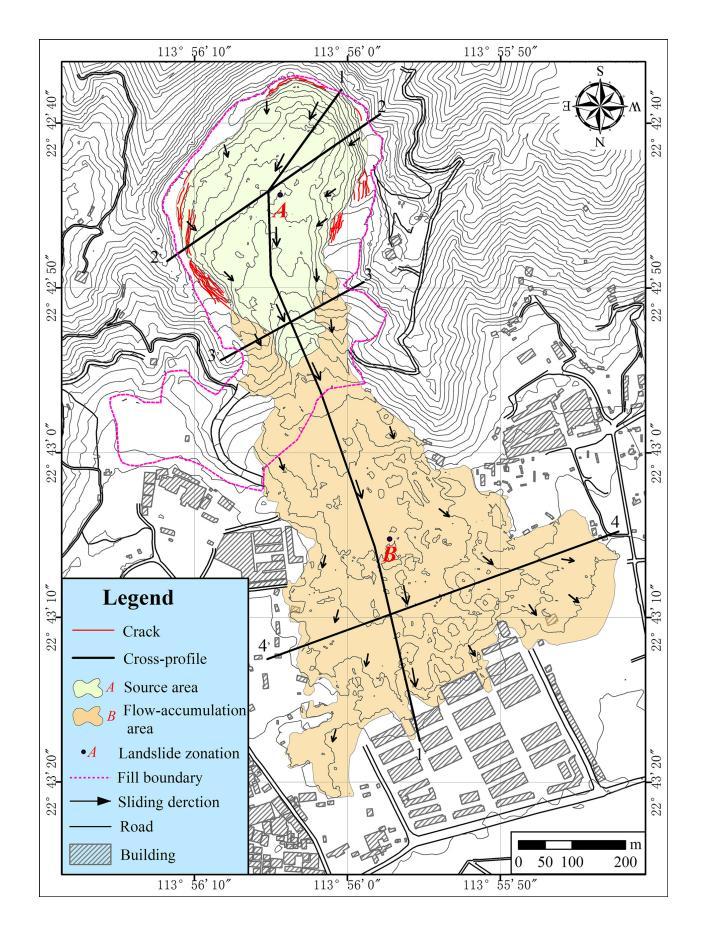
The flowslide area can be divided into the source area and the flow-accumulation area as shown in Fig. 9. The source area was the abandoned quarry pit. The mass slid in the direction of  $340^{\circ}$  with a maximum traveling distance of 1203 m (Fig. 10). The maximum thickness of the remaining material in the source area was 41.51 m with an average of 20.5 m (Figs. 9 and 10). The maximum deposit thickness in the flow-accumulation area was 18.2 m with an average of 8.21 m (Fig. 8b). The geometry of a flowslide can be expressed in length (*L*), height (*H*), width (*W*), and area (*S*) (Legros, 2002; Scheidegger, 1973). The geometry in Fig. 11, with values tabulated in Tables 1, 2, and 3.

The presence of the aforementioned rock ridges formed unfavorable topography for the retaining slope stability, as it promoted a narrow gully for groundwater flow and concentration (Figs. 7c and 9). As a result of the retaining slope failure, a large opening was formed at the elevation of 73.7 m (between the front edge of the steep scarp and the rear edge of the flow-accumulation area) as shown in Figs. 9, 10, and 12a. The displaced material was stratified in the middle part of the flow-accumulation area during the high-speed sliding. The shape of the failed retaining slope was half-elliptic-like with a width ( $W_{4-1}$ ) of 217.7 m and a height ( $H_b$ ) of 27.5 m (Fig. 13a and c).

Figure 9. The topographic map of the flowslide.

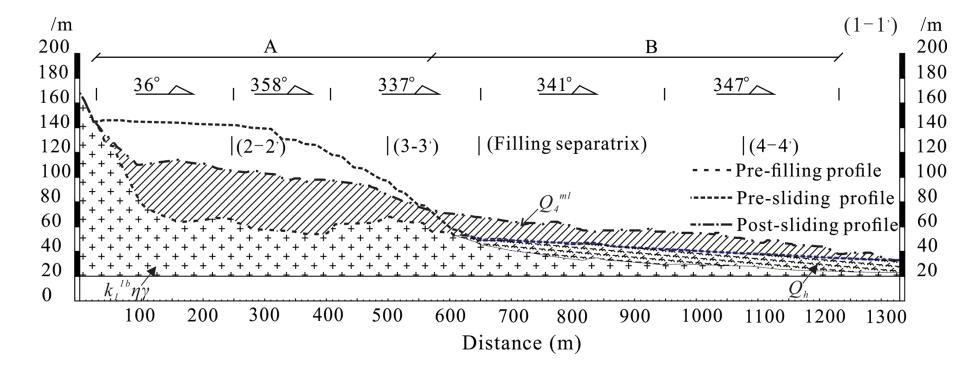
Figure 10. The geological and topographical cross section (profile line 1-1').

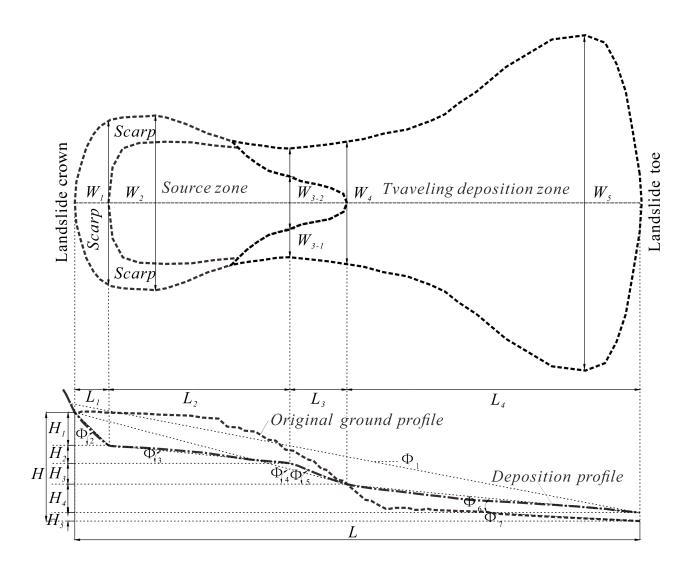
The source area of the flowslide was at an elevation of 142 m, and the horizontal runout distance (*L*) was approximately 1203 m with an elevation difference (*H*) of 111 m (Fig. 11). The velocity of a high-speed landslide can be estimated by  $v = \sqrt{2g \times (H - f \times L)}$  (Scheidegger, 1973), where v is the sliding velocity (m s<sup>-1</sup>), g is the gravitational acceleration (m s<sup>-12</sup>), and H and L are the elevation difference and horizontal distance (m) between the crown and toe of the flowslide, respectively. The equivalent friction coefficient, f, is the ratio of height to runout distance of the flowslide (f = 0.092). The travel velocity was back-calculated and is presented in Fig. 17.

**Figure 11.** Simplified illustration of the flowslide geometry. *L*: runout distance; *H*: elevation; *W*<sub>1</sub>: scarp width; *W*<sub>2</sub>: max width of the source area; *W*<sub>3</sub>: frontal width of the source area; *W*<sub>4</sub>: width of the shear crack; *W*<sub>5</sub>: max width of the flow-accumulation area;  $L_1$ : horizontal length of the scarp;  $L_2$ : horizontal length of the mild slope;  $L_3$ : horizontal length of the steep slope;  $L_4$ : horizontal length of the flow-accumulation area; *H*<sub>1</sub>: height of the scarp; *H*<sub>2</sub>: height of the mild slope; *H*<sub>3</sub>: height of the steep slope; *H*<sub>4</sub>: height of the flow-accumulation area; *H*<sub>5</sub>: thickness of the toe of the flowslide;  $\Phi_1$ : extension angle;  $\Phi_2$ : slope gradient of the scarp;  $\Phi_3$ : mild slope gradient;  $\Phi_4$ : slope gradient of the flow-accumulation area;  $\Phi_7$ : slope gradient of the foundation area.

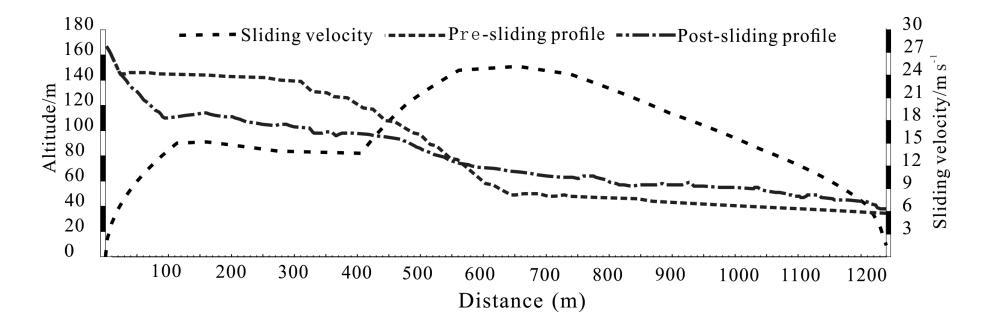
Based on the back-calculated velocity profile, two sharp increases were identified, including the initiation of the waste filling movement from the steep scarp and the acceleration of the flowslide exiting the dumpsite. The travel velocity was  $15.17 \text{ m s}^{-1}$  as waste filling reached the bottom of the steep scarp. The velocity of the displaced material gradually decreased to around  $13 \text{ m s}^{-1}$  before accelerating to the maximum velocity of  $25.15 \text{ m s}^{-1}$  as it reached the opening of

the quarry. The second sharp acceleration was followed by the rapid dissipation of kinematic energy and reduction in travel velocity after encountering obstructions in the flowaccumulation area. It was estimated that the velocity was reduced to  $15.68 \,\mathrm{m\,s^{-1}}$  when it made contact with downstream buildings. The geometry and velocity profile exhibited clear characteristics associated with high-speed longrunout flowslides.

Figure 17. The estimated travel velocity profile along profile line 1-1' with pre-/post-sliding landform.

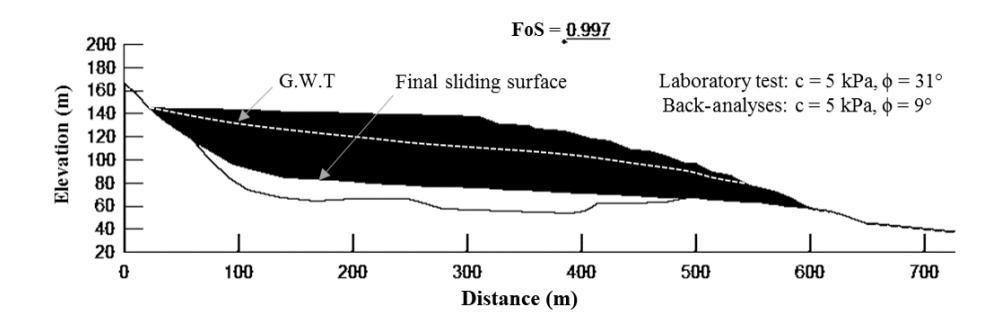
Numerical simulation for diffuse failure involves liquefaction, and post-failure propagation is challenging (Take and Beddoe, 2014); the conventional LEM is typically not applicable for analyzing the propagation of a landslide originating from a diffuse failure induced by liquefaction (Cascini et al., 2009, 2013). Back calculations were performed by using SLOPE/W (GEO-SLOPE International Ltd., 2005) with Morgenstern-Prince limit equilibrium analysis under the assumption that a fully saturated basal zone formed in the dumpsite before failure. The back analyses using the LEM method typically set the factor of safety (FoS) to unity to back-calculate the mobilized strength. The final sliding surface and a hypothetic groundwater level were added to determine the shear strength in an iterative approach with  $\rho_{dry} =$  $1.65 \,\mathrm{g}\,\mathrm{cm}^{-3}$  for the filling (Fig. 18); however the backcalculated friction angle was significantly less than the experimental finding.

Figure 18. Back-calculated mobilized strength by using 2-D numerical model with LEM.
