Nat. Hazards Earth Syst. Sci., 18, 921–934, 2018 https://doi.org/10.5194/nhess-18-921-2018 © Author(s) 2018. This work is distributed under the Creative Commons Attribution 4.0 License.

# Damage during the 6–24 February 2017 Ayvacık (Çanakkale) earthquake swarm

Ramazan Livaoğlu<sup>1</sup>, Mehmet Ömer Timurağaoğlu<sup>1</sup>, Cavit Serhatoğlu<sup>1</sup>, and Mahmud Sami Döven<sup>2</sup>

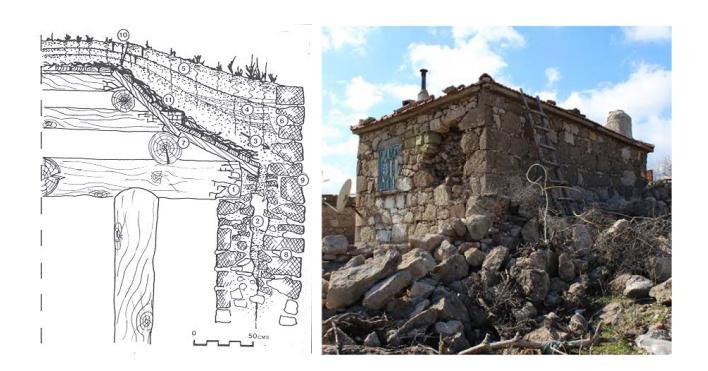
pecially in the Black Sea region of Turkey and in other hillside/mountainside regions where timber is abundant. In any case, stone is a material that can be easily found, and lack of timber leaves people no choice but to use more stone in construction details. However, stone is not a suitable material in earthquake-prone areas, because of its unit weight and being difficult to process. Timber also has an extensive history as a main structural reinforcing element known as *hattl* in rubble stone, brick and adobe houses, the predominant types of houses for ordinary people especially in rural areas (Fig. 3; Hughes, 2000).

**Figure 3.** Typical wall construction detail (Hughes, 2000) and typical view of a dwelling from the region.

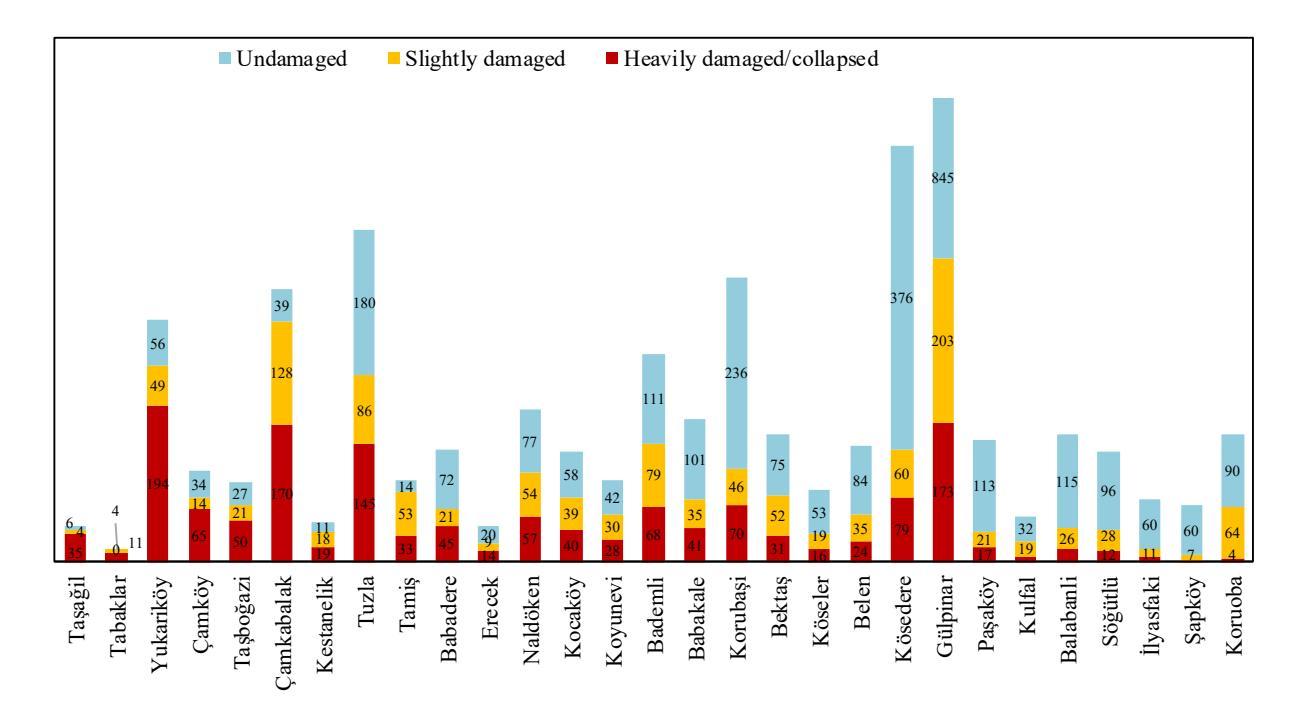
Figure 10. Number of buildings according to damage level due to Ayvacık (Çanakkale) earthquake swarm.

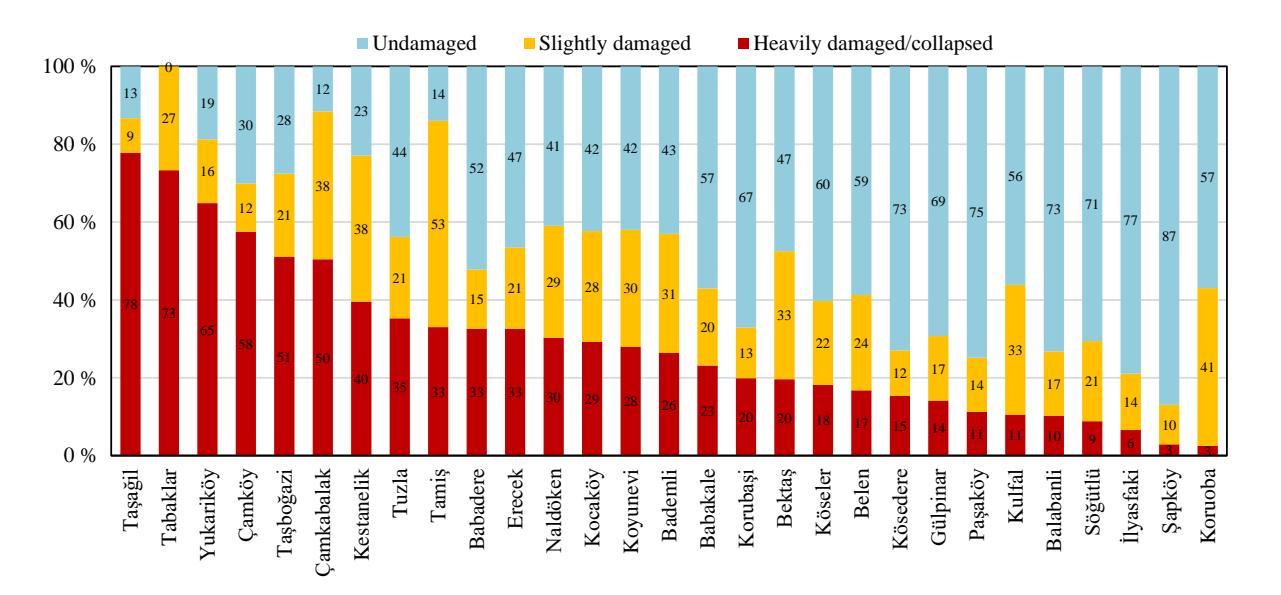
ters of earthquakes, although structures located in the town of Gülpınar experienced significantly less damage than other villages close to the epicenters (Fig. 11). These results may be related to the construction techniques and development level of Gülpınar, which are more advanced than the other villages.

Figure 11. Damage ratios in villages according to damage level due to Ayvacık (Çanakkale) earthquake swarm.

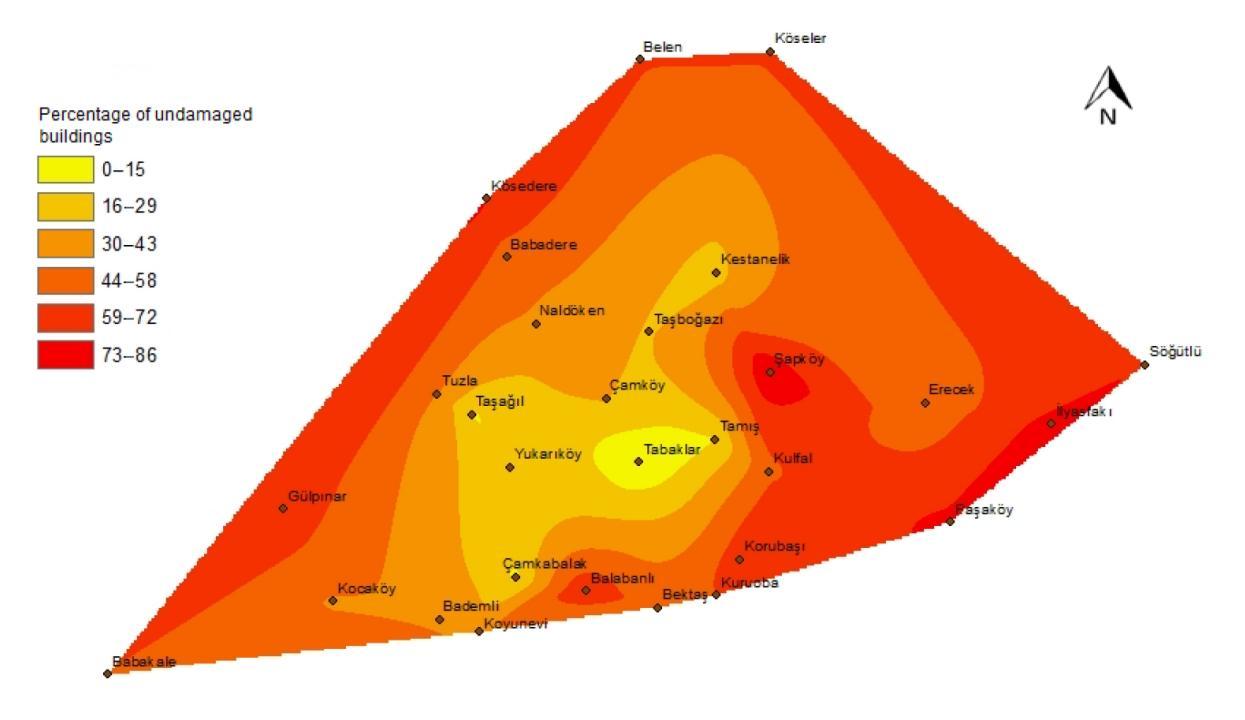
Distribution maps of buildings in percentages according to damage levels are given in Figs. 12, 13 and 14, respectively. These figures clearly indicate that the percentage of heavily damaged/collapsed structures in Gülpınar was lower than in other villages close to the epicenters that suffered significant damage. The reason for this can be explained by Gülpınar being a historical center of the region, containing cultural heritage sites. The differences in terms of past experiences and development level between Gülpınar and other villages subsequently affect the quality of construction. Thus, structural damage was more prominent in the villages with relatively low economic development, and where there are no engineered buildings as observed by the authors.

Figure 12. Distribution maps of undamaged buildings in percentage.

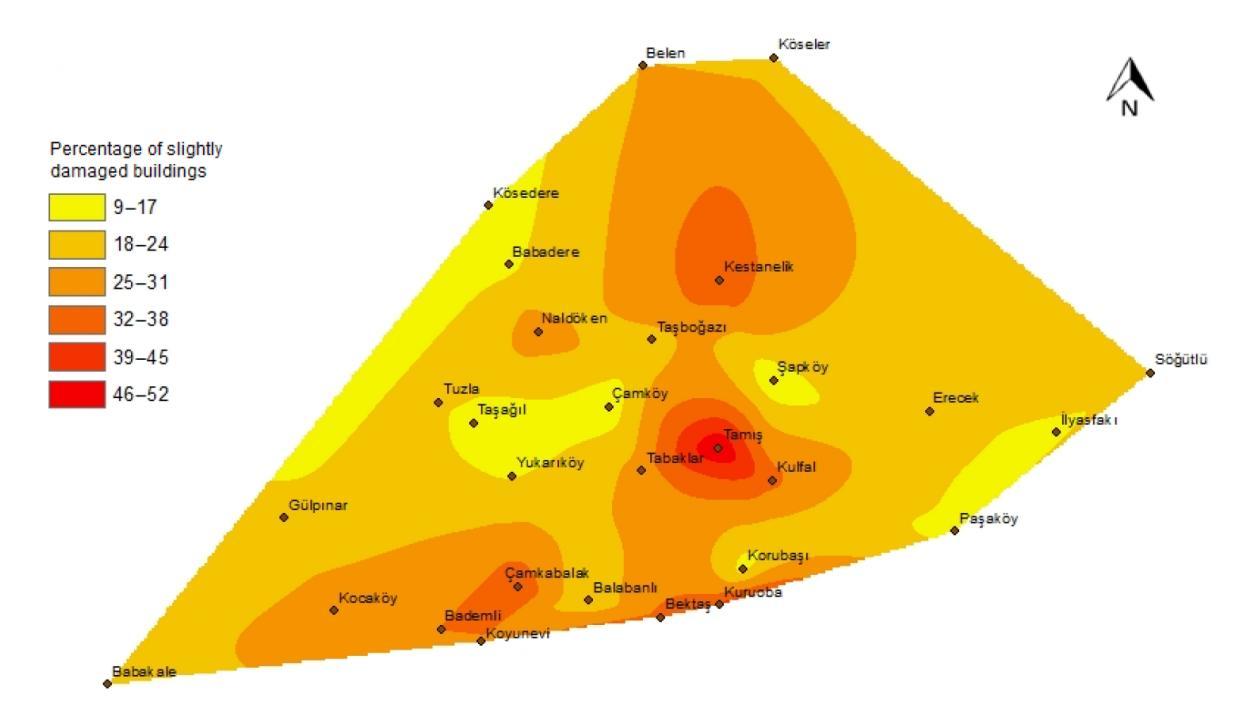
Figure 13. Distribution maps of slightly damaged buildings in percentage.

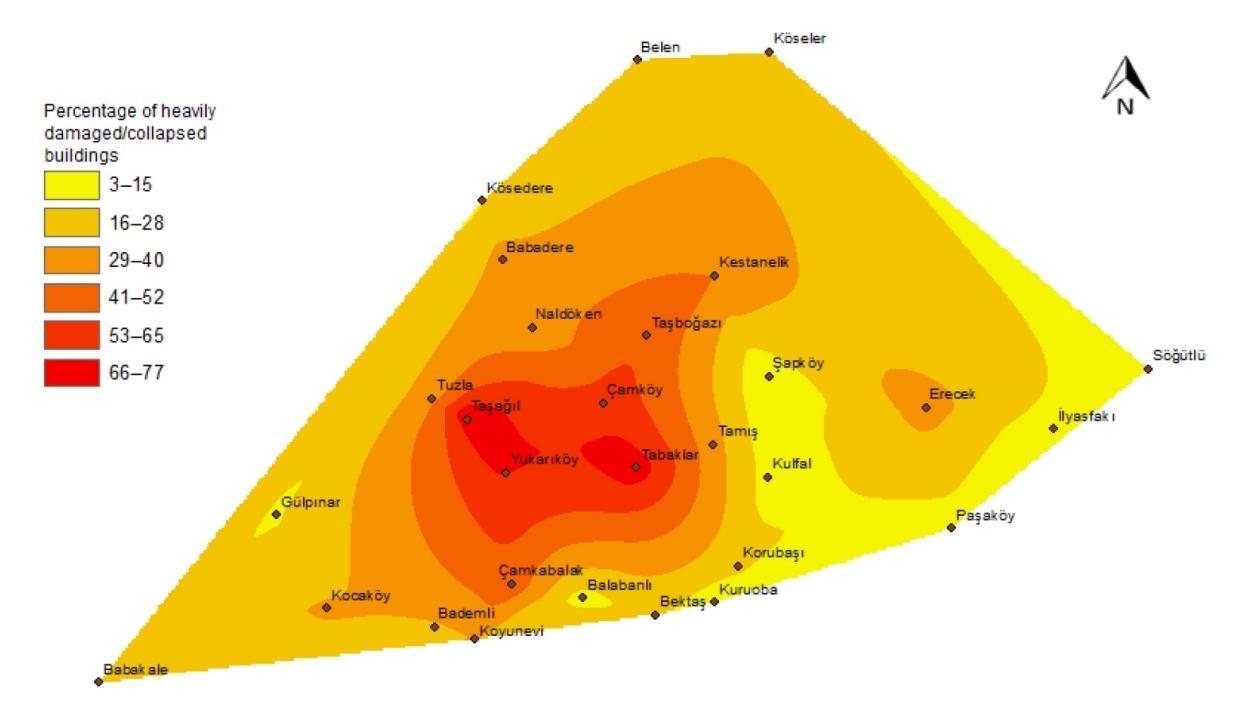
Figure 14. Distribution maps of heavily damaged/collapsed buildings in percentage.

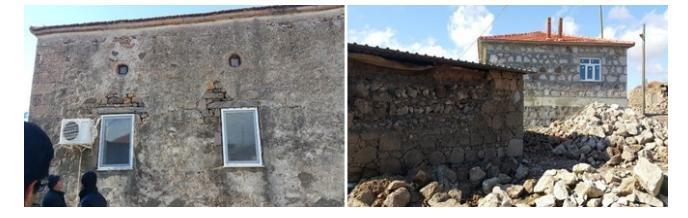
Figure 22. Examples of undamaged dwellings.

tance (Tomazevic, 1999). While bending and shear forces created by a moderate earthquake can be easily resisted by reinforced masonry with lateral and horizontal elements such as RC or timber (Fig. 22), the dwellings made from stone with no mortar cannot resist these forces. This construction defect causes in-plane failures by means of excessive shear force or bending or out-of-plane failure by bending depending on the aspect ratio of the unreinforced masonry elements.
