Post-event field survey of 28 September 2018 Sulawesi earthquake and tsunami

Wahyu Widiyanto^{1,2}, Purwanto B. Santoso², Shih-Chun Hsiao¹, and Rudy T. Imananta³

Abstract. An earthquake with a magnitude of $M_w = 7.5$ that occurred in Sulawesi, Indonesia, on 28 September 2018 triggered liquefaction and tsunamis that caused severe damage and many casualties. This paper reports the results of a post-tsunami field survey conducted by a team with members from Indonesia and Taiwan that began 13 d after the earthquake. The main purpose of this survey was to measure the run-up of tsunami waves and inundation and observe the damage caused by the tsunami. Measurements were made in 18 selected sites, most in Palu Bay. The survey results show that the run-up height and inundation distance reached 10.7 m in Tondo and 488 m in Layana. Inundation depths of 2 to 4 m were common at most sites and the highest was 8.4 m in Taipa. The arrival times of the tsunami waves were quite short and different for each site, typically about 3–8 min from the time of the main earthquake event. This study also describes the damage to buildings and infrastructure and coastal landslides.

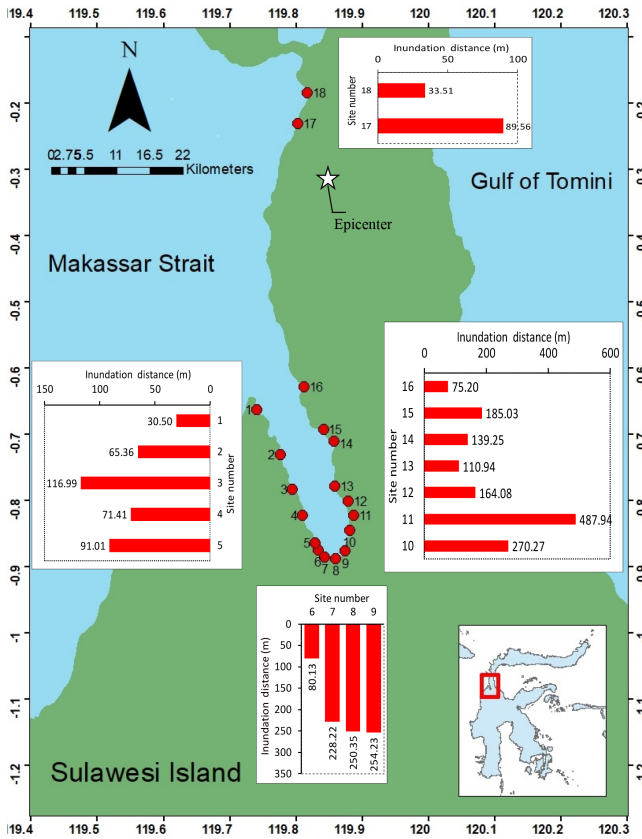
The southern coast of the bay (end of Palu Bay) includes Sites 7 to 9 (Lere, Besusu Barat, and Talise). The run-up heights at Lere and Besusu Barat were low (1.40 and 1.12 m, respectively). Talise had a higher run-up of 3.02 m, but all three sites had almost the same inundation distance (200 to 250 m). The density of buildings in this area seems to have prevented the tsunami from reaching further inland. The flat topography resulted in run-up elevation that did not differ much from sea level.

Figure 3. Measurement results of inundation distances.

Sites 12 and 13 are Mamboro and Taipa. A run-up height of 3.5 m and a flow depth of 5.36 m caused severe damage to houses and casualties in Mamboro. In Taipa, a run-up of 4.88 m reached the roof of the passenger terminal of Taipa Port. North of Pantoloan Port is Wani Port (Site 15). Run-up, inundation, and flow depth were significant at this site

(3.58, 185.13, and 5.14 m, respectively). Site 16 (Lero) is the northernmost survey site inside Palu Bay. This site faces Site 1, which also lies at the mouth of Palu Bay. The last two sites were Tanjung Padang and Lende. These sites are located outside Palu Bay and close to the epicenter. A run-up of around 1 m was found at both sites. The coastal area between Sites 16 and 17 has steep slopes (hilly area). No tsunami footage was found for this area.

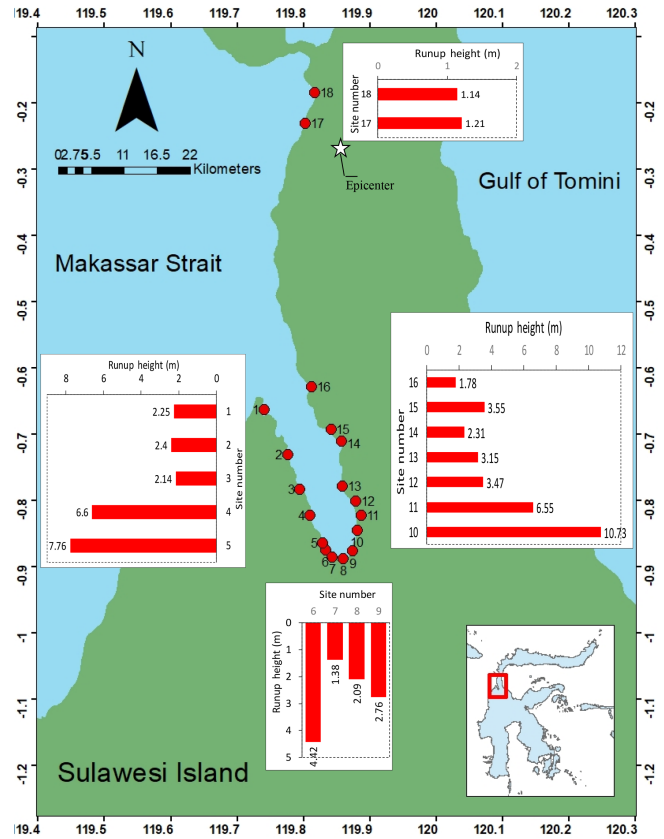
Figure 4. Measurement results of run-up heights.

ings, truncated building elements, collapsed walls, trash that was carried away, and fixed debris. A survivor showed us the highest places of the tsunami water in this area. A total of four cross sections of the coast were measured by our team. The measured run-up heights were 10.73, 7.97, 10.14, and 8.50 m, respectively, as shown in Table 1. The run-up height of 10.73 m is the highest in this survey (Fig. 5), which left only a few buildings standing. The highest run-up found in the field survey of Omira et al. (2019) was in Benteng Village, with a height of 9.1 m. Benteng Village (on the western coast) is compared with the highest run-up location found in our survey (Tondo, on the eastern coast).

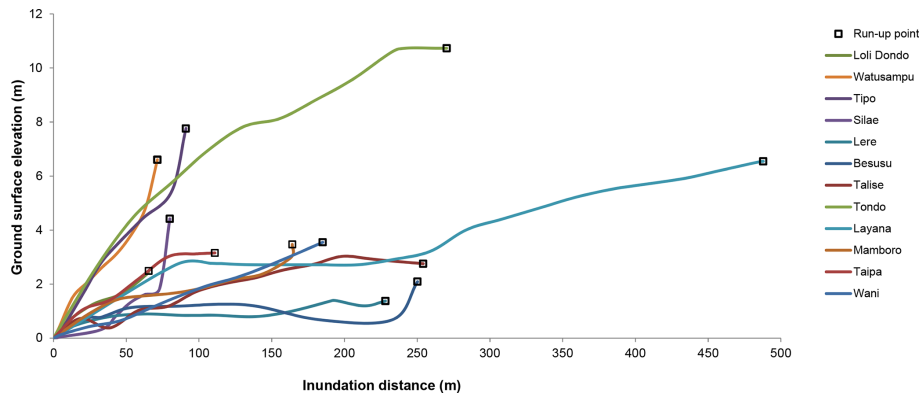
Figure 5. Transects of beach where tsunami wave arrived. The longest inundation distance is at the Layana site and the highest run-up is at the Tondo site.

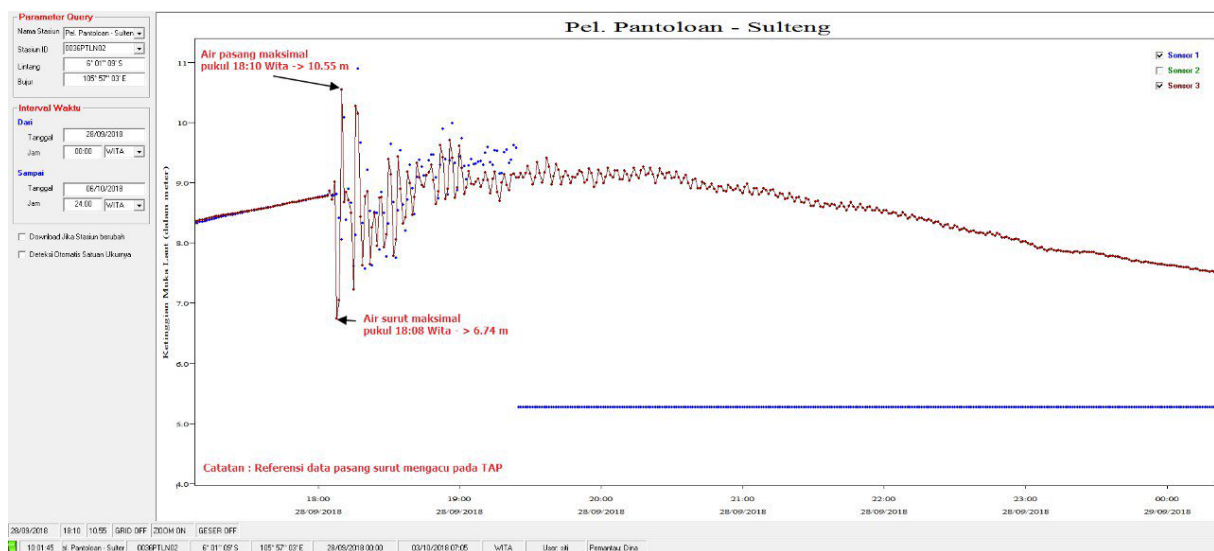
imum low tide (6.74 m) was at 18:08 local time and the maximum tide (10.55 m) was at 18:10 local time. This means that the tsunami wave height recorded at the station was 3.8 m. This wave height can be seen more clearly in Fig. 9, which is from the same source as that for Fig. 8. In addition, the first tsunami wave arrived at 18:07, with the wave trough at 18:08 and the wave crest at 18:10 local time (UTC+8).

Figure 8. Water level recording at the Pantoloan tidal station managed by the Geospatial Information Agency (Sudibyo, 2018a).

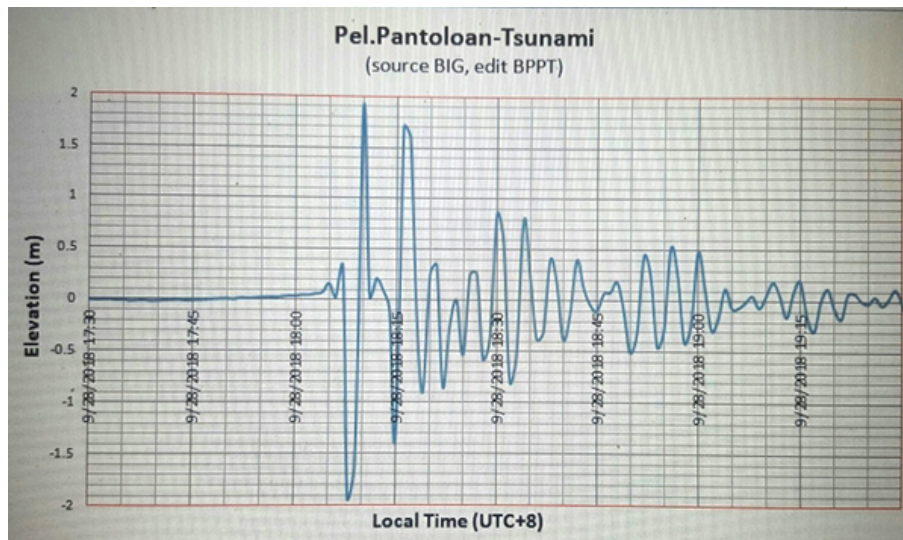
Figure 9. Magnified view of Fig. 9, sourced from the Geospatial Information Agency (Sudibyo, 2018b).
