The 22 December 2018 Mount Anak Krakatau volcanogenic tsunami on Sunda Strait coasts, Indonesia: tsunami and damage characteristics

Syamsidik^{1,2}, Benazir^{1,2}, Mumtaz Luthfi^{1,3}, Anawat Suppasri⁴, and Louise K. Comfort⁵

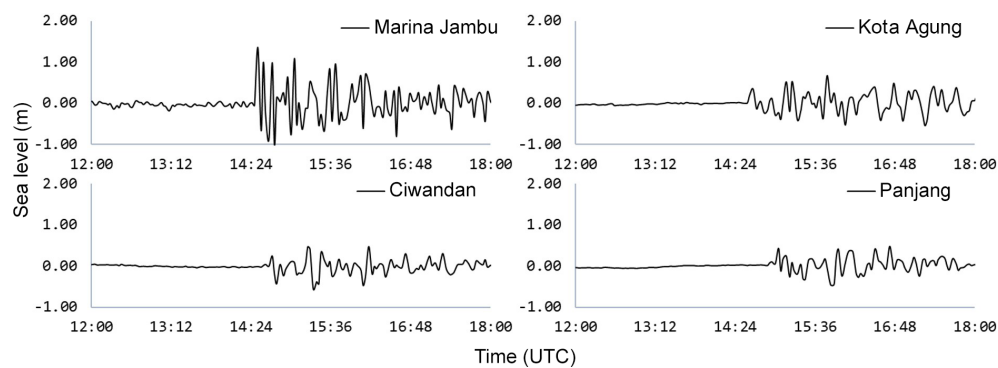
Tsunami arrivals were determined based on water elevations monitored at four tidal-gauge stations located around the Sunda Strait. The stations were Marina Jambu, Ciwandan, Panjang and Kota Agung. The tidal-gauge stations are operated by Indonesia Geospatial Information Agency (BIG, 2018). Each of the stations recorded 1 min interval water levels and are available online. Figure 2 shows the filtered tidal data from all four stations. The first detected tsunami wave arrival was recorded at Marina Jambu station at 14:30 UTC (at 21:30 local time). The time of generation of the tsunami from the source was not clear, since no tidal station was located around the volcano. Thirteen minutes later (14:43 UTC), the tsunami wave was recorded at the Ciwandan station, near Cilegon, Banten. The first tsunami wave was recorded at 14:40 UTC at the Kota Agung station, which was almost simultaneous with the Ciwandan station. Although Panjang is closer to the Mount Krakatau complex than Kota Agung, due to tsunami wave arrays that caused diffraction and refraction, the arrival time at Kota Agung was 10 min earlier than at Panjang stations (at 14:50 UTC). The landslide area at the southern part of Mount Anak Krakatau also contributed to arrival times.

Figure 2. Filtered water elevation fluctuations measured at four tide-gauge stations around Sunda Strait, indicating the tsunami wave at arrival.

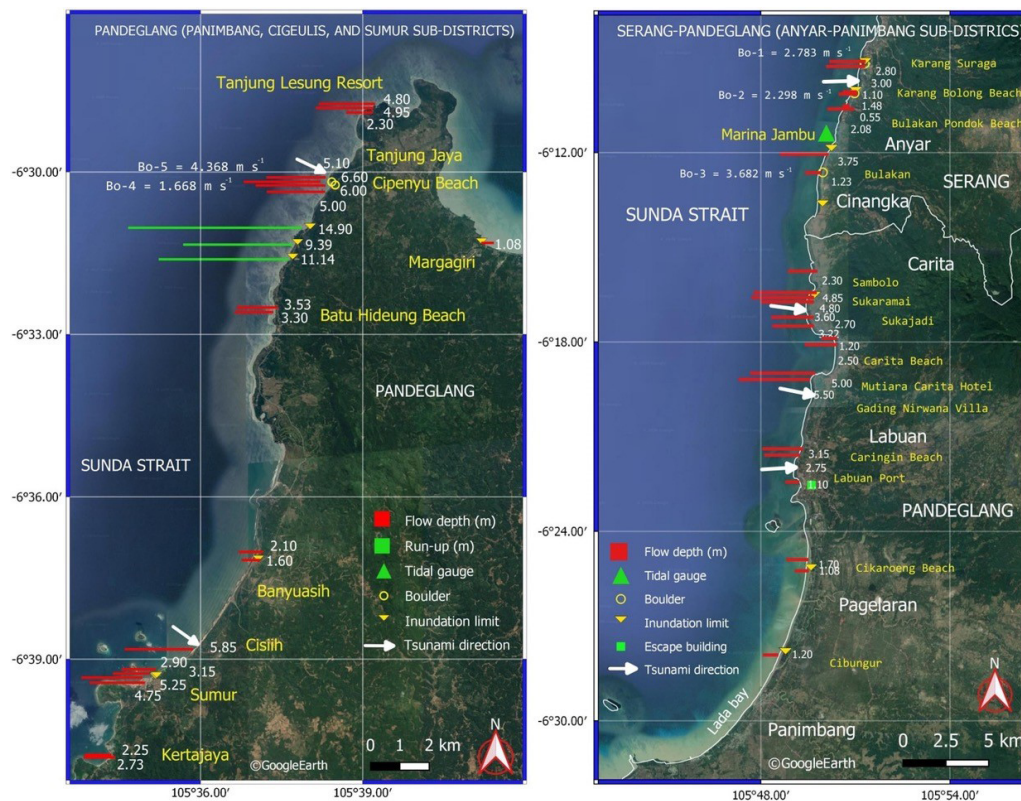
Impacts of the tsunami in Banten were found to be more severe than in Lampung. Along the western coast of Banten, impacts were visible but not seen to be continuous. Figure 3 shows tsunami flow depth distribution and run-up limits measured at Banten coasts. There were some areas where evidence of tsunami waves could not be identified based on physical observations and eyewitness interviews. It is important to note that the interviewees' expressions were not meant to clarify the tidal-gauge data, as this was difficult to do. Tide elevation data reported from the tide stations were 1 min average data. The northernmost extent of the tsunami effects was located at the Anyar coast. The northernmost point of the tsunami depth was identified at Villa A Pahmi, located in the village of Karang Suraga. Here, the tsunami depth was 2.80 m (F02), identified from gazebo roof damage in the backyard of the villa. Around this village, the maximum tsunami depth was 3.00 m (F01), based on a broken twig. Around Villa A Pahmi, a number of tsunami boulders were also found. Boulder materials came from a revetment structure protecting the coastline from erosion. The location of the revetment made determination of the travel distance of the transported boulders more facile. The farthest point of the transported boulder was 28 m from the revetment structure (Bo-1). Based on interviews with two tsunami survivors in this village, there were two significant wave attacks in this area; the second wave was the largest and the most destructive. A similar account was also revealed by another survivor at Villa Karang Bolong of Serang. Tsunami waves damaged some houses and villas in this area. To the south of this area, impacts of the tsunami were more visible, as they were seen in the Cinangka sub-district.

Figure 3. Tsunami flow depth distribution around Serang, the northern area of Pandeglang (a) and around southern Pandeglang (Panimbang–Sumur; b). Flow depths are drawn in red bars. Green bars represent run-up heights. The green rectangle represents the location of a tsunami escape building at Labuan. (The map is adapted from Google Earth.)

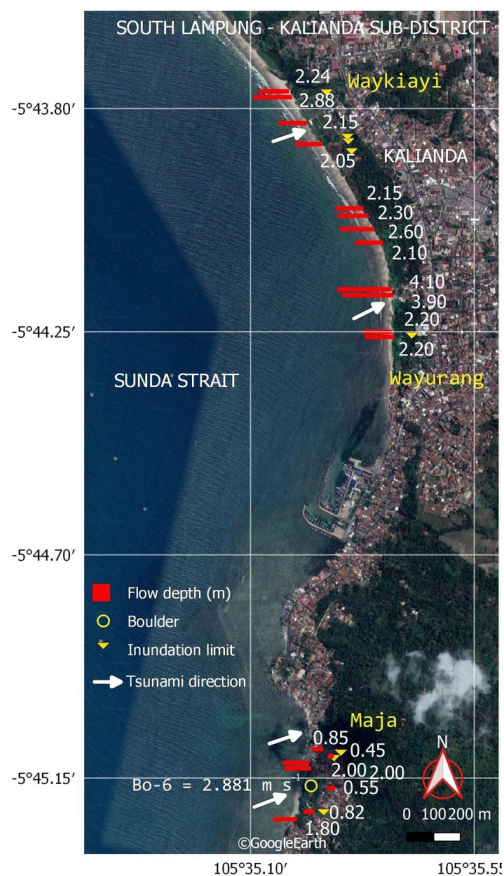
Impacts of the tsunami generated by the Mount Anak Krakatau eruption in Lampung were measured three locations, i.e. two areas in South Lampung and one area in the district of Tanggamus. South Lampung was the most tsunami-affected area at the Lampung coasts. In South Lampung, impacts of the tsunami were found to be significant in the Kalianda and Rajabasa sub-districts. Three villages in Kalianda were selected for detailed investigations, namely Waykiayi, Wayurang and Maja. Distributions of tsunami flow depths in Kalianda can be seen in Fig. 9.

Figure 9. Flow depth distribution and run-up limits in Kalianda, South Lampung. Green bars and yellow triangles represent flow heights and inundation limits measured at the locations, respectively. (The base map was adapted from Google Earth.)

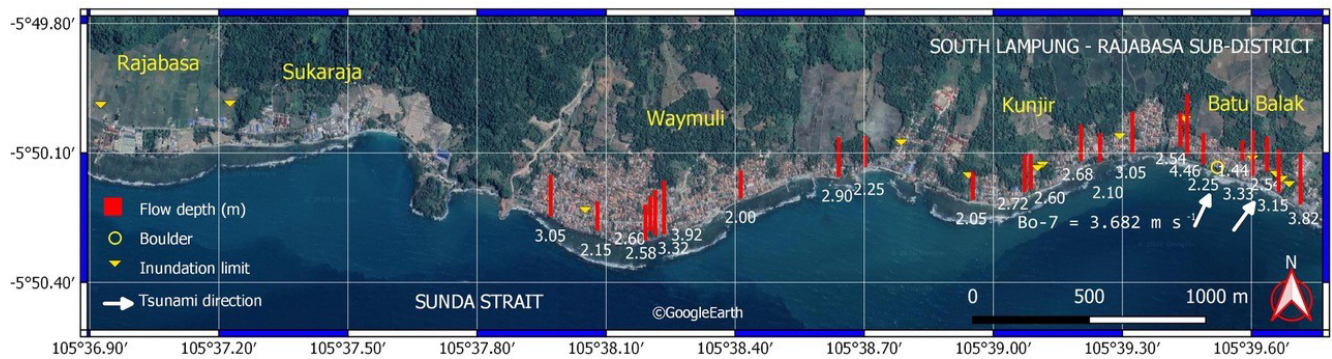
Impacts of the tsunami on Rajabasa were worse than those on Kalianda. We surveyed three villages in this sub-district, namely the villages of Waymuli, Kunyir and Batu Balak. Measured tsunami flow depths in this area were between 2.0 and 4.5 m, as can be seen in Fig. 10. This is a fishing community, and the majority of the coastal area is a residential area for the fishermen. Other related buildings, such as a shrimp hatchery, were also damaged by the tsunami.

Figure 10. Flow depth distribution and run-up limits in Rajabasa, South Lampung. (The map was adapted from Google Earth.)

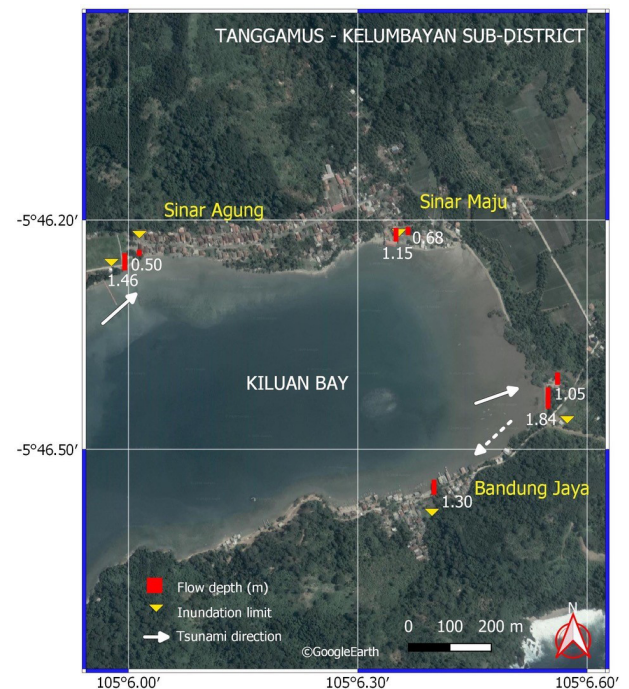
namely Sinar Agung, Sinar Maju and Bandung Jaya. Measured tsunami flow depths were 1.46, 1.15 and 1.84 m at the villages of Sinar Agung, Sinar Maju and Bandung Jaya, respectively (see points F114, F111 and F116 in Syamsidik et al., 2019b). The most severe impact in this area was investigated at a wooden elevated house that was transported about 3.5 m from its original location. A lone casualty was found at this location. Here, tsunami flow depth was 1.05 m (point F115). Other damage was found at an elevated wooden house at the northeastern part of the bay. Based on eyewitness in-

terviews, damage was caused by the reflected tsunami wave after hitting the closed end of the bay.

Figure 12. Tsunami flow depths distribution in Teluk Kiluan, Lampung. An arrow represents the tsunami wave direction reflected from the close end of the bay. (The map was adapted from Google Earth.)

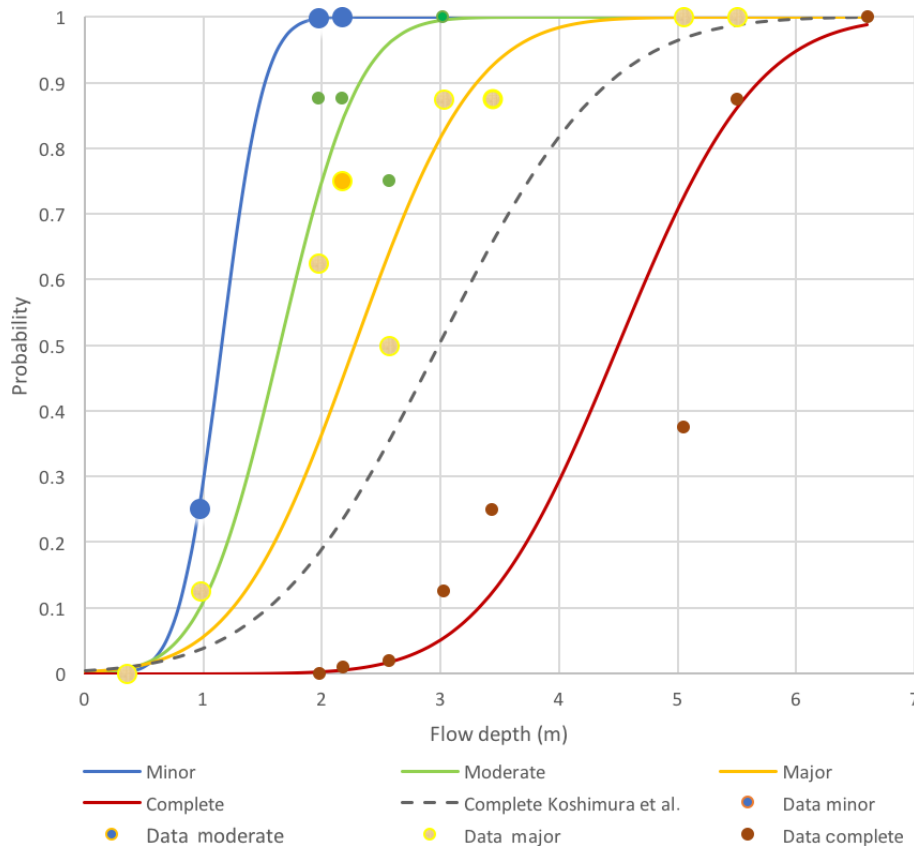
Fragility curves in Fig. 14 reveal that the absolute damage due to the tsunami waves occurred at a flow depth of 6.5 m. Lower probabilities of complete damage were found in this study compared to the 2004 Indian Ocean tsunami in Banda Aceh (Koshimura et al., 2009). These findings were significantly different from the 2018 Palu tsunami (Paulik et al., 2019), where earthquake and liquefaction (liquefied gravity flows) also contributed to the damage (Sassa and Takagawa, 2019).

Figure 14. Fragility curves of confined-masonry-type houses, as impacts of the 2018 Mount Anak Krakatau volcanogenic tsunami. Dashed line represents a complete damage fragility curve produced by Koshimura et al. (2009).
