Tsunami vulnerability of buildings and people in South Java – field observations after the July 2006 Java tsunami

S. Reese¹, W. J. Cousins², W. L. Power², N. G. Palmer², I. G. Tejakusuma³, and S. Nugrahadi³

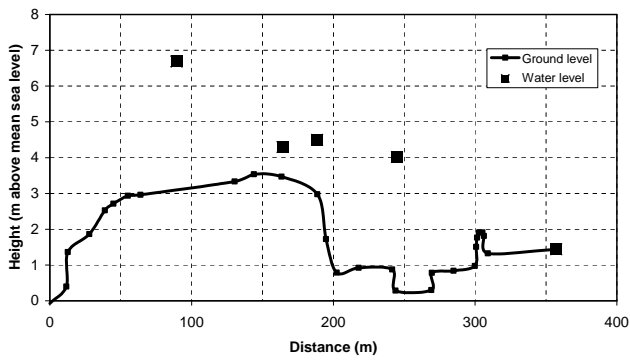
Fig. 2. Ground profile and flow depths measured at Widarapayung (Transect 1).

Elevation and depth measurements (Transect 1) were taken here. The sand dune beneath the pool complex was about 150 m wide and rose to a height of about 3.5 m above mean sea level (m.s.l.) (Fig. 2). The inland edge of the dune fell sharply to paddy fields about 1 m above m.s.l., then a further 0.5 m to a sluggish river running parallel to the beach for several kilometres. The tsunami flooded the paddy fields and river, and the subsequent rapid drainage washed away the approaches to a bridge across the river. Inland of the river there were more paddy fields that had been lightly inundated up to about 50 m beyond the river, giving a total inundation distance of about 350 m. There were extensive deposits of fresh sand on the sand dune (measured between 14 and 25 cm; Fig. 3), often covering low vegetation and ground litter, and deposits of compacted sandy silt in the paddy fields between the dune and the river. The crops in those paddy fields had been destroyed.

Figure 2 (above) shows the ground profile and estimated flow depths at Widarapayang. Zero distance represents the edge of the sea at the time of the profile measurement. At this location the beach was about 40 m wide. Except the urban areas most of the transects typically followed the same profile. There was usually a gently sloping beach, followed by relatively flat sand dune 200 to 400 m wide (bearing houses and trees), and then a steep descent to lower-lying paddy fields. At Widarapayang the topography was slightly different due to a river that cut through the fields.

The maximum observed water level at this site was 6.7 m, the maximum flow depth 3.75 m and the inundation limit 357 m. The water level estimate at 250 m from the coast was from an eye witness account that the water reached the handrail on a bridge across the river behind the near-shore dune. It appears unrealistically high, but might have been from a bow-wave that could have occurred during the post-tsunami flood flow down the river, rather than during the initial tsunami.

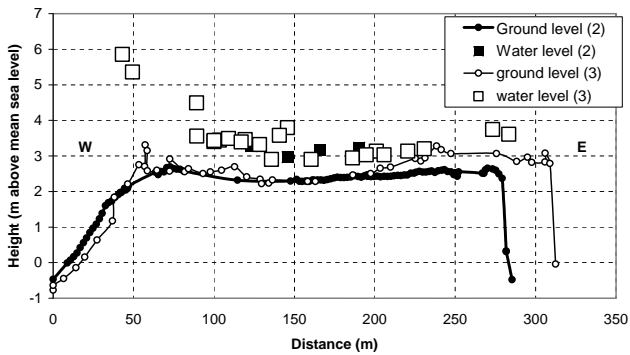
The next example (Fig. 7, Transects 2 and 3) is from urban locations in Pangandaran. According to eye-witnesses the tsunami struck the western part of the peninsula first (about 16:19 LT), travelled around the tombolo, and hit the eastern part of the peninsula about 1 min later. This is consistent with Lavigne et al.'s (2007) observations. According to eye-witnesses, the water met not exactly in the middle but slightly further east around 200 m from the western beach, because of the time delay of the eastward wave. These observations are reflected in our inundation graphs which indicate a minimum water depth at about the 200 m mark.

The maximum measured wave height and flow depth for Transect 2 were 3.27 m and 0.95 m, respectively, and 5.86 m and 3.10 m for transect 3. These seem to correspond with the survey results from Lavigne et al. (2007) and Tsuji et al. (2007). Note also the very rapid decrease in water depth, from about 3 m to less than 1 m, in a distance of about 100 m.

Fig. 7. Ground profile and estimated water levels of transect 2 & 3 in Pangandaran. The steep drop at the right-hand (east) side is a sea wall at the eastern end.

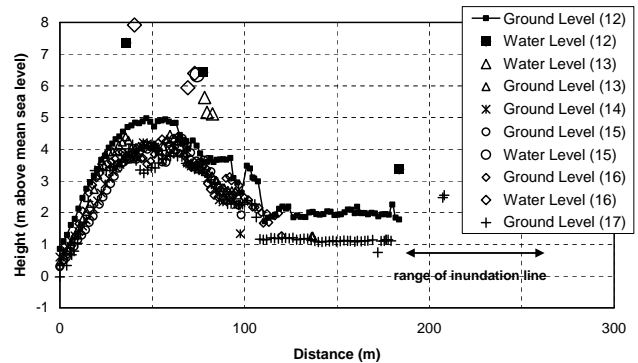
Profile 12 was at the easternmost end, profile 17 at the westernmost (Fig. 8). There was a steady decrease in height of the entire ground profile, by about 1 m, from east to west. Profile 12 traversed the dune then crossed paddy fields to an “island” in the paddy fields, while profile 17 traversed the coastal dune then paralleled a road through the paddy fields. The remaining profiles terminated at the inland edge of the

Fig. 8. Ground profiles 12–17 and water levels throughout Batuhiiu.

coastal dune. All the measurements show the same pattern with the maximum water level around the dune crest (e.g. 7.9 m, flow depths 3.7 m along transect 16), decreasing to 2 m around the buildings and 1 m in the paddy fields. The Inundation line was observed to lie between 260 m (transect 12) and 180 m (transect 17).

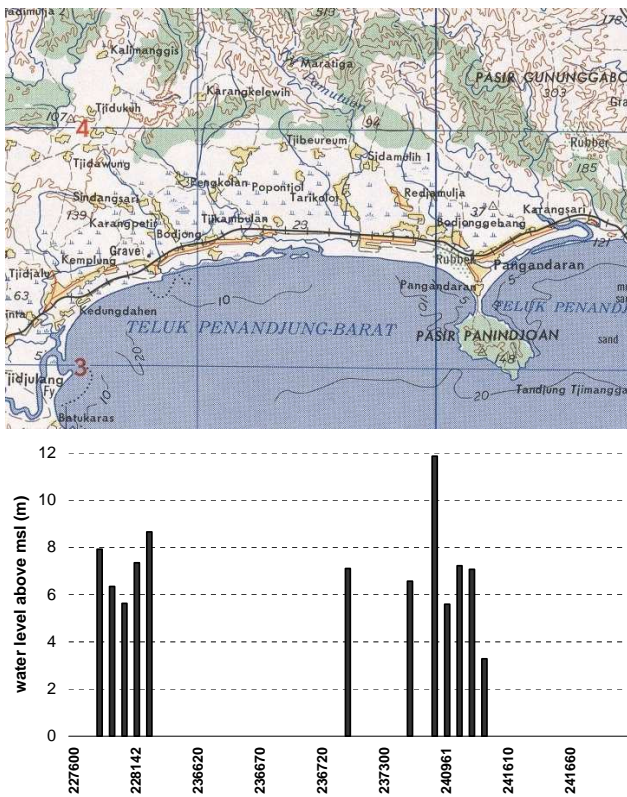
Along the coast in the Pangandaran district the maximum water levels ranged from 3.3 m in the sheltered areas close to the Pangandaran peninsula, to 11.9 m in Pananjung Village (Fig. 9). The water height of 11.9 m (above m.s.l. – corresponding to a depth of about 9 m above ground level) was an observation made by the manager of a hotel in relation to palm trees between the hotel and the sea. It is much higher than all other estimates and so, assuming that it is as reliable as the others, must have been a localised phenomenon. The

Fig. 9. Maximum observed water levels in the Pangandaran area.

fact that other teams did not measure water levels of this dimension in this area might argue for an overestimation. Our other levels are in line with the measurements from Lavigne et al. (2007) and Tsuji et al. (2007).

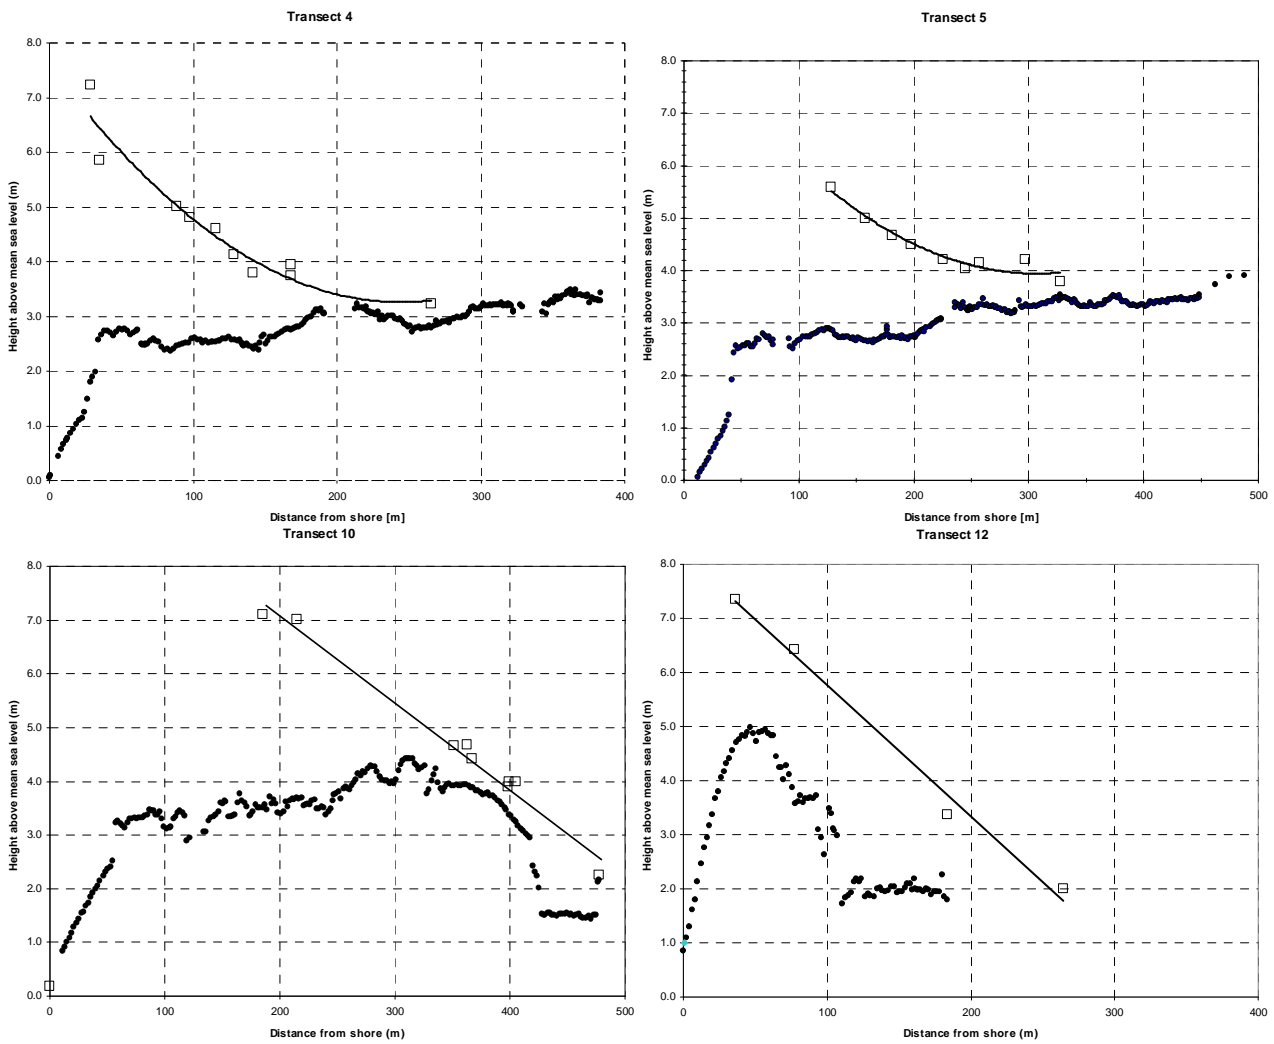
Comparing the various ground profiles and wave height measurements shows how the on-shore topography affects the flow of the tsunami wave. By taking the wave heights/water levels and adding a trend-line reveals two different patterns, a linear and an exponential decay of the water level (Fig. 10).

The upper graphs show a profile with a gradually increasing terrain while the topography of the lower transects is characterised by a steep descent towards a lower-lying hinterland. Looking at the trend-lines, the two top graphs illustrate an exponential decay of the on-shore wave and is more or less what you would expect from drag (trees, buildings) over a distance inland. However, the linear trend-lines indicate that the dunes may have acted as a broad-crested weir, causing the waves to speed up on the down-slope side, as has also been observed during the Indian Ocean Tsunami (see EERI, 2005).

Fig. 10. Decay of on-shore water level.

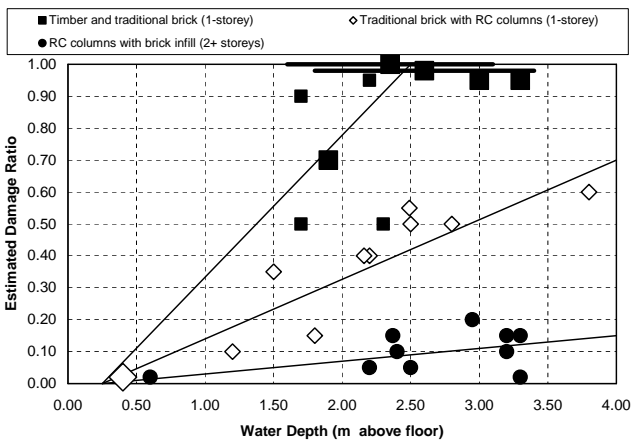
Damage ratios, defined as (cost to repair)/(cost to replace), were derived from subjective estimates of the proportionate levels of damage to the four main structural elements of the damaged buildings, with the four elements being the foundation and floor (estimated 15% of total construction cost), walls (50%), roof and ceiling (15%) and fittings & services (20%). The importance of reinforcement was very clear – traditional unreinforced brick buildings were essentially totally destroyed (damage ratio = 1) at an inundation depth of 2 m, whereas adding minimal reinforced-concrete columns reduced the damage levels to one third of that (0.33) (Fig. 15). Multi-storey buildings with substantial reinforced-concrete frames suffered relatively very low levels of damage. Figure 15 shows the damage ratios for the four construction types. Based on these damage ratios, simplistic linear fragility curves were derived. Damage functions or fragility curves are the most common way to estimate hazard related damage because there is usually a correlation between monetary losses (or the damage state) and the hazard intensity, in this case inundation depth. The zero points for the straight lines are not well constrained, and probably are only

Fig. 15. Estimated damage ratios and fragility curves as a function of inundation depth for various types of Pangandaran buildings. The large symbols represent averages from large groups of buildings (60 or more) that had relatively uniform levels of damage, and the small symbols one to few buildings. Two of the large symbols are associated with ranges in water depth indicated by horizontal bars. A damage ratio of 0.9 indicates that the concrete floor was potentially reusable, 1.0 indicates that the area had been bulldozed clear.

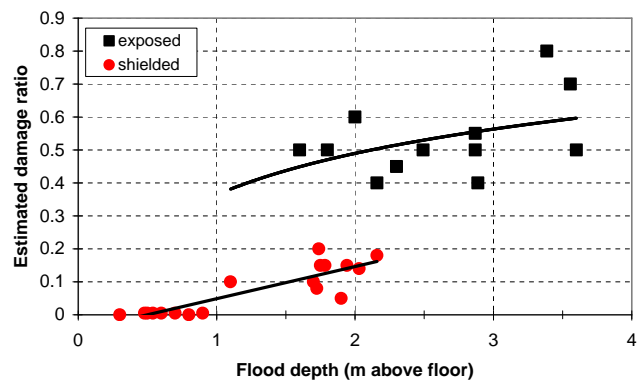
Fig. 16. Damage ratios and fragility curves as a function of inundation depth and exposure for traditional brick buildings with RC columns.

made of brick with RC columns sustained damage not greater than 20%, similar exposed buildings all suffered damage above 40% and were exposed to greater flood depths (Fig. 16). Thus, these buildings need to be separated and accordingly two different fragility curves are required. A regression analysis suggests two completely different shapes. For the exposed buildings a logarithmic shape fits best while for the shielded buildings an exponential shape seems more appropriate.

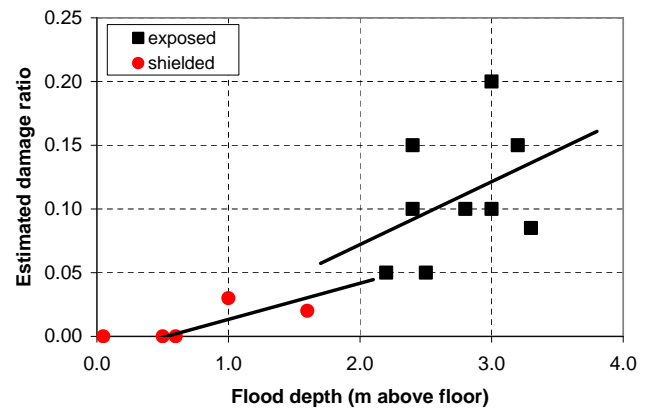
Looking at the well-constructed, reinforced buildings under this perspective doesn't show a clear trend as before (Fig. 17), but it is likely that this is due to the smaller number of samples. Nevertheless, a difference in the level of damage is still visible. The exposed buildings have sustained damage levels 2 to 5 times higher than the shielded ones.

Fig. 17. Damage ratios and fragility curves as a function of inundation depth and exposure for buildings made of RC columns with brick infill.

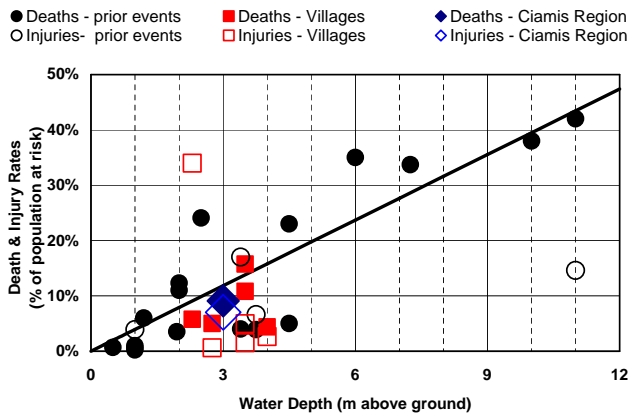
Fig. 18. Death and injury rates as functions of water depth. The trend line is fitted to the death data from prior events (Saunders (compiler) 2006).

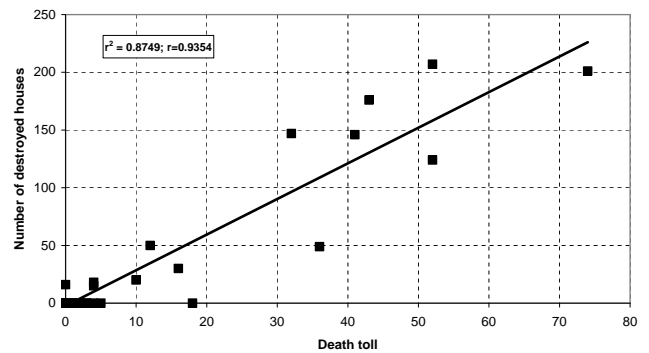
More recently there has been a tendency to relate casualties to levels of damage. The detailed Java data enabled us to analyse the data regarding a possible correlation between the death toll and the number of houses destroyed. There appeared to be a clear correlation between the two parameters (Fig. 19), possibly providing a way of estimating casualties when direct counts are not available.

Fig. 19. Death rates as functions of building destruction.
