The 27 May 1937 catastrophic flow failure of gold tailings at Tlalpujahua, Michoacán, México

J. L. Macías¹, P. Corona-Chávez², J. M. Sánchez-Núñez³, M. Martínez-Medina^{4,5}, V. H. Garduño-Monroy², F. García-Tenorio¹, and G. Cisneros-Máximo¹

Received: 16 June 2014 – Accepted: 6 July 2014 – Published: 20 August 2014

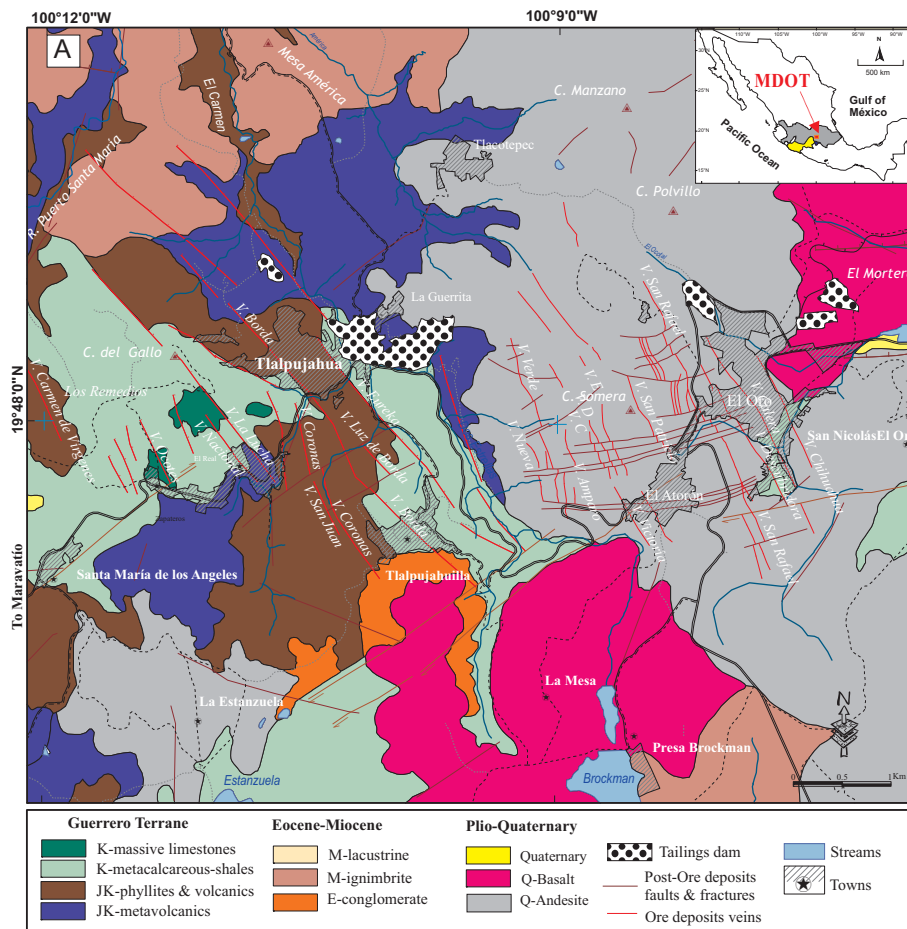
Figure 1. Location of the Mining District of El Oro-Tlalpujahua (MDOT) in Central Mexico (inset), showing the principal rock types, ore veins, and tailings dams. Geological map of the MDOT from Corona-Chavez et al. (2010).

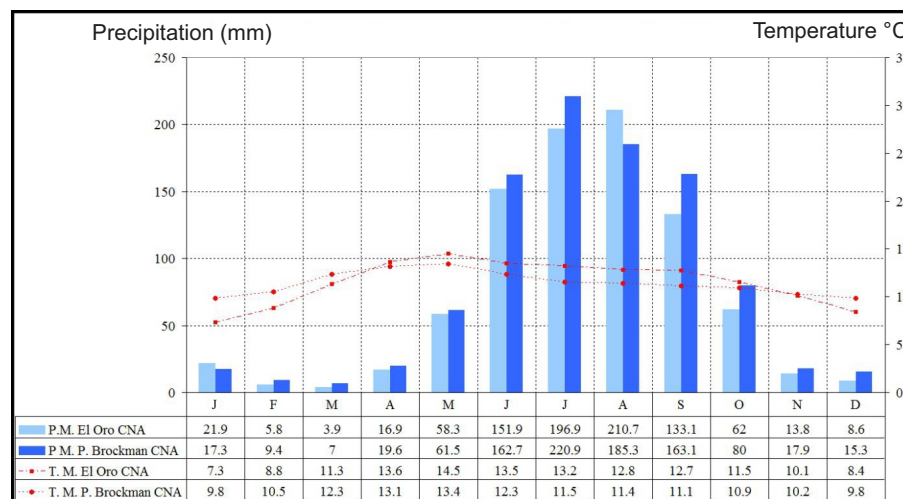
Unfortunately, no local weather stations existed around the MDOT before the failure. The first station (15183-Oro), which became operational in 1972, is relatively close to the Los Cedros metallurgical plant (Fig. 5). This station has a continuous rainfall record from 1972 to 2002, with some small gaps in 1988, 1993, and 1994. By using descriptive statistical methods. Martínez-Medina et al. (2012) concluded that the MDOT showed an average precipitation of 900 mm year⁻¹ (904 mm mode and a median of 34 mm). These results resemble the regional rainfall weather (see Fig. 2). However, it is worth noting that, during this period, at least two years had atypical rainfall (exceeding > 1200 mm). The first is evidently related to the 27 May 1937 catastrophic flow failure and, the second occurred during the 1986 year, when the rainfall exceeded 2000 mm (Fig. 13). Martínez-Medina et al. (2012) argued that return periods for 1800–2100 mm rainfalls occurred every 29 years. On the other hand, there is evidence that atypical rainfall periods have caused other catastrophic debris flows along the Tlalpujahua-Americas stream as it has been attested by at least two historical floods (older than 1937) observed in the stratigraphic record (site TL-14). One of them, had a coarser granulometry than the 1937 flood, and contained broken glass and blocks from an old bridge destroyed by this debris flow suggesting that previous events along the Tlalpujahua-Americas stream have had larger magnitudes. By considering the time recurrence of the most recent extreme rainfall event (in 1986) and the sedimentological record, we may expect that an atypical event may occur in the near future in Tlalpujahua and consequently the risk is still present.

Figure 2. Annual precipitation and temperature data recorded at the meteorological stations at from El Oro (15183) and Presa Brockman (15070) of the Comisión Nacional del Agua (CNA).

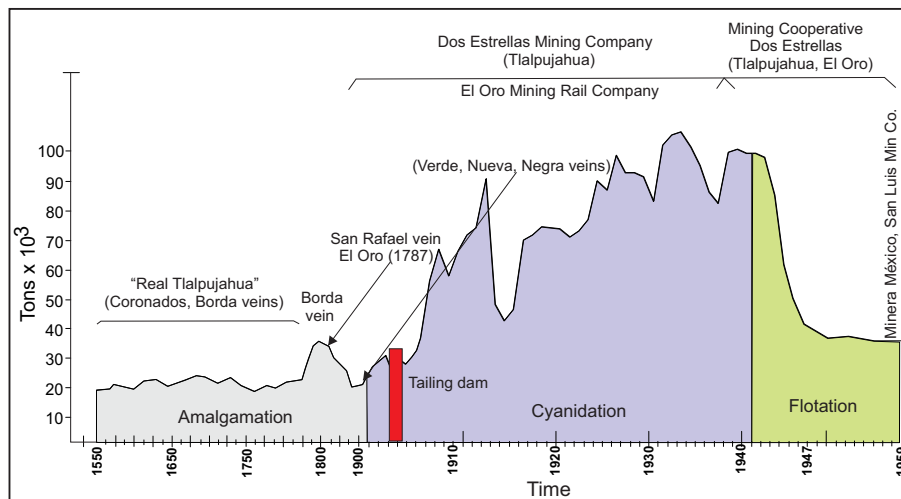
Figure 3. Historical record of the amounts of material extracted by the Mining Company (1898–1938) and Cooperativa Minera “Dos Estrellas” (1939–1959) and the relationships with the metallurgical processes used (after Uribe Salas, 2008).

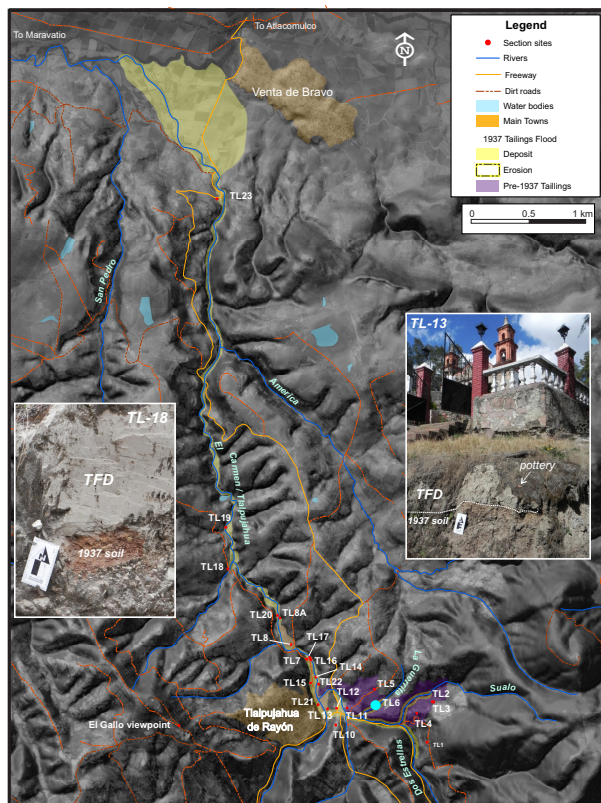
Twenty-two stratigraphic sections were measured of the remnants along the path of the Tailings Flood Deposit (TFD) (Fig. 8). From ten of these sections, we sampled 14 specimens to perform granulometric analyses from -8 to $+12 \phi$ grain-sizes (Fig. 9). The correlation of these sections suggested that the deposit mainly consists of one massive layer. However, at two locations (El Carmen Church TL08 and TL14) three and two beds were described, respectively. At locations between San Jesus del Monte and El Carmen the deposit is soft and loose, but beyond El Carmen church it is partly indurated and contains void spaces in all sections.

Along its extent, the TFD has variable thicknesses, for instance around 40 cm at section TL-13 (San Jesus del Monte Church), 2.8 m at site TL16 (0.8 km downstream), and 40 cm at the farthest location (TL-23) (Fig. 8). As a whole, the deposit is massive, matrix-supported ($> 56 \%$), and composed of sandy to clayey particles (Fig. 9, Table 2). These characteristics indicate that the deposit had an unimodal granulometric distribution with the main mode shifting from 1 to 4ϕ (Table 2) and good sorting ($0.55\text{--}1.35 \sigma \phi$). The structure, texture, and grain-size characteristics of TFD suggest it corresponds to a hyperconcentrated flow deposit (Fig. 9). In some sections, however,

Figure 8. Shaded relief map of the MDOT displaying the location of Tlalpujahua and Venta de Bravo villages, the extension of Los Cedros tailings in 1937 as well as the present extension of the 1937 flood deposit. Red circles are stratigraphic sections measured during this study.

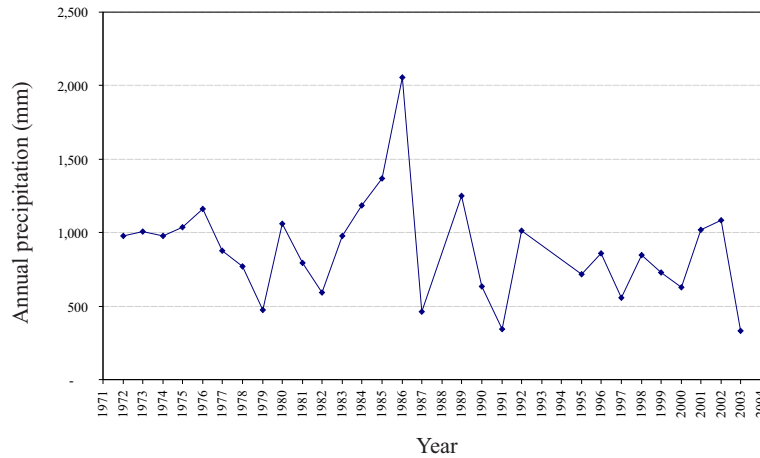
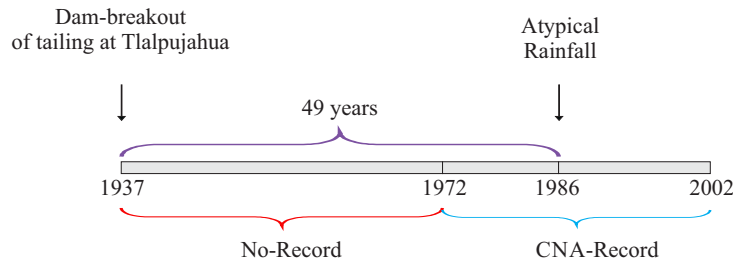
Figure 13. Timeline showing the 1986 year with exceptionally high precipitation recorded in the region of MDOT. Data from the 15183-El Oro meteorological station. The Las Llamas flood occurred during sustained intense rainfall in May 1937 when no weather station existed. It is interesting to note two atypical precipitation events have return periods of 49 years (Corona Chavez et al., 2010).
