Nat. Hazards Earth Syst. Sci. Discuss., 2, 4299–4330, 2014 www.nat-hazards-earth-syst-sci-discuss.net/2/4299/2014/ doi:10.5194/nhessd-2-4299-2014 © Author(s) 2014. CC Attribution 3.0 License.

Rockslides on limestone cliffs with sub-horizontal bedding in the southwestern calcareous area, China

Z. Feng¹, B. Li¹, Y. P. Yin², and K. He³

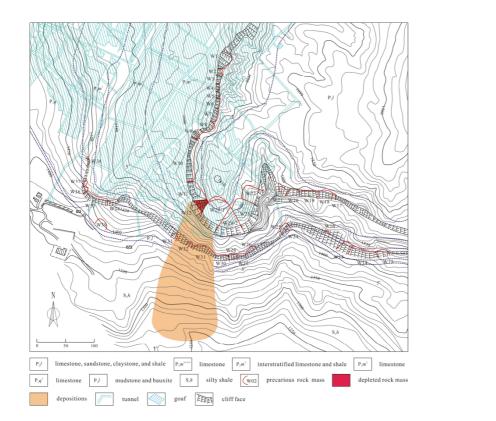
Figure 7. Topographic map of the Zengzi Cliff area and the distribution of precarious rock masses on its edge. Room and pillar mining has been conducted in the $P_1/$ sequence since 1983, and the goaf extends from south to north. The depth of the goaf is about 100–120 m for the first step and 350–400 m for the second step.

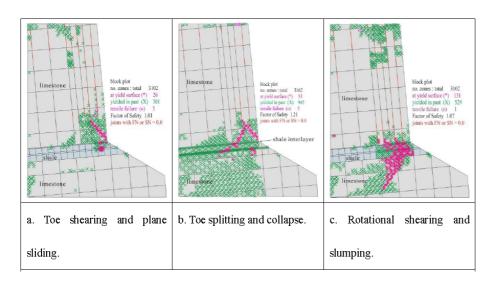
- over the interlayer as well as the overlying competent rocks. The rock mass at the toe is in a plastic state as a result of compression fractures. Two yield surfaces dipping in opposite directions are formed (Fig. 14b), similar to tensile failure behavior for some brittle rock samples. The displacement prior to collapse is limited, and remarkable squeezing out is unlikely to be observed in the toe area (Fig. 15b).
- ²⁵ A rock slide might burst out in hard rock where back scars cut through, and no discontinuities or weak strata are exposed at the toe. Irregular scars caused by brittle and shear failure through rock mass dip out of the cliff faces. The yield zone is mainly located at the block toe but not in the underlying rocks (Fig. 14a). The fracture of the toe rock mass gives rise to joints opening immediately above. Numerical computation

Figure 14. Plastic state and joint opening for rockslide initiation in cliff slopes.

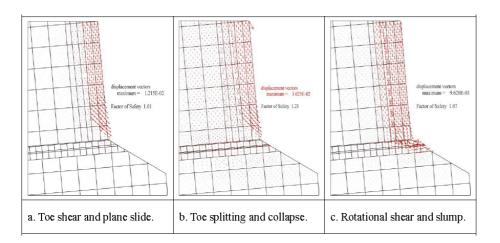
- ⁵ The natural stress field is characterized by a tensile zone on the crest and stress concentration at the toe. When a thick incompetent basal layers is present, the jointed slope tends to fail as a slump. A yielding curved surface gradually emerges in the basal layers under long-term gravitational compression of the upper cap rock. A large plastic zone is present in the weak basal layers and nearby hard rock mass (Fig. 14c).
- ¹⁰ The horizontal movement of the weak stratum is prominent. Pre-existing joints in the hard rock mass widen upward and slip with the ductile flow of the basal layers. The movement of the massive unstable rock mass is dominated by subsidence in the crest area and back tilting at the toe (Fig. 15c).

gives a plane yield surface at the bottom of the separated block, which is called a potential failure surface (Fig. 15a). A small displacement appears before the outbreak of a compound slide. However, ground fractures on the crest and spalling in the toe area might occur.

Figure 15. Displacement vectors of the initial failures of cliff slopes.

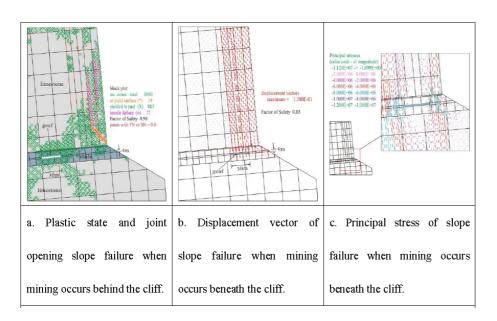
The failures at the three locations described above are related to large areas of mining out. Pells (2008) used a continuum 2-D model to assess macro-scale movements of cliff faces caused by total extraction and proved that the steep slope tends to tilt outwards when mining occurs beneath the cliff, and extraction well behind the cliff face causes back tilt. Our similar simulations are shown in Fig. 16. The rock slide model in Fig. 14a was adopted. The roof tends to collapse, and the surrounding rocks gradually fracture. The undermining-induced subsidence of the crest causes the dilation and tensile failure of the rock mass (Fig. 16a). The FOS decreases from 1.01 to 0.98 when the underground mining is located behind the cliff face. When the extraction is directly beneath the cliff, the rock mass is subjected to a small constraint; hence, cliff failure break-out through the fractured rock mass between the goaf and open face is feasible (Fig. 16b). The maximum principal stress on both sides of the goaf increases while that of the overlying rocks decreases (Fig. 16c).

Figure 16. Numerical simulations of mining in cliff slopes.
