The 27 May 1937 catastrophic flow failure of gold tailings at Tlalpujahua, Michoacán, México

J. L. Macías¹, P. Corona-Chávez², J. M. Sánchez-Núñez³, M. Martínez-Medina^{4,5}, V. H. Garduño-Monroy², F. García-Tenorio¹, and G. Cisneros-Máximo¹

Received: 16 June 2014 – Accepted: 6 July 2014 – Published: 20 August 2014

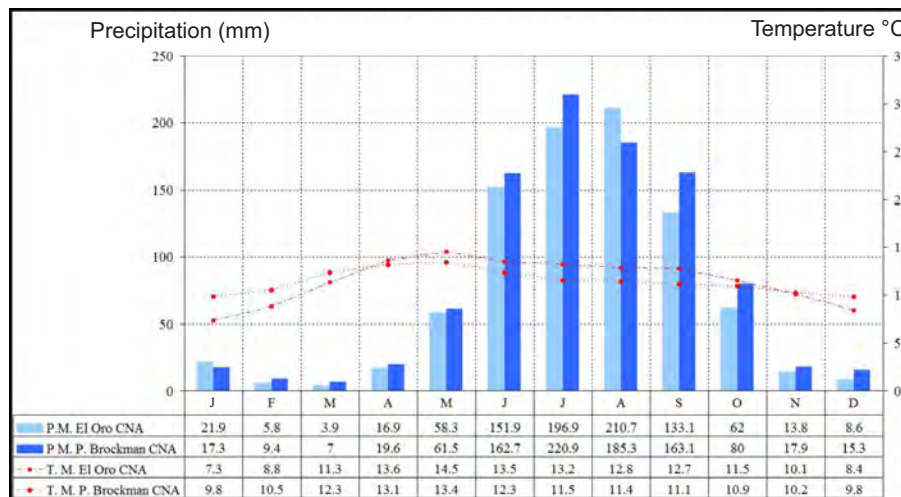
Unfortunately, no local weather stations existed around the MDOT before the failure. The first station (15183-Oro), which became operational in 1972, is relatively close to the Los Cedros metallurgical plant (Fig. 5). This station has a continuous rainfall record from 1972 to 2002, with some small gaps in 1988, 1993, and 1994. By using descriptive statistical methods. Martínez-Medina et al. (2012) concluded that the MDOT showed an average precipitation of 900 mm year⁻¹ (904 mm mode and a median of 34 mm). These results resemble the regional rainfall weather (see Fig. 2). However, it is worth noting that, during this period, at least two years had atypical rainfall (exceeding > 1200 mm). The first is evidently related to the 27 May 1937 catastrophic flow failure and, the second occurred during the 1986 year, when the rainfall exceeded 2000 mm (Fig. 13). Martínez-Medina et al. (2012) argued that return periods for 1800–2100 mm rainfalls occurred every 29 years. On the other hand, there is evidence that atypical rainfall periods have caused other catastrophic debris flows along the Talpujahu-Americas stream as it has been attested by at least two historical floods (older than 1937) observed in the stratigraphic record (site TL-14). One of them, had a coarser granulometry than the 1937 flood, and contained broken glass and blocks from an old bridge destroyed by this debris flow suggesting that previous events along the Talpujahu-Americas stream have had larger magnitudes. By considering the time recurrence of the most recent extreme rainfall event (in 1986) and the sedimentological record, we may expect that an atypical event may occur in the near future in Talpujahu and consequently the risk is still present.

Figure 2. Annual precipitation and temperature data recorded at the meteorological stations at from El Oro (15183) and Presa Brockman (15070) of the Comisión Nacional del Agua (CNA).

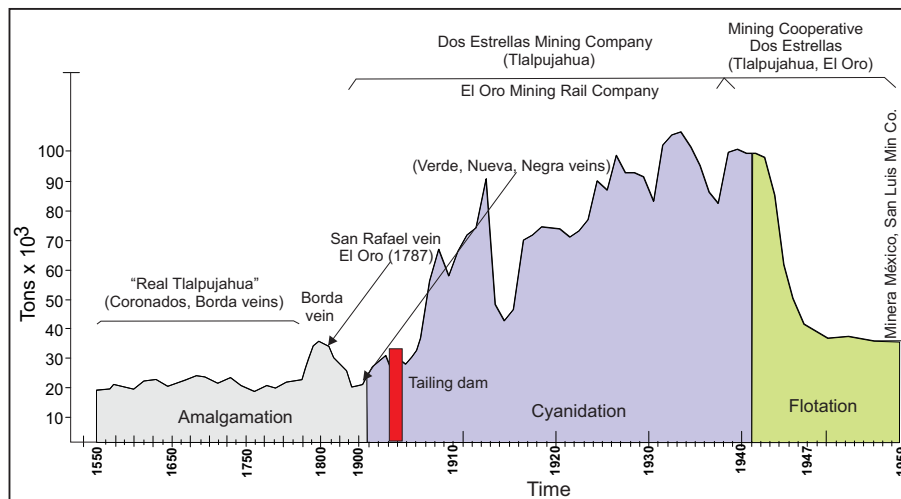
Figure 3. Historical record of the amounts of material extracted by the Mining Company (1898–1938) and Cooperativa Minera “Dos Estrellas” (1939–1959) and the relationships with the metallurgical processes used (after Uribe Salas, 2008).

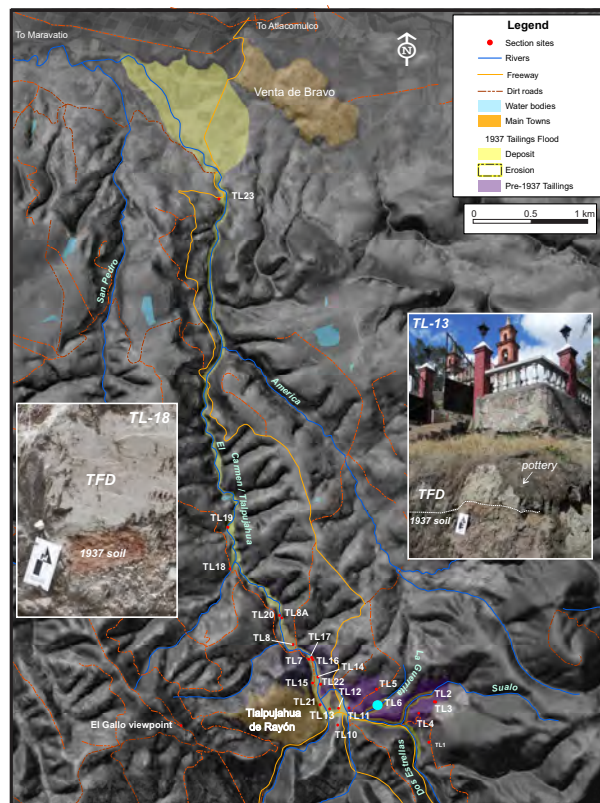
Twenty-two stratigraphic sections were measured of the remnants along the path of the Tailings Flood Deposit (TFD) (Fig. 8). From ten of these sections, we sampled 14 specimens to perform granulometric analyses from -8 to $+12 \phi$ grain-sizes (Fig. 9). The correlation of these sections suggested that the deposit mainly consists of one massive layer. However, at two locations (El Carmen Church TL08 and TL14) three and two beds were described, respectively. At locations between San Jesus del Monte and El Carmen the deposit is soft and loose, but beyond El Carmen church it is partly indurated and contains void spaces in all sections.

Along its extent, the TFD has variable thicknesses, for instance around 40 cm at section TL-13 (San Jesus del Monte Church), 2.8 m at site TL16 (0.8 km downstream), and 40 cm at the farthest location (TL-23) (Fig. 8). As a whole, the deposit is massive, matrix-supported ($> 56 \%$), and composed of sandy to clayey particles (Fig. 9, Table 2). These characteristics indicate that the deposit had an unimodal granulometric distribution with the main mode shifting from 1 to 4ϕ (Table 2) and good sorting ($0.55\text{--}1.35 \sigma \phi$). The structure, texture, and grain-size characteristics of TFD suggest it corresponds to a hyperconcentrated flow deposit (Fig. 9). In some sections, however,

Figure 8. Shaded relief map of the MDOT displaying the location of Tlalpujahua and Venta de Bravo villages, the extension of Los Cedros tailings in 1937 as well as the present extension of the 1937 flood deposit. Red circles are stratigraphic sections measured during this study.

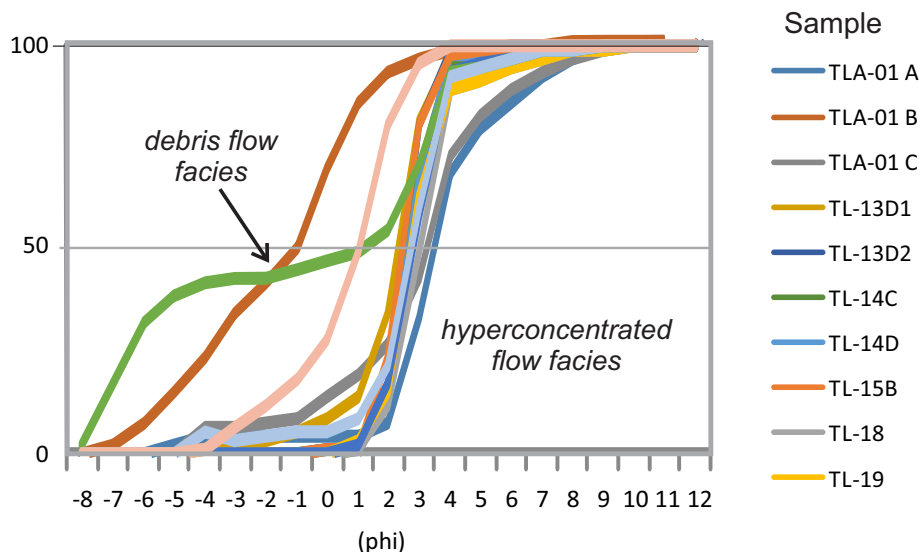
Figure 9. Cumulative curves of the TFD deposit at different distances from the source. Most of the deposits are fine-grained (hyperconcentrated flow deposits) while a few exposures contained boulder and gravel-sized particles set in a silty matrix (debris flow deposits). See Fig. 8 for locations of the samples.
