J. L. Macías et al.

The 27 May 1937 catastrophic flow failure of gold tailings at Tlalpujahua, Michoacán, México

Received: 16 June 2014 – Accepted: 6 July 2014 – Published: 20 August 2014

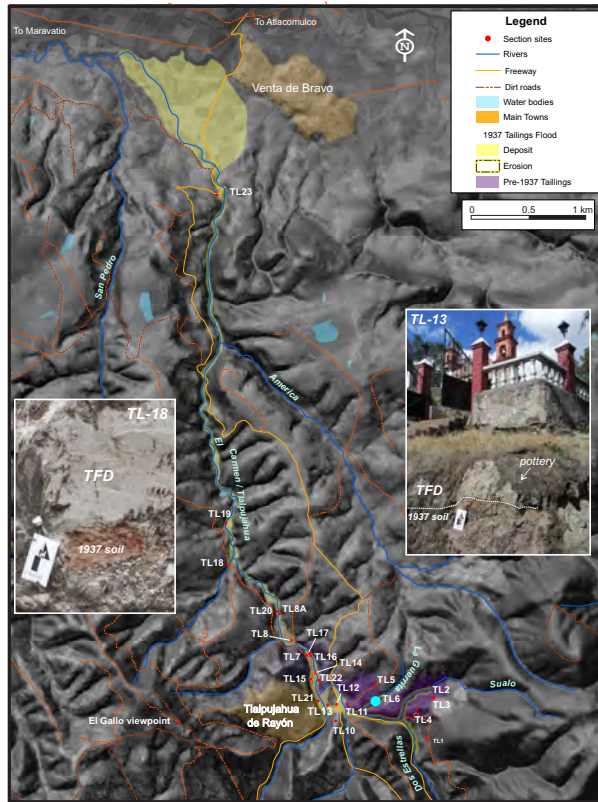
Along its extent, the TFD has variable thicknesses, for instance around 40 cm at section TL-13 (San Jesus del Monte Church), 2.8 m at site TL16 (0.8 km downstream), and 40 cm at the farthest location (TL-23) (Fig. 8). As a whole, the deposit is massive, matrix-supported ($> 56\%$), and composed of sandy to clayey particles (Fig. 9, Table 2). These characteristics indicate that the deposit had an unimodal granulometric distribution with the main mode shifting from 1 to 4 ϕ (Table 2) and good sorting ($0.55\text{--}1.35 \sigma\phi$). The structure, texture, and grain-size characteristics of TFD suggest it corresponds to a hyperconcentrated flow deposit (Fig. 9). In some sections, however,

Figure 8. Shaded relief map of the MDOT displaying the location of Tlalpujahuá and Venta de Bravo villages, the extension of Los Cedros tailings in 1937 as well as the present extension of the 1937 flood deposit. Red circles are stratigraphic sections measured during this study.

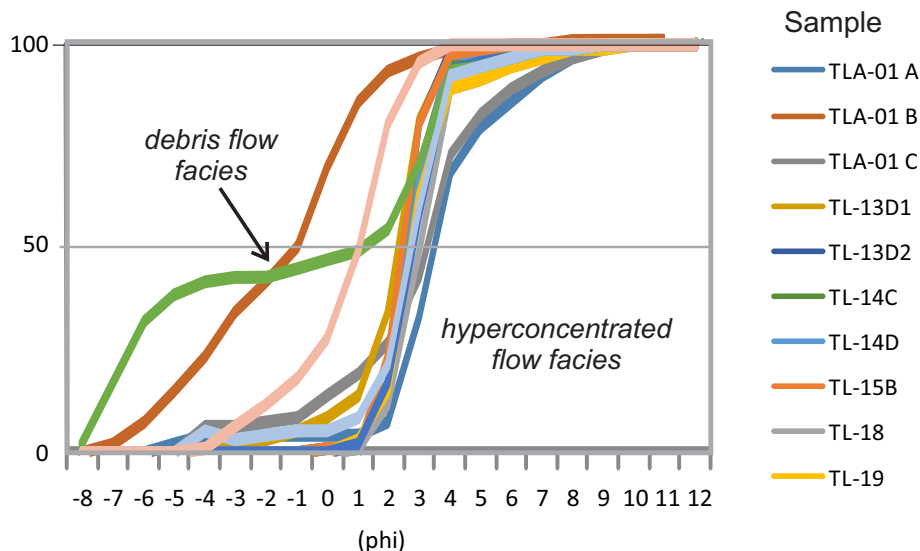
Twenty-two stratigraphic sections were measured of the remnants along the path of the Tailings Flood Deposit (TFD) (Fig. 8). From ten of these sections, we sampled 14 specimens to perform granulometric analyses from -8 to $+12 \phi$ grain-sizes (Fig. 9). The correlation of these sections suggested that the deposit mainly consists of one massive layer. However, at two locations (El Carmen Church TL08 and TL14) three and two beds were described, respectively. At locations between San Jesus del Monte and El Carmen the deposit is soft and loose, but beyond El Carmen church it is partly indurated and contains void spaces in all sections.

Figure 9. Cumulative curves of the TFD deposit at different distances from the source. Most of the deposits are fine-grained (hyperconcentrated flow deposits) while a few exposures contained boulder and gravel-sized particles set in a silty matrix (debris flow deposits). See Fig. 8 for locations of the samples.

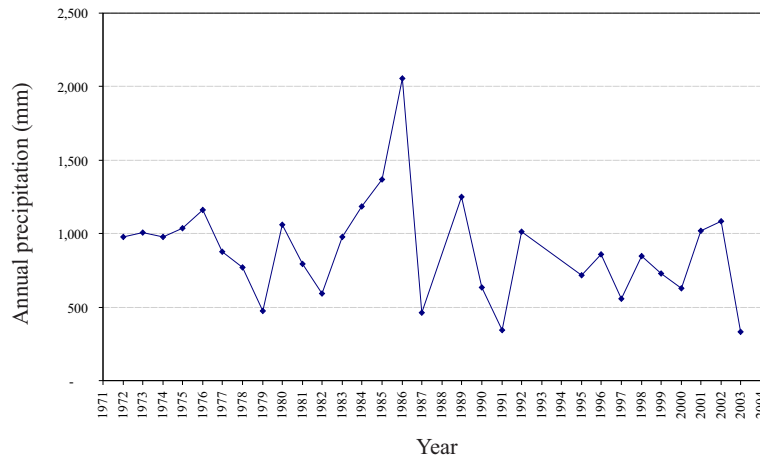
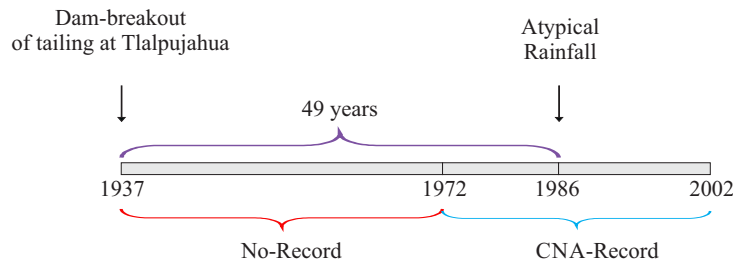
Figure 13. Timeline showing the 1986 year with exceptionally high precipitation recorded in the region of MDOT. Data from the 15183-El Oro meteorological station. The Las Llamas flood occurred during sustained intense rainfall in May 1937 when no weather station existed. It is interesting to note two atypical precipitation events have return periods of 49 years (Corona Chavez et al., 2010).
