1 **Causes and consequences of the Sinkhole at “El Trebol” of Quito,**
2 **Ecuador - Implications to economic damage and risk assessment**

28 **Abstract**

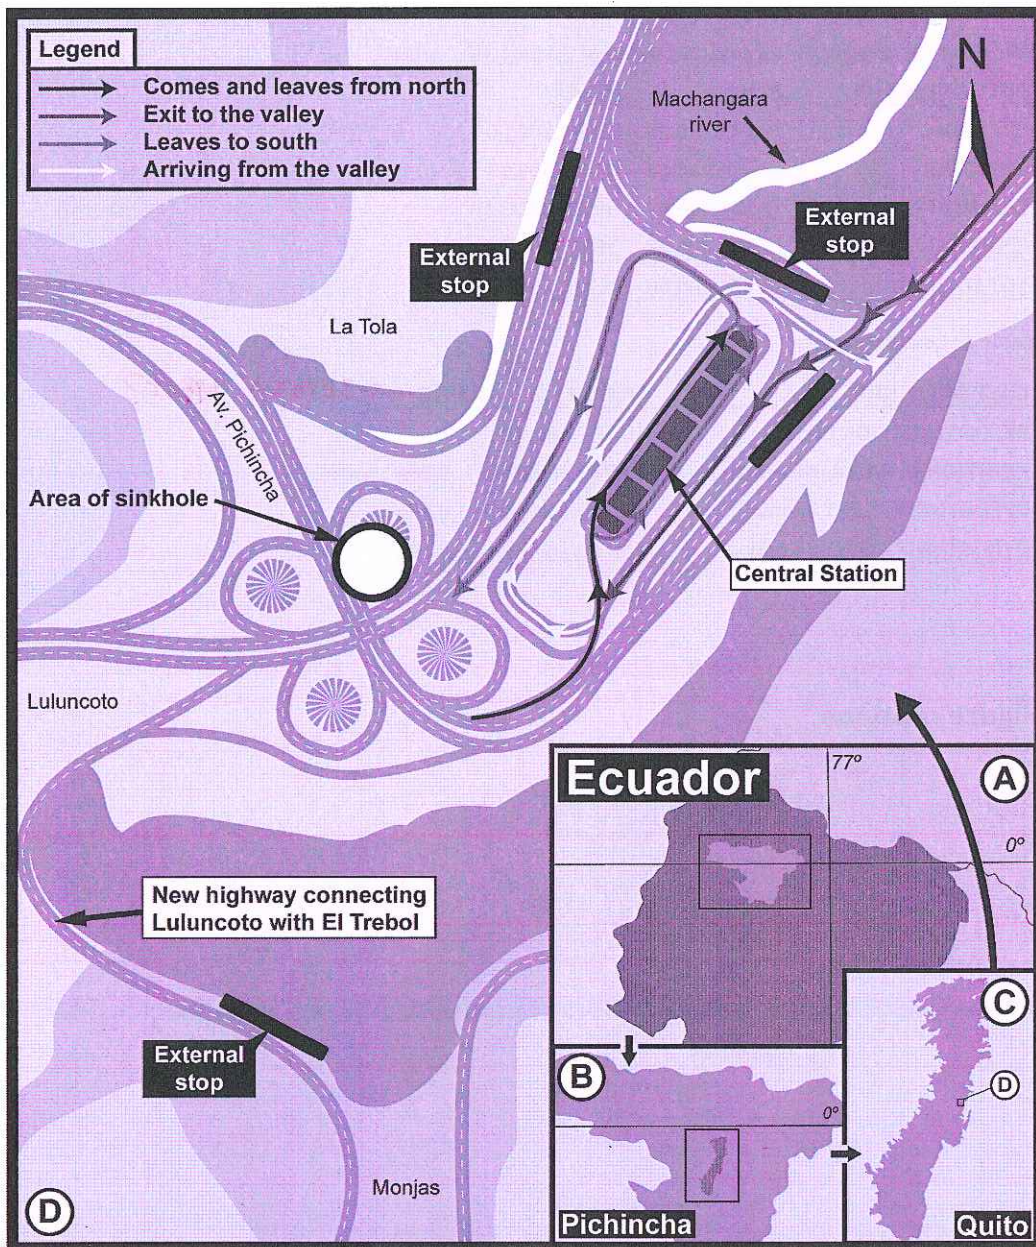
574 Figure 1: Overview of the setting of a) Ecuador, b) Province of Pichincha, c) city of Quito, d) El Trebol and
 575 surrounding infrastructure
