1       **Causes and consequences of the Sinkhole at “El Trebol” of Quito,**  
2       **Ecuador - Implications to economic damage and risk assessment**

29 The so-called “El Trébol” is a critical road interchange in Quito connecting the north  
30 and south regions of the city. In addition, it connects Quito with the highly populated  
31 “Los Chillos” valley, one of the most traveled zones in the Ecuadorian capital. El  
32 Trébol was constructed in the late sixties in order to resolve the traffic jams of the  
33 capital city and for that purpose the Machángara river was rerouted through a concrete  
34 box tunnel. In March 2008, the tunnel contained a high amount of trash furniture that  
35 had been impacting the top portion of the tunnel, compromising the structural  
36 integrity. On the 31st of March 2008 after a heavy rainfall a sinkhole of great  
37 proportions was formed in the Trébol traffic hub. In the first few minutes, with an  
38 initial diameter of 30 meters. The collapse continued to grow in the following days  
39 until the final dimensions of 120 meters in diameter and some 40 meters of depth,

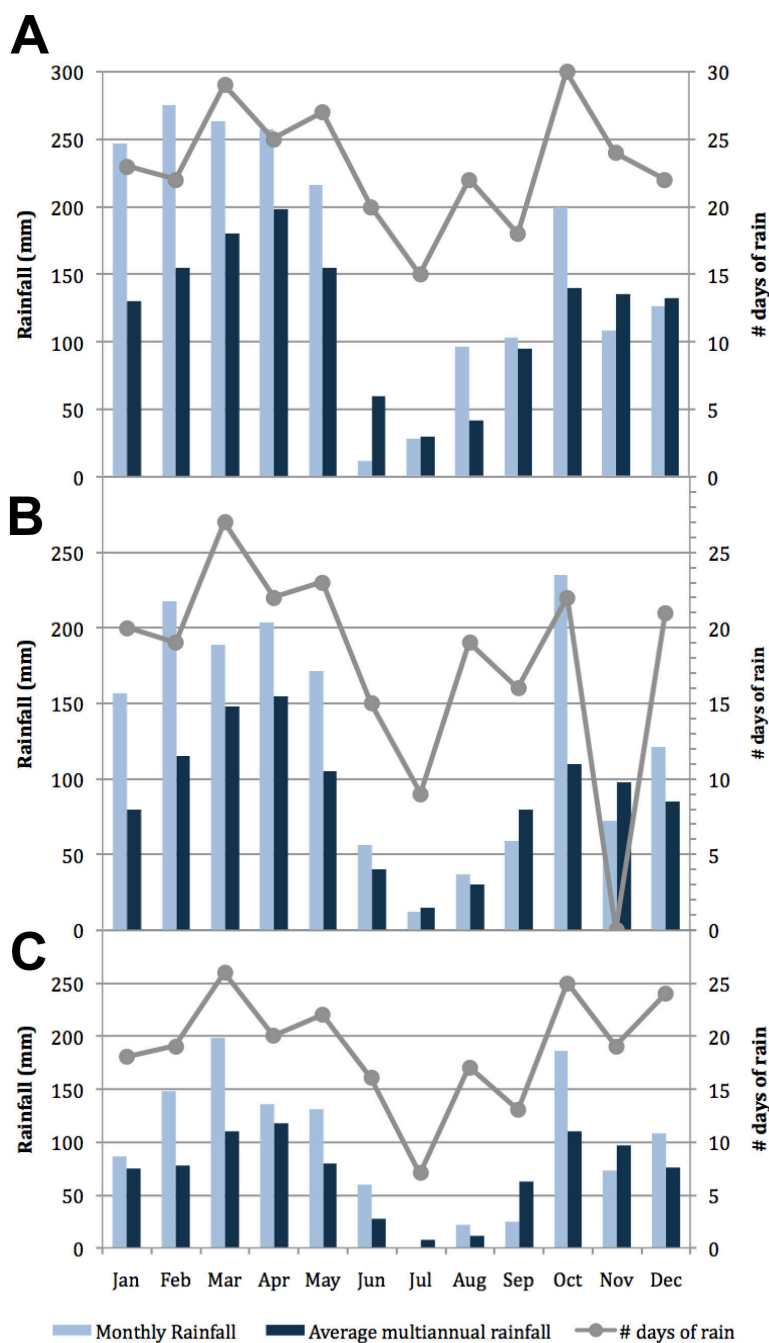
160 The distribution of rainfall along the year considering data from 1962 shows the  
161 prevalence of two periods with abundant rainfall being these, February-May and  
162 October-November respectively, while the drier seasons correspond to June-  
163 September and December-January (EMAAP-Q, 2006; Fig. 5). On the other hand, as  
164 for the multiannual distribution of rainfall it is important to highlight that the wet  
165 season between January and March of 2008 was considered the strongest of the last  
166 20 years with accumulated rainfall during the first three months of 2008 being much  
167 higher than the recorded during other heavy rainy seasons of 1989, 1993 and 2000  
168 (Salazar et al., 2009). In particular, a peak of 21.2 l/m<sup>2</sup> was registered on the 31st of  
169 March, 2008 during a heavy rainfall that lasted 4 hours from 1p.m. to 5 p.m (INAMHI,  
170 2008; El Comercio, 2008; Salazar et al., 2009). Additionally, within the whole 2008

171 and coinciding in the three meteorological stations closest to El Trebol, March  
172 recorded continuous raining since it was the month with the highest number of days of  
173 rain, with 27 and 29 out of 31 days in Iñaquito and Izobamba respectively (Fig 5a, 5b,  
174 5c).

584 Figure 5 a, b, c: Total monthly rainfall, average multiannual rainfall number of days with rain per month  
 585 (higher than 0.1 mm) of the three meteorological stations closest to El Trebol (, Iñaquito and La Tola). A)  
 586 Izoambamba: Lat.: -0.366089, Long.: -78.555061; Alt.: 3085.00 m.a.s.l.; B) Iñaquito: Lat.: -0.175000; Long.: -  
 587 78.485278; Alt.: 2789.12; C) La Tola Lat.: -0.175000; Long.: -78.485278; Alt.: 2789.12 m.a.s.l. From INAHMI  
 588 (2010).
