1 The catastrophic landfill flowslide at Hongao dumpsite on December 20, 2015 in Shenzhen, China

6 **Abstract** A catastrophic flowslide occurred at Hongao dumpsite on Dec 20, 2015 in the Guangming New
7 District of Shenzhen, China. The flowslide caused 69 casualties with 8 missing and damaged 33 buildings.
8 In the absence of extreme weather condition and seismic activity, the cause(s) of the failure was analyzed
9 on the basis of multi-temporal remote sensing images, site investigation, *in-situ* tests, laboratory tests, and
10 numerical analyses. The preliminary results showed that the volume of the flowslide deposit was 2.32×10^6
11 m^3 and the volume of dumpsite filling was $6.27 \times 10^6 \text{ m}^3$ at the time of the event, which is three times larger
12 than the design capacity. The flowslide has the characteristics of high travel velocity and long run-out
13 distance. The displaced material was primarily silty soil in mixture of construction and demolition waste at
14 high moisture content. The primary causes of the failure were concluded as follow: (1) The dumpsite

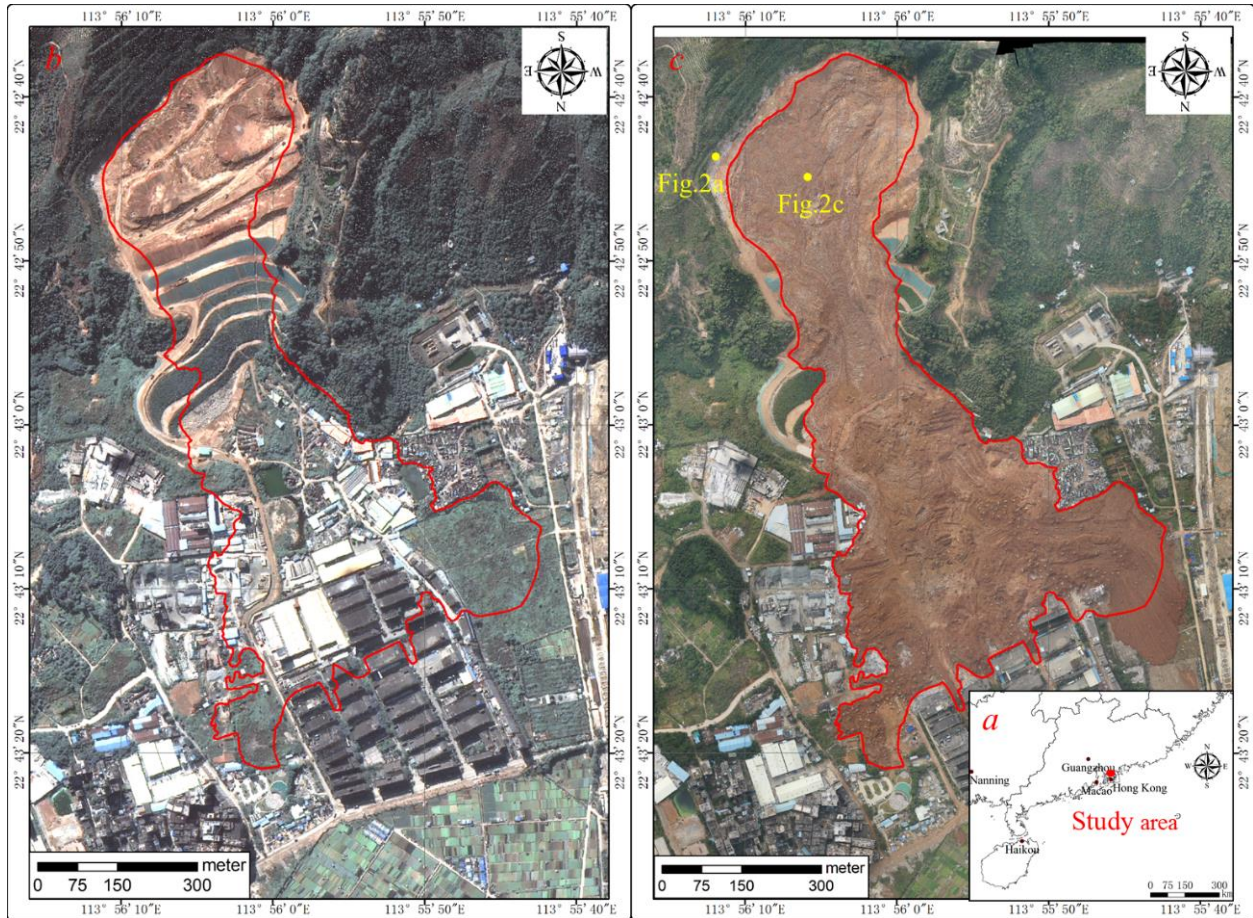
94
 95 Fig. 1 Location of the study site and images of the pre-/post-failure dumpsite. The boundary of the flowslide
 96 is indicated in red. **a** the location of the study area; **b** Pleiades satellite image (Dec 18, 2015); **c** Aerial photo
 97 of the flowslide (Dec 23, 2015).

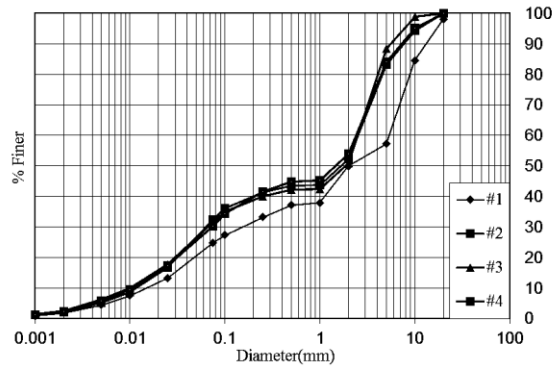
117 Fig. 3 Particle size distribution of the waste filling (with sieve sizes of 20, 10, 5, 2.0, 1, 0.5, 0.25, 0.10,
 118 0.075, 0.025, 0.01, 0.005, 0.002, and 0.001 mm)

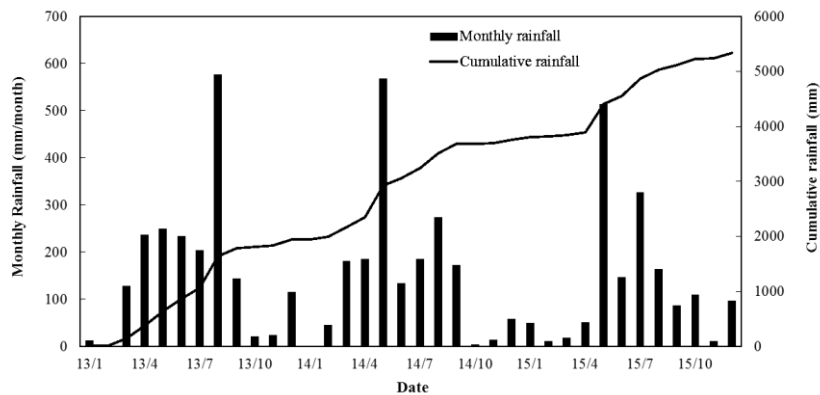
120 Fig. 4 Monthly rainfall and cumulative precipitation between 2013 and Dec 2015.

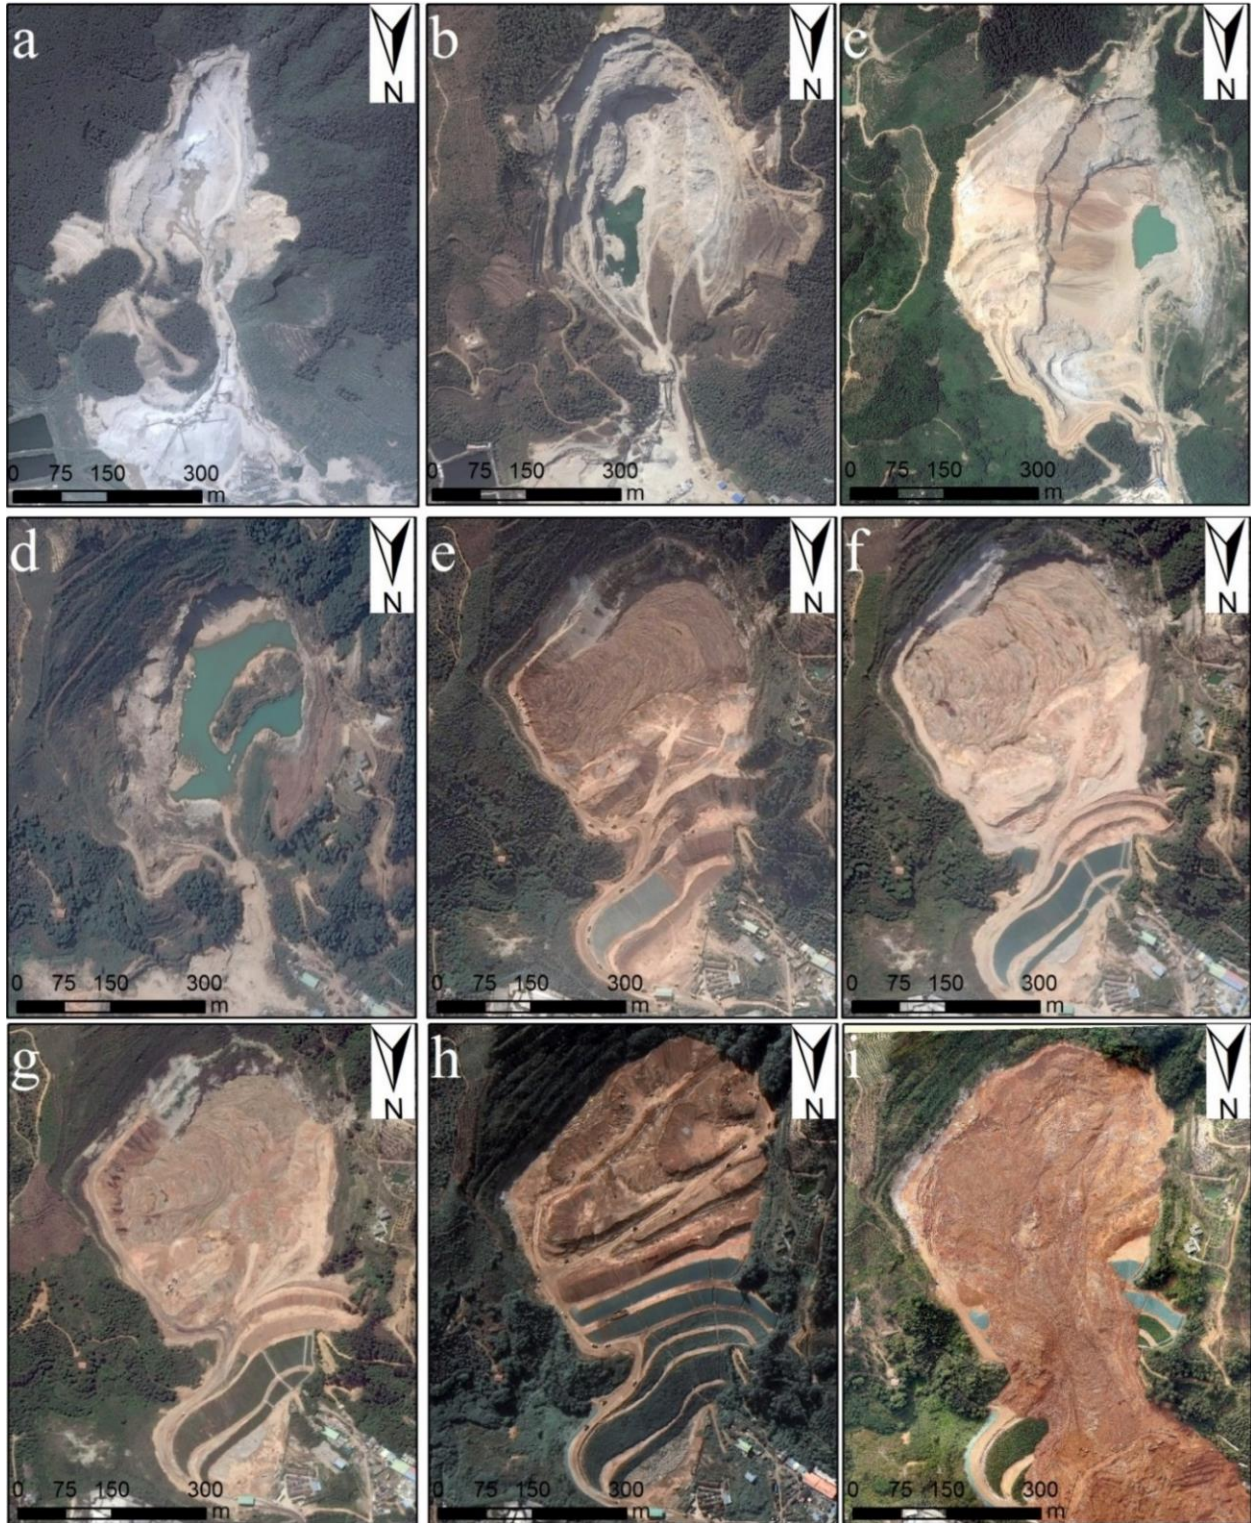
139 the quarry exit. The gully was covered during the construction of a multi-bench retaining slope between the
140 rock hills as waste disposal continued throughout the process (Fig. 7e). Disposal activity started possibly
141 in 2014 (Fig. 7e and 7f), and the accumulation rate of the waste filling was considerably fast (Zou, 2016).

142 An unpaved road was excavated on the east of the quarry connecting the crest and toe of the hillslope as
143 shown in Fig. 7e. A large number of trucks can be seen transporting waste filling to the dumpsite. A large
144 amount of construction waste was dumped in the pit with 4 slope benches built at the exit of the pit (Fig.
145 7e). The volume of the waste increased significantly with the 1st and 2nd benches completed in late 2014,
146 and the 3rd to 4th benches were still under construction until Jan 2015 (Fig. 7f).

Fig. 7 Multi-temporal remote sensing images of the study area. **a** 08/31/2002; **b** 02/20/2008; **c** 08/30/2010; **d** 11/25/2013; **e** 11/17/2014; **f** 01/23/2015; **g** 04/14/2015; **h** Pleiades (12/18/2015); **i** Aerial (12/23/2015). Image **a** to **g** were obtained from Google Earth. A service road was excavated at the exit of the quarry with a width of nearly 70 m (see image **a**, **b**, **c**, and **d**).

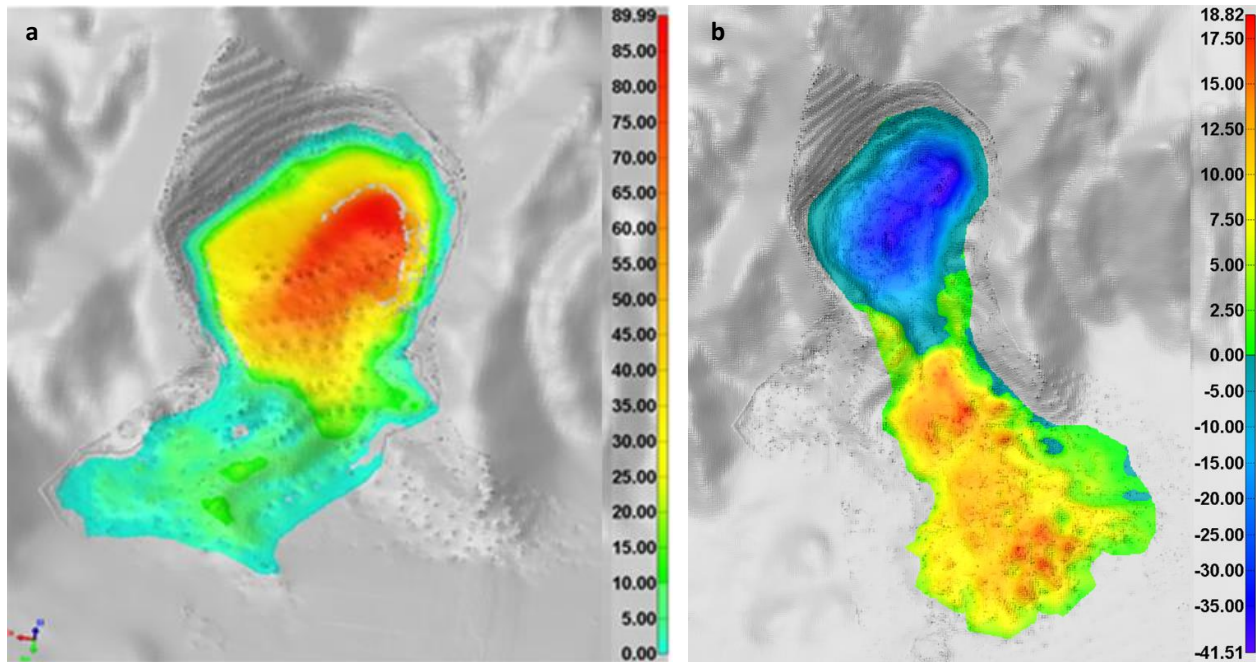
156 bench was still under construction before failure. The thickness of the waste filling was around 90 m with
157 a volume of $6.3 \times 10^6 \text{ m}^3$ (Fig. 8a) by extracting the difference between the pre- and post-filling DEMs.

163
 164 Fig. 8 **a** The thickness distribution of the dumpsite based on the pre-/post-disposal DEMs; **b** The elevation
 165 variations of the dumpsite estimated between the pre-/post-sliding DEMs.

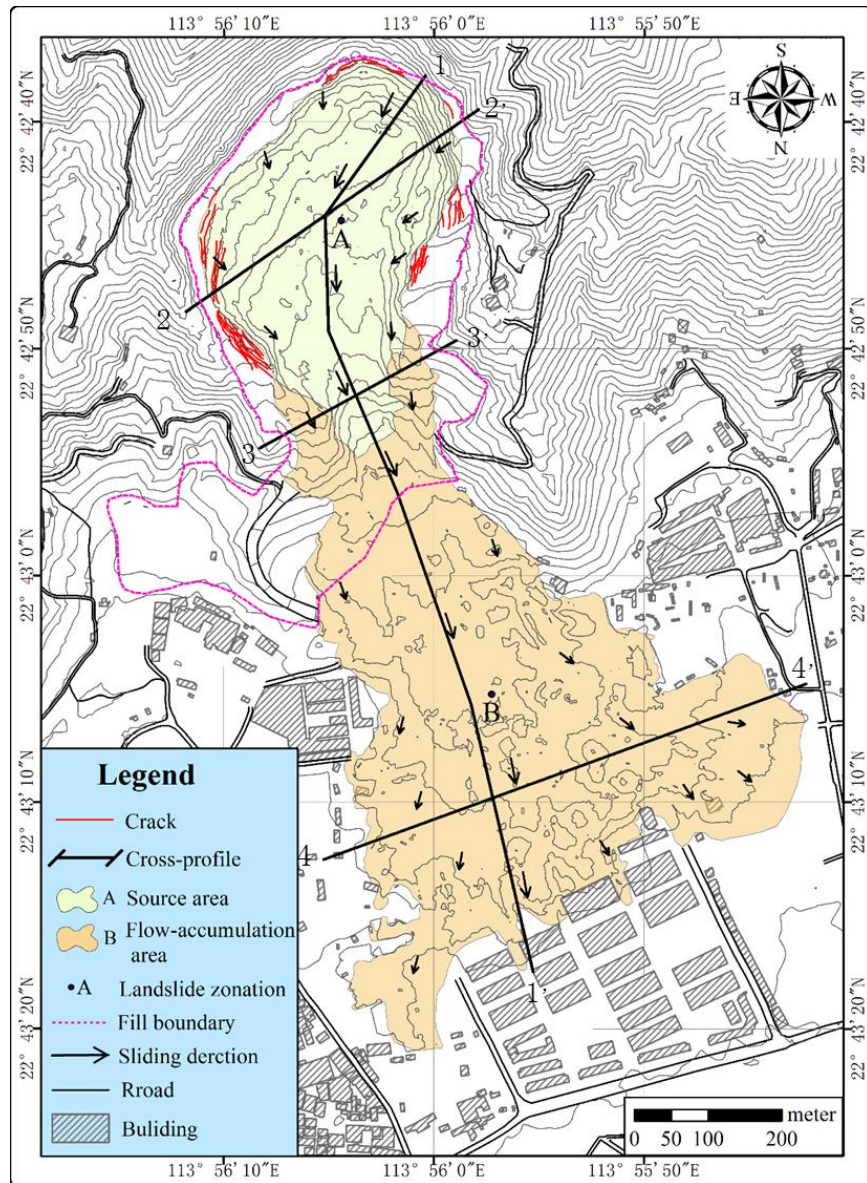
167 The flowslide area can be divided into the source area and flow-accumulation area as shown in Fig. 9. The
 168 source area was the abandoned quarry pit. The mass slid in the direction of 340° with maximum traveling
 169 distance of 1203 m. The maximum thickness of the remaining material in the source area was 41.51 m with
 170 an average of 20.5 m (Fig. 9 and Fig. 10). The maximum deposit thickness in the flow-accumulation area
 171 was 18.2 m with an average of 8.21 m (Fig. 8b). The geometry of a flowslide can be expressed in length
 172 (L), height (H), width (W), and area (S) (Legros, 2002; Scheidegger, 1973). The geometric parameters are
 173 indicated in the simplified flowslide geometry in Fig. 11 with values listed in Table 1, Table 2 and Table 3.

Fig. 9 The topographic map of the flowslide.

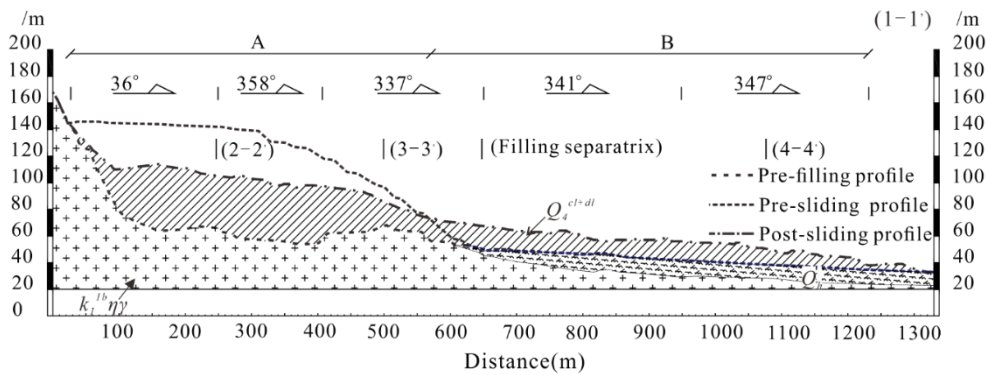
Fig. 10 The geological and topographical cross section (profile line 1-1')

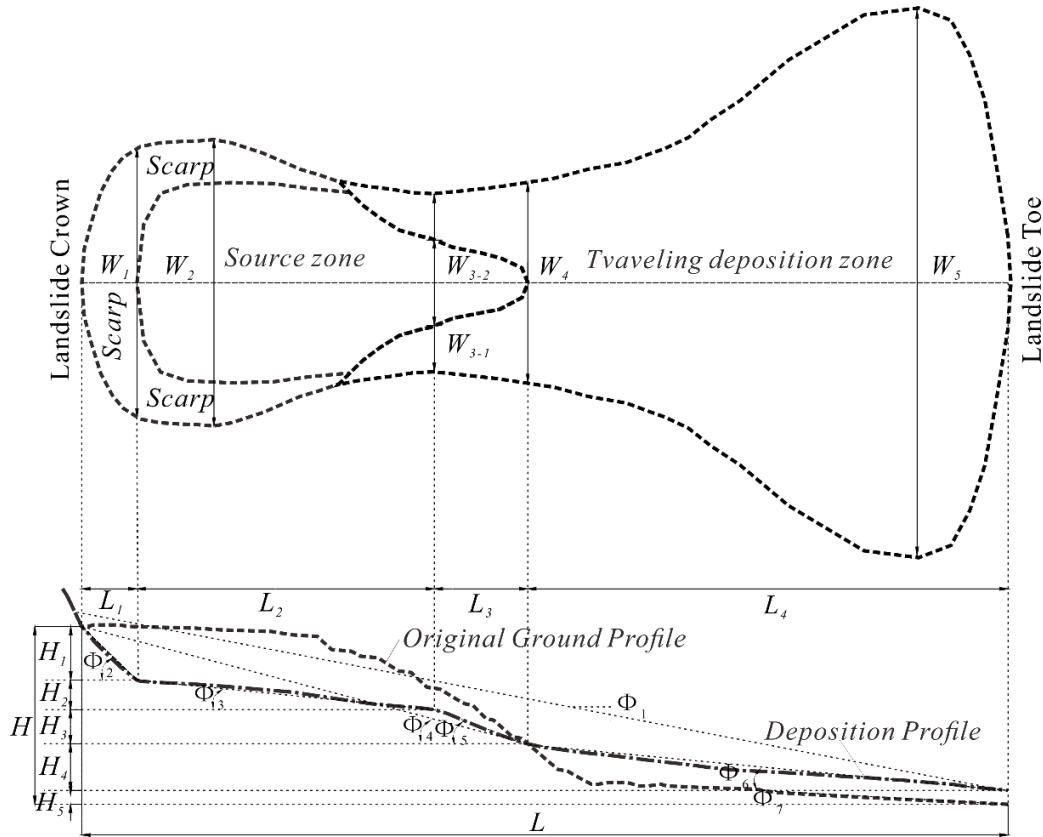
178
 179 Fig. 11 Simplified illustration of the flowslide geometry. L: run-out distance; H: elevation; W₁: scarp width;
 180 W₂: max width of the source area; W₃: frontal width of the source area; W₄: width of the shear crack; W₅:
 181 max width of the flow-accumulation area; L₁: horizontal length of the scarp; L₂: horizontal length of the
 182 mild slope; L₃: horizontal length of the steep slope; L₄: horizontal length of the flow-accumulation area; H₁:
 183 height of the scarp; H₂: height of the mild slope; H₃: height of the steep slope; H₄: height of the flow-
 184 accumulation area; H₅: thickness of the toe of the flowslide; Φ₁: extension angle; Φ₂: slope gradient of the
 185 scarp; Φ₃: mild slope gradient; Φ₄: slope gradient of the source area; Φ₅: steep slope gradient; Φ₆: slope
 186 gradient of the flow-accumulation area; Φ₇: slope gradient of the foundation area

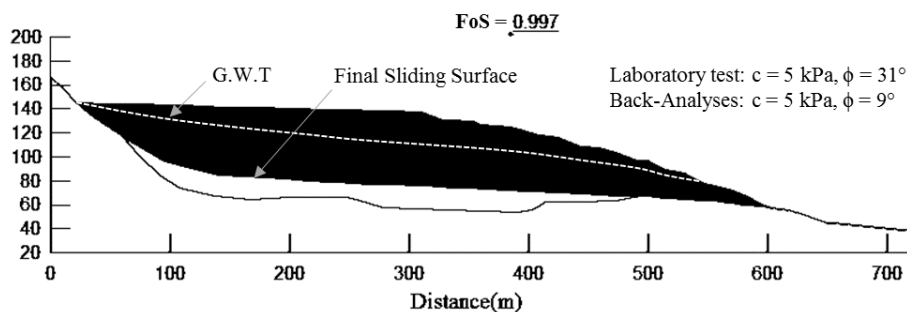
279 Numerical simulation for diffuse failure involves liquefaction and post-failure propagation is challenging
280 (Take and Beddoe, 2014), and the conventional LEB is typically not applicable for analyzing propagation
281 of landslide originating from diffuse failure induced by liquefaction (Cascini et al., 2009, 2013). Back-
282 analyses was performed using SLOPE/W with Morgenstern Prince Limit Equilibrium Analysis under the
283 assumption of a fully saturated basal zone in the dumpsite before failure. The back-analyses using LEB
284 method typically set the FoS to unity for back-calculating the mobilized strength. The final sliding surface
285 and a hypothetical groundwater level were added to determine the shear strength in an iterative approach with
286 estimated dry density of filling of 1.65 g/cm³ (Fig. 18), however the back-calculated friction angle was
287 significantly less than the experimental result.

289 Fig. 18 Back-calculated mobilized strength by using 2D numerical model with LEM.
