1 The catastrophic landfill flowslide at Hongao dumpsite on December 20, 2015 in Shenzhen, China

6 **Abstract** A catastrophic flowslide occurred at Hongao dumpsite on Dec 20, 2015 in the Guangming New
7 District of Shenzhen, China. The flowslide caused 73 casualties with 4 missing and damaged 33 buildings.
8 In the absence of extreme weather condition and seismic activity, the causes of the failure were analyzed
9 on the basis of multi-temporal remote sensing images, site investigation, *in-situ* tests, laboratory tests, and
10 numerical analyses. Site investigations showed that the volume of the flowslide deposit was $2.32 \times 10^6 \text{ m}^3$
11 and the volume of dumpsite filling was $6.27 \times 10^6 \text{ m}^3$ at the time of the event, which is 3 times greater than
12 the design capacity. The flowslide was characterized by high travel velocity and long runout distance. The
13 displaced material was primarily silty soil in mixture of construction and demolition waste at high water

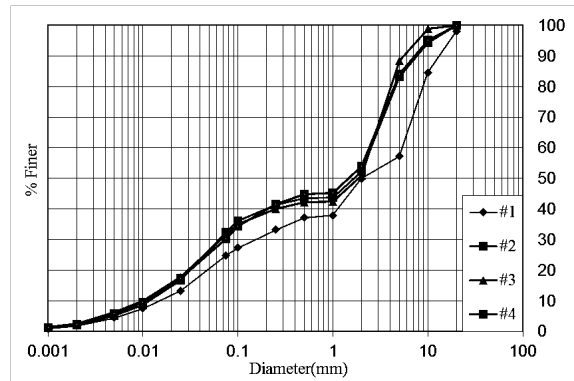
115 Fig. 3 Particle size distribution of the waste filling (with sieve sizes of 20, 10, 5, 2.0, 1, 0.5, 0.25, 0.10,
 116 0.075, 0.025, 0.01, 0.005, 0.002, and 0.001 mm)

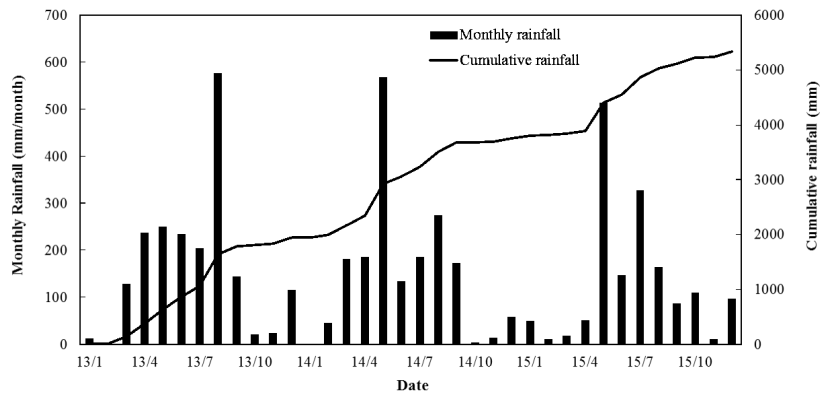
118 Fig. 4 Monthly rainfall and cumulative precipitation between 2013 and Dec 2015.

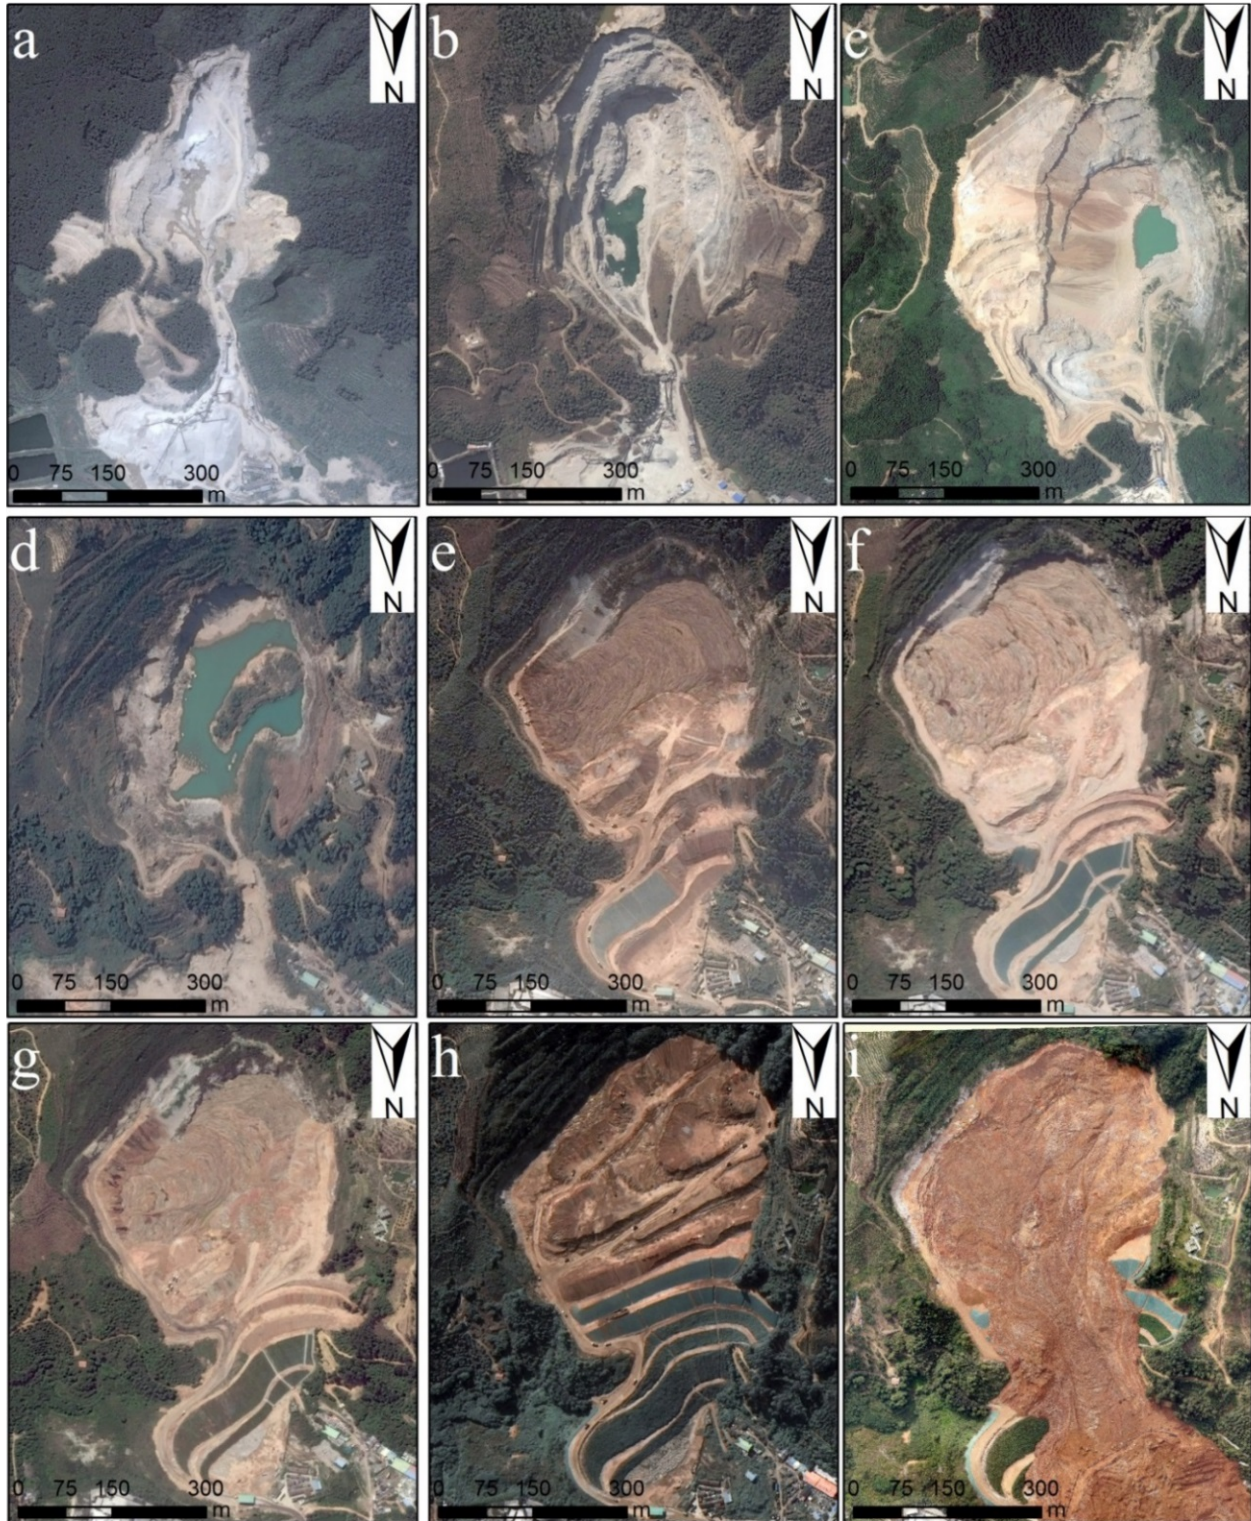
137 of the quarry exit. The gully was covered by the construction of a multi-benched retaining slope between
138 the rock hills as waste disposal continued throughout the process (Fig. 7e). Disposal activity started possibly
139 in 2014 (Fig. 7e and 7f), and the accumulation rate of the waste filling was considerably fast (Zou, 2016).

140 An unpaved road was excavated on the east of the quarry connecting the crest and toe of the hillslope as
141 shown in Fig. 7e. A large number of trucks can be seen transporting waste filling to the dumpsite. A large
142 amount of construction waste was dumped in the pit with 4 slope benches built at the exit of the pit (Fig.
143 7e). The volume of the waste increased significantly with the 1st and 2nd benches completed in late 2014,
144 and the 3rd to 4th benches were still under construction until Jan 2015 (Fig. 7f).

157 Fig. 7 Multi-temporal remote sensing images of the study area. **a** 08/31/2002; **b** 02/20/2008; **c** 08/30/2010;
 158 **d** 11/25/2013; **e** 11/17/2014; **f** 01/23/2015; **g** 04/14/2015; **h** Pleiades (12/18/2015); **i** Aerial (12/23/2015).
 159 Image **a** to **g** were obtained from Google Earth. A service road was excavated at the exit of the quarry with
 160 a width of nearly 70 m (see image **a**, **b**, **c**, and **d**).

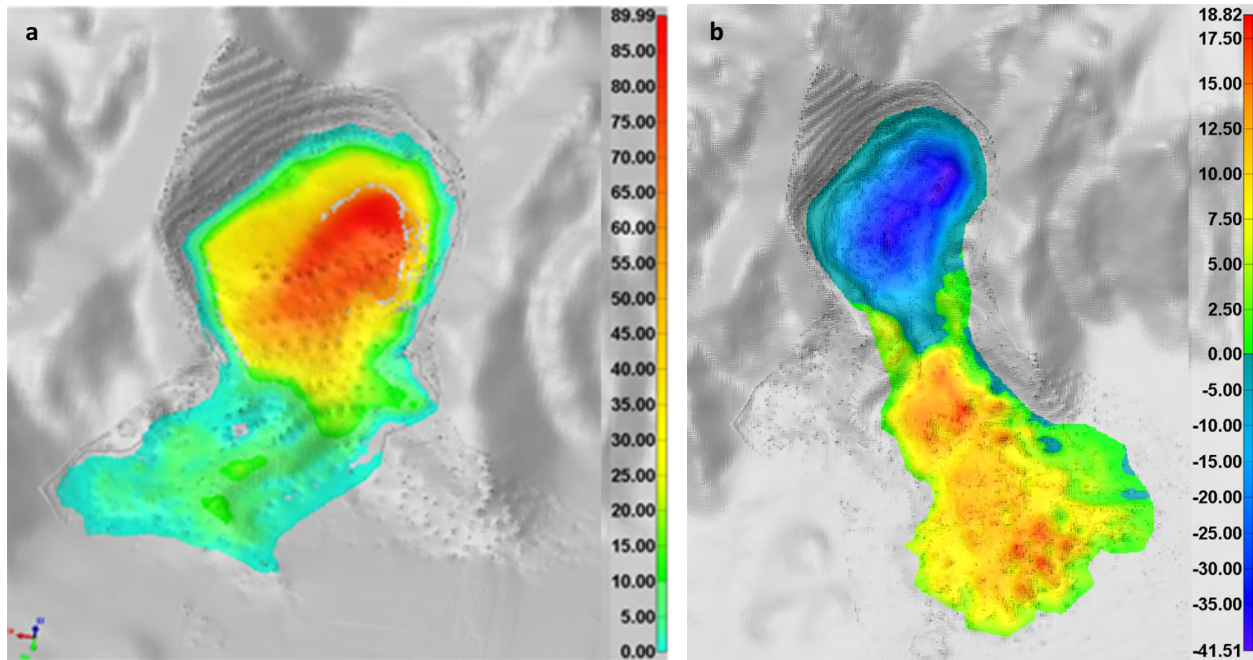
154 bench was still under construction before failure. The thickness of the waste filling was around 90 m with
155 a volume of $6.3 \times 10^6 \text{ m}^3$ (Fig. 8a) by extracting the difference between the pre- and post-filling DEMs.

161
 162 Fig. 8 **a** The thickness distribution of the dumpsite based on the pre-/post-disposal DEMs; **b** The elevation
 163 variations of the dumpsite estimated between the pre-/post-sliding DEMs.

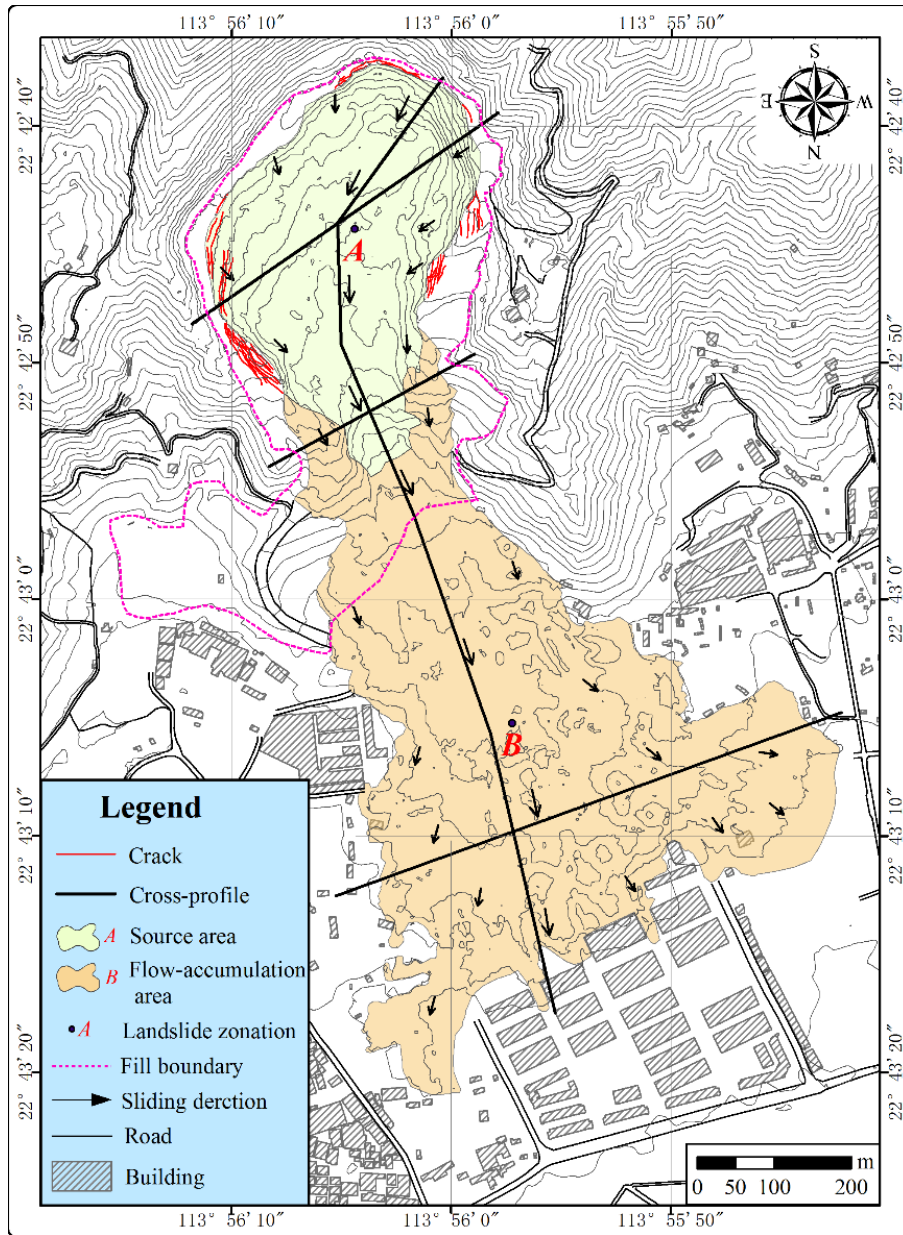
Fig. 9 The topographic map of the flowslide.

165 The flowslide area can be divided into the source area and the flow-accumulation area as shown in Fig. 9.
 166 The source area was the abandoned quarry pit. The mass slid in the direction of 340° with the maximum
 167 traveling distance of 1203 m. The maximum thickness of the remaining material in the source area was
 168 41.51 m with an average of 20.5 m (Fig. 9 and Fig. 10). The maximum deposit thickness in the flow-
 169 accumulation area was 18.2 m with an average of 8.21 m (Fig. 8b). The geometry of a flowslide can be
 170 expressed in length (L), height (H), width (W), and area (S) (Legros, 2002; Scheidegger, 1973). The
 171 geometric parameters are indicated in the simplified flowslide geometry in Fig. 11 with values tabulated in
 172 Table 1, Table 2 and Table 3.

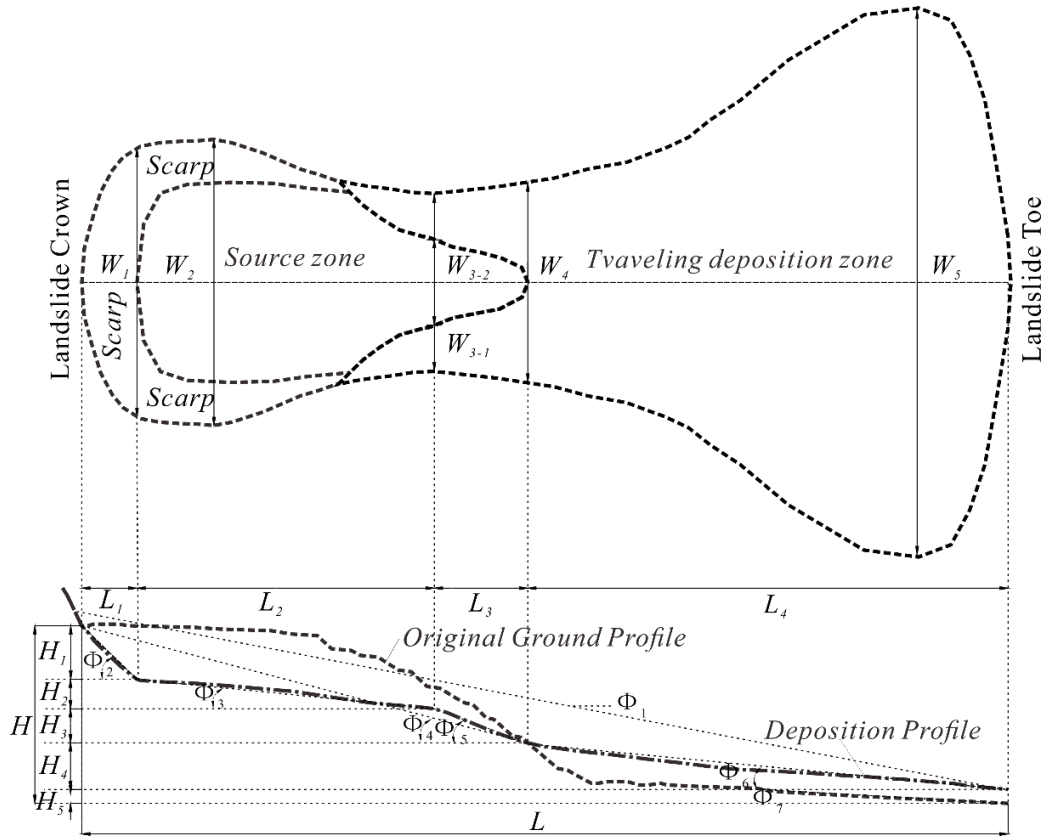
177
 178 Fig. 11 Simplified illustration of the flowslide geometry. L: runout distance; H: elevation; W₁: scarp width;
 179 W₂: max width of the source area; W₃: frontal width of the source area; W₄: width of the shear crack; W₅:
 180 max width of the flow-accumulation area; L₁: horizontal length of the scarp; L₂: horizontal length of the
 181 mild slope; L₃: horizontal length of the steep slope; L₄: horizontal length of the flow-accumulation area; H₁:
 182 height of the scarp; H₂: height of the mild slope; H₃: height of the steep slope; H₄: height of the flow-
 183 accumulation area; H₅: thickness of the toe of the flowslide; Φ₁: extension angle; Φ₂: slope gradient of the
 184 scarp; Φ₃: mild slope gradient; Φ₄: slope gradient of the source area; Φ₅: steep slope gradient; Φ₆: slope
 185 gradient of the flow-accumulation area; Φ₇: slope gradient of the foundation area

252 The source area of the flowslide was in the elevation of 142 m and the horizontal runout distance (L) was
253 approximately 1203 m with an elevation difference (H) of 111 m (Fig. 11). The velocity of a high-speed
254 landslide can be estimated by $v = \sqrt{2g \times (H - f \times L)}$ (Scheidegger, 1973), where v is the sliding velocity
255 (m/s), g is the gravitational acceleration (m/s^2), H and L are the elevation difference and horizontal distance
256 (m) between the crown and toe of the flowslide, respectively. f is the equivalent friction coefficient referred
257 as the ratio of height and runout distance of the flowslide ($f = H/L$). The equivalent friction coefficient of
258 the flowslide was 0.092. The sliding velocity was back-calculated and presented in Fig. 17.

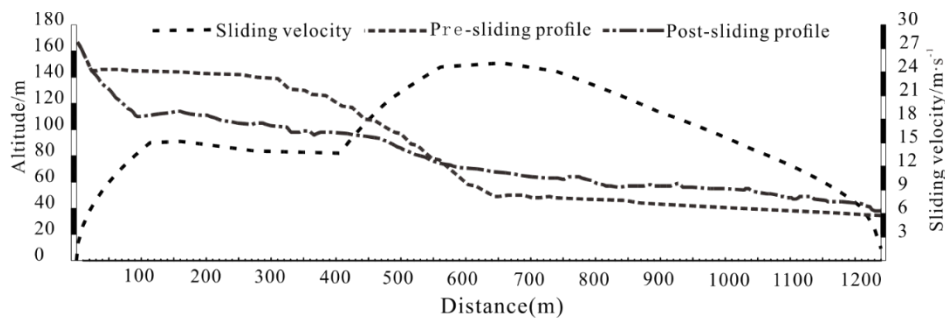
259
260 Fig. 17 The relationship between sliding velocity along profile line 1-1' and pre-/post-sliding landform.

261 Based on the back-calculated velocity profile, two sharp increases were identified, including the initiation
262 of the waste filling near the steep scarp and the acceleration of the flowslide when exiting the dumpsite.
263 The sliding velocity was increased to 15.17 m/s as waste filling reached the bottom of the steep scarp. The
264 velocity displaced material gradually decreased to approximately 13 m/s before accelerate to the maximum
265 velocity of 25.15 m/s as it reached the opening of the quarry. The second sharp acceleration was followed
266 by the rapid dissipation of kinematic energy and reduction in velocity after reaching the flow-accumulation
267 area (elev. 50 m). It was estimated that the sliding velocity was reduced to 15.68 m/s when it made contact
268 with the downstream buildings, and then ceased moving due to the obstruction. The geometry and velocity
269 exhibited clear characteristics associated with high-speed long-runout flowslides.

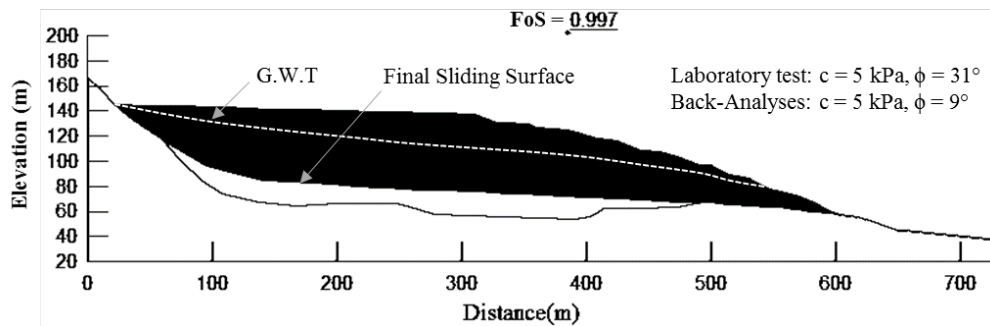
277 Numerical simulation for diffuse failure involves liquefaction and post-failure propagation is challenging
278 (Take and Beddoe, 2014), and the conventional LEB is typically not applicable for analyzing propagation
279 of landslide originating from diffuse failure induced by liquefaction (Cascini et al., 2009, 2013). Back-
280 analyses was performed using SLOPE/W with Morgenstern Prince Limit Equilibrium Analysis under the
281 assumption of a fully saturated basal zone in the dumpsite before failure. The back-analyses using LEB
282 method typically set the FoS to unity for back-calculating the mobilized strength. The final sliding surface
283 and a hypothetical groundwater level were added to determine the shear strength in an iterative approach with
284 estimated dry density of filling of 1.65 g/cm³ (Fig. 18), however the back-calculated friction angle was
285 significantly less than the experimental result.

287 Fig. 18 Back-calculated mobilized strength by using 2D numerical model with LEM.

288 The implausible mobilized strength shows that back-analyses using LEB is not applicable to the flowslide,
289 as the failure may involve liquefaction with subsequent progressive failure and post-failure propagation.
290 Notwithstanding the complex progressive mechanism and over-simplified force equilibrium method, the
291 misleading results of the back-analyses can be directly ascribe to the misuse of static pre-shearing pore-
292 water pressure with measured final sliding surface. Such erroneous back-analyses strategy was discussed
293 in detail by Take et al., (2004). It was postulated that the failure may be initiated at a relatively shallow
294 depth near the base of the slope as a result of static liquefaction, and followed by progressive backward
295 mobilization of the fillings in the dumpsite.
