# 1 The catastrophic landfill flowslide at Hongao dumpsite on December 20, 2015 in Shenzhen, China

2 Qiang Xu<sup>1</sup>, Dalei Peng<sup>1</sup>, Weile Li<sup>1</sup>, Xiujun Dong<sup>1</sup>, Wei Hu<sup>1</sup>, Minggao Tang<sup>1</sup>, Fangzhou Liu<sup>2\*</sup>

6 **Abstract** A catastrophic flowslide occurred at Hongao dumpsite at approximately 11:40 AM on Dec 20,  
7 2015, in Guangming New District of Shenzhen, China. The flowslide damaged 33 buildings and caused  
8 total death toll of ~~69 and 8 missing~~, with the absence of extreme weather condition and seismic activity.  
9 The slope failure was analyzed on the basis of multi-temporal remote sensing images, site investigation, *in-*  
10 *situ* tests, laboratory experiment, and numerical analysis. The preliminary results showed that the volume  
11 of the flowslide deposit was ~~2.32×10<sup>6</sup> m<sup>3</sup>~~ and the volume of dumpsite filling was ~~6.27×10<sup>6</sup> m<sup>3</sup>~~ at the time  
12 of the event, ~~which is three times larger than the maximum design capacity~~. The flowslide had the  
13 characteristics of high travel speed and long run-out distance, of which the displaced material was primarily

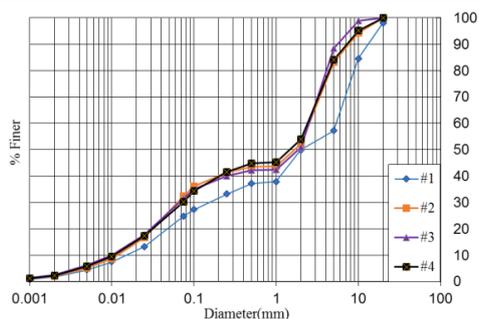
Fig. 4 Particle size distribution curves of the waste filling.

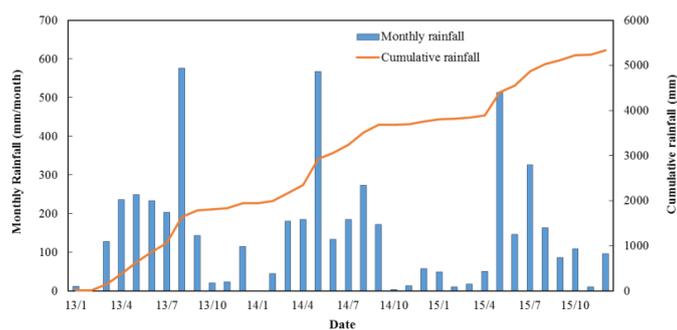
Fig.5 Monthly rainfall and cumulative precipitation between 2013 and Dec 2015.

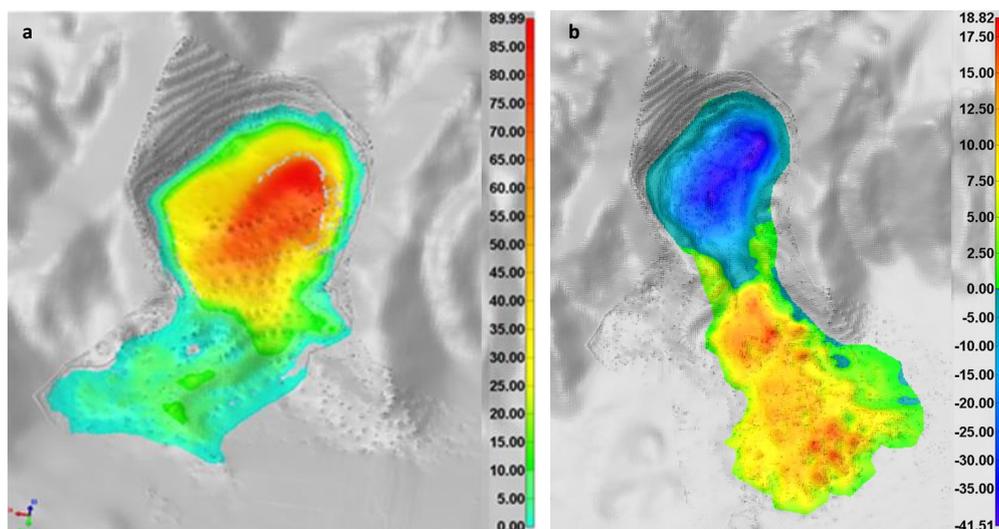
169 drainage channels installed on the hillslope, and the eighth bench was still under construction during the  
170 flowslide. The thickness of the dumpsite was estimated as 90 m with total volume of  $6.3 \times 10^6 \text{ m}^3$  (Fig. 9a)  
171 by extracting the difference between the pre- and post-filling DEMs.

172  
173 Fig. 9 **a** The thickness distribution of the dumpsite based on the pre-/post-disposal DEMs; **b** The elevation  
174 variations of the dumpsite estimated between the pre-/post-sliding DEMs.

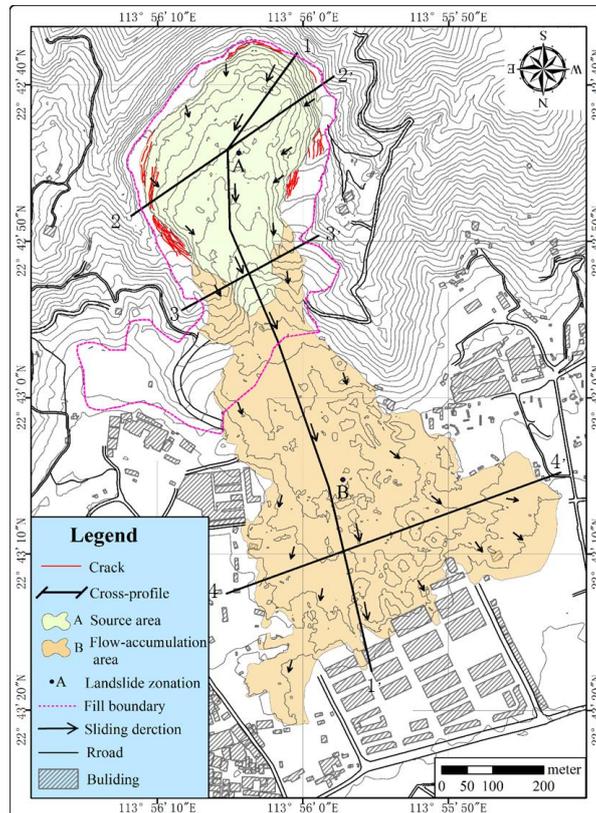
Fig.11 The topographic map of the flowslide.

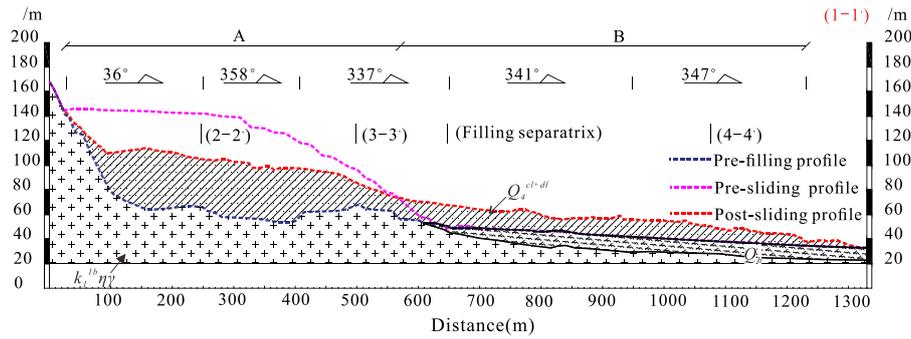
Fig.12 The geological and topographical cross section (profile line 1-1')

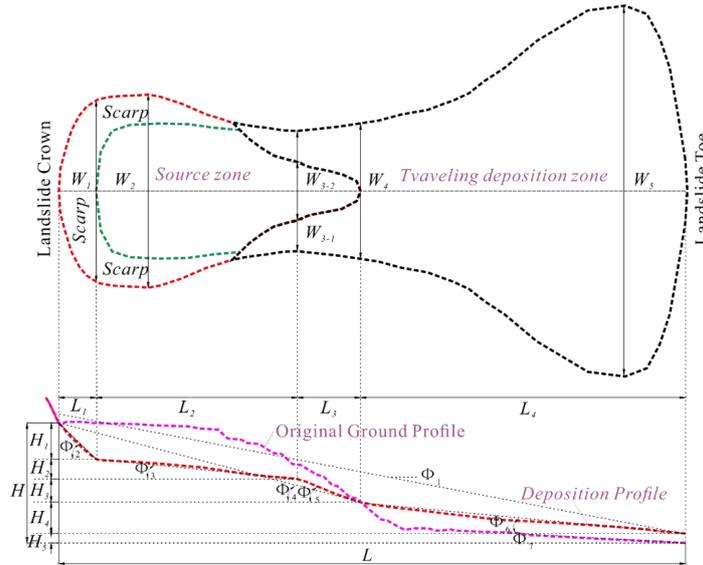
192 Fig. 13 Simplified illustration of the flowslide geometry. L: run-out distance; H: elevation; W<sub>1</sub>: scarp width;  
 193 W<sub>2</sub>: max width of the source area; W<sub>3</sub>: frontal width of the source area; W<sub>4</sub>: width of the shear crack; W<sub>5</sub>:  
 194 max width of the flow-accumulation area; L<sub>1</sub>: horizontal length of the scarp; L<sub>2</sub>: horizontal length of the  
 195 mild slope; L<sub>3</sub>: horizontal length of the steep slope; L<sub>4</sub>: horizontal length of the flow-accumulation area; H<sub>1</sub>:  
 196 height of the scarp; H<sub>2</sub>: height of the mild slope; H<sub>3</sub>: height of the steep slope; H<sub>4</sub>: height of the flow-  
 197 accumulation area; H<sub>5</sub>: thickness of the toe of the flowslide; Φ<sub>1</sub>: extension angle; Φ<sub>2</sub>: slope gradient of the  
 198 scarp; Φ<sub>3</sub>: mild slope gradient; Φ<sub>4</sub>: slope gradient of the source area; Φ<sub>5</sub>: steep slope gradient; Φ<sub>6</sub>: slope

199 gradient of the flow-accumulation area; Φ<sub>7</sub>: slope gradient of the foundation area

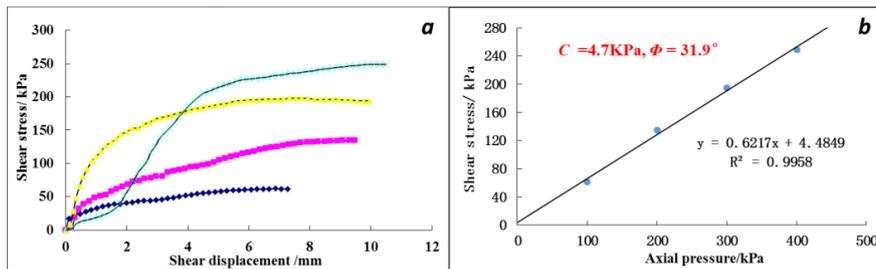
294 Based on *in-situ* tests for waste filling density and moisture content as well as the laboratory compaction  
295 test, it was found that the dry density varies from 1.25 to 1.48 g/cm<sup>3</sup> and void ratio ranged between 0.83  
296 and 1.31. Standard compaction test results suggested that the optimal water content of the waste filling was  
297 15.31% with the highest dry density of 1.79 g/cm<sup>3</sup>. The surface of the waste filling was in loose state with  
298 degree of compaction of the dumpsite ranged from 69.83% to 82.68%. Undrained shear test estimated that  
299 *c* and  $\Phi$  of the waste filling is 4.7 kPa and 31.9°, respectively (Fig. 24), which is considerably higher than  
300 gradient of the retaining slope.

301  
302 Fig. 24 Shear strength of the waste filling specimen obtained by undrained shear test.

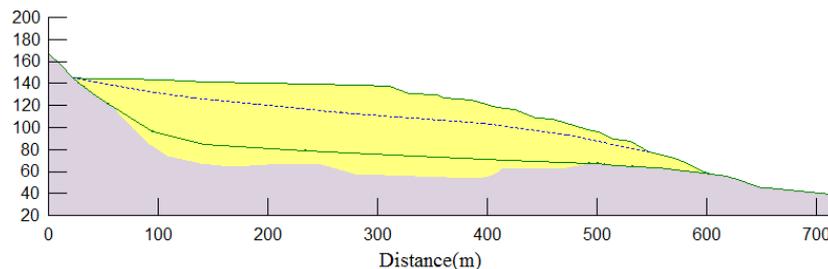
304 The numerical analysis aims at inverse analyzing the friction angle of the waste filling under the occurrence  
305 of the flowslide. Dumpsite slope FoS was estimated by using SLOPE/W software with Morgenstern Prince  
306 Limit Equilibrium Analysis method. Since it is postulated that the sliding mass in the lower portion of the  
307 dumpsite was saturated prior to the flowslide, a hypothetical sliding surface and the groundwater level were  
308 added into the model. The FoS was determined with an iterative approaching by changing the position of the  
309 sliding surface until failure of the dumpsite (Fig. 25 and Fig. 26). The physical parameters for the model  
310 were determined by the laboratory experiments and inversion analysis (Table 4).

311  
312 Fig. 25 Hypothetical sliding surface (green solid line) and groundwater level (blue dash line) in 2D numerical  
313 model.
