Damages during February, 6-24 2017 Çanakkale earthquake swarm

Abstract. On February 6, 2017 a swarm of earthquakes began at the western end of the Turkey. This has been the first recorded swarm at Çanakkale region since continuous seismic monitoring began in 1970. The number of located earthquakes increased during the next ten days. This paper describes the output of a survey carried out in the earthquake prone towns of Ayvacık, Çanakkale, Turkey, in February 2017 after the earthquakes. Observations collected on site regard traditional buildings at the rural area of Ayvacık. A description of the main structural features and their effects on the most frequently viewed damage modes are related in plane, out of plane behaviour of the wall regarding construction practice, connection type etc. It was found that there were no convenient connection details like cavity-ties or sufficient mortar strength resulting in decreased and/or lack of lateral load bearing capacity of the wall.

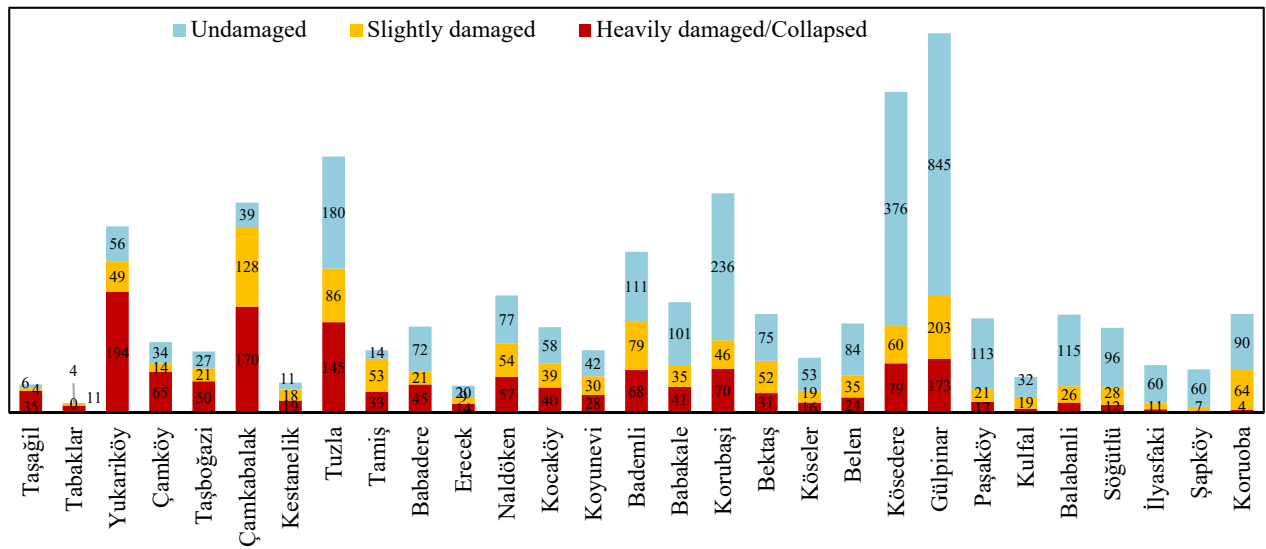
Figure 10 Number of buildings according to damage level due to Ayvacık Earthquake swarm

- 10 Since, the energy release was relatively very small comparing to the earthquakes occurred on NAFZ or on the other most active zone EAFZ of Turkey, no RC structures collapsed in the area other than the poorly constructed stone masonry dwelling in rural area. According to data obtained from Provincial Directorates of Environment and Urbanization, in twenty-nine villages alone, where there were about 2600 damaged or collapsed buildings, more than 25% of the mansion or dwelling either collapsed or were heavily damaged. According to official estimates, within the affected area, a total of 1465

- 15 structure (including buildings, houses, barns, offices, stores and haylofts) were heavily damaged or collapsed, 1170 of them suffered medium or minor repairable damage. Also, a total of 1990 structures did not experience any damage. The locations of twenty-nine villages together with epicenters of considered earthquakes, their magnitudes and PGAs are given in Figure 9 while number of damaged structures and damage ratios according to these villages are given in Figure 10 and 11, respectively. Also, distribution maps of buildings according to percentage for damage levels are given in Figures 12, 13 and

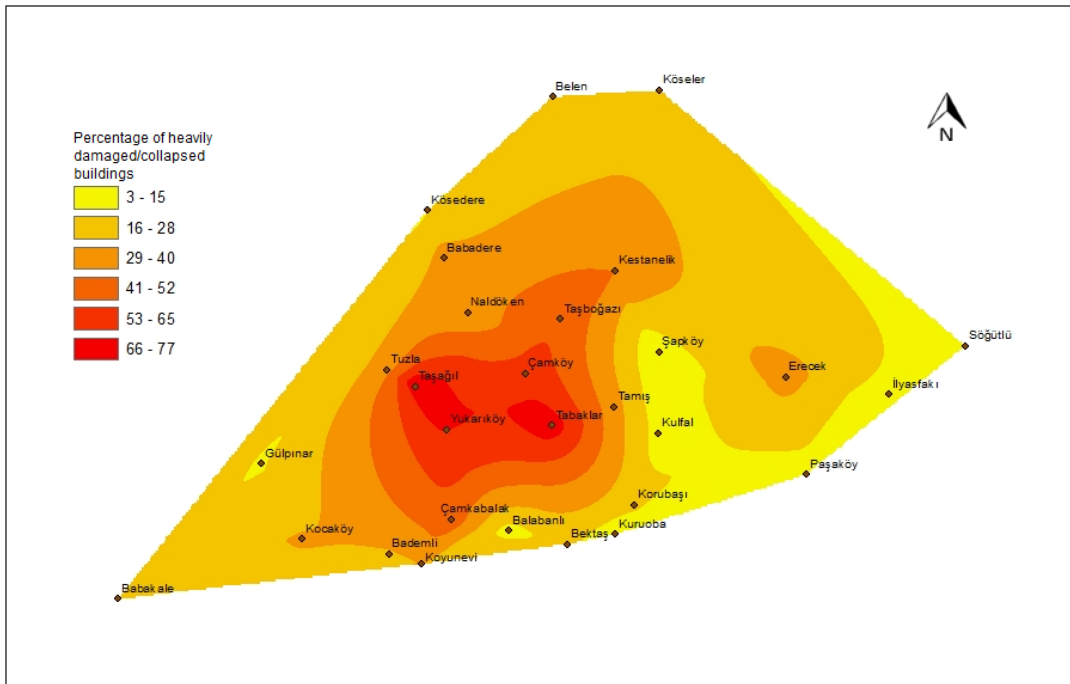
Figure 14 Distribution maps of damaged/collapsed buildings according to percentage

- 20 14, respectively. According to this figures, single or a few storey non engineered heavy masonry buildings with very poor details, however, along the sloping hills to the west of Gülpınar-Ayvacic, practically survived the earthquake without significant damage (Figure 14). It should be also noted that Gülpınar is relatively close to the epicenter of the earthquake than other town such as Taşagıl, Yukarıköy and Çamköy where dwellings were suffered very high damages. Gülpınar is also historical center in this area and has the cultural heritages, so the differences in terms of the cultural accumulation and

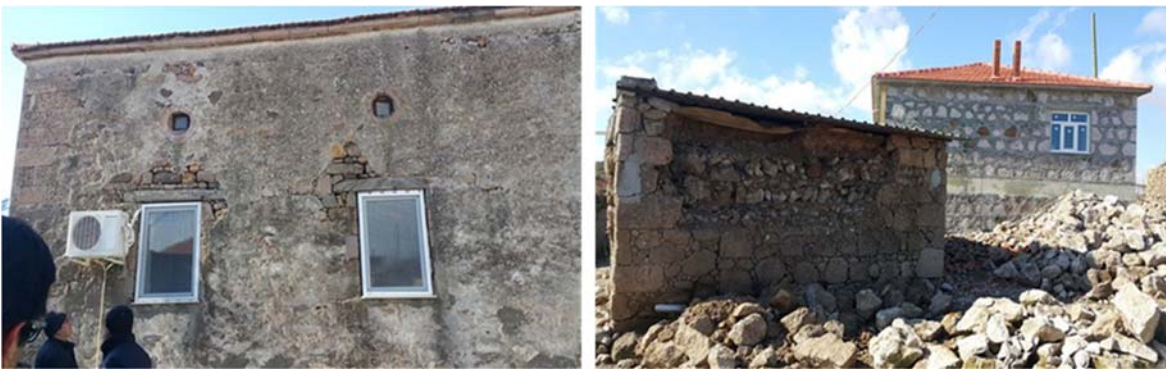
Figure 21 Examples of undamaged dwellings

In many cases, distinctive diagonal or inclined cracks have been observed in load-bearing window piers or walls with low width-to-height ratios as a result of inadequate shear resistance (Tomazevic, 1999). While bending and shear from moderate earthquake can be easily resisted by reinforced-masonry with lateral and horizontal elements such as RC or timber (Fig. 21), the dwelling made by stone in no mortar cannot resist them. This construction defect is causing in-plane failures by means of excessive shear force or bending or out of plane failure by bending depending on the aspect ratio of the unreinforced masonry elements.
