Response to Dr. Molinari:

Damages during February, 6-24 2017 Çanakkale earthquake swarm

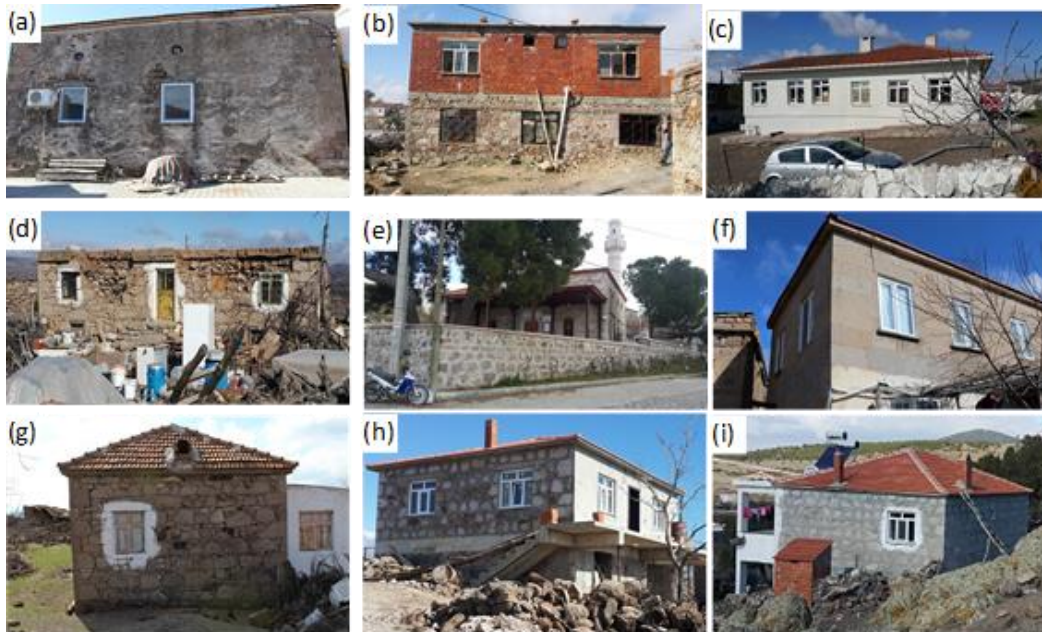
In the reconnaissance area, observations showed that the construction materials and skills ~~are were~~ extremely deficient. Modern materials and techniques ~~are were just only~~ used in a small part portion of the observed region. Moreover, cement mortar between stones was not used ~~for in~~ almost 50% of the walls. There ~~are were~~ a few ~~of~~ buildings in which reinforced concrete elements were partly or fully used ~~in the reconnaissance area~~. Curing of concrete is still not practiced as an integral part of the concreting process. The concrete blocks are of poor quality because of ~~the~~ poor quality of the concrete, ~~a~~ lack of compaction and very little or no curing. The existing building types in the area are shown in Fig. 4.

Figure 4: Existing building types in reconnaissance area: a) hatıl dwelling b) stone and brick in cement mortar, c) engineered RC building d) hatıl building with heavy roof, e) historical masonry with cut stone, f) cut stone without mortar, g) stone without mortar, h), i) stone in cement mortar with reinforced concrete.

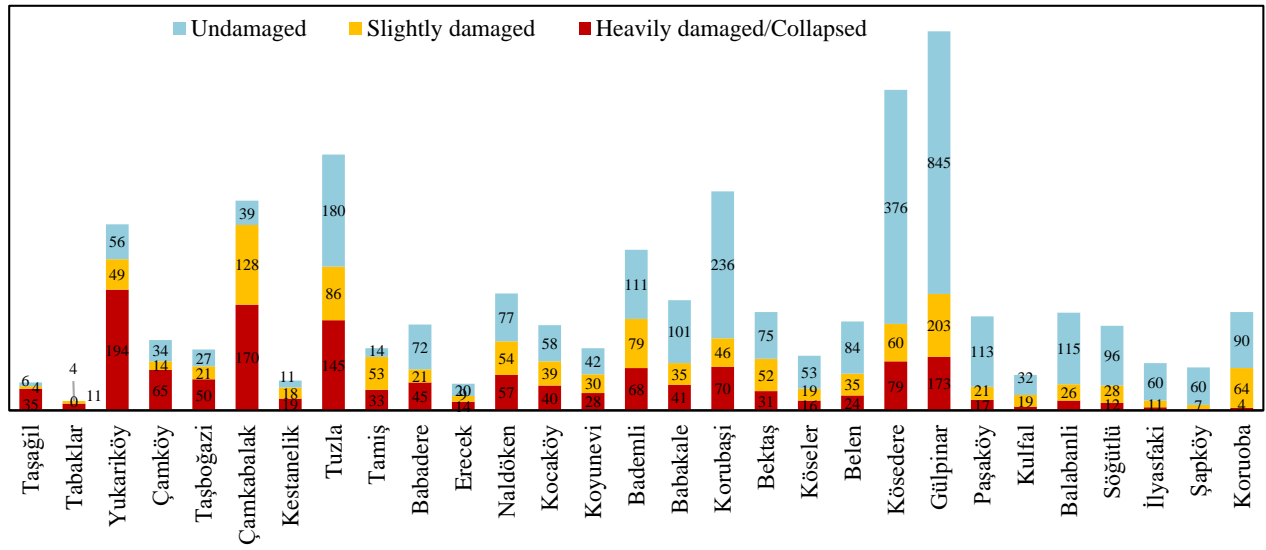
Number of buildings according to villages are given Figure 10. Moreover, total number of buildings are added to the text as below with updated numbers.

Figure 10: Number of buildings according to damage level due to Ayvacık Earthquake swarm

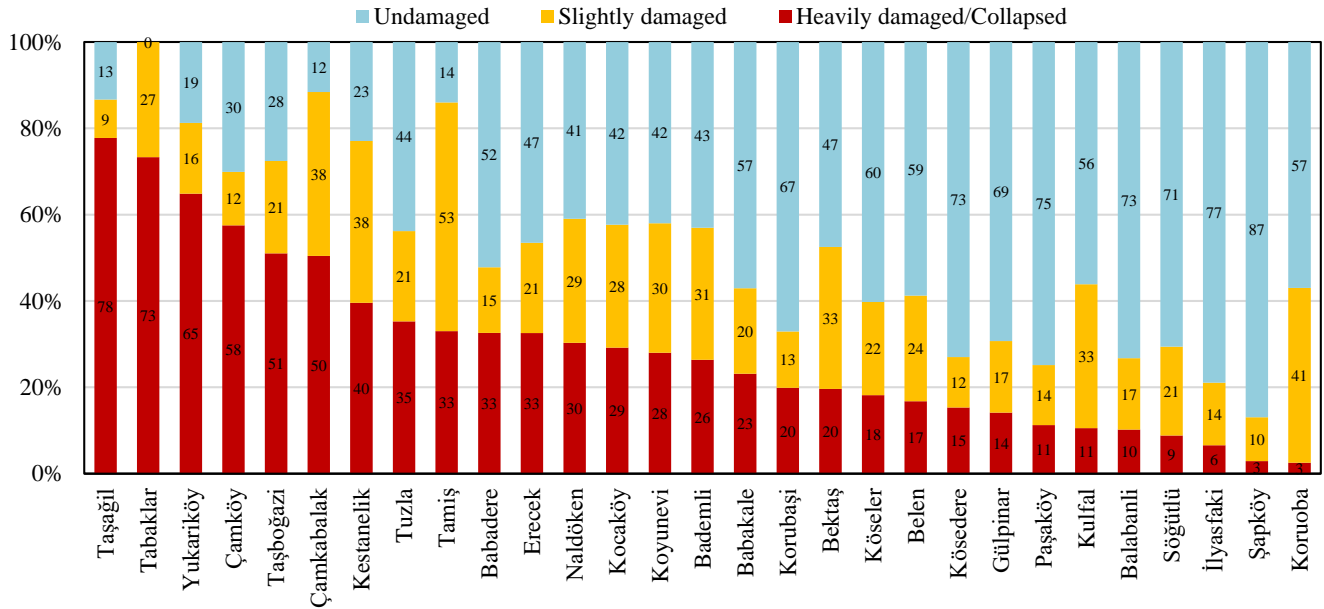
Since, the energy release was relatively very small comparing compared to the earthquakes that occurred on NAFZ or on EAFZ, the other most active zone EAFZ of Turkey, no RC structures collapsed in the area other than the poorly constructed stone masonry dwellings in rural areas. According to the data obtained from Çanakkale Provincial Directorates of Environment and Urbanization, in twenty-nine villages alone, where there were about 276050 damaged or collapsed buildings out of 5790 structures while 3083 structures did not experiencesuffer any damage more than 25% of the mansion or dwelling either collapsed or were heavily damaged. According to official estimates, within the affected area, a total of 146705 (25%) structures (including buildings, houses, barns, offices, stores and haylofts) were heavily damaged or collapsed, and 1235170 (22%) of them structures suffered medium or minor repairable damage. Also Moreover, a total of 30832990 (53%) structures did not experience suffer any damage. The locations of twenty-nine villages together with the epicenter epicentres of considered the studied earthquakes, their magnitudes, and PGAs are given in Figure 9, while the number of damaged structures and damage ratios according to within these villages are given in Figures 10 and 11, respectively. It can be seen from Figure 9 that Taşgöl, Yukarıköy and Çamköy, etc. as well as Gülpınar are close to the epicenter epicentres of earthquakes, although structures located in the town of Gülpınar town has experienced significantly less significant damage than other villages close to the epicenter epicentres (Figure 11). This resultsThese results may relate

to the construction techniques and development level of Gülpınar, which are higher more improved than the other villages.

5 Figure 11: Damage ratios in Villages according to damage level due to Ayvacık Earthquake swarm

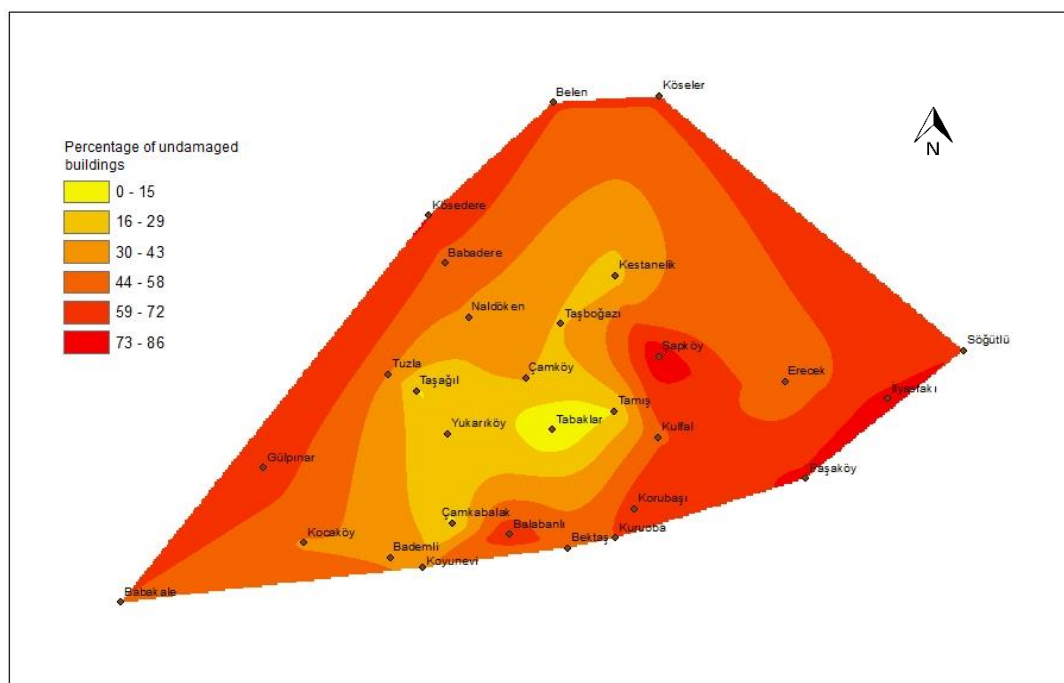
Also, distribution maps of buildings according to percentage for in percentages according to damage levels are given in Figures 12, 13 and 14, respectively. According to these figures, more clearly indicate that the percentage of heavily damaged/collapsed structures in Gülpınar was lower than other villages close to the epicentres that suffered significant damages. The reason for this can be explained by Gülpınar being a historical town centre in the region, therefore the town contain cultural heritage sites. The differences in terms of cultural accumulation and development level between Gülpınar and other villages subsequently affect the quality of construction. Thus, structural damage was more prominent in the villages with relatively low economical development, and where there are no engineered buildings as observed by the authors. that structures in Gülpınar experienced rare heavily damaged/collapsed level while several structures in villages close to the epicenter suffer significant damage level. The reason of this situation is that a single or a few storey non engineered heavy masonry buildings with very poor details, however, along the sloping hills to the west of Gülpınar Ayvaıcık, practically survived the earthquake without significant damage (Figure 14). It should be also noted that Gülpınar is relatively close to the epicenter of the earthquake than other town such as Taşağıl, Yukarıköy and Çamköy where dwellings were suffered very high damages. Gülpınar is also a historical center in this area and has the cultural heritages, so the differences in terms of the cultural accumulation and development level between Gülpınar and the other villages affect the quality of the construction. Thus, the structural damage was concentrated mainly in the villages which have relatively very low economical level and where there are not any engineered buildings observed by the authors.

Figure 12: Distribution maps of undamaged buildings according to percentage

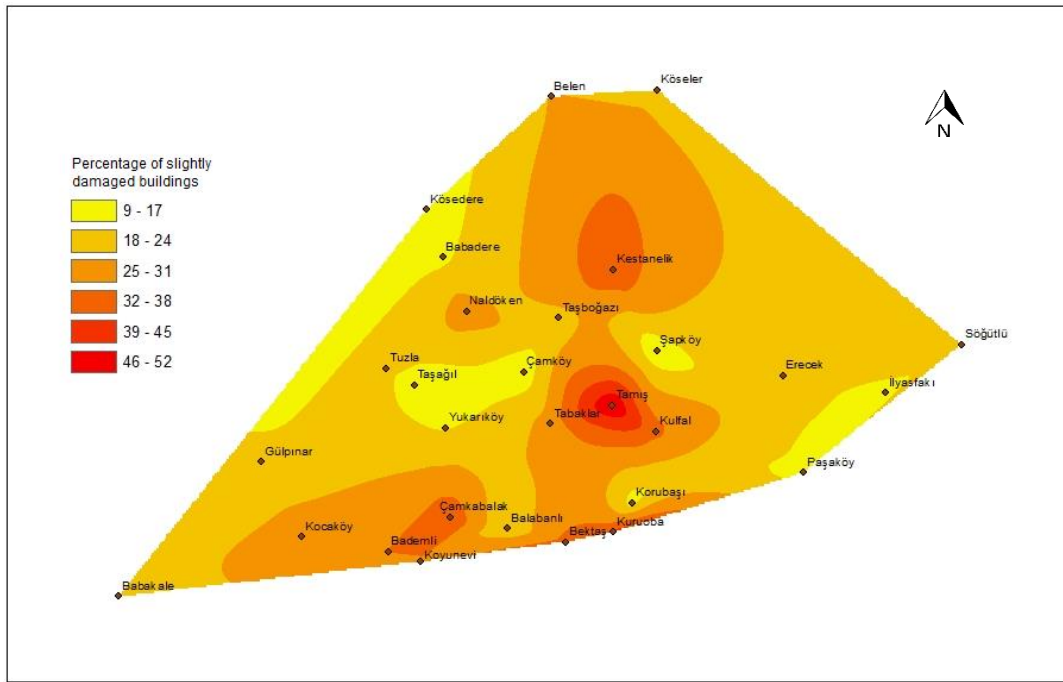
Figure 13: Distribution maps of slightly damaged buildings [according to](#) percentage

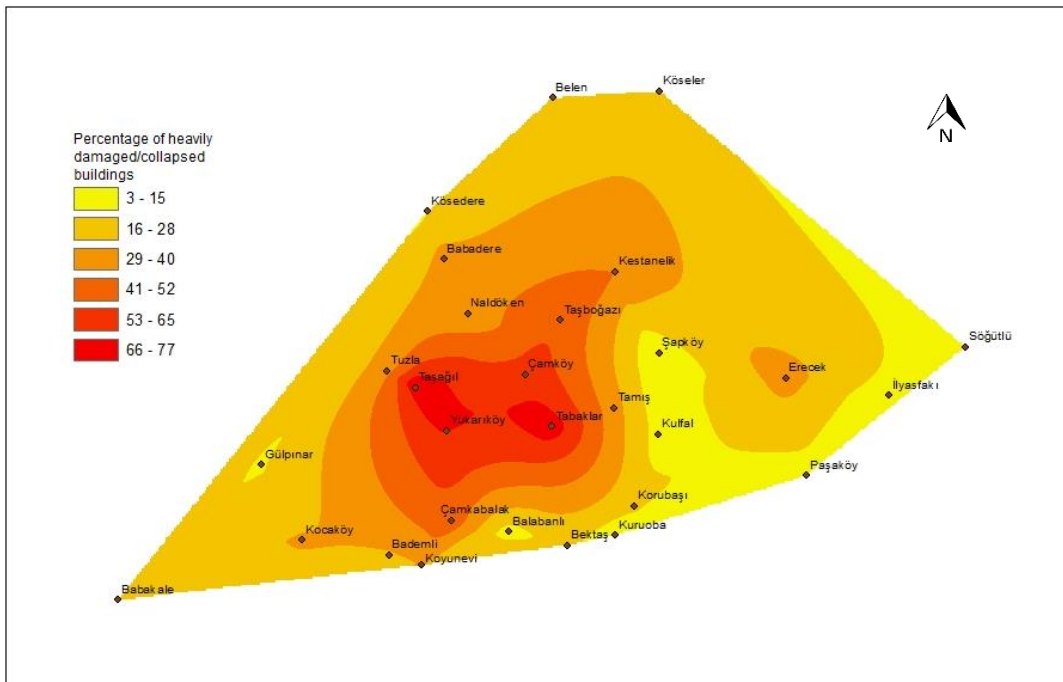
Figure 14: Distribution maps of [heavily](#) damaged/collapsed buildings [according to](#) percentage

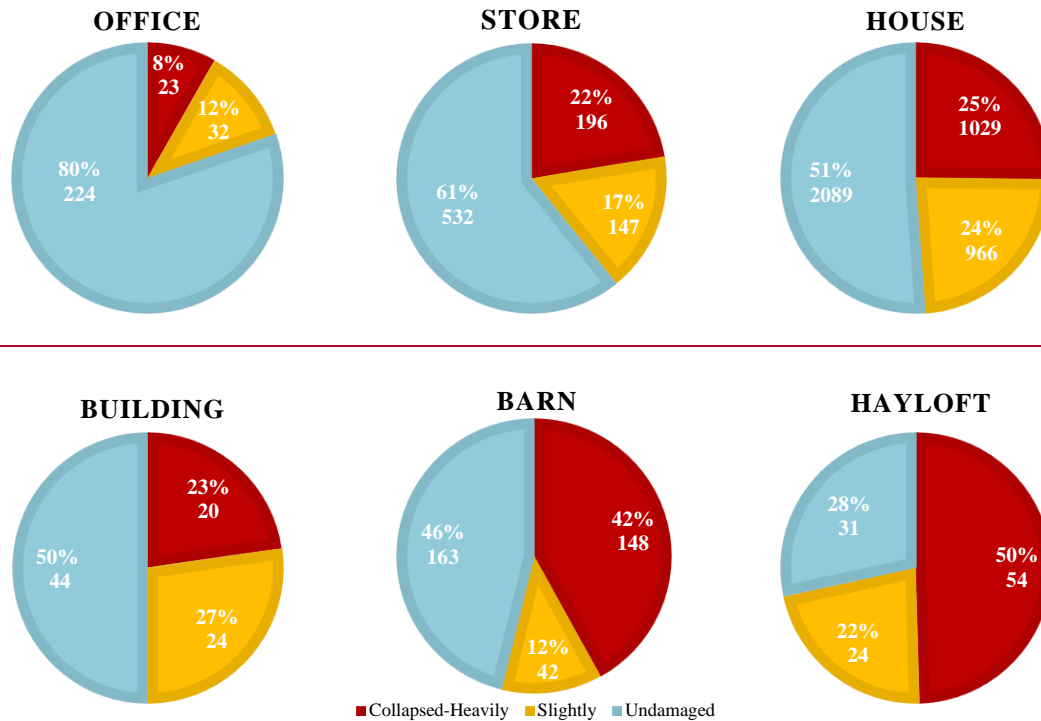
Distribution maps mentioned above are created for all structures regardless of ~~considering~~the structure types. However, evaluation of damage levels according to structure types may ~~bring~~introduce a new ~~viewpoint~~perspective in ~~order to~~ ~~interpret~~interpreting the damages. Besides, such a parametric study may be a guide in order not to repeat similar mistakes when reconstructing structures ~~having a high ratio of~~with a high heavily damaged/collapsed ~~level~~ratio according to structure types. Damage ratios according to six structure types are generated in Figure 15 with the support of Çanakkale Provincial Directorates of Environment and Urbanization. As can be seen from the figure, the construction practices applied on Haylofts and Barns should be substantially revised ~~for such a possible~~in order to minimize damages from a potential similar earthquake. On the other hand, the ~~techni~~techniques used on structures having approximately %25 a heavily damaged ratio of approximately 25%, such as stores, houses and buildings may be reviewed and enhanced according to technical deficiencies mentioned in the next section. ~~However, o~~It can be seen that office structures experienced relatively less damage compared to other structure types. Thus, it can be said that construction of office structures ~~have closer~~were performed more in line with the conditions required by TEC' 2007.

Figure 15: Damage ratios and levels according to structure type
