Damages during February, 6-24 2017 Çanakkale earthquake swarm

Ramazan Livaoğlu¹, Mehmet Ömer Timurağaoğlu¹, Cavit Serhatoğlu¹, Mahmud Sami Döven²

Abstract. On February 6, 2017 a swarm of earthquakes began at the western end of the Turkey. This has been the first recorded swarm at Çanakkale region since continuous seismic monitoring began in 1970. The number of located earthquakes increased during the next ten days. This paper describes the output of a survey carried out in the earthquake prone towns of Ayvacık, Çanakkale, Turkey, in February 2017 after the earthquakes. Observations were made on site regarding traditional buildings at the rural area of Ayvacık. A description of the main structural features and their effects on the most frequently viewed damage modes were made according to in plane, out of plane behaviour of the wall regarding construction practice, connection type etc. It was found that there were no convenient connection details like cavity-ties or sufficient mortar strength resulting in decreased and/or lack of lateral load bearing capacity of the wall.

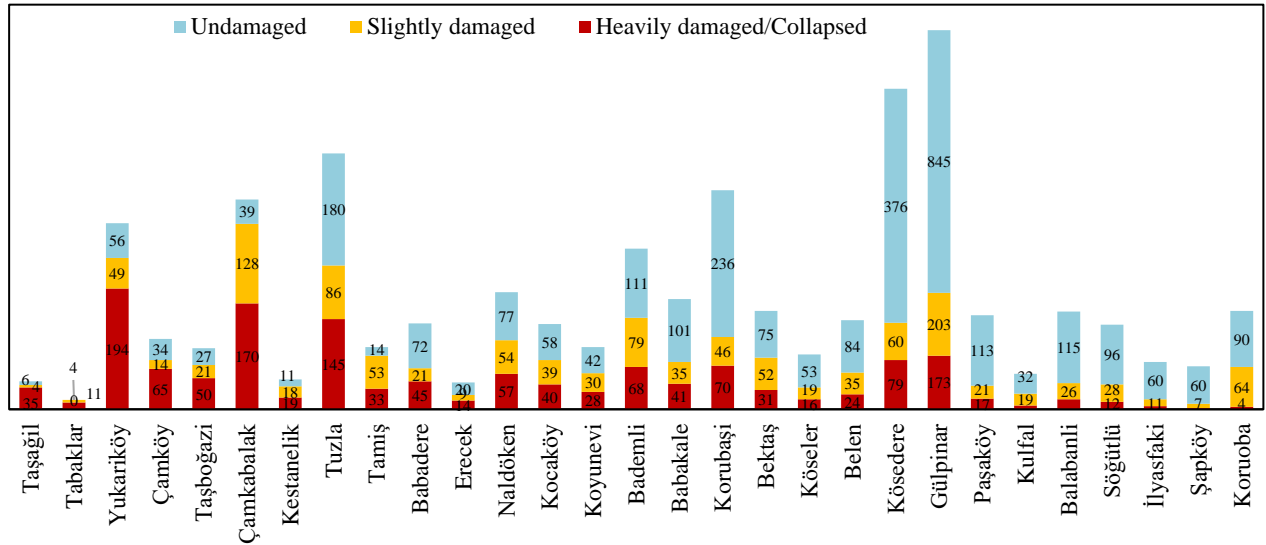
- Since the energy release was relatively very small compared to the earthquakes that occurred on NAFZ or on EAFZ, the other
- 10 most active zone of Turkey, no RC structures collapsed in the area other than the poorly constructed stone masonry dwellings in rural areas. According to the data obtained from Çanakkale Provincial Directorates of Environment and Urbanization, in twenty-nine villages ~~alone~~, there were about 2705 damaged or collapsed buildings out of 5790 structures while 3083 structures did not suffer any damage. According to official estimates, within the affected area, a total of 1470 (25%) structures (including buildings, houses, barns, offices, stores and haylofts) were heavily damaged or collapsed, and 1235 (22%) structures suffered

- 15 medium or minor repairable damage. Moreover, a total of 3083 (53%) structures did not suffer any damage. The locations of twenty-nine villages together with the epicentres of the studied earthquakes, their magnitudes, and PGAs are given in Figure 9, while the number of damaged structures and damage ratios within these villages are given in Figures 10 and 11, respectively. It can be seen from Figure 9 that Taşağıl, Yukarıköy and Çamköy, as well as Gülpınar are close to the epicentres of earthquakes, although structures located in the town of Gülpınar experienced significantly less damage than other villages close to the

Figure 10: Number of buildings according to damage level due to Ayvacık Earthquake swarm

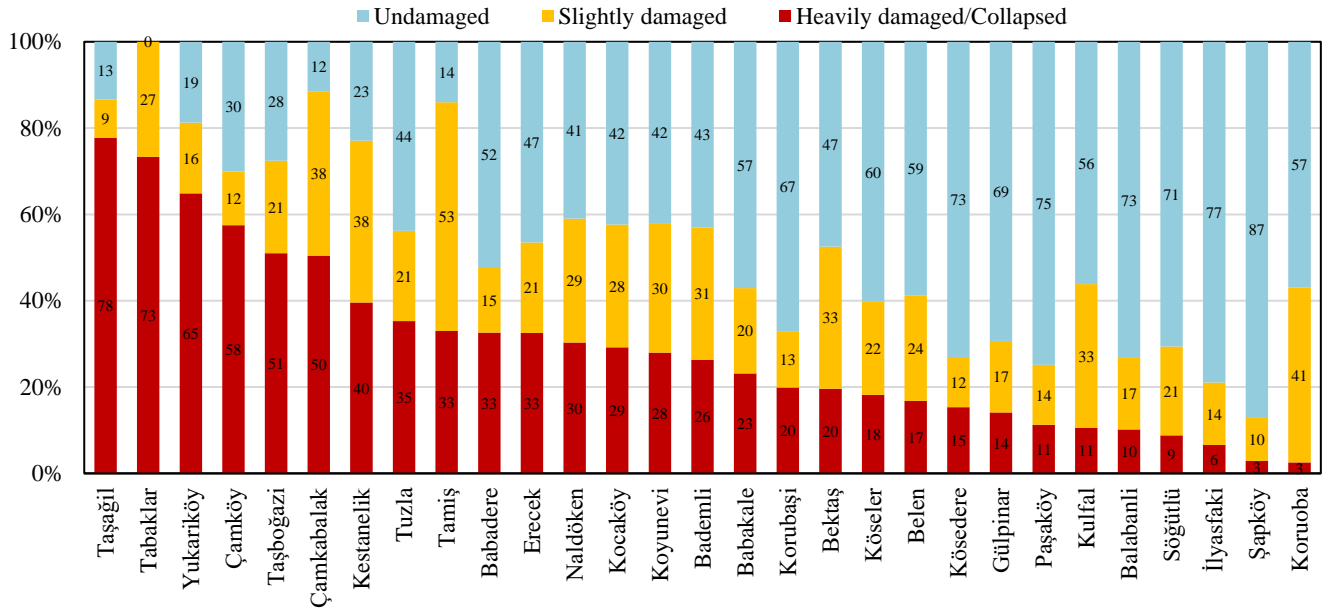
- 20 epicentres (Figure 11). These results may relate to the construction techniques and development level of Gülpınar, which are more improved than the other villages.

Figure 11: Damage ratios in Villages according to damage level due to Ayvacık Earthquake swarm

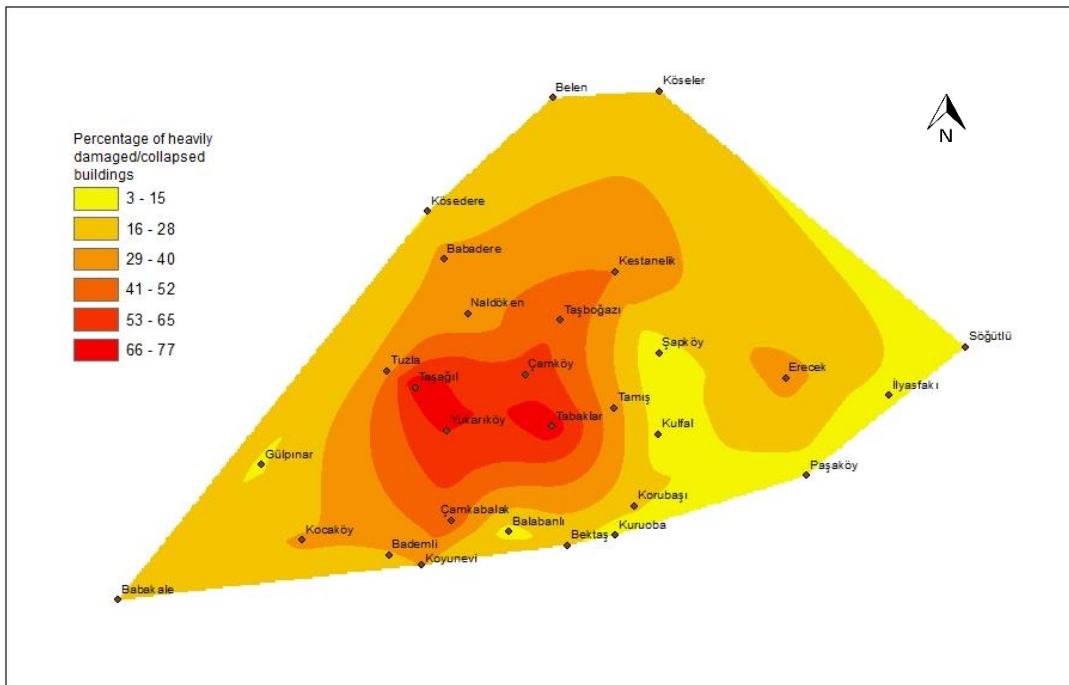
Distribution maps of buildings in percentages according to damage levels are given in Figures 12, 13 and 14, respectively. These figures clearly indicate that the percentage of heavily damaged/collapsed structures in Gülpınar was lower than other villages close to the epicentres that suffered significant damages. The reason for this can be explained by Gülpınar being a historical town centre in the region, therefore the town contain cultural heritage sites. The differences in terms of cultural accumulation and development level between Gülpınar and other villages subsequently affect the quality of construction. Thus, structural damage was more prominent in the villages with relatively low economical development, and where there are no engineered buildings as observed by the authors.

Figure 14: Distribution maps of heavily damaged/collapsed buildings in percentage

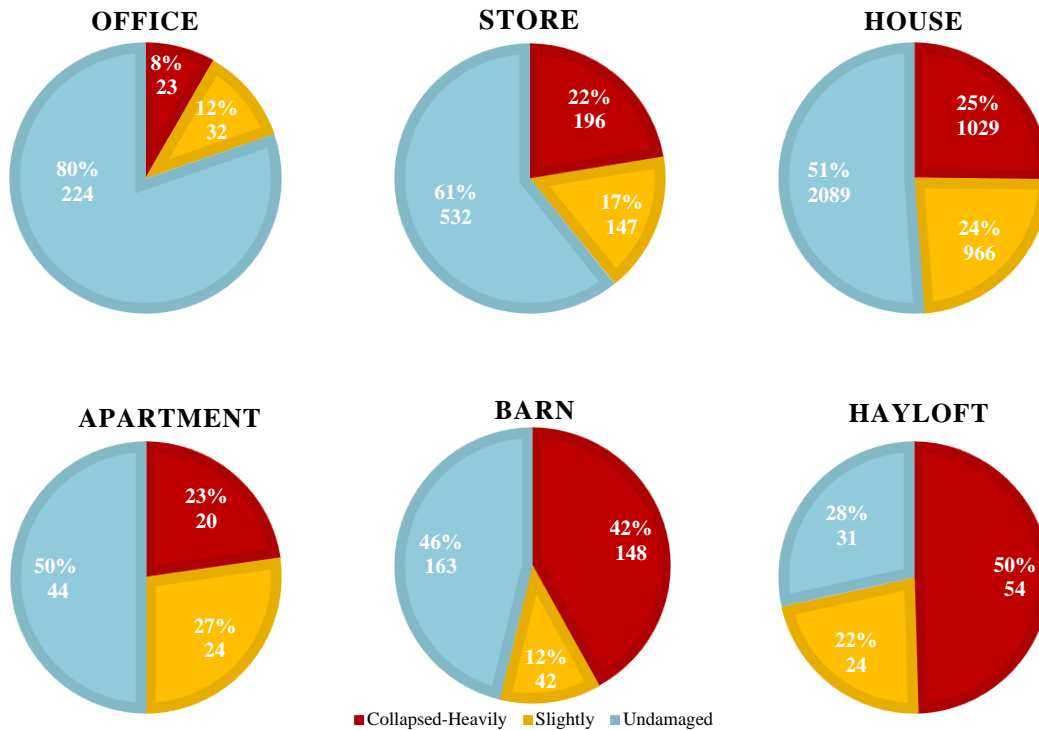
- The second point is on the Figure 15 and related paragraph. Structure type is related with the construction, but the authors refer the occupancy of the units/buildings. So that the terminology is misused here. We can understand the different ways of usage such as office, store (shop would fit better), house (housing unit or single housing unit), barn and hayloft. However, it is not clear what “building” refers to. Here I recommend the authors to cross structure types and occupancy to reach some tangible findings. For instance, if the percentage of x structures is homogenously distributed in each occupancy, here the maintenance related to the occupancy would be primary point in damage ratios. Or if the percentage of x structure is higher in haylofts and barns and the damage ratio is also high, the conclusion would be on the problems of the construction/structure type.

As stated by the referee, the structure type in the text is turn into “structure” and building is revised as “apartment” in Fig. 15. The authors, in the reconnaissance region, observed that most of haylofts

and barns are constructed, similar to house, by using stone without mortar and also net span between walls of the structures were great. This is added to the paper. However, a specific value of damage ratio could not be given because either authors or government agencies did not carry out such a survey.

Distribution maps mentioned above are created for all structures regardless of the structure ~~types~~. However, evaluation of damage levels according to structure ~~types~~ may introduce a new perspective in interpreting the damages. Besides, such a parametric study may be a guide in order not to repeat similar mistakes when reconstructing structures with a high heavily damaged/collapsed ratio according to structure ~~types~~. Damage ratios according to six structure ~~types~~ are generated in Figure 15 with the support of Çanakkale Provincial Directorates of Environment and Urbanization. As can be seen from the figure, the construction practices applied on Haylofts and Barns should be substantially revised in order to minimize damages from a potential similar earthquake. Because most of haylofts and barns are constructed using stone without mortar and also net span between walls of the structures were great. On the other hand, the techniques used on structures having a heavily damaged ratio of approximately 25%, such as stores, houses and ~~buildings-apartments~~ may be reviewed and enhanced according to technical deficiencies mentioned in the next section. It can be seen that office structures experienced relatively less damage compared to other structure ~~types~~. Thus, it can be said that construction of office structures ~~were~~was performed more in line with the conditions required by TEC' 2007.

Figure 15: Damage ratios and levels according to structure type

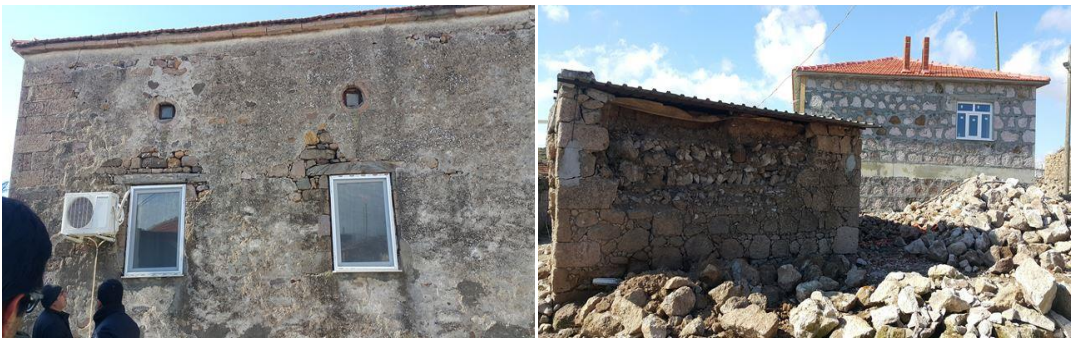
Figure 22: Examples of undamaged dwellings
