Damages during February, 6-24 2017 Çanakkale earthquake swarm

Abstract. On February 6, 2017 a swarm of earthquakes began at the western end of the Turkey. This has been the first recorded swarm at Çanakkale region since continuous seismic monitoring began in 1970. The number of located earthquakes increased during the next ten days. This paper describes the output of a survey carried out in the earthquake prone towns of Ayvacık, Çanakkale, Turkey, in February 2017 after the earthquakes. Observations were made on site regarding traditional buildings at the rural area of Ayvacık. A description of the main structural features and their effects on the most frequently viewed damage modes were made according to in plane, out of plane behaviour of the wall regarding construction practice, connection type etc. It was found that there were no convenient connection details like cavity-ties or sufficient mortar strength resulting in decreased and/or lack of lateral load bearing capacity of the wall.

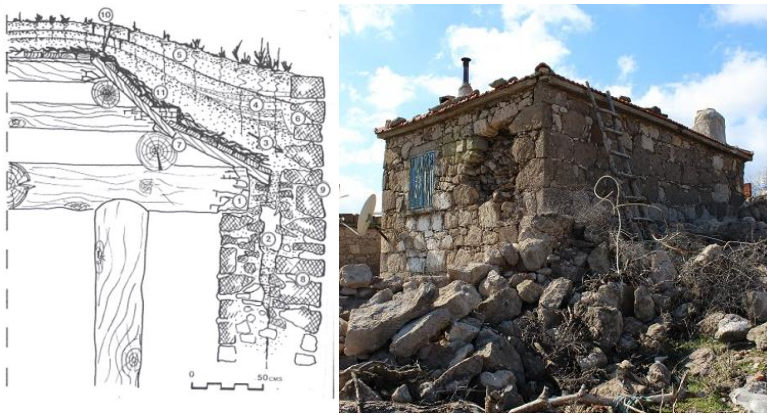
Figure 3: Typical wall construction detail (Hughes, 2000) and typical view of a dwelling from the region

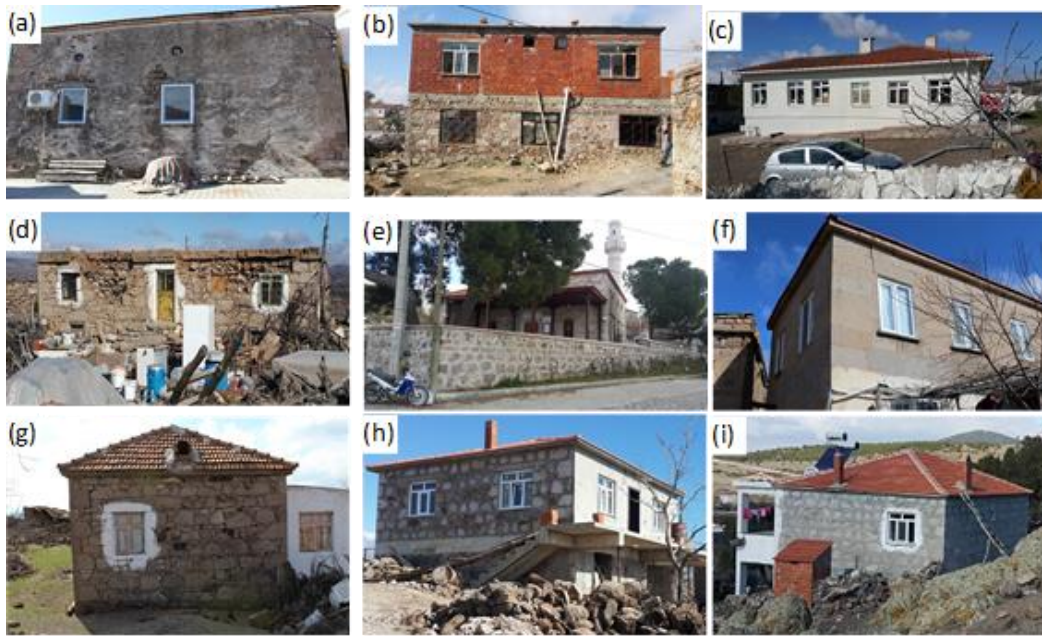
In the reconnaissance area, observations showed that the construction materials and skills were extremely deficient. Modern materials and techniques were only used in a small portion of the observed region. Moreover, cement mortar between stones was not used in almost 50% of the walls. There were a few buildings in which reinforced concrete elements were partly or fully used. Curing of concrete is still not practiced as an integral part of the concreting process. The concrete blocks are of poor quality because of poor quality of the concrete, lack of compaction and very little or no curing. The existing building types in the area are shown in Fig. 4.

5 **Figure 4: Existing building types in reconnaissance area: a) hatıl dwelling b) stone and brick in cement mortar, c) engineered RC building d) hatıl building with heavy roof, e) historical masonry with cut stone, f) cut stone without mortar, g) stone without mortar, h), i) stone in cement mortar with reinforced concrete.**
