Damages during February, 6-24 2017 Çanakkale earthquake swarm

Ramazan Livaoğlu¹, Mehmet Ömer Timurağaoğlu¹, Cavit Serhatoğlu¹, Mahmud Sami Döven²

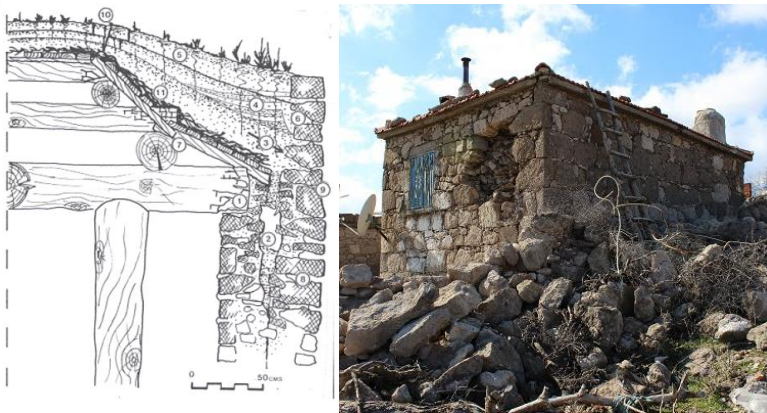
Figure 3: Typical wall construction detail (Hughes, 2000) and typical view of a dwelling from the region

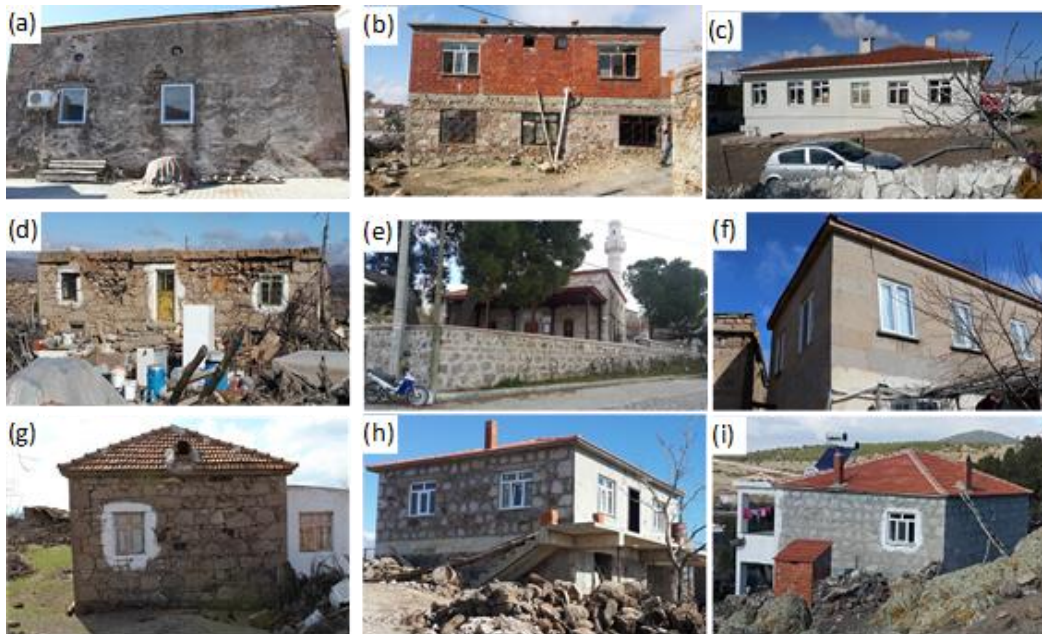
In the reconnaissance area, observations showed that the construction materials and skills were extremely deficient. Modern materials and techniques were only used in a small portion of the observed region. Moreover, cement mortar between stones was not used in almost 50% of the walls. There were a few buildings in which reinforced concrete elements were partly or fully used. Curing of concrete is still not practiced as an integral part of the concreting process. The concrete blocks are of poor quality because of poor quality of the concrete, lack of compaction and very little or no curing. The existing building types in the area are shown in Fig. 4.

5 **Figure 4: Existing building types in reconnaissance area: a) hatıl dwelling b) stone and brick in cement mortar, c) engineered RC building d) hatıl building with heavy roof, e) historical masonry with cut stone, f) cut stone without mortar, g) stone without mortar, h), i) stone in cement mortar with reinforced concrete.**

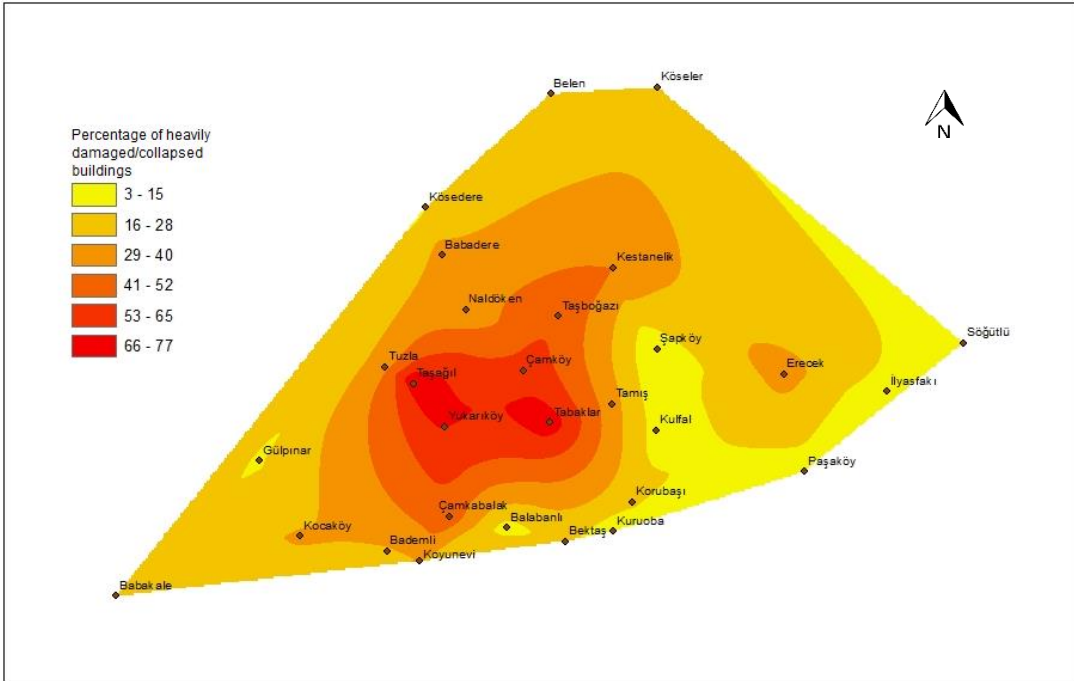
Distribution maps of buildings in percentages according to damage levels are given in Figures 12, 13 and 14, respectively. These figures clearly indicate that the percentage of heavily damaged/collapsed structures in Gülpınar was lower than other villages close to the epicentres that suffered significant damages. The reason for this can be explained by Gülpınar being a historical town centre in the region, therefore the town contain cultural heritage sites. The differences in terms of cultural accumulation and development level between Gülpınar and other villages subsequently affect the quality of construction. Thus, structural damage was more prominent in the villages with relatively low economical development, and where there are no engineered buildings as observed by the authors.

Figure 14: Distribution maps of heavily damaged/collapsed buildings in percentage

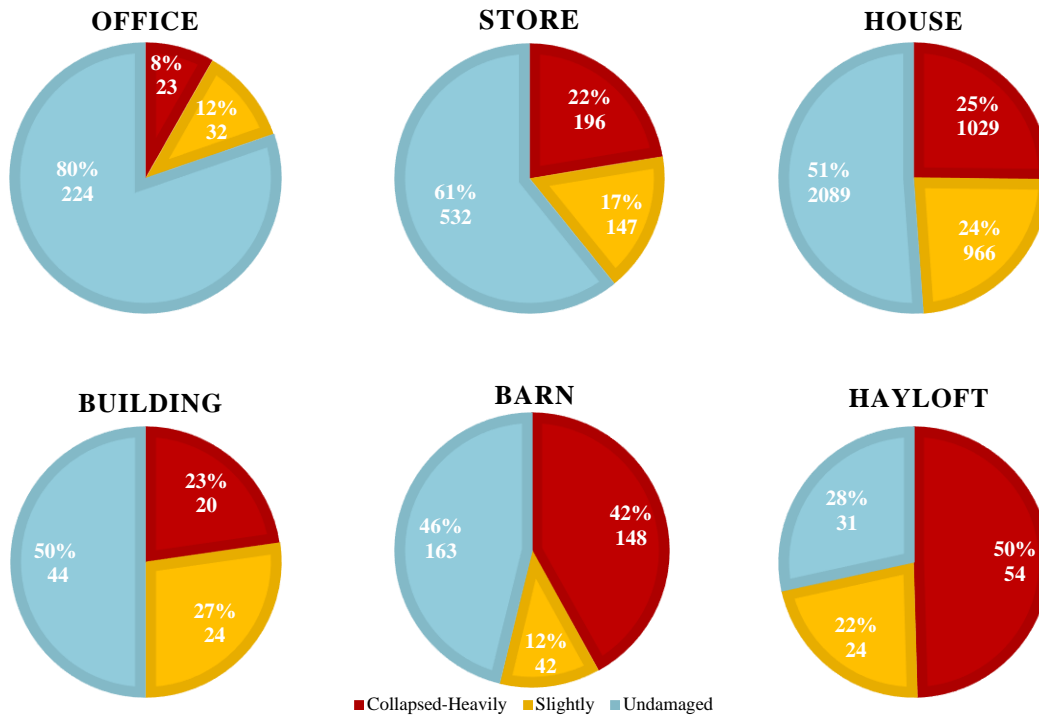
Distribution maps mentioned above are created for all structures regardless of the structure types. However, evaluation of damage levels according to structure types may introduce a new perspective in interpreting the damages. Besides, such a parametric study may be a guide in order not to repeat similar mistakes when reconstructing structures with a high heavily damaged/collapsed ratio according to structure types. Damage ratios according to six structure types are generated in Figure 15 with the support of Çanakkale Provincial Directorates of Environment and Urbanization. As can be seen from the figure, the construction practices applied on Haylofts and Barns should be substantially revised in order to minimize damages from a potential similar earthquake. On the other hand, the techniques used on structures having a heavily damaged ratio of approximately 25%, such as stores, houses and buildings may be reviewed and enhanced according to technical deficiencies mentioned in the next section. It can be seen that office structures experienced relatively less damage compared to other structure types. Thus, it can be said that construction of office structures were performed more in line with the conditions required by TEC' 2007.

15 **Figure 15: Damage ratios and levels according to structure type**

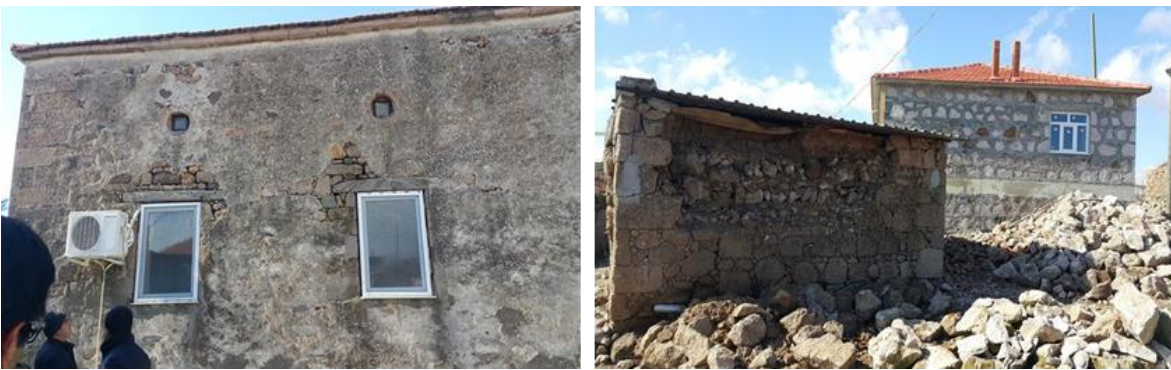
Figure 22: Examples of undamaged dwellings
