Damages during February, 6-24 2017 Çanakkale earthquake swarm

Ramazan Livaoğlu¹, Mehmet Ömer Timurağaoğlu¹, Cavit Serhatoğlu¹, Mahmud Sami Döven²

Abstract. On February 6, 2017 earthquake swarm began at the western end of the Turkey. This has been the first recorded swarm at Çanakkale region since continuous seismic monitoring began in 1970. The number of located earthquakes increased during the next ten days. This paper describes the output of a survey carried out in the earthquake prone towns of Ayvacık, Çanakkale, Turkey, in February 2017 after the earthquakes. Observations were made on site regarding traditional buildings at the rural area of Ayvacık. A description of the main structural features and their effects on the most frequently viewed damage modes were made according to in plane, out of plane behaviour of the wall regarding construction practice, connection type etc. It was found that there were no convenient connection details like cavity-ties or sufficient mortar strength resulting in decreased and/or lack of lateral load bearing capacity of the wall. Furthermore, distribution maps of damaged/undamaged buildings according to villages, damage ratios, structures and d

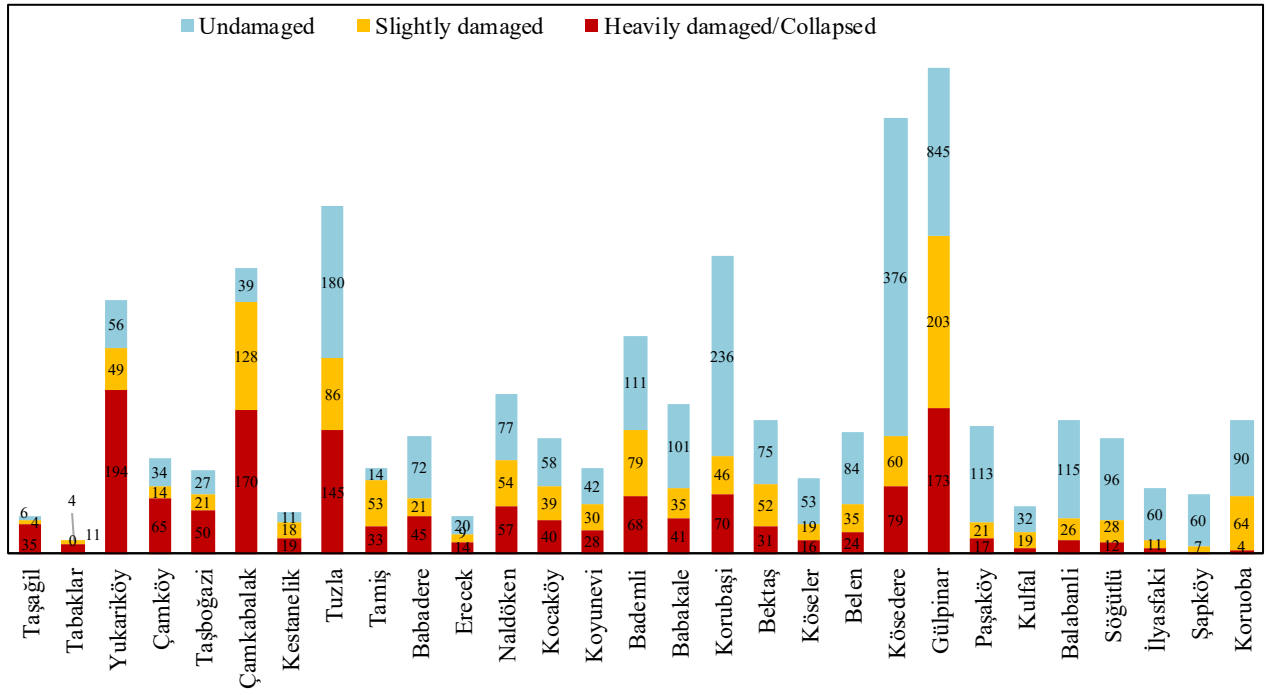
Since the energy release was relatively very small compared to the earthquakes that occurred on NAFZ or on EAFZ, the other most active zone of Turkey, no RC structures collapsed in the area other than the poorly constructed stone masonry dwellings in rural areas. According to the data obtained from Çanakkale Provincial Directorates of Environment and Urbanization, in twenty-nine villages, there were about 2705 damaged or collapsed buildings out of 5790 structures while 3083 structures did not suffer any damage. According to official estimates, within the affected area, a total of 1470 (25%) structures (including apartments, houses, barns, offices, stores and haylofts) were heavily damaged or collapsed, and 1235 (22%) structures suffered medium or minor repairable damage. Moreover, a total of 3083 (53%) structures did not suffer any damage. The locations of twenty-nine villages together with the epicentres of the studied earthquakes, their magnitudes, and PGAs are given in Figure 9, while the number of damaged structures and damage ratios within these villages are given in Figures 10 and 11, respectively. It can be seen from Figure 9 that Taşağıl, Yukarıköy and Çamköy, as well as Gülpınar are close to the epicentres of earthquakes, although structures located in the town of Gülpınar experienced significantly less damage than other villages close to the epicentres (Figure 11). These results may relate to the construction techniques and development level of Gülpınar, which are more improved than the other villages.

Figure 10: Number of buildings according to damage level due to Ayvacık earthquake swarm

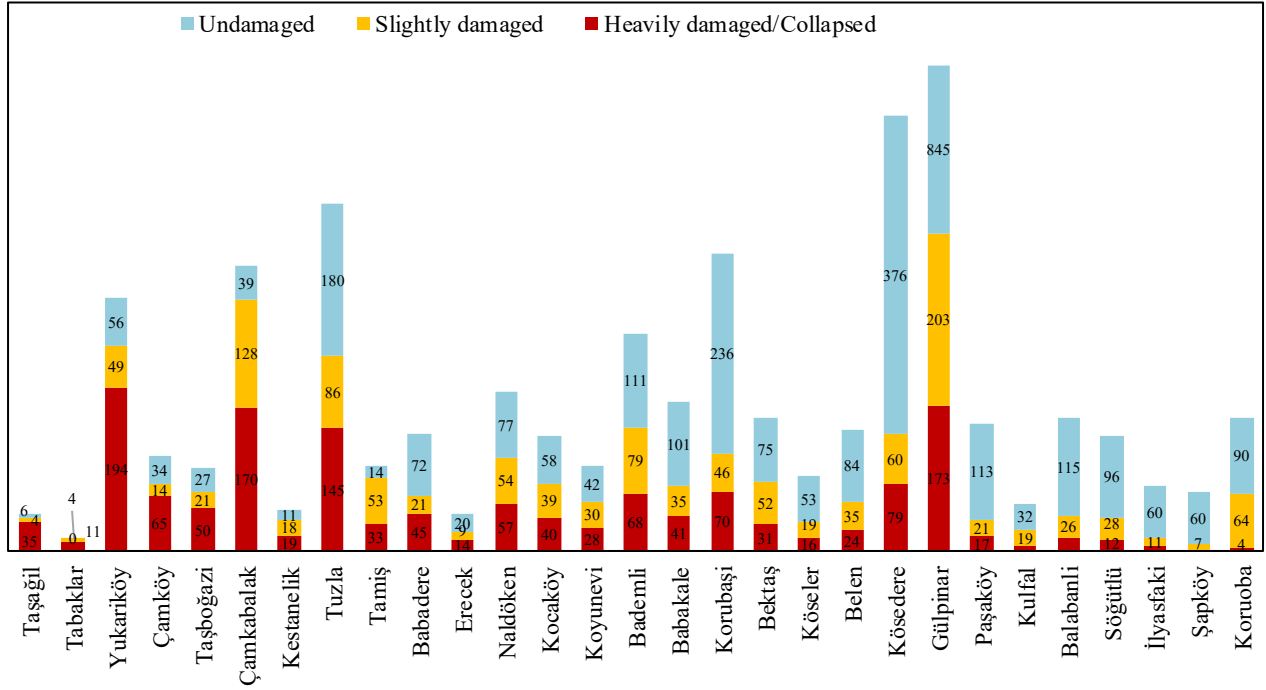
Figure 11: Damage ratios in Villages according to damage level due to Ayvacık earthquake swarm

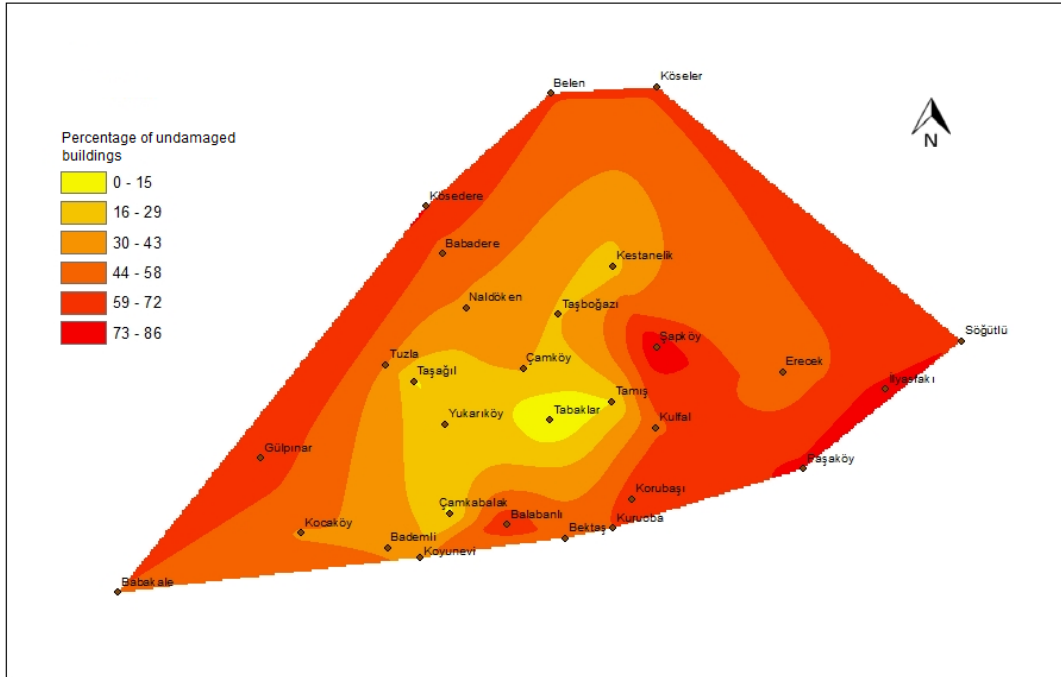
Distribution maps of buildings in percentages according to damage levels are given in Figures 12, 13 and 14, respectively. These figures clearly indicate that the percentage of heavily damaged/collapsed structures in Gülpınar was lower than other villages close to the epicentres that suffered significant damages. The reason for this can be explained by Gülpınar being a historical town centre in the region, therefore the town contain cultural heritage sites. The differences in terms of cultural accumulation and development level between Gülpınar and other villages subsequently affect the quality of construction. Thus, structural damage was more prominent in the villages with relatively low economical development, and where there are no engineered buildings as observed by the authors.

10 **Figure 12: Distribution maps of undamaged buildings in percentage**

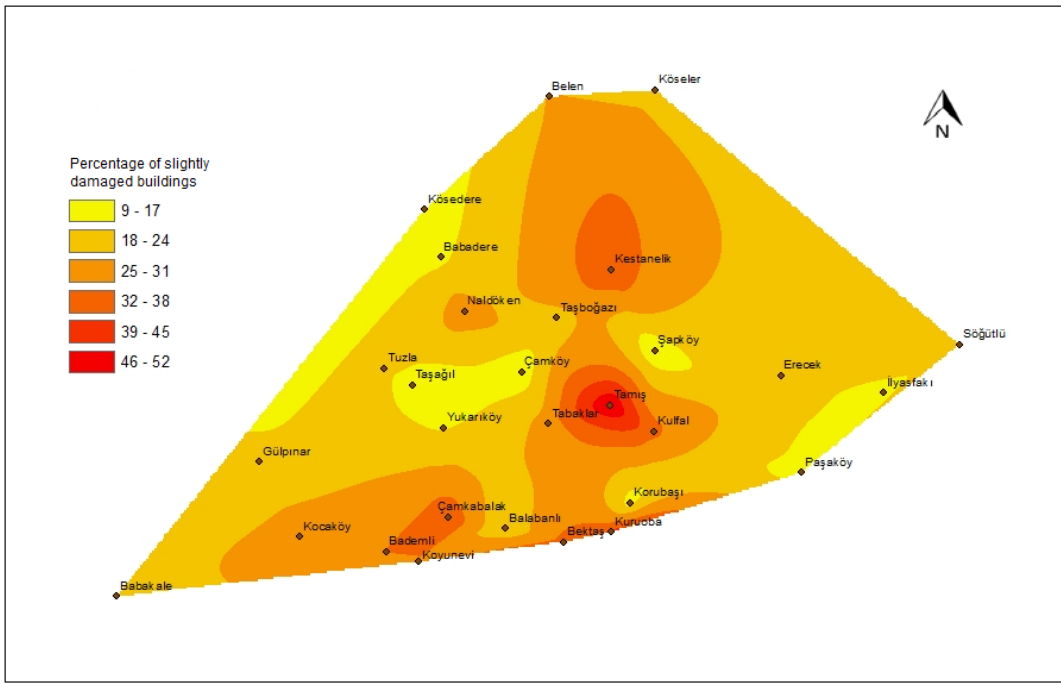
Figure 13: Distribution maps of slightly damaged buildings in percentage

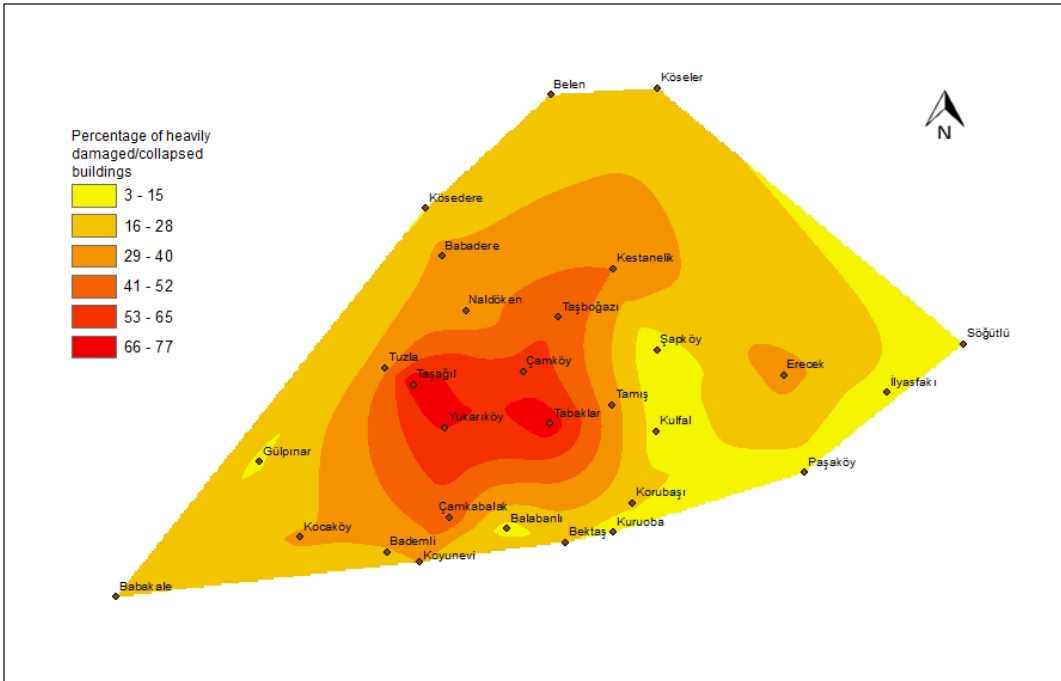
Figure 14: Distribution maps of heavily damaged/collapsed buildings in percentage

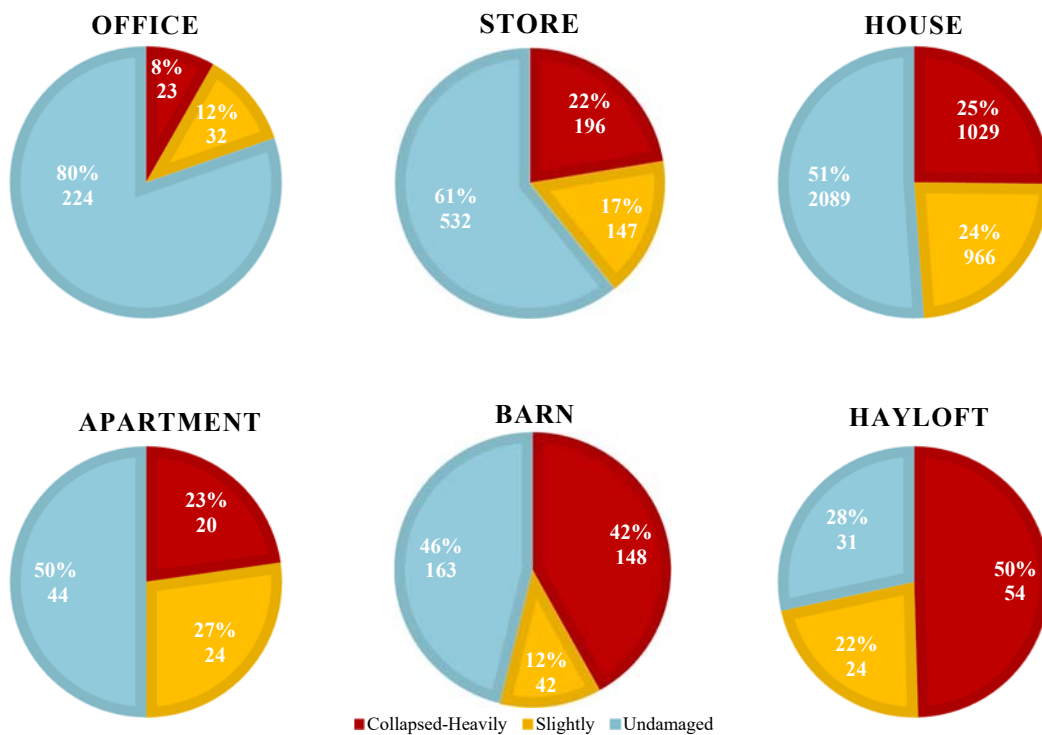
Distribution maps mentioned above are created for damage ratios according to damage levels of all structures. However, evaluation of damage levels according to structure may introduce a new perspective in interpreting the damages. Besides, such a parametric study may be a guide in order not to repeat similar mistakes when reconstructing structures with a high heavily damaged/collapsed ratio according to structure. Damage ratios according to six structure are generated in Figure 15 with the support of Çanakkale Provincial Directorates of Environment and Urbanization. As can be seen from the figure, the construction practices applied on Haylofts and Barns should be substantially revised in order to minimize damages from a potential similar earthquake. Because most of haylofts and barns are constructed using stone without mortar and also net span between walls of the structures were high. On the other hand, the techniques used on structures having a heavily damaged ratio of approximately 25%, such as stores, houses and apartments may be reviewed and enhanced according to technical deficiencies mentioned in the next section. It can be seen that office structures experienced relatively less damage compared to other structure. Thus, it can be said that construction of office structures was performed more in line with the conditions required by TEC' 2007.

Figure 15: Damage ratios and levels according to structure
