Damages during February, 6-24 2017 Çanakkale earthquake swarm

Ramazan Livaoğlu¹, Mehmet Ömer Timurağaoğlu¹, Cavit Serhatoğlu¹, Mahmut Sami Döven²

Abstract. On February 6, 2017 a swarm of earthquakes began at the western end of the Turkey. This has been the first recorded swarm at Çanakkale region since continuous seismic monitoring began in 1970. The number of located earthquakes increased during the next ten days. This paper describes the output of a survey carried out in the earthquake prone towns of Ayvacık, Çanakkale, Turkey, in February 2017 after the earthquakes. Observations collected on site regard traditional
10 buildings at the rural area of Ayvacık. A description of the main structural features and their effects on the most frequently viewed damage modes are related in plane, out of plane behavior of the wall regarding construction practice, connection type etc. It was found that there were no convenient connection details like cavity-ties or sufficient mortar strength resulting in decreased and/or lack of lateral load bearing capacity of the wall.

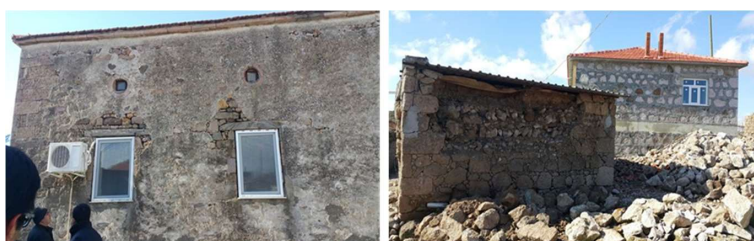
In many cases, distinctive diagonal or inclined cracks have been observed in load-bearing window piers or walls with low width-to-height ratios as a result of inadequate shear resistance (Tomazevic, 1999). While bending and shear from moderate earthquake can be easily resisted by reinforced-masonry with lateral and horizontal elements such as RC or timber (Fig. 15), the dwelling made by stone in no mortar cannot resist them. This construction defect is causing in-plane failures by means of excessive shear force or bending or out of plane failure by bending depending on the aspect ratio of the unreinforced masonry elements.

Figure 15 Examples of undamaged dwellings
