Seismic vulnerability of vernacular Newari buildings in Nepal: observations and analysis of damage due to 1934, 1988, 2011, and 2015 earthquakes

Abstract. This paper reports the seismic vulnerability of vernacular Newari buildings based on the damage observations during four major earthquakes (1934, 1988, 2011 and 2015) that struck Bhaktapur city. Some specific features that contributed to collapse prevention in traditional masonry buildings are also highlighted in this paper. In this paper, we have outlined the insights of each earthquake using forensic interpretations and the recommendations by various researchers after 1934 and 1988 earthquakes are compared in terms of their implementation. With the help of damage database recorded during 1934, 1988 and 2015 earthquakes, we have created damage probability matrices and empirical fragility functions for traditional masonry structures. The fragility functions and damage probability matrices derived in this study highlight that most of the vernacular Newari buildings are likely to be collapsed in the case of strong to major earthquakes.

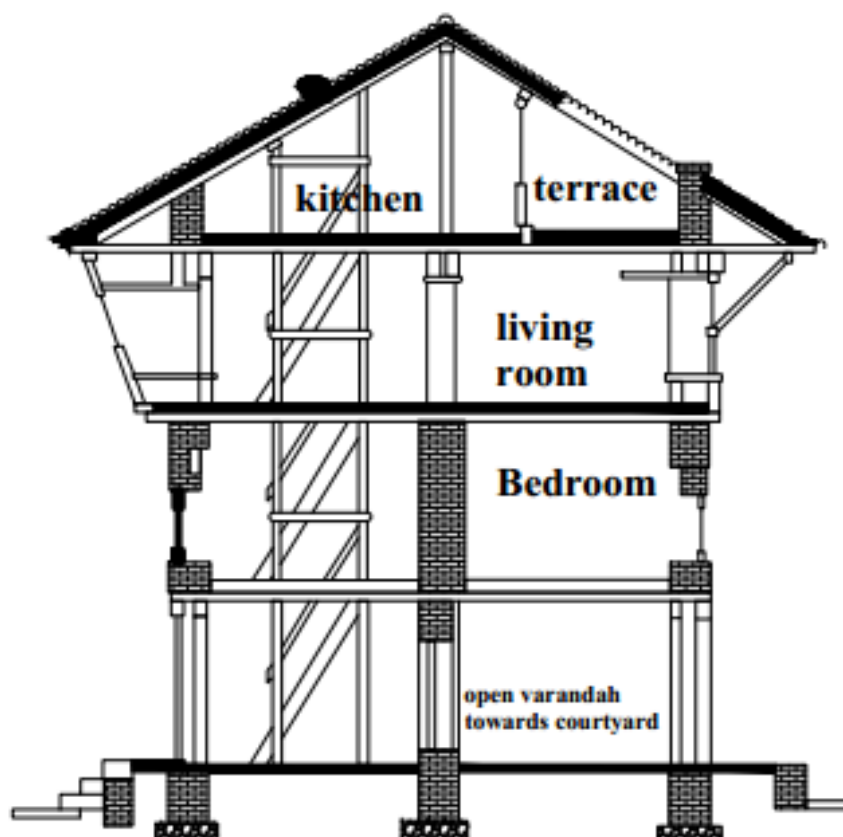
Figure 2: Vernacular brick masonry building.

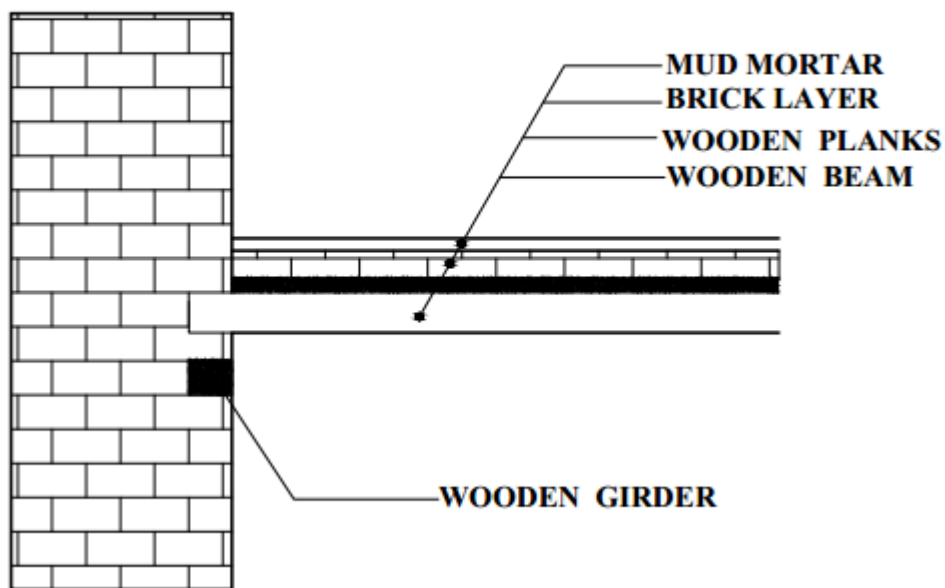
Figure 3: A section of the masonry wall.

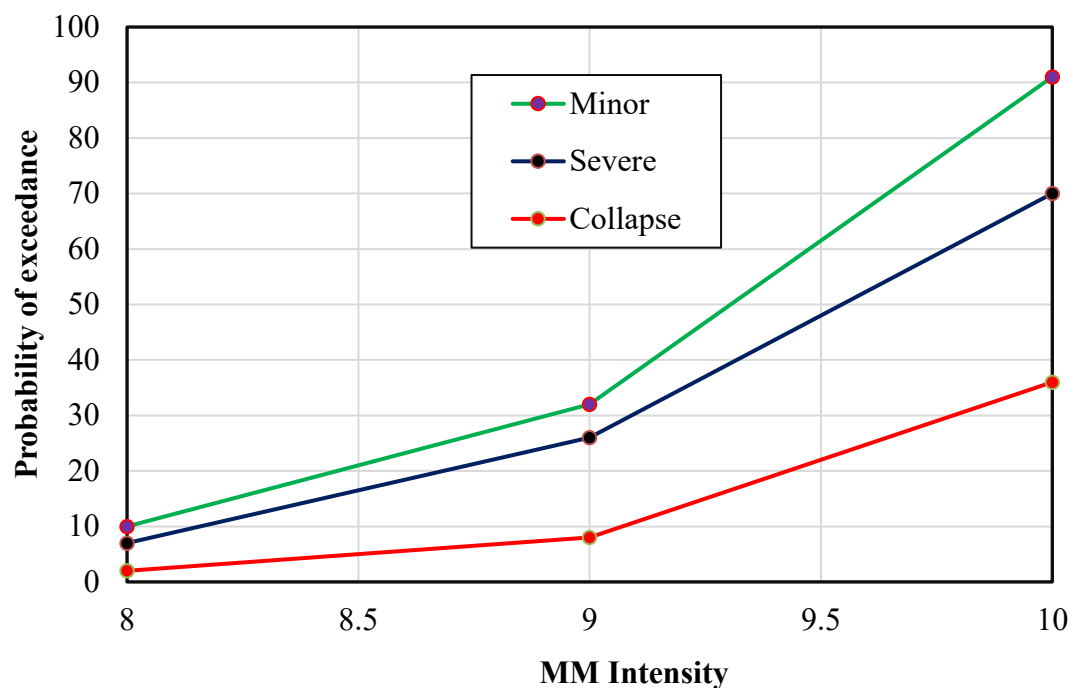
Where $N(DS, I)$ denotes the number of buildings in damage state DS; and $N(I)$ indicates the total number of buildings subjected to the earthquake event. DPMs for VIII, IX and X intensity levels were derived based on the damage data available from historical accounts. The DPMs for traditional masonry buildings is presented in Table 3. The DPMs were subsequently converted into fragility functions by as shown in Fig. 21.

Figure 21: Fragility functions for traditional masonry buildings in Bhaktapur.

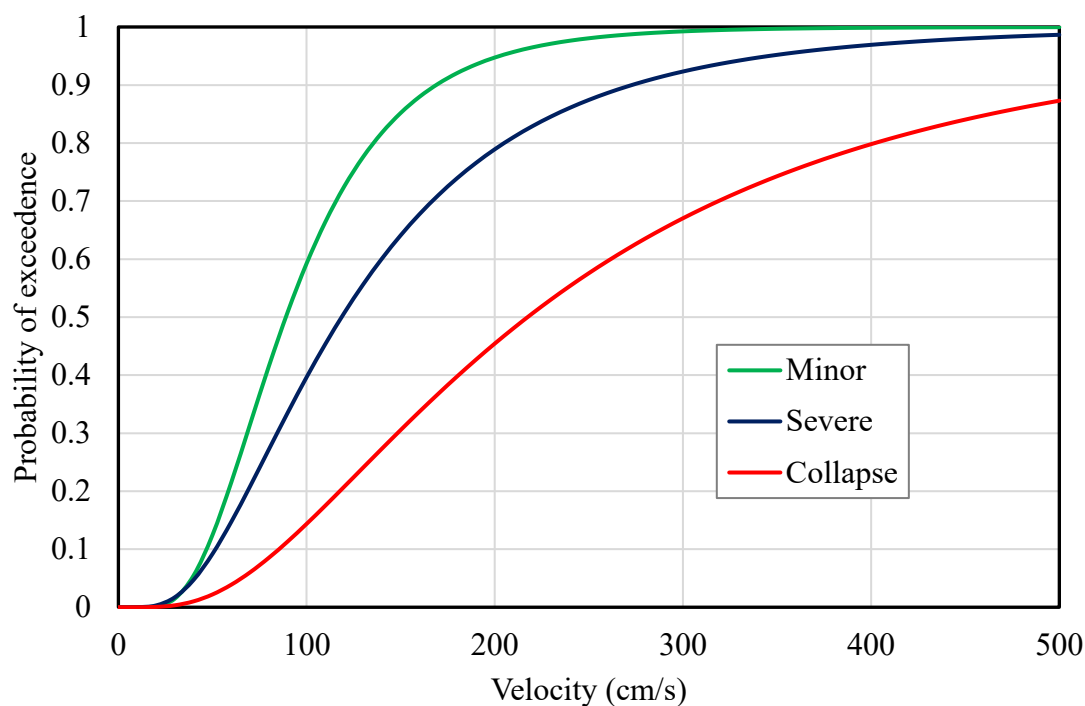
Where $F(C|IM = x)$ indicates the probability that a ground motion with $IM = x$ will cause the given damage state (minor, severe, collapse); $\Phi(\cdot)$ is the standard normal cumulative distribution function; ε is the median of the fragility function; and β is the logarithmic standard deviation. A summary of the estimated lognormal distribution parameters for minor, severe and collapse damage states is also presented in Table 4 below. Fragility functions for three damage states are derived from the damage data of 1934, 1988 and 2015 earthquakes as shown in Fig. 22.

Figure 22: Fragility functions for traditional masonry buildings in Bhaktapur.
