## The 22 December 2018 Mount Anak Krakatau Volcanogenic Tsunami on Sunda Strait Coasts, Indonesia: tsunami and damage characteristics

### ABSTRACT

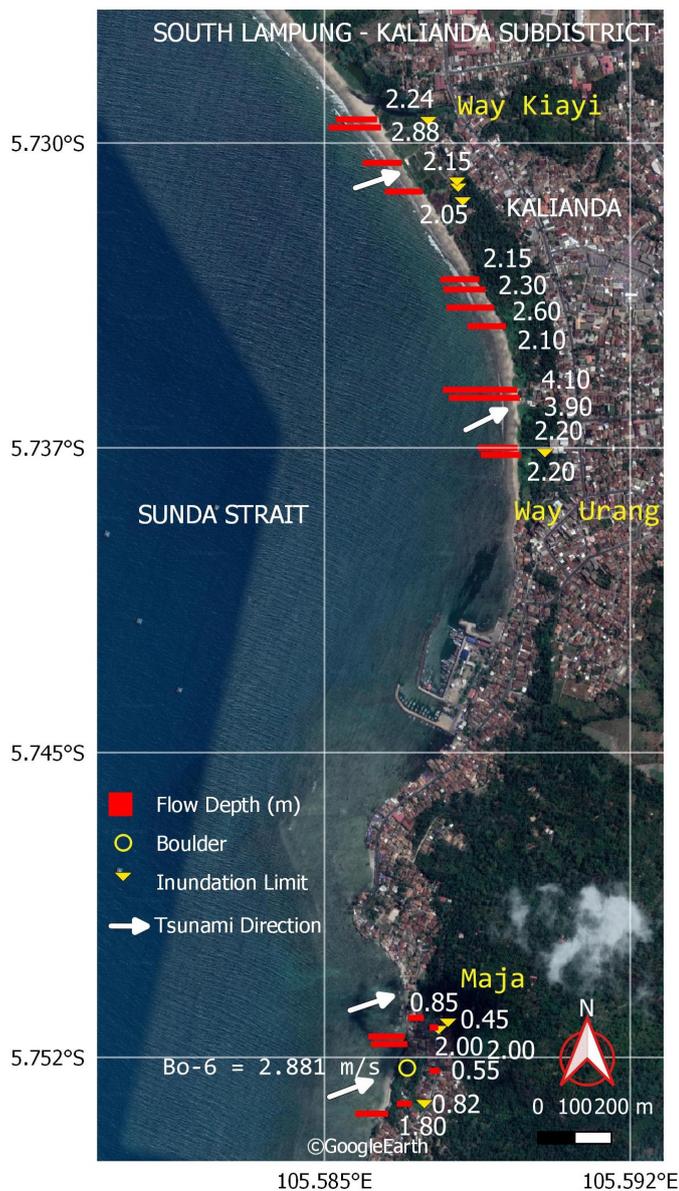
Impacts of the tsunami generated by the Mount Anak Krakatau eruption in Lampung Province were measured three locations, i.e. two areas in South Lampung and one area in Tanggamus District. South Lampung was the most tsunami-affected area at the Lampung coasts. In South Lampung district, impacts of the tsunami were found to be significant in Kalianda and Rajabasa sub-districts. Three villages in Kalianda were selected for detailed investigations, namely Way Kiayi, Way Urang and Maja. Distributions of tsunami flow depths in Kalianda can be seen in **Fig. 9**. In general, the majority of the Way Kiayi coastal residential community was deserted. Although tsunami flow depth was as high as 2.00 m and could still be found at an area about 100 m from coastline, not much major damage to buildings was identified. Nonetheless, some houses that were located around the coastal area were demolished by the tsunami wave, leaving floors as the only visible elements of the houses remaining. In Way Urang village, some houses were completely destroyed by the tsunami. A tsunami flow depth of 3.90 m was measured by one broken tree branch in the coastal area (Point F78 in the Appendix). Maja Village's coastal area is a residential fishing village. A seawall was constructed to protect the houses from high waves generated from the Sunda Strait. Highest tsunami flow depth was 2.0 m from ground level (F70 and F71), measured at a house close to the seawall. Impacts of the tsunami on Rajabasa area were worse than in Kalianda. We surveyed three villages in this sub-district, namely Way Muli, Kunjir and Batu Balak villages. Measured tsunami flow depths in this area were between 2.0 m–4.5 m as can be seen in **Fig. 10**. This is a fishing community, and the majority of the coastal area is a residential area for the fishermen. Other related buildings, such as a shrimp hatchery, were also damaged by the tsunami. **Fig. 12** shows an aerial view of the damage caused by the tsunami in Batu Balak and Kunjir villages. At the hatchery plant, tsunami flow depth was measured at 3.82 m from ground level (Point F88 in the Appendix). An elementary school in Kunjir located close to the coastline sustained massive damage. At this school, tsunami flow depth was measured at 3.33 m (Point F91). The tsunami inundation limit was located 160 m from the coastline. Although Kunjir area was protected by a revetment structure with a crown 2.5 m above mean sea level, it could not protect the area from the tsunami. On the revetment, tsunami flow depth was at 2.10 m, based on a tree mistakenly grown on top of the structure. In Way Muli, the highest tsunami flow depth was 3.92 m (Point F105).

**Fig. 9.** Flow depth distribution and run-up limits in Kalianda, South Lampung. Green bars and yellow triangles represent flow heights and inundation limits measured at the locations, respectively. (The map is adopted from Google Earth).

**Fig. 9.** Flow depths distribution and run-up limits in Kalianda, South Lampung. (The map is adopted from Google Earth).

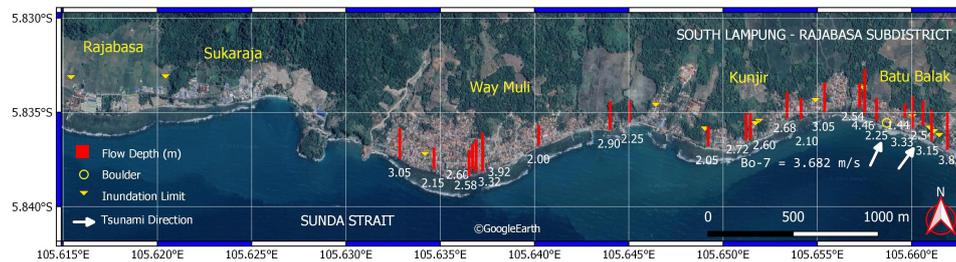
**Fig. 10.** Flow depth distribution and run-up limits in Rajabasa, South Lampung. (The map is adopted from Google Earth).

**Fig. 10.** Flow depths distribution and run-up limits in Rajabasa, South Lampung. (The map is adopted from Google Earth).

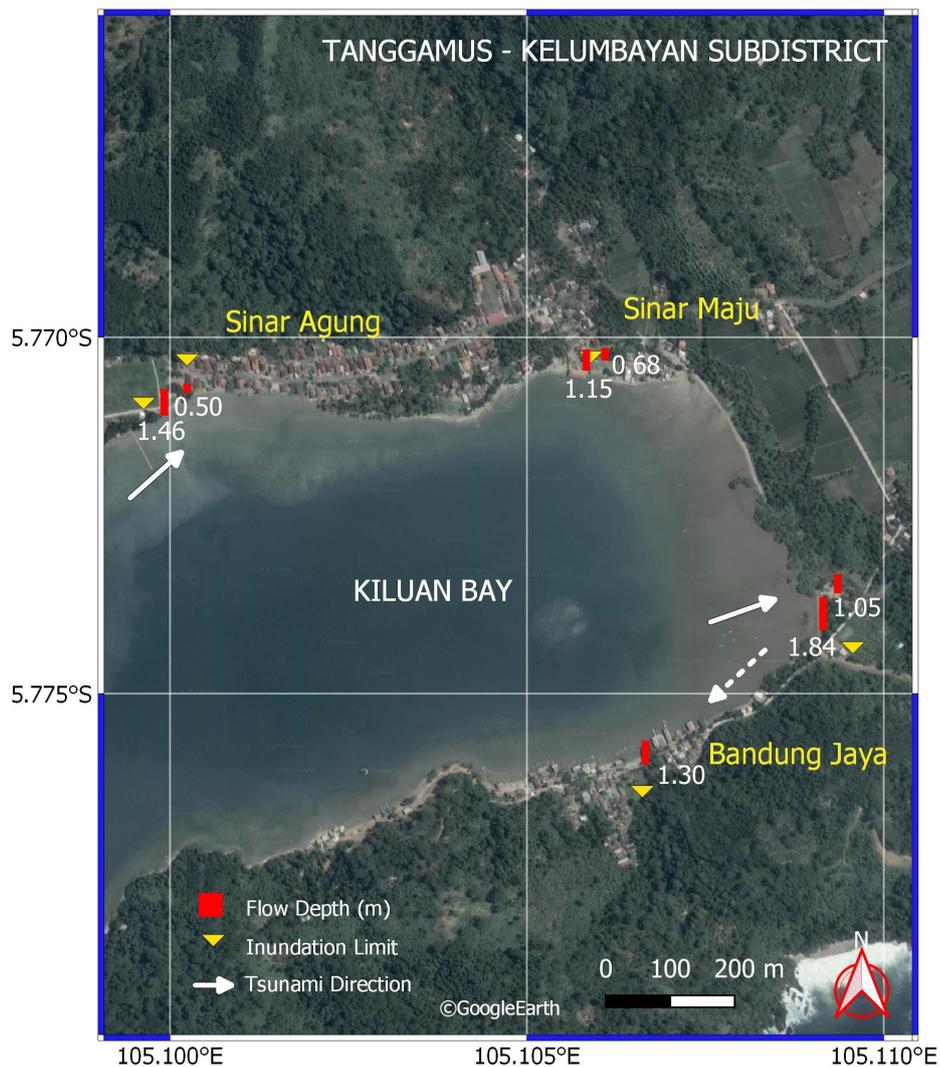
**Fig. 11.** Tsunami flow depth distribution in Kiluan Bay, Lampung. Dashed arrow represents the tsunami wave direction reflected from the closed end of the bay. (The map is adopted from Google Earth).

At Tanggamus District, Lampung, impacts of the tsunami were less severe. The only place where a  
5 casualty was reported was at Kiluan Bay of Kelumbayan sub-district. This bay is located about 79 km to  
the west of Bandar Lampung, the capital city of Lampung Province. Distribution of flow depths and flow  
directions at Kiluan Bay of Tanggamus can be seen in **Fig. 11**. Along the bay, there are three villages  
where tsunami impact was measured, namely, Sinar Agung, Sinar Maju and Bandung Jaya. Measured  
10 tsunami flow depths were 1.46 m, 1.15 m and 1.84 m at Sinar Agung, Sinar Maju and Bandung Jaya  
villages, respectively (see Points F114, F111 and F116 in the Appendix). The most severe impact in this  
area was investigated at a wooden elevated house that was transported about 3.5 m from its original  
location. The lone casualty was found at this location. Here, tsunami flow depth was 1.05 m (Point F115).

**Fig. 11.** Tsunami flow depths distribution in Kiluan Bay, Lampung. A dash-arrow represents the tsunami wave direction reflected from the close-end of the bay. (The map is adopted from Google Earth).

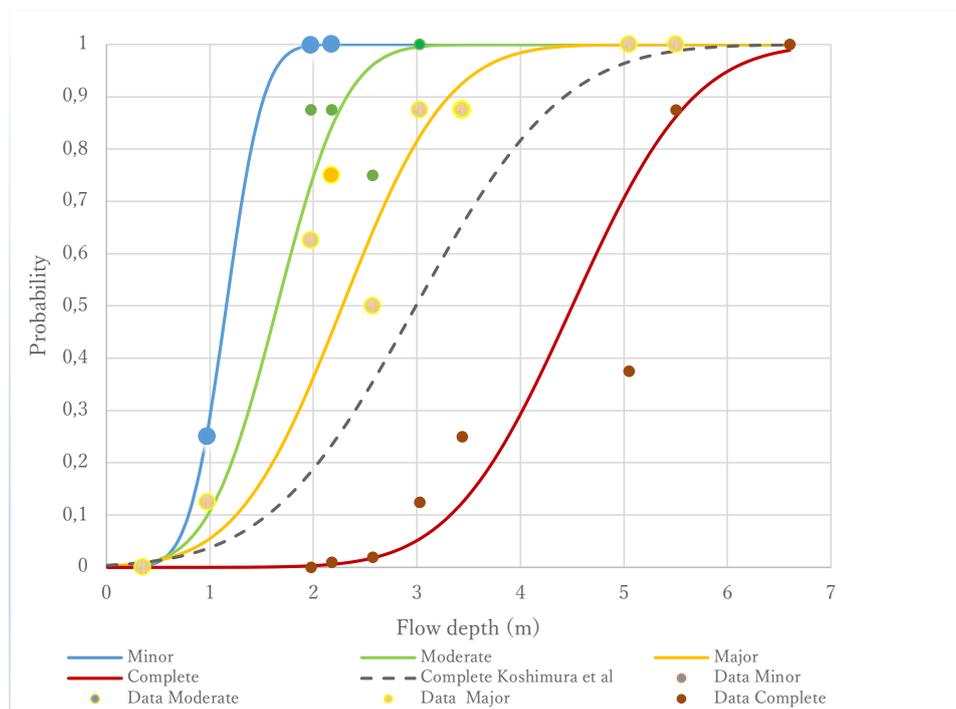
Fragility curves in **Fig. 14** reveal that the absolute damage due to the tsunami waves occurred at a flow depth of 6.5 m. Lower probabilities of complete damage were found in this study compared to the 2004 Indian Ocean tsunami in Banda Aceh (Koshimura et al., 2009). These findings were significantly different from the 2018 Palu tsunami (Paulik et al., 2019) where earthquake and liquefaction (liquefied gravity flows) also contributed to the damage (Sassa and Takagawa, 2019).

**Fig. 14.** Fragility curves of confined masonry-type houses, for impacts of the 2018 Mount Anak Krakatau volcanogenic tsunami. Dashed line represents a complete damage fragility curve produced by Koshimura et al. (2009).

**Table 2.** A summary of damage conditions of CM-type houses due to impacts of the 2018 Mount Anak Krakatau tsunami.

Damage Condition	Number of houses	$\mu$	$\sigma$	$R^2$
DS0	14	-	-	-
DS1	4	1.1585	0.2848	0.999
DS2	8	1.6499	0.5249	0.898
DS3	32	2.2806	0.8021	0.877
DS4	13	4.5017	0.9195	0.894

**Fig. 14.** Fragility curves of Confined Masonry type houses, as impacts of the 2018 Mount Anak Krakatau volcano-genic tsunami. Dashed-line represents a complete damage fragility curve produced by Koshimura et al. (2009).
