The 22 December 2018 Mount Anak Krakatau Volcanogenic Tsunami on Sunda Strait Coasts, Indonesia: tsunami and damage characteristics

Syamsidik^{1,2}, Benazir^{1,2}, Mumtaz Luthfi¹, Anawat Suppasri³, and Louise K. Comfort⁴

ABSTRACT

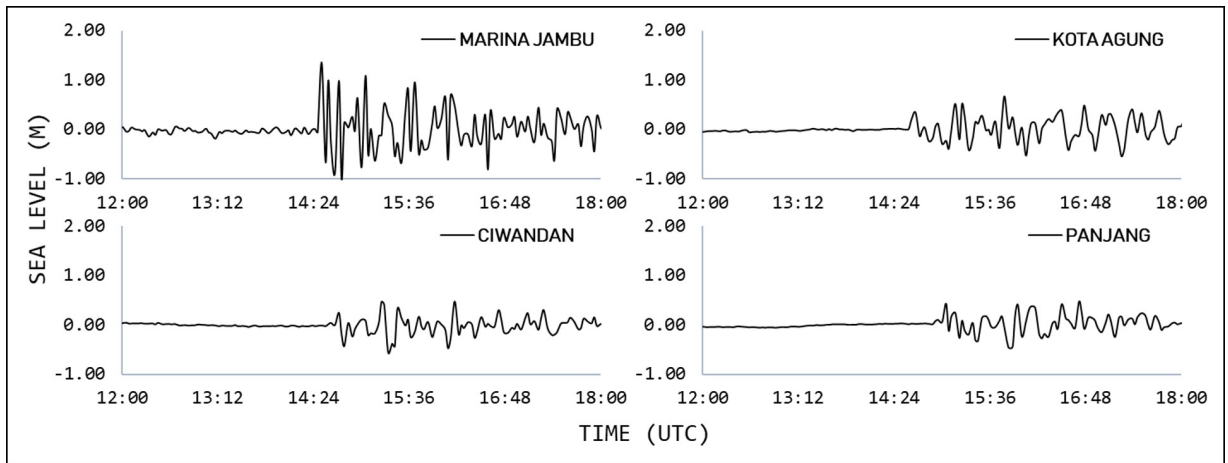
5 **Fig. 2.** Filtered water elevation fluctuations measured at four tide-gauge stations around Sunda Strait, indicating the arrival tsunami wave.

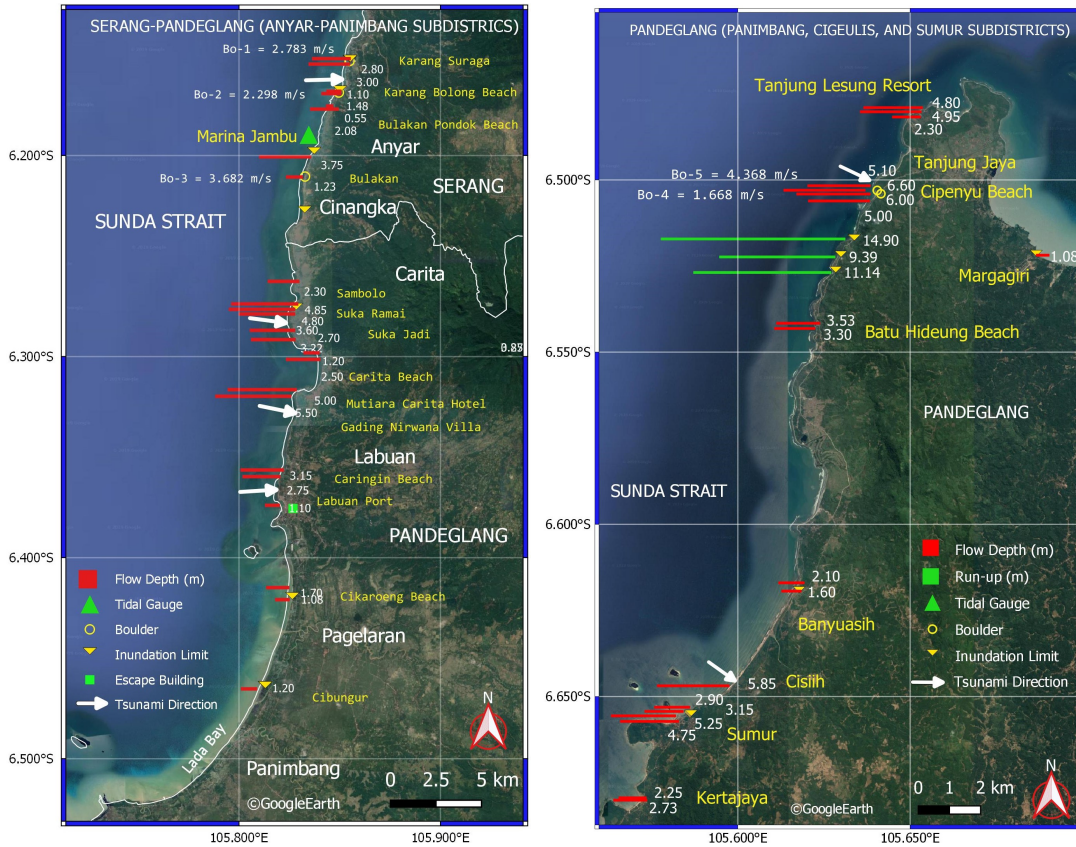
Impacts of the tsunami in Banten were found to be more severe than in Lampung. Along the western coast of Banten, impacts were visible but not seen to be continuous. **Fig. 3** shows tsunami flow depth distribution and run-up limits measured at Banten coasts. There were some areas where evidence of tsunami waves could not be identified based on physical observations and eyewitness interviews. It is important to note that the interviewees expressions were not meant to clarify the tidal gauge data, as this was difficult to do. Tide elevation data reported from the tide stations were one-minute average data. The northernmost extent of the tsunami effects was located at Anyar coast. The northernmost point of the tsunami depth was identified at a villa named Villa A Pahmi, located at Karang Suragak village. Here, the tsunami depth was 2.80 m (F02), identified from gazebo roof damage in the back yard of the villa. Around this village, the maximum tsunami depth was 3.00 m (F01), based on a broken twig. Around Villa A Pahmi, a number of tsunami boulders were also found. Boulder materials came from a revetment structure protecting the coastline from erosion. Location of the revetment made determination of the travel distance of the transported boulders more facile. The farthest point of the transported boulder was 28 m from the revetment structure (Bo-1). Based on interviews with two tsunami survivors in this village, there were two significant wave attacks in this area; the second wave was the largest and the most destructive. A similar account was also revealed by another survivor at Villa Karang Bolong of Serang District. Tsunami waves damaged some houses and villas in this area. To the south of this area, impacts of the tsunami were more visible, as they were seen in Cinangka sub-district.

Fig. 3. Tsunami flow depth distribution around Serang, the northern area of Pandeglang district (left figure) and around southern Pandeglang area (Panimbang-Sumur, right figure). Flow depths are drawn in red bars. Green bars represent run-up heights. The green rectangle represents the location of a tsunami escape building at Labuan. (The map is adopted from Google Earth).

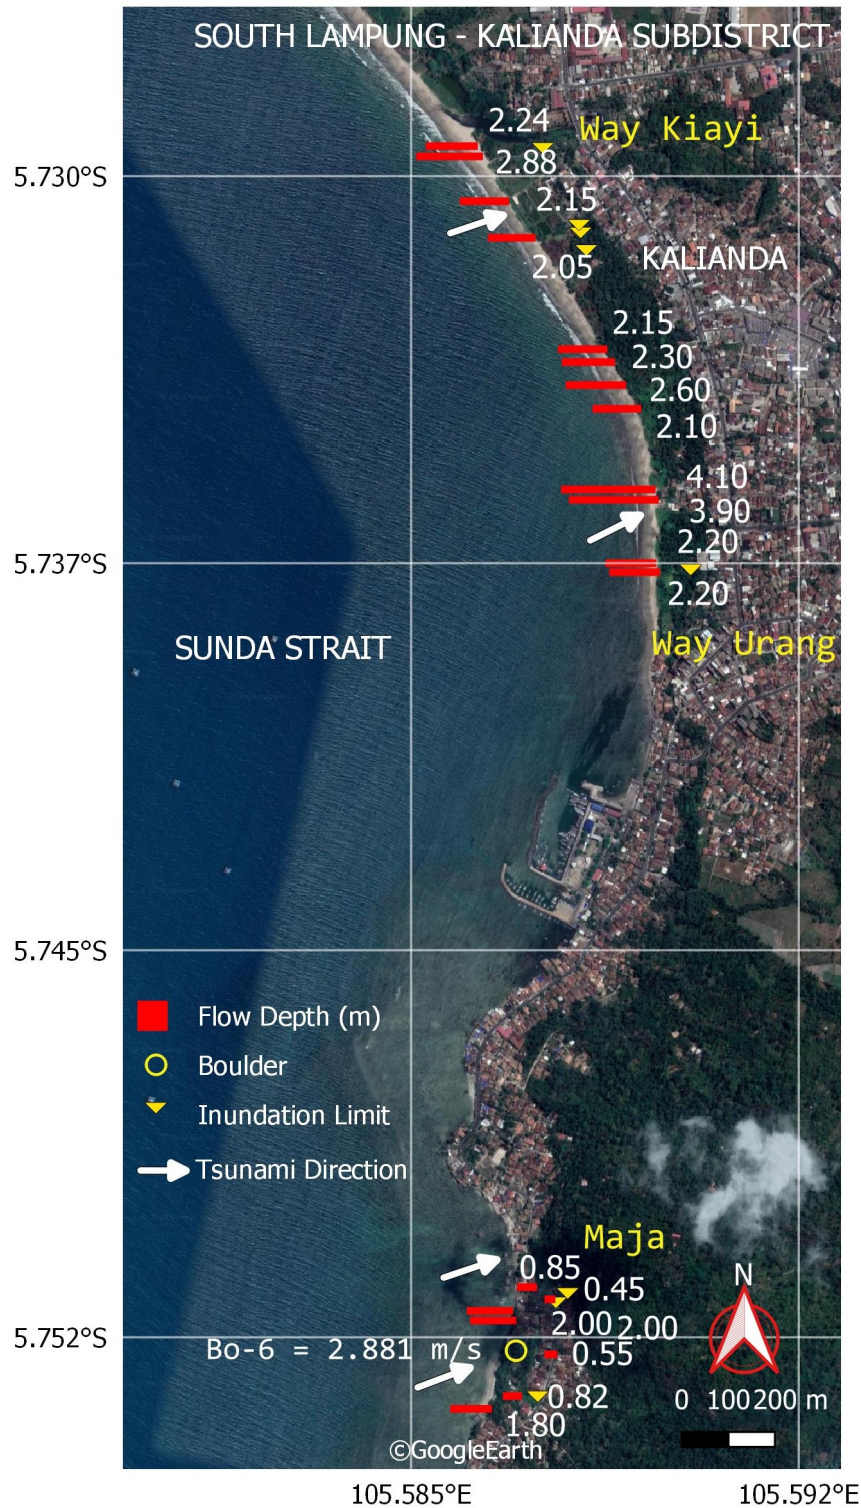
Impacts of the tsunami generated by the Mount Anak Krakatau eruption in Lampung Province were measured three locations, i.e. two areas in South Lampung and one area in Tanggamus District. South Lampung was the most tsunami-affected area at the Lampung coasts. In South Lampung district, impacts of the tsunami were found to be significant in Kalianda and Rajabasa sub-districts. Three villages in Kalianda were selected for detailed investigations, namely Way Kiayi, Way Urang and Maja. Distributions of tsunami flow depths in Kalianda can be seen in **Fig. 9**.

Fig. 9. Flow depths distribution and run-up limits in Kalianda, South Lampung. Green bars and yellow triangles represent flow heights and inundation limits measured at the locations, respectively. (The base map was adopted from Google Earth).

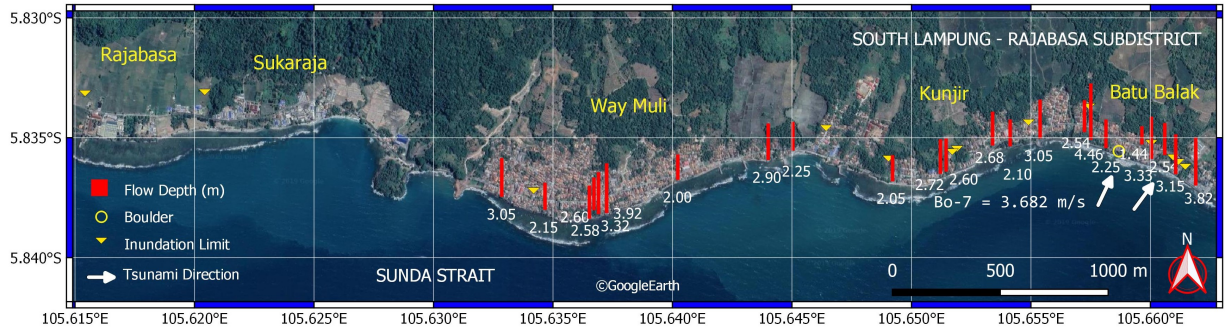
Impacts of the tsunami on Rajabasa area were worse than in Kalianda. We surveyed three villages in this sub-district, namely Way Muli, Kunjir and Batu Balak villages. Measured tsunami flow depths in this area were between 2.0 m–4.5 m as can be seen in **Fig. 10**. This is a fishing community, and the majority of the coastal area is a residential area for the fishermen. Other related buildings, such as a shrimp hatchery, were also damaged by the tsunami.

Fig. 10. Flow depths distribution and run-up limits in Rajabasa, South Lampung. (The map was adopted from Google Earth).

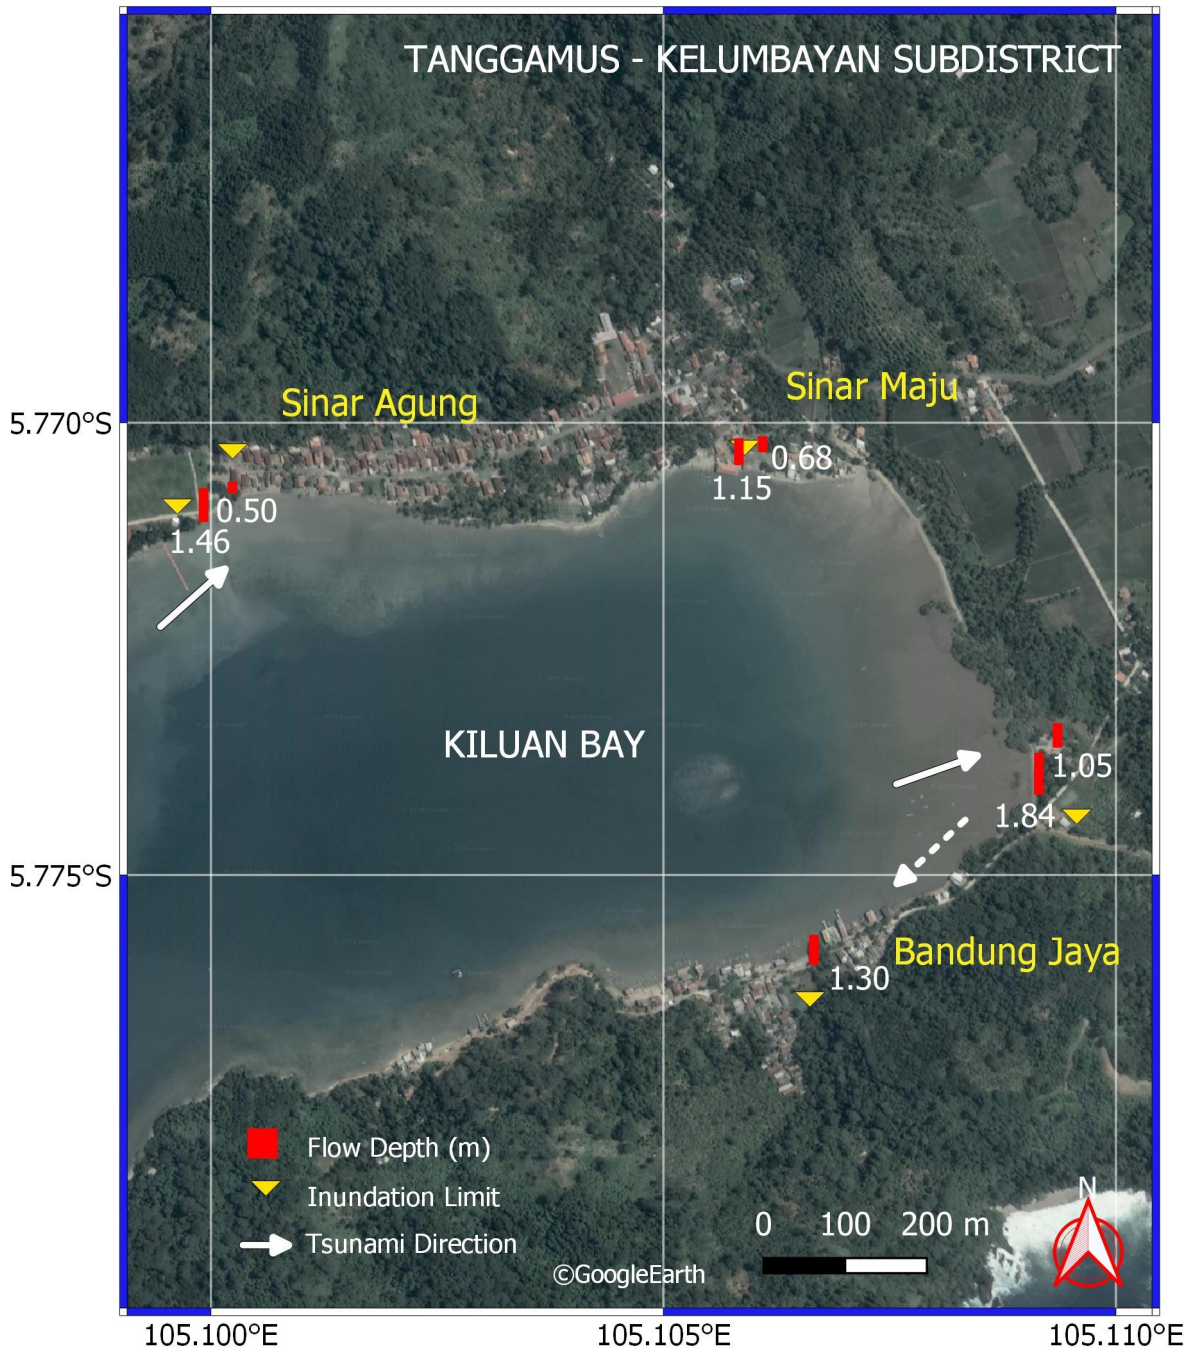
25 At Tanggamus District, Lampung, impacts of the tsunami were less severe. The only place where a casualty was reported was at Kiluan Bay of Kelumbayan sub-district. This bay is located about 79 km to the west of Bandar Lampung, the capital city of Lampung Province. Distribution of flow depths and flow directions at Kiluan Bay of Tanggamus can be seen in **Fig. 12**. Along the bay, there are three villages where tsunami impact was measured, namely, Sinar Agung, Sinar Maju and Bandung Jaya. Measured tsunami flow depths were 1.46 m, 1.15 m and 1.84 m at Sinar Agung, Sinar Maju and Bandung Jaya villages, respectively (see Points F114, F111 and F116 in Syamsidik et al. (2019b)). The most severe impact in this area was investigated at a wooden elevated house that was transported about 3.5 m from its original location. The lone casualty was found at this location. Here, tsunami flow depth was 1.05 m (Point F115). Other damage was found at an elevated wooden house at the northeastern part of the bay. Based on eyewitness interviews, damaged was caused by the reflected tsunami wave after hitting the closed end of the bay.

Fig. 12. Tsunami flow depths distribution in Kiluan Bay, Lampung. A dash-arrow represents the tsunami wave direction reflected from the close-end of the bay. (The map was adopted from Google Earth).
