The 22 December 2018 Mount Anak Krakatau Volcanogenic Tsunami on Sunda Strait Coasts, Indonesia: tsunami and damage characteristics

Syamsidik^{1,2}, Benazir^{1,2}, Mumtaz Luthfi¹, Anawat Suppasri³, and Louise K. Comfort⁴

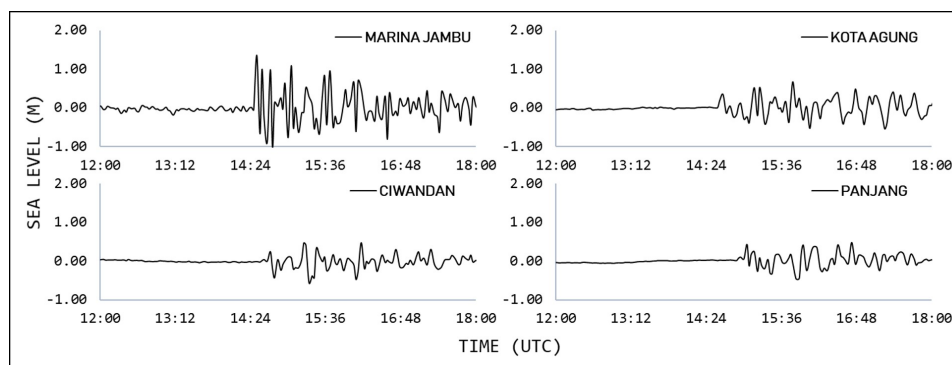
Tsunami arrivals were determined based on water elevations monitored at four tidal-gauge stations located around the Sunda Strait. The stations were Marina Jambu, Ciwandan, Panjang and Kota Agung. The tidal-gauge stations are operated by Indonesia Geospatial Information Agency (BIG). Each of the stations recorded one-minute interval water levels and are available online. **Fig. 2** shows the filtered tidal data from all four stations. The first detected tsunami wave arrival was recorded at Marina Jambu Station at 14.30 UTC (at 09.30 PM local time). The time of generation of the tsunami from the source was not clear since no tidal station was located around the volcano. Ten minutes later (14.43 UTC), the tsunami wave was recorded at Ciwandan station, near Cilegon, Banten. The first tsunami wave was recorded at 14.40 UTC at Kota Agung station, which was almost simultaneous with Cilegon station. Although Panjang is closer to Mount Krakatau Complex than Kota Agung, due to tsunami wave arrays that caused diffraction and refraction, the arrival time at Kota Agung was 10 minutes later than at Panjang stations (at 14.50 UTC). The landslide area at the southern part of Mount Anak Krakatau also contributed to arrival times.

Fig. 2. Filtered water elevation fluctuations measured at four tidal-gauge stations around Sunda Strait, indicating tsunami wave arrival times. Data was obtained from the Indonesia National Geospatial Information Agency (BIG, 2018).

Fig. 2. Filtered water elevation fluctuations measured at four tide-gauge stations around Sunda Strait, indicating the arrival tsunami wave.

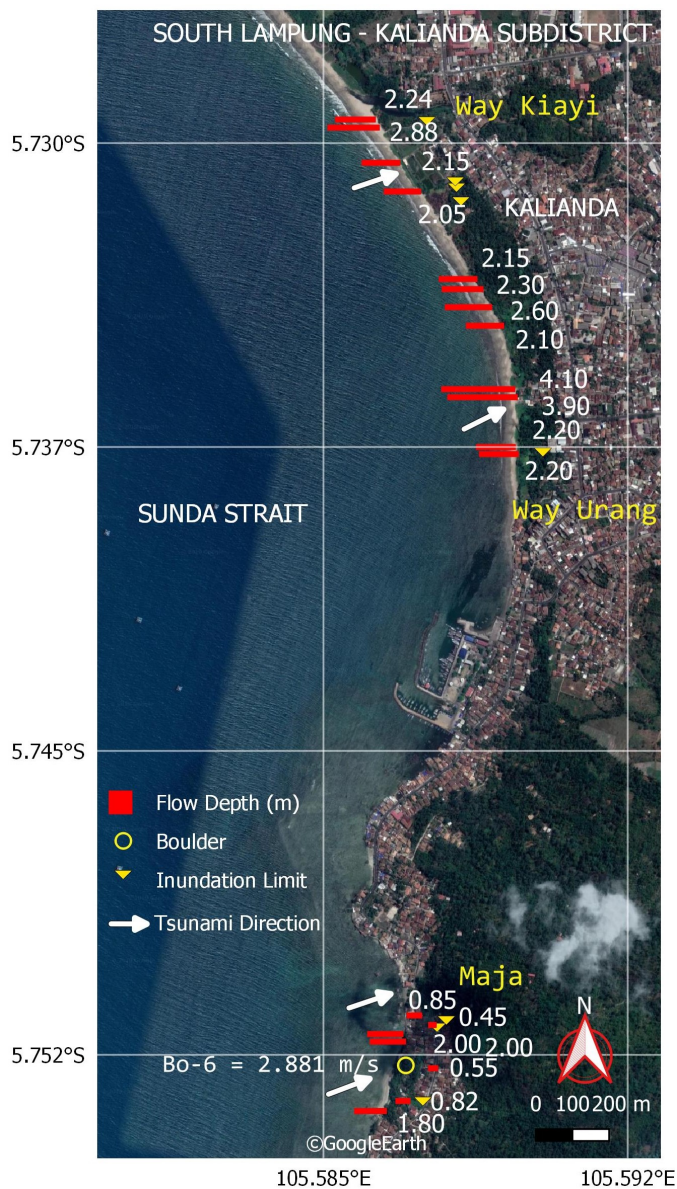
Impacts of the tsunami generated by the Mount Anak Krakatau eruption in Lampung Province were measured three locations, i.e. two areas in South Lampung and one area in Tanggamus District. South Lampung was the most tsunami-affected area at the Lampung coasts. In South Lampung district, impacts of the tsunami were found to be significant in Kalianda and Rajabasa sub-districts. Three villages in Kalianda were selected for detailed investigations, namely Way Kiayi, Way Urang and Maja. Distributions of tsunami flow depths in Kalianda can be seen in **Fig. 9**. In general, the majority of the Way Kiayi coastal residential community was deserted. Although tsunami flow depth was as high as 2.00 m and could still be found at an area about 100 m from coastline, not much major damage to buildings was identified. Nonetheless, some houses that were located around the coastal area were demolished by the tsunami wave, leaving floors as the only visible elements of the houses remaining. In Way Urang village, some houses were completely destroyed by the tsunami. A tsunami flow depth of 3.90 m was measured by one broken tree branch in the coastal area (Point F78 in the Appendix).

Fig. 9. Flow depth distribution and run-up limits in Kalianda, South Lampung. Green bars and yellow triangles represent flow heights and inundation limits measured at the locations, respectively. (The map is adopted from Google Earth).

Fig. 9. Flow depths distribution and run-up limits in Kalianda, South Lampung. (The map is adopted from Google Earth).

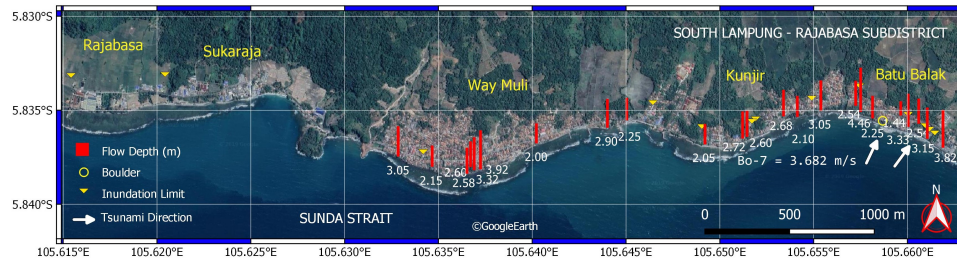
Impacts of the tsunami on Rajabasa area were worse than in Kalianda. We surveyed three villages in this sub-district, namely Way Muli, Kunjir and Batu Balak villages. Measured tsunami flow depths in this area were between 2.0 m–4.5 m as can be seen in **Fig. 10**. This is a fishing community, and the majority of the coastal area is a residential area for the fishermen. Other related buildings, such as a shrimp hatchery, were also damaged by the tsunami.

Fig. 10. Flow depth distribution and run-up limits in Rajabasa, South Lampung. (The map is adopted from Google Earth).

Fig. 10. Flow depths distribution and run-up limits in Rajabasa, South Lampung. (The map is adopted from Google Earth).

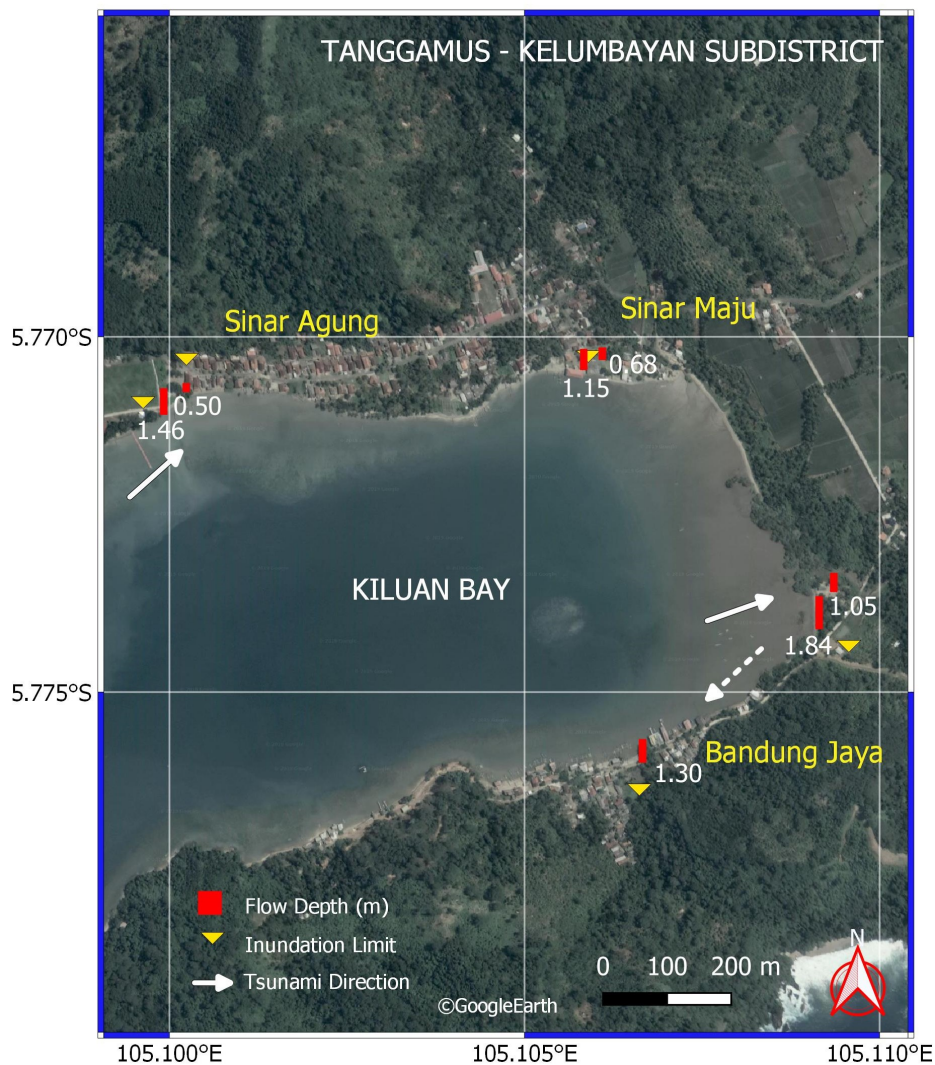
Fig. 11. Tsunami flow depth distribution in Kiluan Bay, Lampung. Dashed arrow represents the tsunami wave direction reflected from the closed end of the bay. (The map is adopted from Google Earth).

At Tanggamus District, Lampung, impacts of the tsunami were less severe. The only place where a
5 casualty was reported was at Kiluan Bay of Kelumbayan sub-district. This bay is located about 79 km to
the west of Bandar Lampung, the capital city of Lampung Province. Distribution of flow depths and flow
directions at Kiluan Bay of Tanggamus can be seen in **Fig. 11**. Along the bay, there are three villages
where tsunami impact was measured, namely, Sinar Agung, Sinar Maju and Bandung Jaya. Measured
10 tsunami flow depths were 1.46 m, 1.15 m and 1.84 m at Sinar Agung, Sinar Maju and Bandung Jaya
villages, respectively (see Points F114, F111 and F116 in the Appendix). The most severe impact in this
area was investigated at a wooden elevated house that was transported about 3.5 m from its original
location. The lone casualty was found at this location. Here, tsunami flow depth was 1.05 m (Point F115).

Fig. 11. Tsunami flow depths distribution in Kiluan Bay, Lampung. A dash-arrow represents the tsunami wave direction reflected from the close-end of the bay. (The map is adopted from Google Earth).
