Post-event Field Survey of 28 September 2018 Sulawesi Earthquake and Tsunami

Abstract. An earthquake with a magnitude of $M_w = 7.5$ that occurred in Sulawesi, Indonesia on September 28, 2018, triggered liquefaction and tsunamis that caused severe damage and many casualties. This paper reports the results of a post-tsunami field survey conducted by a team with members from Indonesia and Taiwan that began 13 days after the earthquake. The main purpose of this survey was to measure the runup of tsunami waves and inundation and observe the damage caused by the tsunami. Measurements were made in 18 selected sites, most in Palu Bay. The survey results show that the runup height and inundation distance reached 10.7 m in Tondo and 488 m in layana respectively. The arrival times of the tsunami waves were quite short and different for each site, typically about 3-8 minutes from the time of the main earthquake event. This study also describes the damage to buildings and infrastructures, and coastal landslides.

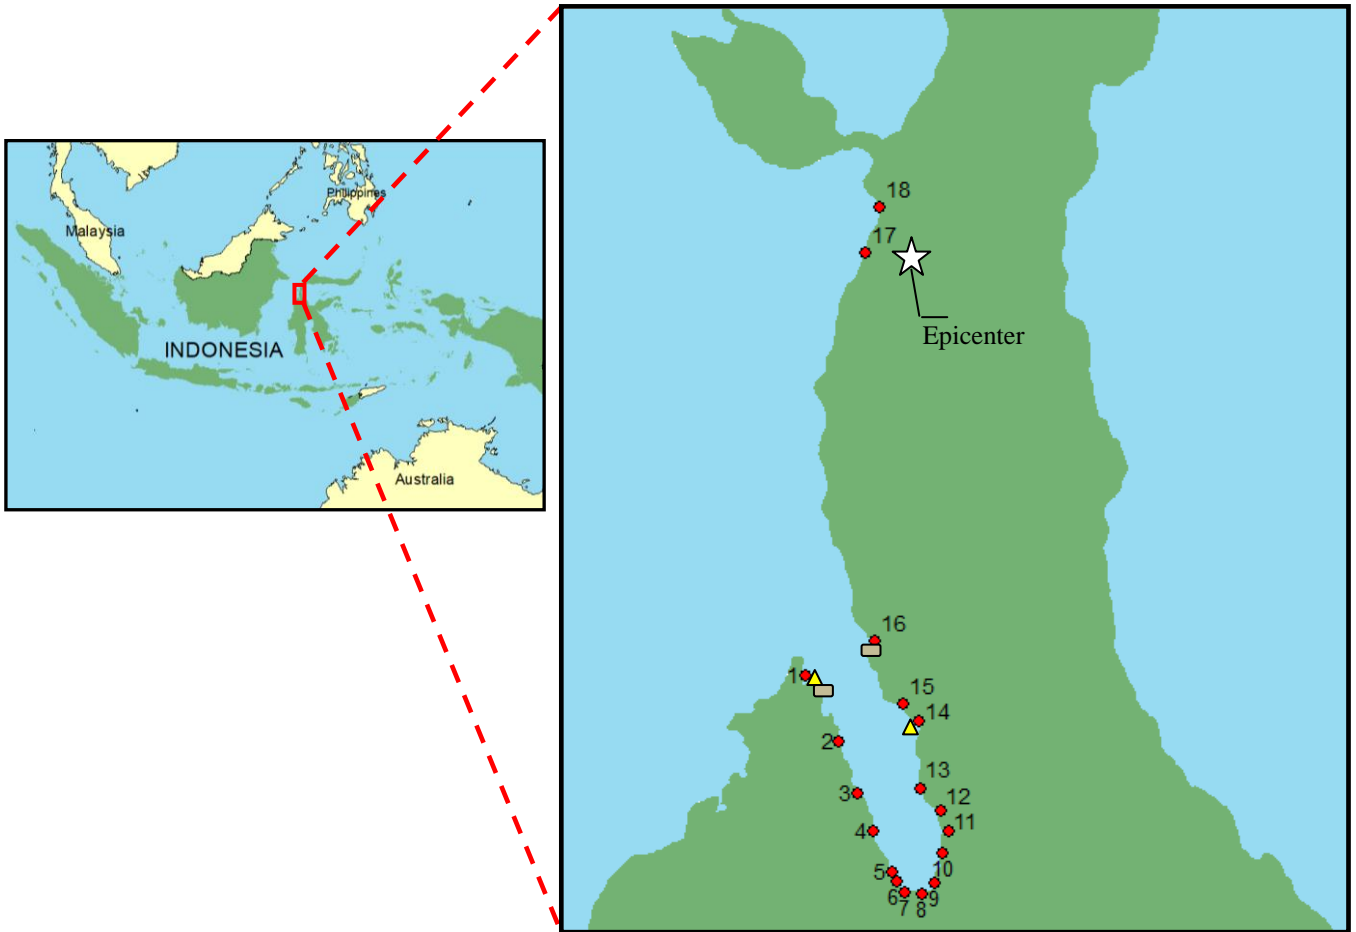
5 **Figure 1:** Survey area of Palu Bay located on Sulawesi island. A camera in a moving car was used to record the tsunami-affected area following the Trans Sulawesi Road paralleled Palu Bay coastline from Site 1 to Site 18. Tidal station were at Site 1 and Site 14. Coastal landslides detected were located at Site 1 and Site 16.

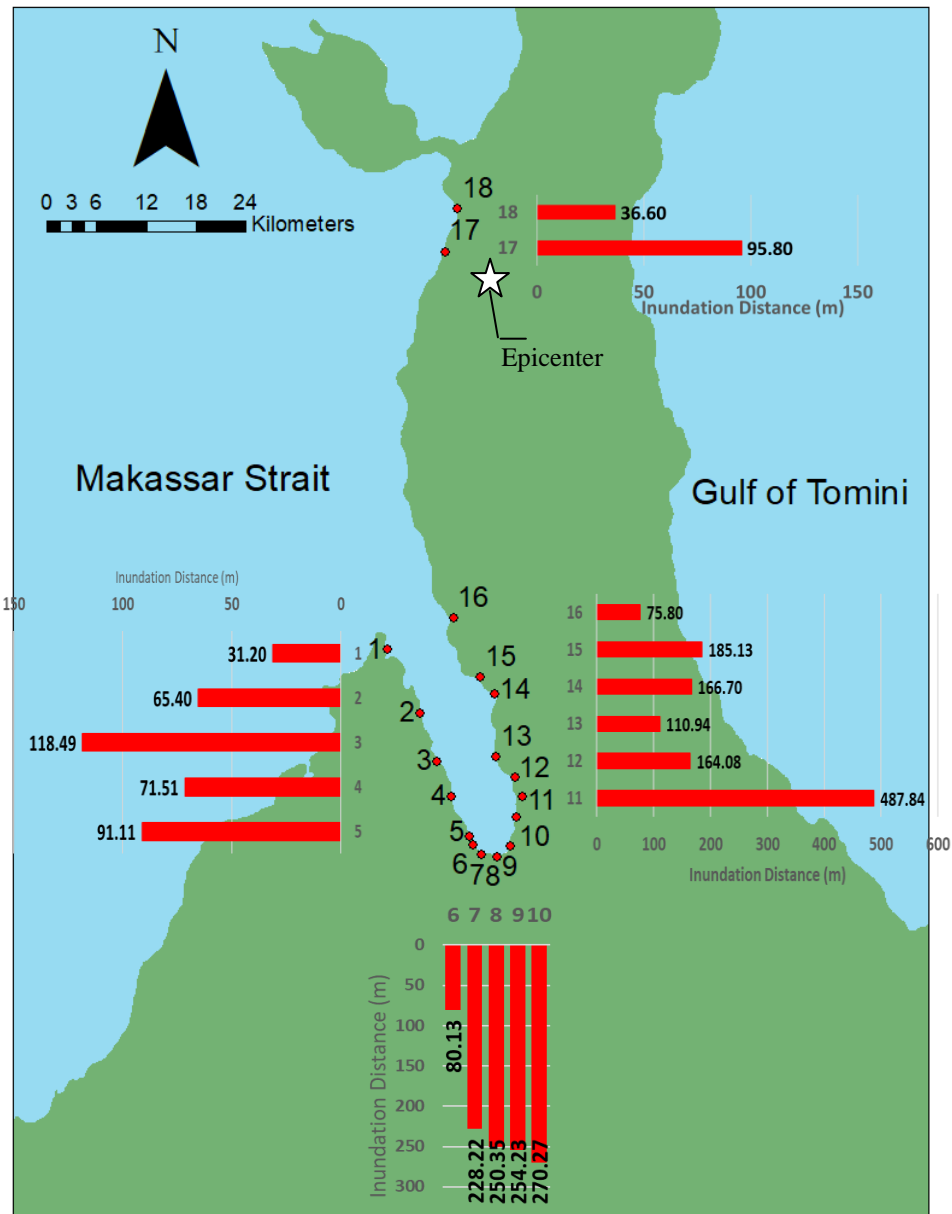
Figure 3: Measurement results of inundation distances.

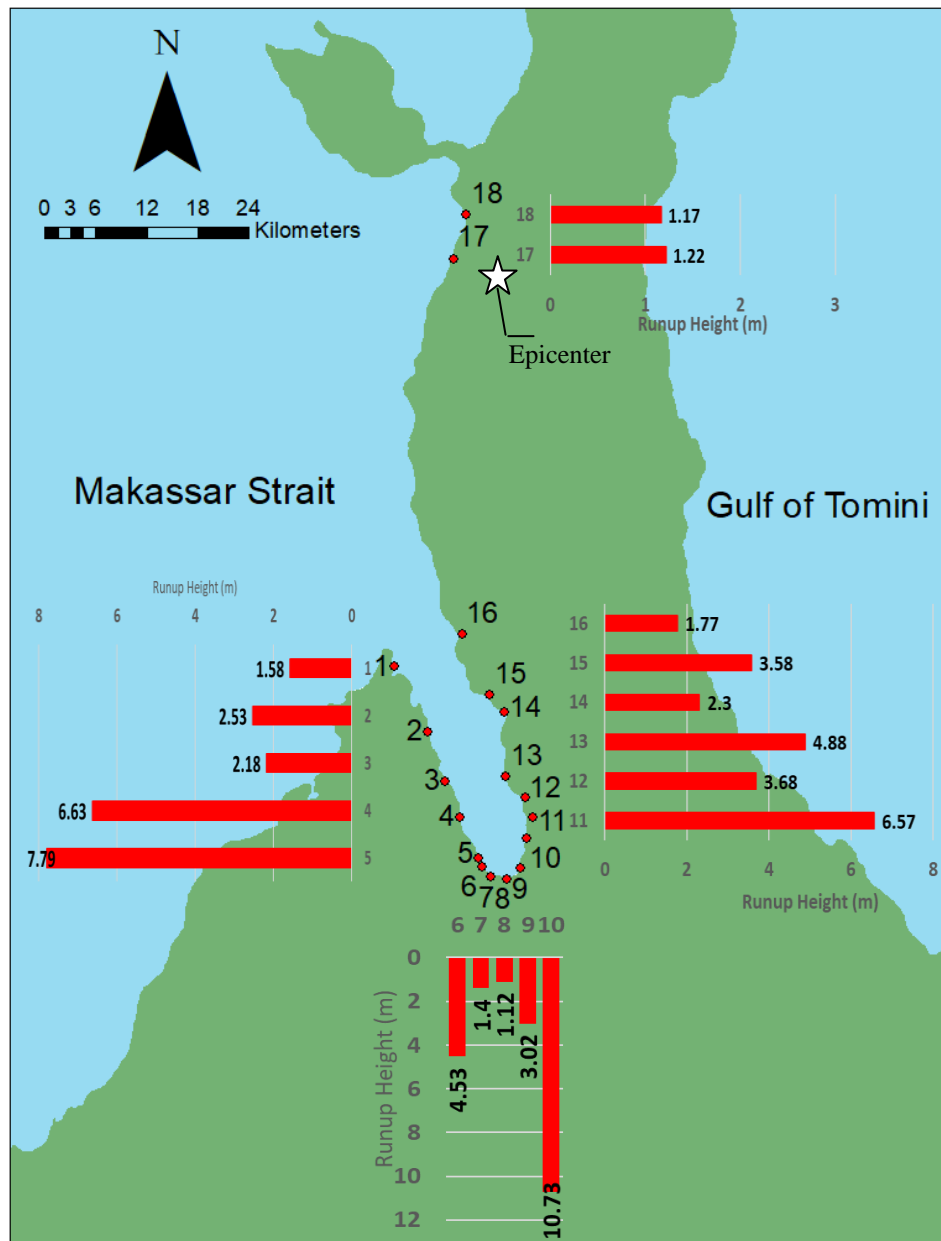
Figure 4: Measurement results of runup heights.

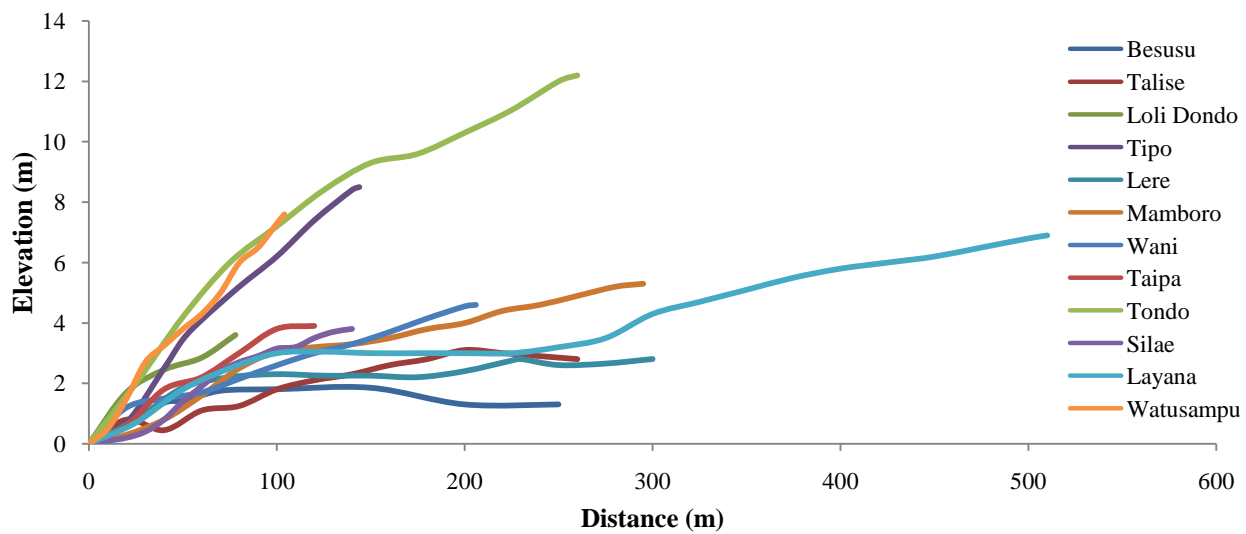
Figure 5: Transects of beach where tsunami wave arrived. The longest inundation distance is at the Layana site and the highest runup is at the Tondo site.

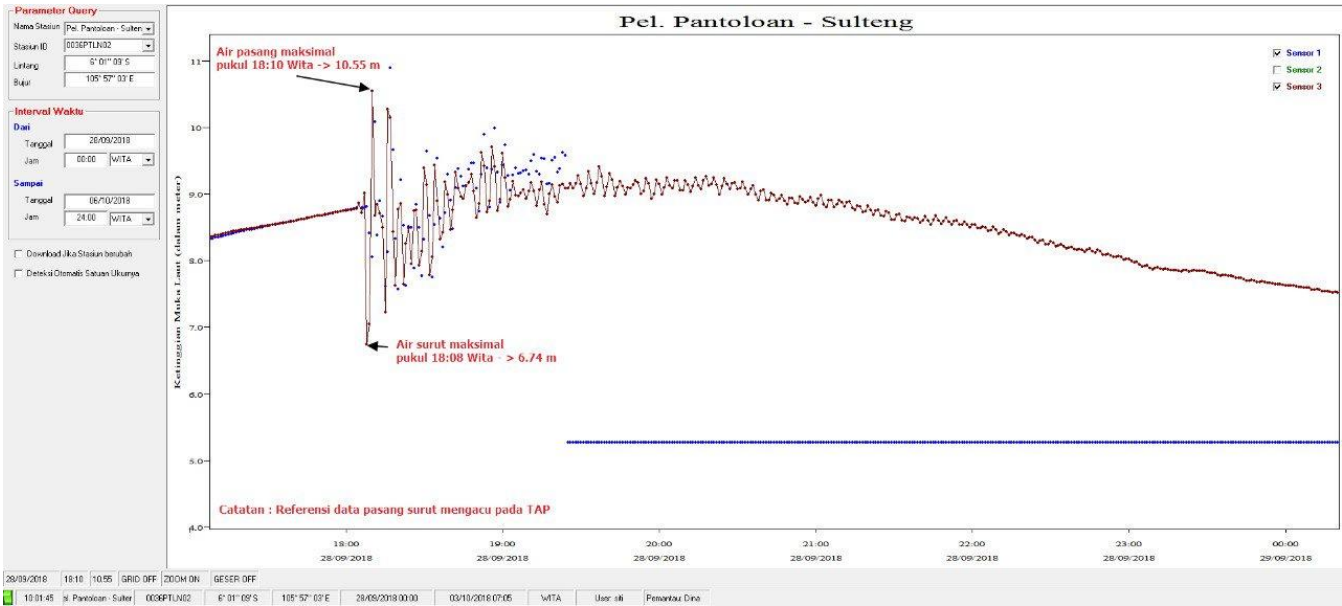
- 20 stopped because the communication network was interrupted. Fig. 8 and Fig. 9 shows the water level recorded when the tsunami arrived. The maximum low tide (6.74 m) was at 18:08 local time and the maximum tide (10.55 m) was at 18:10 local time. This means that the tsunami wave height recorded at the station was 3.8 m. This wave height can be seen more clearly in Fig. 9, which is from the same source as that for Fig. 8. In addition, the first tsunami wave arrived at 18:07, with the wave trough at 18:08 and the wave crest at 18:10 local time (UTC+8).

Figure 8: Water level recording at the Pantoloan tidal station managed by Geospatial Information Agency (Sudibyo, 2018).

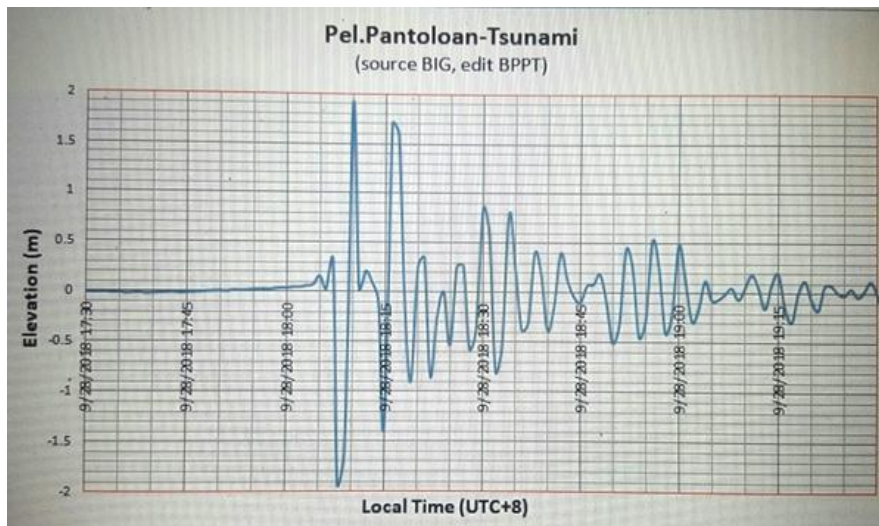
Figure 9: Magnified view of Fig. 9, sourced Geospatial Information Agency (Sudibyo, 2018).
