Post-event Field Survey of 28 September 2018 Sulawesi Earthquake and Tsunami

Wahyu Widiyanto^{1,2}, Purwanto B. Santoso², Shih-Chun Hsiao¹, Rudy T. Imananta³

Abstract. An earthquake with a magnitude of $M_W = 7.5$ that occurred in Sulawesi, Indonesia on September 28, 2018, triggered liquefaction and tsunamis that caused severe damage and many casualties. This paper reports the results of a post-tsunami field survey conducted by a team with members from Indonesia and Taiwan that began 13 days after the earthquake. The main purpose of this survey was to measure the runup of tsunami waves and inundation and observe the damage caused by the tsunami. Measurements were made in 18 selected sites, most in Palu Bay. The survey results show that the runup height and inundation distance reached 10.7 m in Tondo and 488 m in layana respectively. The arrival times of the tsunami waves were quite short and different for each site, typically about 3-8 minutes from the time of the main earthquake event. This study also describes the damage to buildings and infrastructures, and coastal landslides.

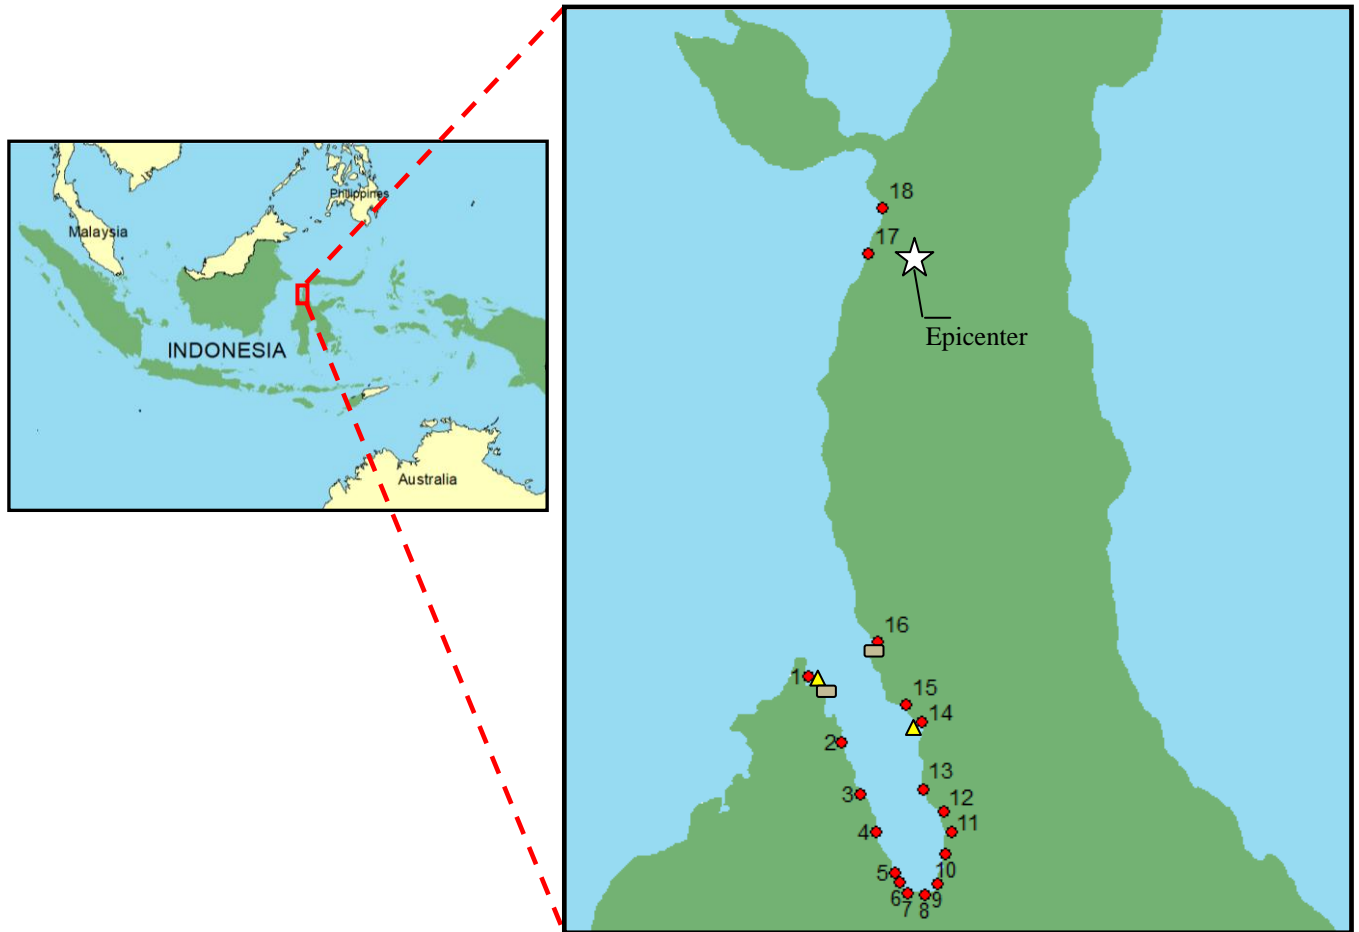
5 **Figure 1:** Survey area of Palu Bay located on Sulawesi island. A camera in a moving car was used to record the tsunami-affected area following the Trans Sulawesi Road paralleled Palu Bay coastline from Site 1 to Site 18. Tidal station were at Site 1 and Site 14. Coastal landslides detected were located at Site 1 and Site 16.

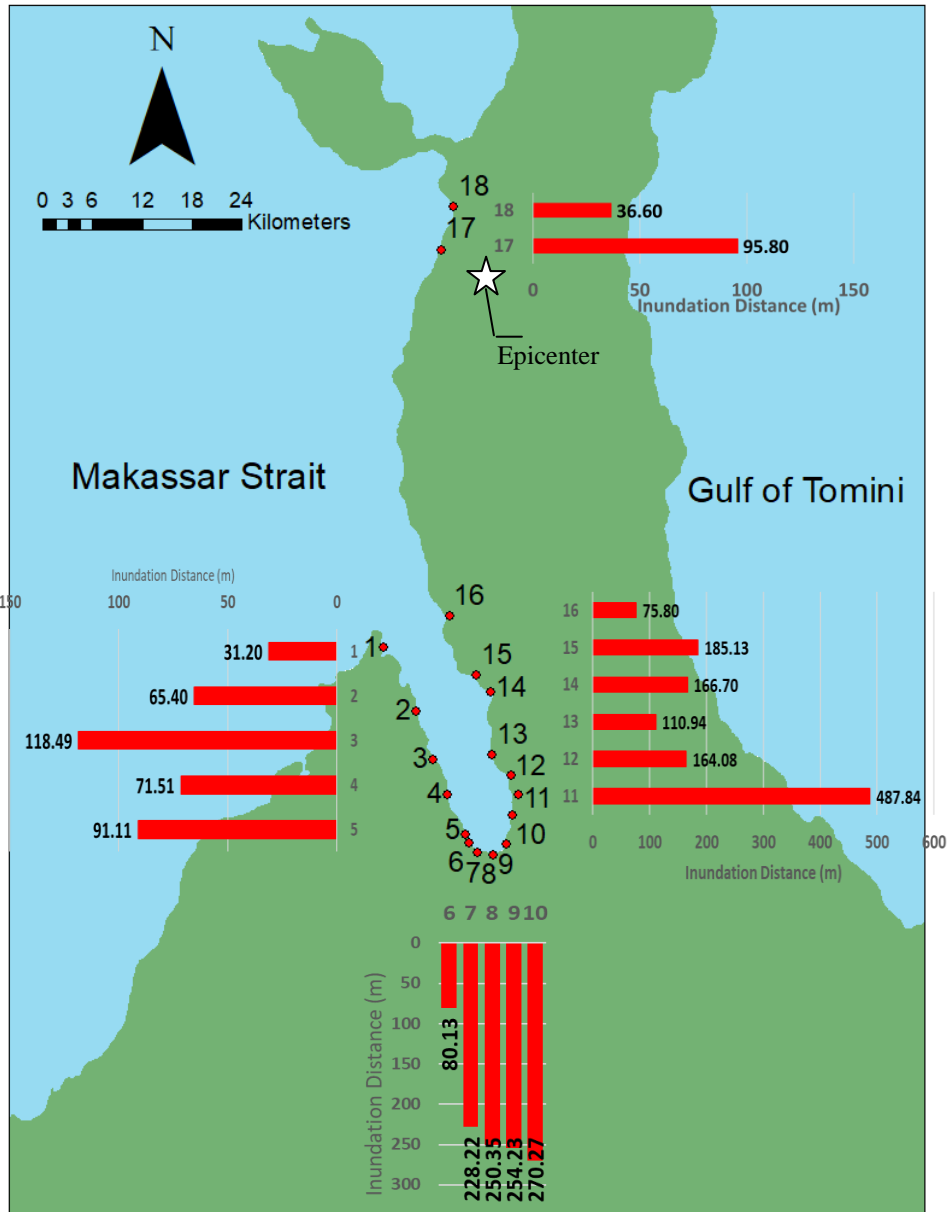
Figure 3: Measurement results of inundation distances.

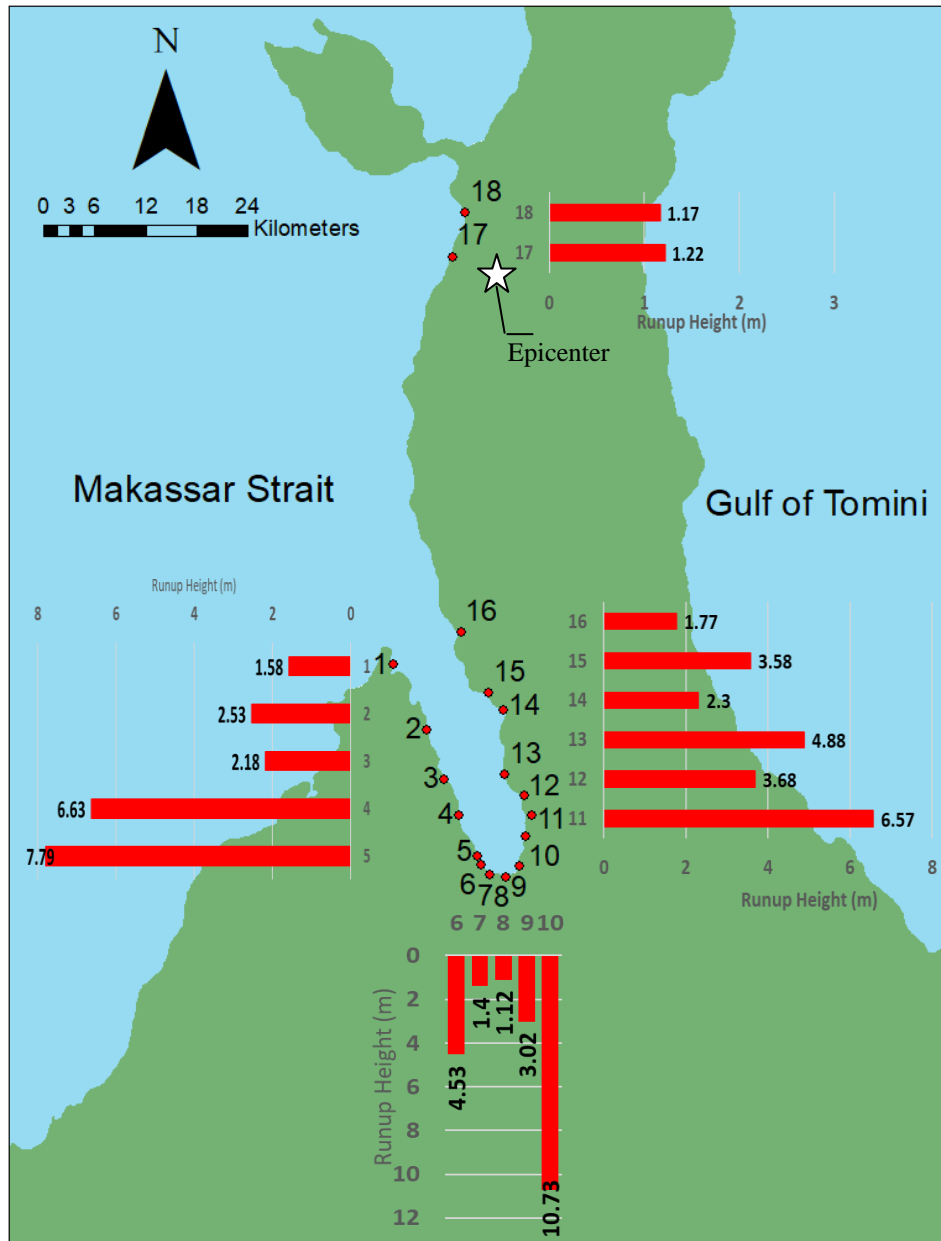
Figure 4: Measurement results of runup heights.

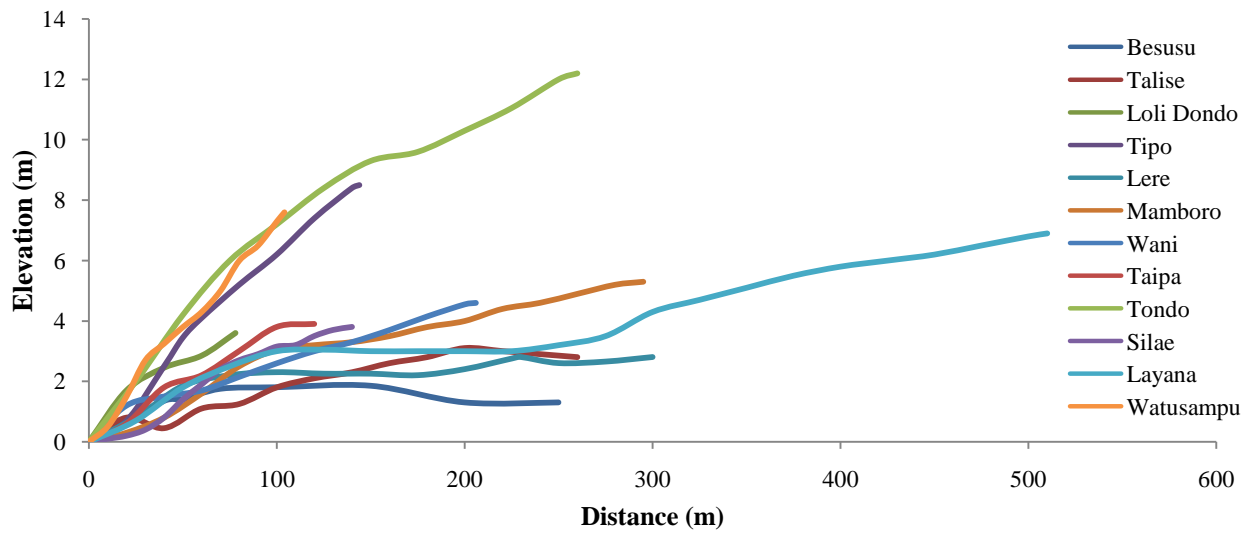
Survey sites in the eastern coast area of Palu Bay consists of Site 10 to 16. Site 10 was located in Tondo. The topography of this area is relatively steep with a slope of 0.06 (6%). Evidence of tsunami water rise was in the form of debris on top of buildings, truncated building elements, collapsed walls, trash carried away, and fixed debris. A survivor also showed the highest places of tsunami water in this area. A total of 4 cross sections of these coast were measured by our team. The
30 measured runup heights were 10.73, 7.97, 10.14, and 8.50 m, respectively, as shown in Table 1. The runup height of 10.73 m is the highest in this survey (Fig. 5) caused a few building surviving. Omira et al. (2019) shows that the highest runup from

Figure 5: Transects of beach where tsunami wave arrived. The longest inundation distance is at the Layana site and the highest runup is at the Tondo site.

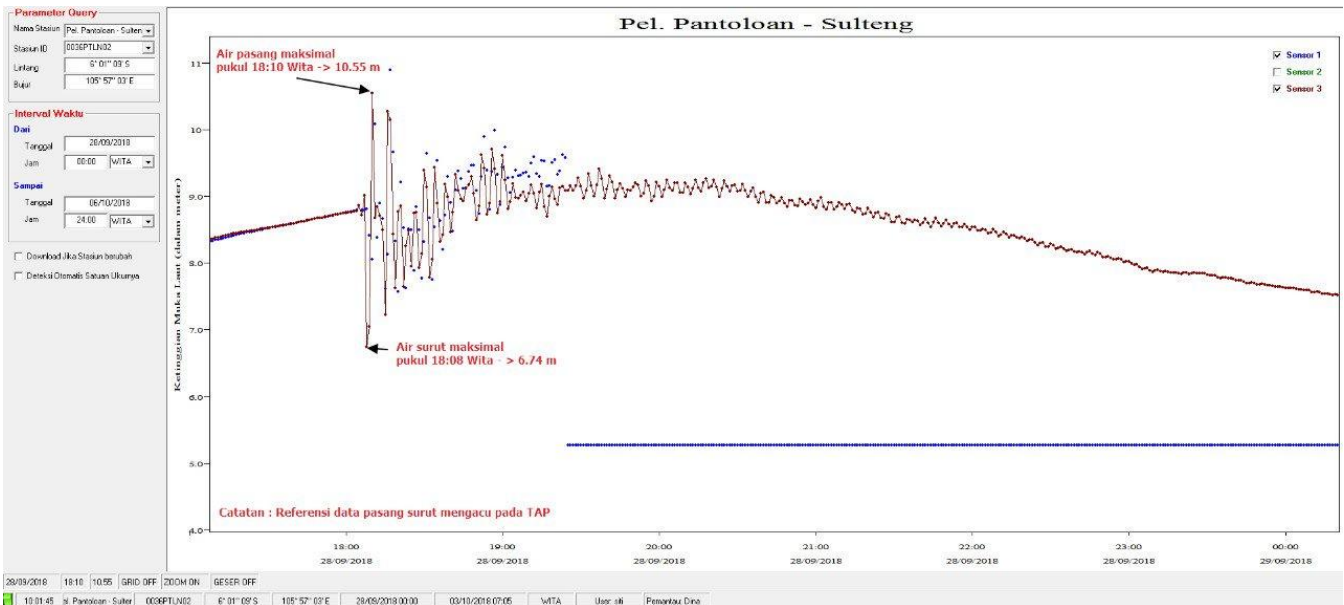
Tidal records may provide a clue on tsunami arrival time. The tidal station closest to the disaster site is Pantoloan Tidal Station. This station is located inside Palu Bay, on a pier in Pantoloan Port and operated by the Agency of Geospatial Information. When the earthquake and tsunami occurred, the recording equipment was not damaged but the data transfer stopped because the communication network was interrupted. Fig. 8 and Fig. 9 shows the water level recorded when the tsunami arrived. The maximum low tide (6.74 m) was at 18:08 local time and the maximum tide (10.55 m) was at 18:10 local time. This means that the tsunami wave height recorded at the station was 3.8 m. This wave height can be seen more clearly in Fig. 9, which is from the same source as that for Fig. 8. In addition, the first tsunami wave arrived at 18:07, with the wave trough at 18:08 and the wave crest at 18:10 local time (UTC+8).

10 **Figure 8:** Water level recording at the Pantoloan tidal station managed by Geospatial Information Agency (Sudibyo, 2018).

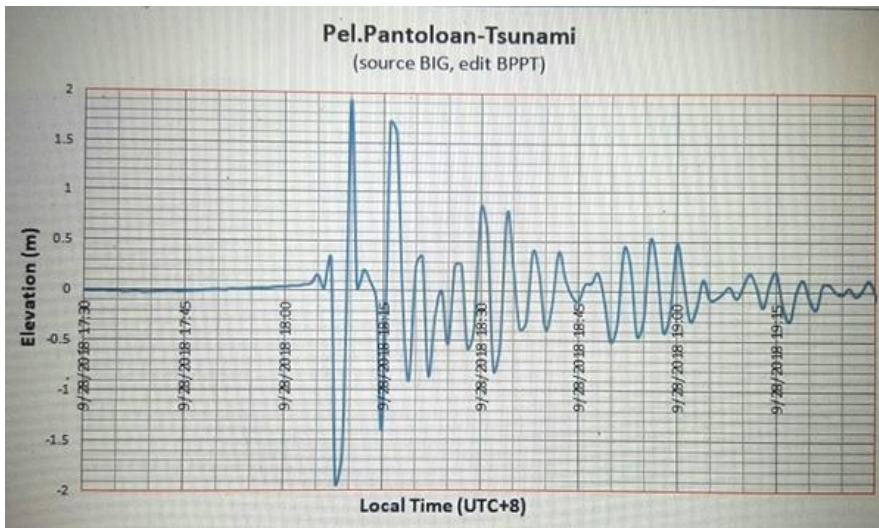
Figure 9: Magnified view of Fig. 9, sourced Geospatial Information Agency (Sudibyo, 2018).
