Post-event Field Survey of 28 September 2018 Sulawesi Earthquake and Tsunami

Wahyu Widiyanto^{1,2}, Purwanto B. Santoso², Shih-Chun Hsiao¹, Rudy T. Imananta³

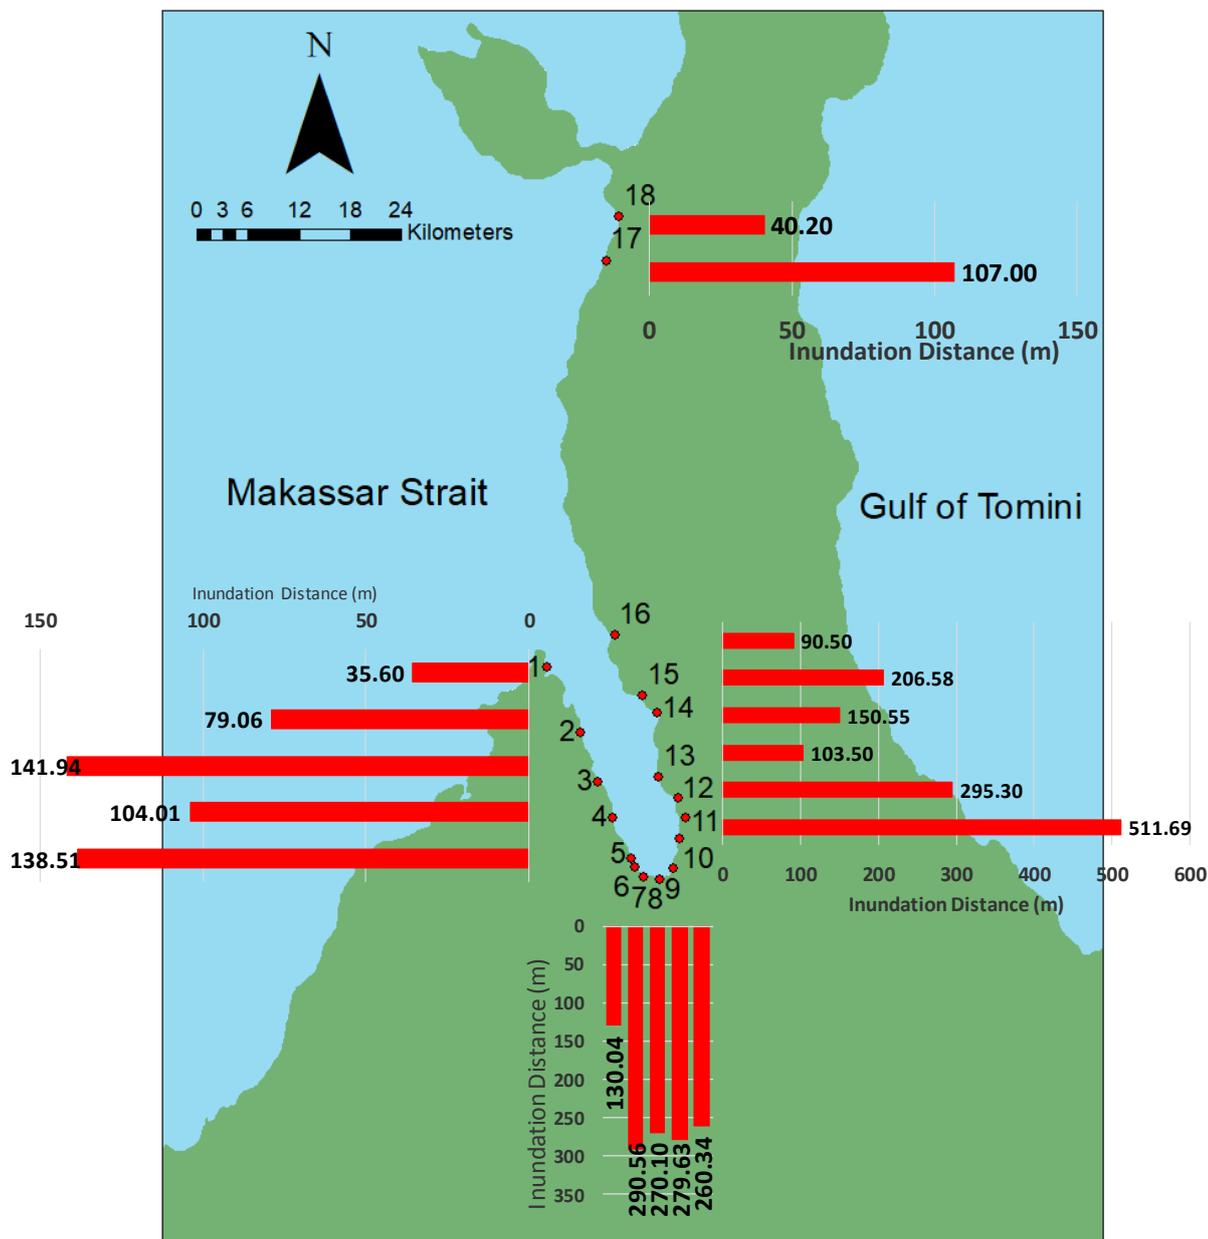
From Table 1 and Fig. 3, the farthest inundation distance from coastline to tsunami border on land is at the Layana site. This site is a trade complex that supports the economic activities of Palu City in particular and Central Sulawesi Province in general. The buildings damaged at this site functioned as shops, warehouses, and corporate offices. The items scattered in the tsunami were predominantly manufactured goods of economic value. This site is thus monitored closely by security forces to prevent looting. The topography of this site is relatively flat with a slope of 0.013 (1.3%). Because of this sloping topography, the tsunami wave reached as far as 511 m inland. The farthest point reached in this area varies greatly because many buildings have long and wide walls that stemmed the tsunami flow further inland.

5 **Figure 3:** Measurement results of inundation distances.

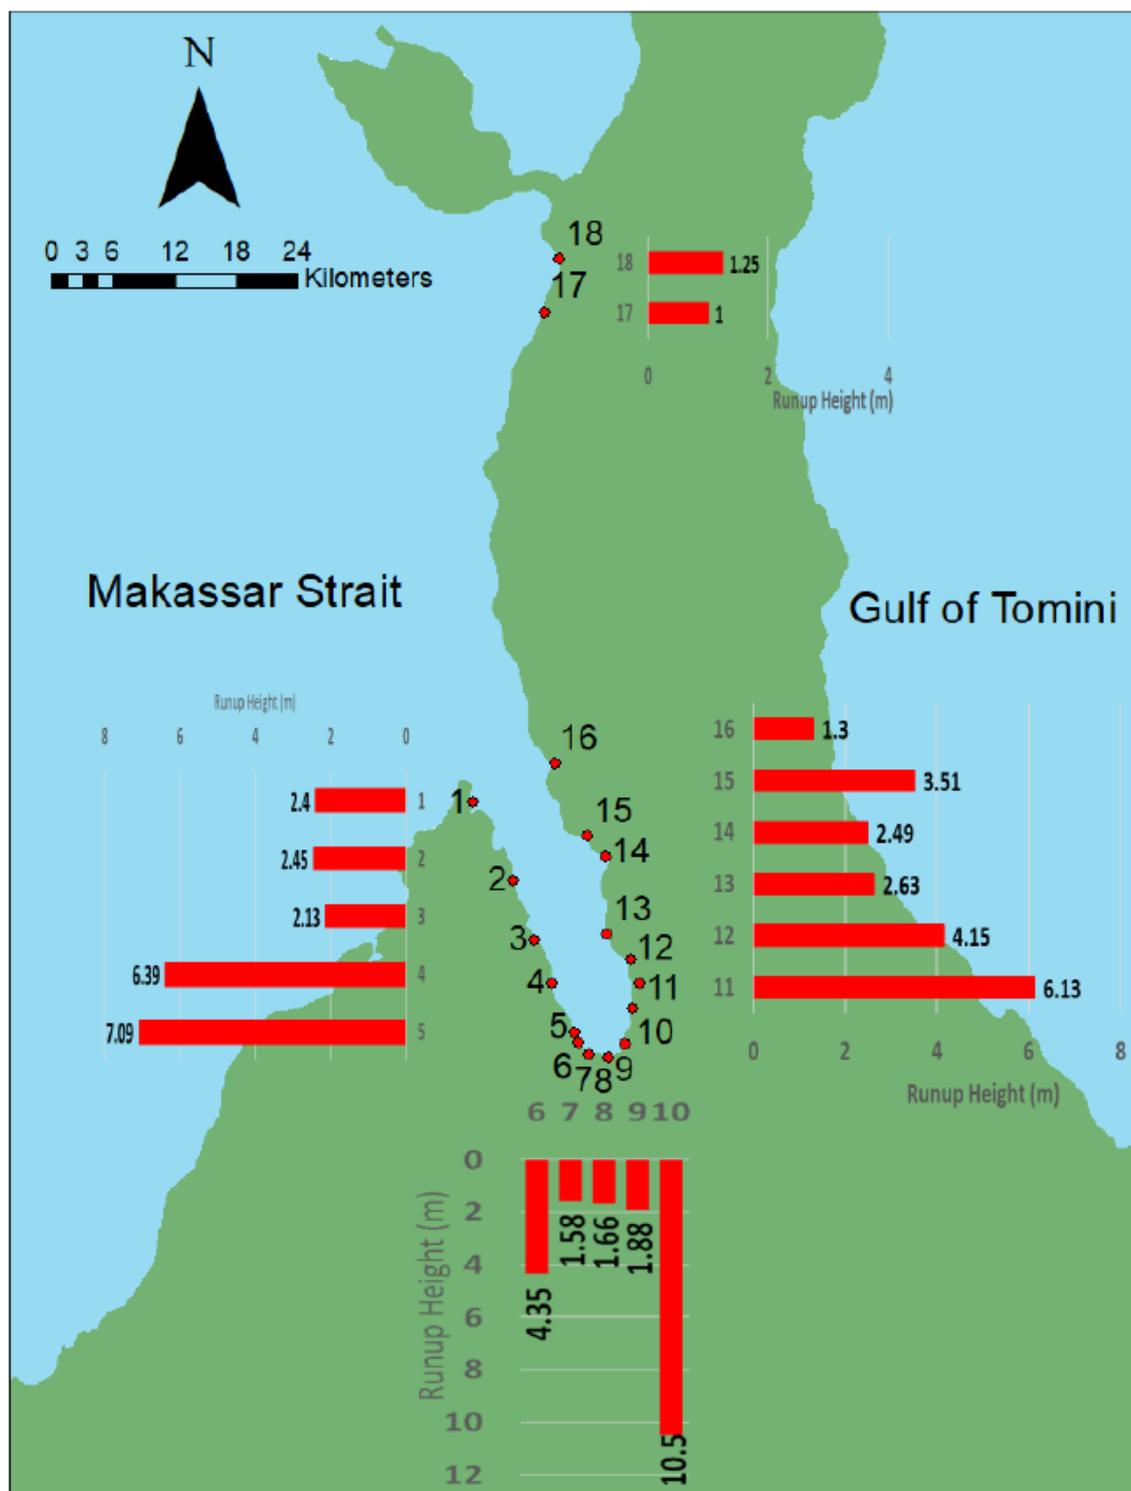
Figure 4: Measurement results of runup heights.

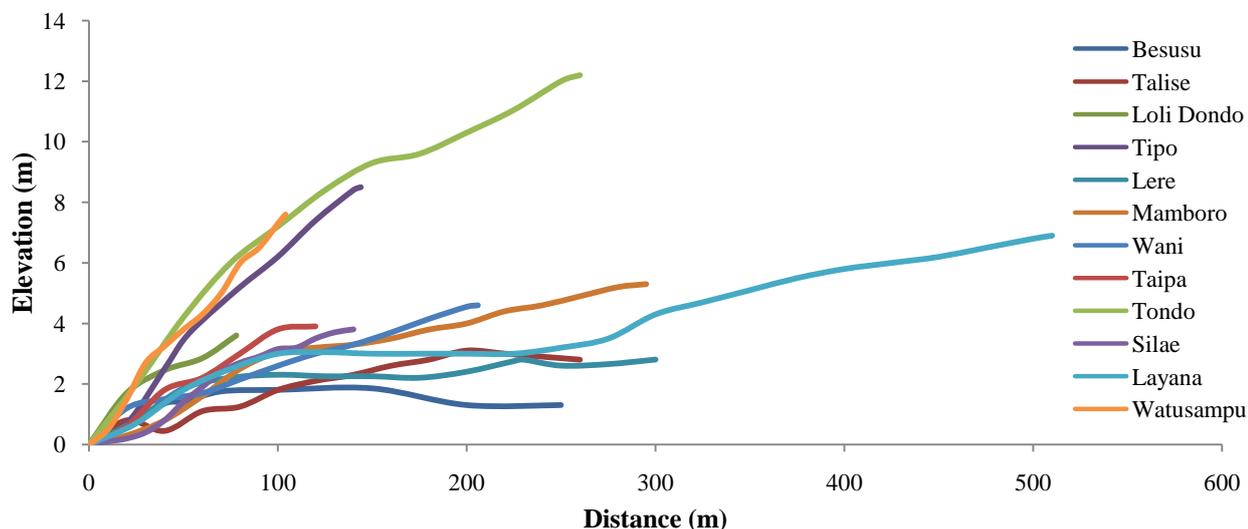
The highest point of the tsunami creeping was found at the Tondo site (Fig. 5). This area has many private boarding houses for students of the University of Tadulako, a state university in the city of Palu. The topography of this area is relatively steep with a slope of 0.06 (6%). Evidence of tsunami water rise was in the form of debris on top of buildings, truncated building elements, collapsed walls, trash carried away, and fixed debris. Eyewitnesses also showed the highest places of tsunami water in this area. A total of 4 cross sections of these coast were measured by our team. The measured runup heights were 12.20, 9.44, 11.61, and 9.97 m, respectively, as shown in Table 1. The runup height of 12.2 m (10.5 m after correction based on astronomical tides) is the highest at the Palu disaster area site. This area was flattened by tsunami (Fig. 6a), buildings collapse. This area is very crowded. Most students were in their boarding houses during the earthquake because it occurred after working hours. Surprisingly, fewer than 10 deaths were recorded. This is likely due to most of the young residents being quite nimble and able to save themselves when the tsunami arrived. This is an important observation for future mitigation efforts.

Figure 5: Transects of beach where tsunami wave arrived. The longest inundation distance is at the Layana site and the highest runup is at the Tondo site.

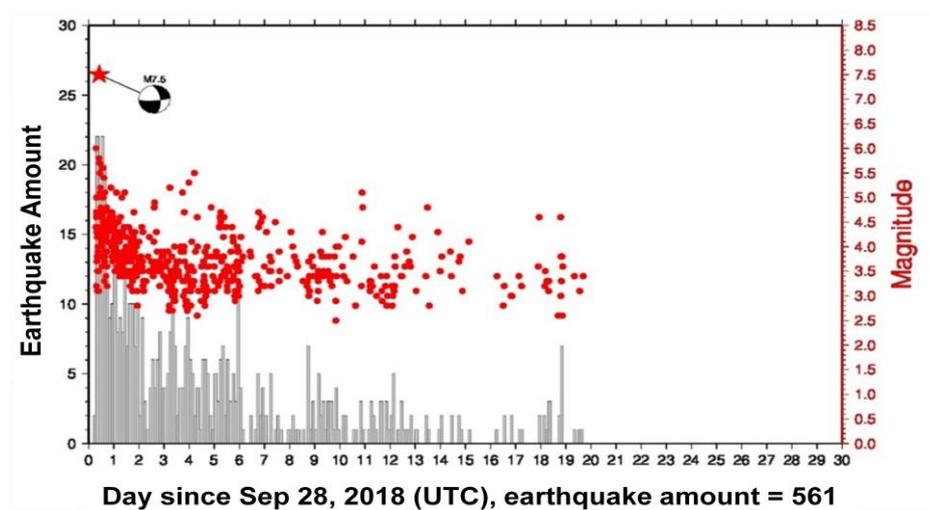
- 5 The aftershock data were collected from the Meteorological, Climatological and Geophysical Agency (BMKG). Figure 8 shows the distribution of aftershocks updated on October 18, 2018, at 09:00 West Indonesia Time. It can be seen that there were 561 earthquakes events for 20 days after the main earthquake with magnitudes of M_w 2.5-6. The frequency of the earthquakes decreased over time, 21 of the earthquakes could be felt by people. Among them, on the day of event, September 28, 2018, from main earthquake time to 06:21 p.m. there were aftershocks with magnitudes of M6.3, M6.2, M6.2, 10 M4.7, M5.6, M5.0, and M6.1, respectively.

5 Figure 8: Aftershock earthquakes ($n = 561$) 20 days after the main earthquake.

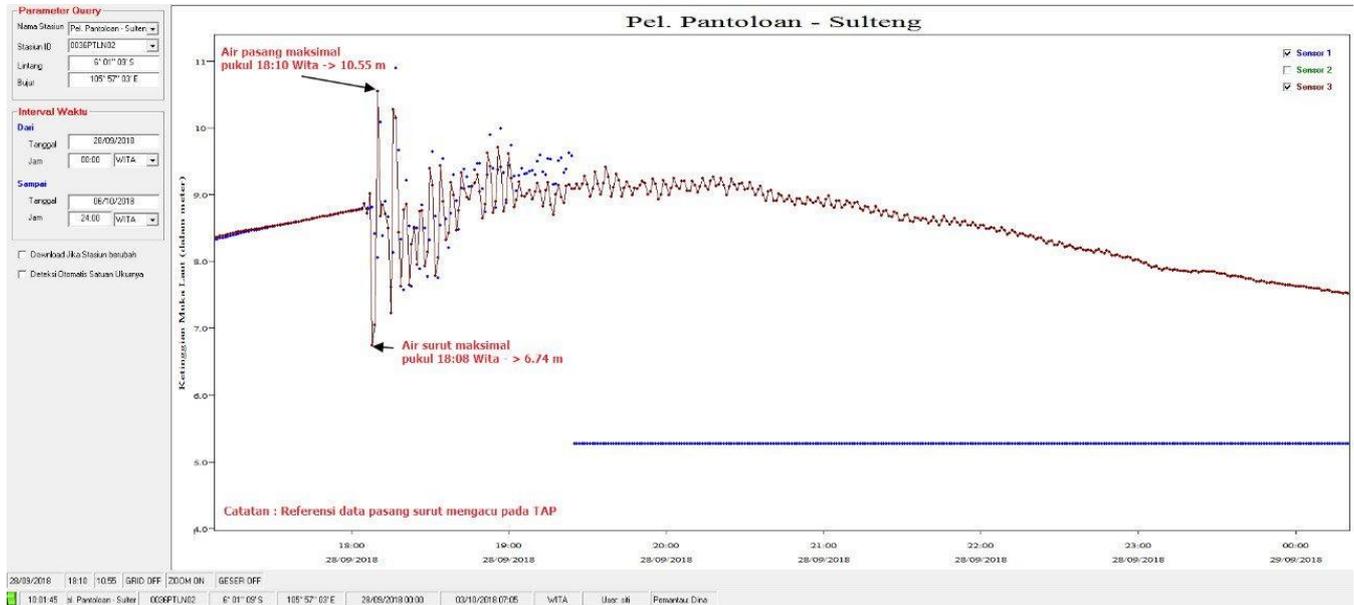
- The tidal station closest to the disaster site is Pantoloan Tidal Station. This station is located inside Palu Bay, on a pier in Pantoloan Port and operated by the Agency of Geospatial Information. When the earthquake and tsunami occurred, the recording equipment was not damaged but the data transfer stopped because the communication network was interrupted. 15 Figure 9 shows the water level recorded when the tsunami arrived. The maximum low tide (6.74 m) was at 18:08 local time and the maximum tide (10.55 m) was at 18:10 local time. This means that the tsunami wave height recorded at the station was 3.8 m. This wave height can be seen in Fig. 10, which is from the same source as that for Fig. 9. In addition, the first tsunami wave arrived at 18:07, with the wave trough at 18:08 and the wave crest at 18:10 local time (UTC+8).

Figure 9: Water level recording at the Pantoloan tidal station (Courtesy: Sudibyo, 2018).

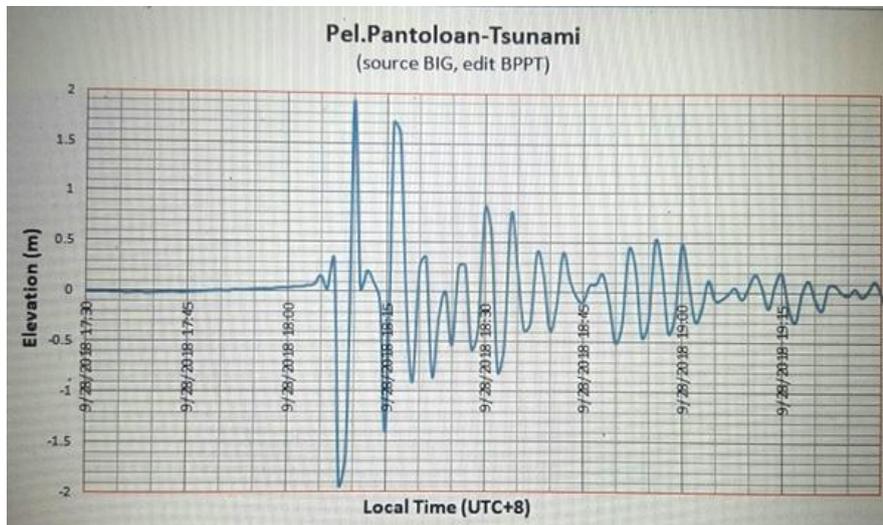
Figure 10: Magnified view of Fig. 9 (Courtesy: Indonesian Geospatial Agency and Agency for Assessment, Implementation of Technology).
