# The catastrophe of the Niedów dam - the causes of the dam's breach, its development and consequences

Stanisław Kostecki<sup>1,\*</sup> and Robert Banasiak<sup>2,\*</sup>

<sup>1</sup>Faculty of Civil Engineering, Wrocław University of Science and Technology

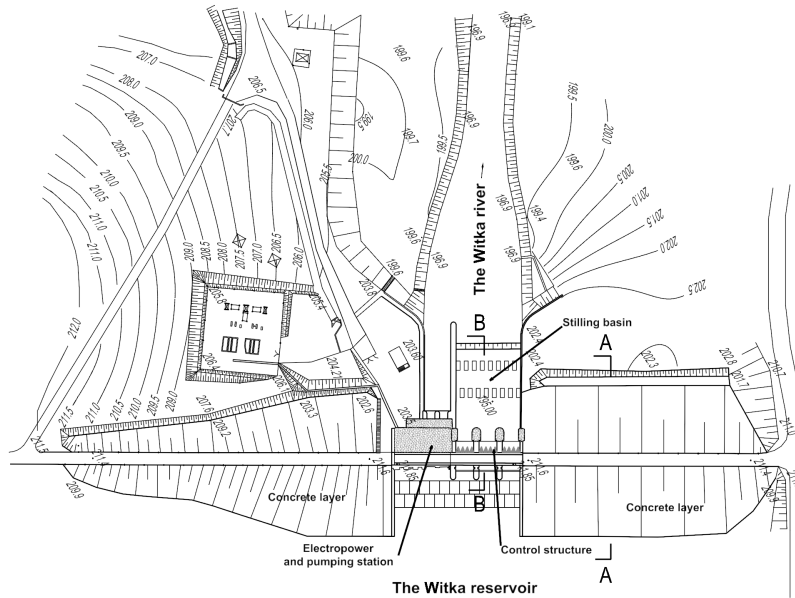
**Figure 2.** Plan view of the Niedów Dam

The Niedów dam consisted of three major sections: the central section (with a concrete water release structure equipped with movable gates, a bottom outlet and a hydropower plant), and two earth embankments. The total length of the central part of the dam was equal to 47.05 m. The length of the earth embankments on the left and right side was 126 m and 94 m, respectively (see Fig. 2).

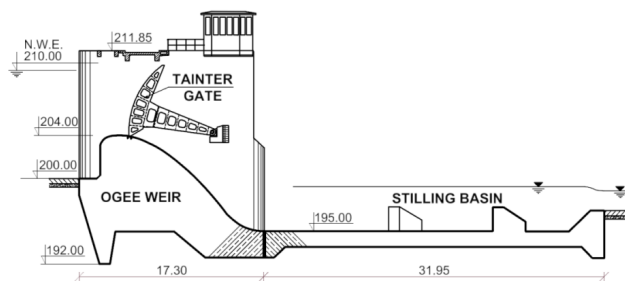
**Figure 3.** Ogee weir cross-section

Three tainter steel gates, with a width of 6.7 m and a height of 6.6 m each, controlled the water outflow from the reservoir (see Fig. 3). The maximum yield of the weir, when the gates are elevated by 5.0 m and the water level in the reservoir reaches 210 m a.s.l., is 500,0 m<sup>3</sup>s<sup>-1</sup>. This corresponds to the design flow with an exceedance probability of 1%. This yield can reach a value of 655 m<sup>3</sup>s<sup>-1</sup> for the designed maximum water level of 210.4 m a.s.l. In addition, the pillars of the central section contained bottom outlets with a size of 2 m x 1 m, which were equipped with vertically moving flat closures. The yield capacity of each outlet was equal to 10 m<sup>3</sup>s<sup>-1</sup> (at a water level upstream of 210 m a.s.l. and a water level downstream of 202,20 m a.s.l.). In normal conditions, these openings were utilized to empty the reservoir. They were also used during the catastrophic event.

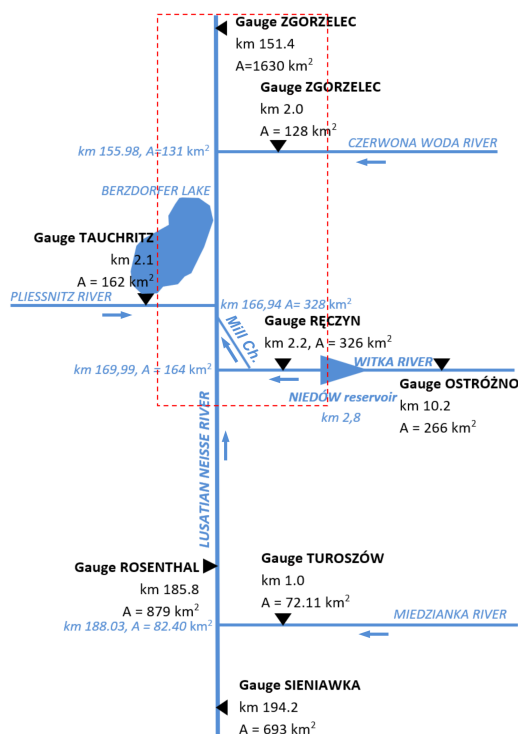
**Figure 10.** Hydrological scheme for the modelled domain (the dashed line indicates part of the 2D model)

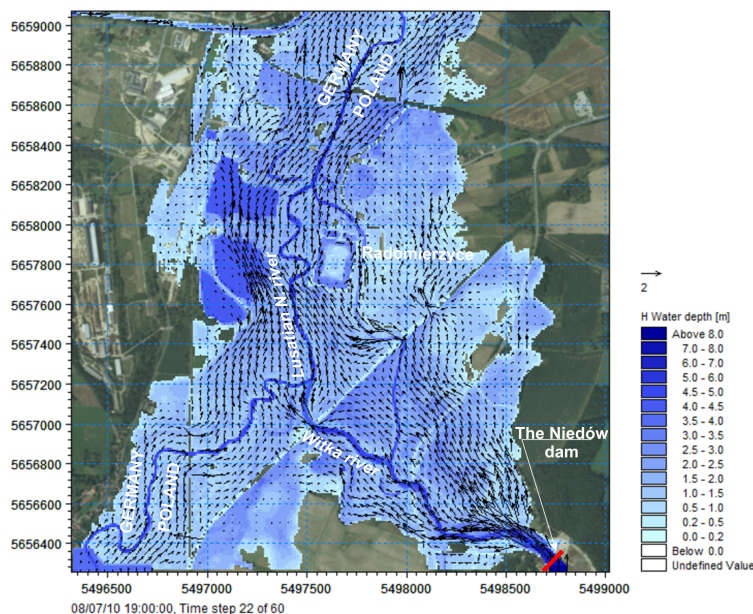
The flooding along the Lusatian Neisse in the studied case is a combination of two major flood waves that originated from the  
upstream river section and the Niedów reservoir outflow. The flood hydrographs constitute the two upper boundary conditions  
245 of the model (see Fig. 11), and they are reconstructed.

**Figure 11.** Simulated water depth and flow velocity vectors downstream from the Niedów dam [Polish UWPP 2000 Reference system (m)]

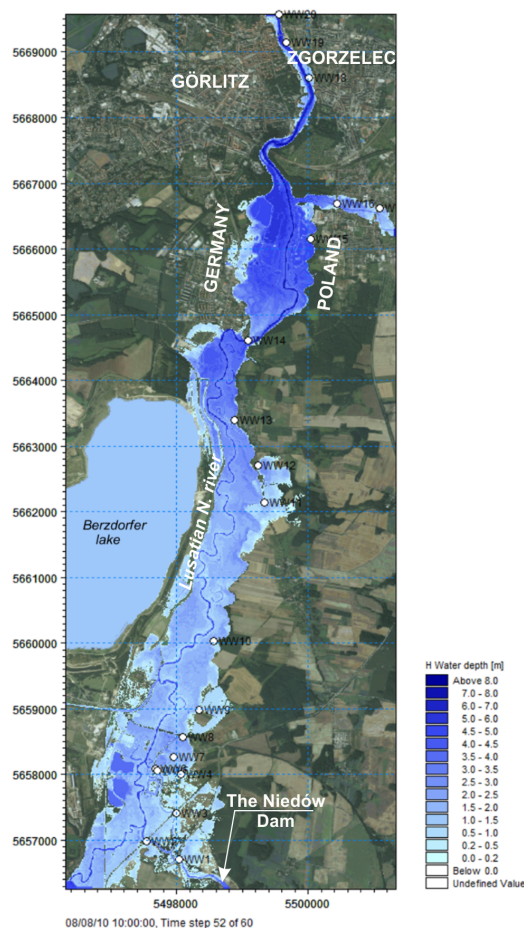
As a result of the conducted simulation, Figure 12 illustrates the flooding at 10:00 on August 8, 2010, when the flood  
peak reached the city of Zgorzelec. This figure also indicates the location of the high water marks (denoted as WW) on the  
right bank. The final computation is considered as a satisfactory reconstruction of the flood in terms of water level, flooding  
260 extent, discharge rate, timing, and water volume. The calculated ordinates of the water table correspond relatively well with  
the high water marks that were measured on site after the flood. The differences between the calculated values and those that

were determined vary from a few centimeters to approx. 0.3 m (Tab. 3). In addition, the calculated overflow volume to the Berzdorfer Lake amounted to 3,783 million  $\text{m}^3$ , which is in accordance with the data provided by the German party. This value was assessed based on the water level increase in the lake before and after the flood passage. The resulting upstream dam breach hydrograph  $Q_{ND}(t)$  was determined for a peak discharge of  $1380 \text{ m}^3\text{s}^{-1}$  at 18:20 (see Fig. 13). The total volume of released water due to the dam's failure was equal to 22 million  $\text{m}^3$ , which is about 5 mln  $\text{m}^3$  more than the inflow to the reservoir.

**Figure 12.** 2D simulation of the flood on the Lusatian Neisse in 2010 (WW - high water mark, whereas WW20 indicates the gauge station Zgorzelec)

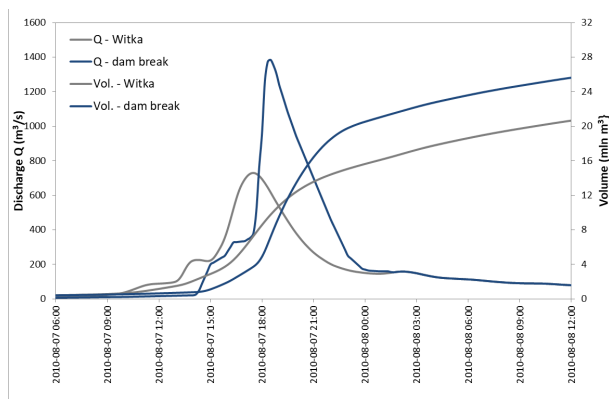
**Figure 13.** Discharge hydrographs for the inflow to the reservoir and the outflow from the reservoir. The later is the result of the dam's failure determined during 2D calculations. The vertical axis on the right shows the cumulated curve of the outflow from the reservoir - the final difference between the curves of both scenarios indicates the water retention in the reservoir under normal conditions.

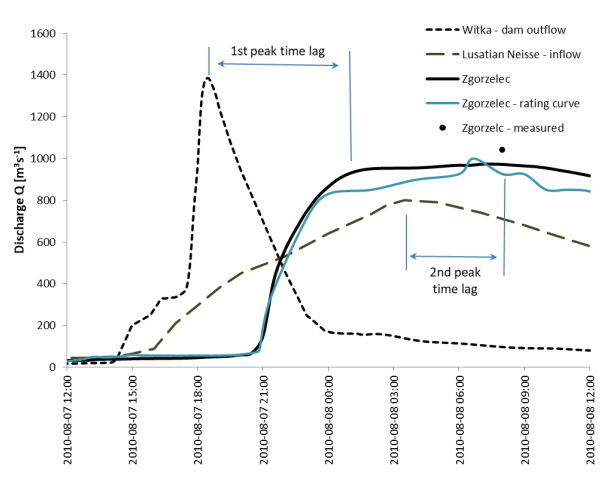
Finally, Figure 14 presents the crucial discharge hydrographs, which reflect the flood wave transformation along the modelled river section. The influence of valley retention on the flood propagation is remarkable. This retention was of about 20 million  $\text{m}^3$ , not counting the inflow to Lake Berzdorfer. Therefore, there was a significant reduction of the flood peak discharge from  $1730 \text{ m}^3\text{s}^{-1}$  at the cross-section near the Witka mouth (km 169.5) to  $950 \text{ m}^3\text{s}^{-1}$  at the Zgorzelec gauge station (km 151.4), which prevented more severe damage in the city of Zgorzelec. In addition, the discharge hydrograph at Zgorzelec shows two peaks - the first one was caused by the Niedów dam's break, and the second one was caused by the flood wave on the Lusatian Neisse, which culminated, importantly and fortunately, about eight hours later than that of the Witka River. As depicted in Figure 14, the travel time of the first flood peak from the outflow from the Niedów reservoir to the Zgorzelec gauge station took about seven hours, while the second peak of the Lusatian Neisse traveled for about 4.5 hours. This is reasonable, taking into account the fact that the second peak travelled over areas that were already flooded, and therefore it was faster than the first one.

**Figure 14.** Hydrographs of discharges of the Witka and the Lusatian Neisse River
