The vulnerability of buildings to a large-scale debris flow and outburst flood hazard **cascade** that occurred on 30 August 2020 in Ganluo, Southwest China

Abstract: In mountainous areas, damage caused by debris flows is often aggravated by subsequent dam-burst floods within the main river confluence zone. On 30 August 2020, a catastrophic disaster chain occurred at the confluence of the Heixiluo Gully and Niri River in Ganluo County, Southwest China, that consisted of a debris flow, the formation of a barrier lake and subsequent dam **break** that flooded the community. This study **presents** a comprehensive analysis of **the characteristics of two hazards and the resulting** damage to buildings from the **cascading hazards**. The peak discharge of the debris flow in the gully mouth reached **1,871** m³/s, and the change in the main river channel resulting from the dam-burst flood, which had a peak discharge of **2,737** m³/s, resulted in a fourfold increase in the extent of flood inundation compared to an ordinary flood. Three hazard zones were established based on the building damage patterns: (I) primary debris flow burial; (II) secondary dam-burst flood inundation and (III)

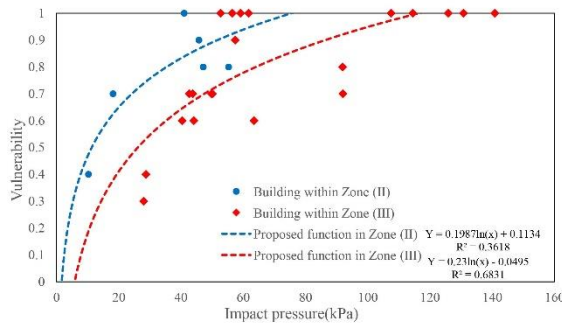
405 The vulnerability curve in Zone (II) and Zone (III) was developed by summing up the damage
406 caused by the multiple hazards and impact pressure (Fig. 12). Logistic functions were proposed
407 separately for the two hazard zones, and the corresponding determination coefficient (R^2) and root
408 mean square error (RMSE) were also obtained. The determination coefficients of the two regression
409 curves in Zone (III) have a higher R^2 . The RMSEs of the curves in Zone (II) and Zone (III) are 0.36
410 and 0.68, respectively. The correlation between vulnerability and inundation depth in the two zones
411 is shown in Fig. 13, with an R^2 lower than impact pressure ($R^2=0.59$ for Zone (II) and $R^2=0.30$ for
412 Zone (III)). Building vulnerability increases with increasing hazard intensity, and the trend is similar
413 in the two zones. The impact pressure thresholds for Zones II and III, where vulnerability is equal

414 to 1, are 75 kPa and 110 kPa, respectively. For the same impact pressure and inundation depth, the
 415 damage to buildings in Zone (II) is greater than that in Zone (III).

Figure 12 Proposed vulnerability functions based on the impact pressure in Zone (II) and Zone (III).

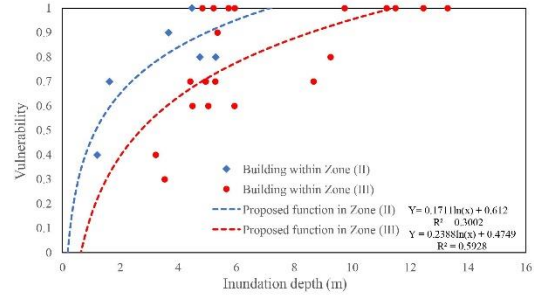
Figure 13 Proposed vulnerability functions based on the inundation depth in Zone (II) and Zone (III).

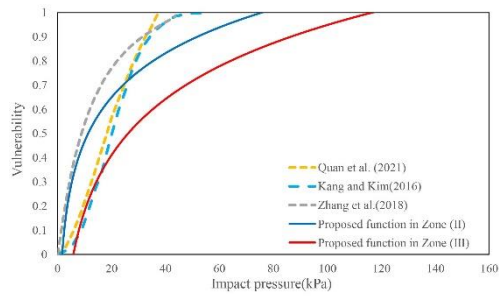
416 The vulnerability curves proposed for Zone (II) and Zone (III) were compared to the three
 417 functions used in debris flow risk assessment (Fig.14, Fig.15). The functions developed by [Quan](#)
 418 [et al. \(2011\)](#) and [Kang et al. \(2016\)](#) were calculated based on damage done to brick masonry and
 419 nonreinforced concrete structures that had been impacted by the debris flows in South Korea and
 420 Italy, respectively. The vulnerability curve proposed by [Zhang et al. \(2018\)](#) was developed for
 421 buildings with brick-concrete structures from the Zhouqu debris flow event in China. The slope of
 422 the two proposed vulnerability curves based on impact pressure is smaller than those of the three
 423 curves. When the impact pressure is less than 20 kPa, the proposed curves show a similar increasing
 424 trend compared to the three functions. However, when the impact pressure is greater than 20 kPa,

434 been recently built by a more professional construction team. For example, the newly built four
 435 **building 7** was not completely damaged by hazard **cascade** under impact pressures greater than 63.5
 436 kPa.

Figure 14 Comparison of the building vulnerability functions with the impact pressure functions proposed by Quan et al. (2011), Kang et al. (2016), and Zhang et al. (2018).

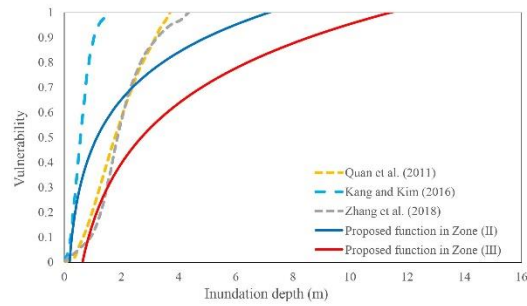
425 the slope of the two proposed vulnerability curves is much smaller than those of the three curves.
 426 For the curves based on inundation depth, when the depth is less than 1.5 m, the slope is steeper
 427 than that of [Quan et al. \(2011\)](#) and [Zhang et al. \(2018\)](#) and slower than that of [Kang et al. \(2016\)](#).
 428 When the depth is greater than 2 m, the damage increases slower than the curves of [Quan et al.](#)
 429 [\(2011\)](#) and [Zhang et al. \(2018\)](#). This disparity may be attributed to the different damage patterns
 430 and structures of the buildings in this study. The three vulnerability functions were generated for a
 431 single debris flow event, whereas the mechanisms by which buildings impacted by floods fail are
 432 not the same when those buildings are subjected to a debris flow. The structures of most buildings
 433 in the study area are tougher than those in the three events, and nearly half of the buildings had

Figure 15 Comparison of the building vulnerability functions with the inundation depth proposed by Quan et al. (2011), Kang et al. (2016), and Zhang et al. (2018).
