The vulnerability of buildings to a large-scale debris flow and outburst flood hazard cascade that occurred on 30 August 2020 in Ganluo, Southwest China

Abstract: In mountainous areas, damage caused by debris flows is often aggravated by subsequent dam-burst floods within the main river confluence zone. On 30 August 2020, a catastrophic disaster chain occurred at the confluence of the Heixiluo Gully and Niri River in Ganluo County, Southwest China, that consisted of a debris flow, the formation of a barrier lake and subsequent dam break that flooded the community. This study presents a comprehensive analysis of the characteristics of two hazards and the resulting damage to buildings from the cascading hazards. The peak discharge of the debris flow in the gully mouth reached 1,871 m³/s, and the change in the main river channel resulting from the dam-burst flood, which had a peak discharge of 2,737 m³/s, resulted in a fourfold increase in the extent of flood inundation compared to an ordinary flood. Three hazard zones were established based on the building damage patterns: (I) primary debris flow burial; (II) secondary dam-burst flood inundation and (III) sequential debris flow buri

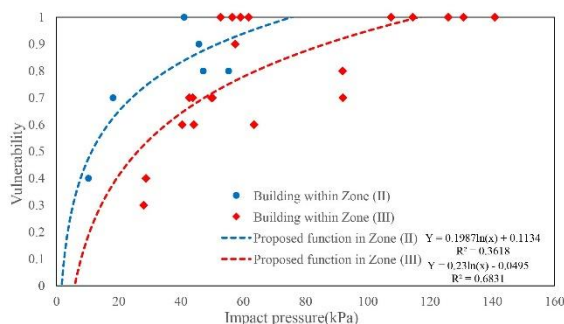
403 The vulnerability curve in Zone (II) and Zone (III) was developed by summing up the damage
404 caused by the multiple hazards and impact pressure (Fig. 12). Logistic functions were proposed
405 separately for the two hazard zones, and the corresponding determination coefficient (R^2) and root
406 mean square error (RMSE) were also obtained. The determination coefficients of the two regression
407 curves in Zone (III) have a higher R^2 . The RMSEs of the curves in Zone (II) and Zone (III) are 0.36
408 and 0.68, respectively. The correlation between vulnerability and inundation depth in the two zones
409 is shown in Fig. 13, with an R^2 lower than impact pressure ($R^2=0.59$ for Zone (II) and $R^2=0.30$ for
410 Zone (III)). Building vulnerability increases with increasing hazard intensity, and the trend is similar
411 in the two zones. The impact pressure thresholds for Zones II and III, where vulnerability is equal

412 to 1, are 75 kPa and 110 kPa, respectively. For the same impact pressure and inundation depth, the
 413 damage to buildings in Zone (II) is greater than that in Zone (III).

Figure 12 Proposed vulnerability functions based on the impact pressure in Zone (II) and Zone (III).

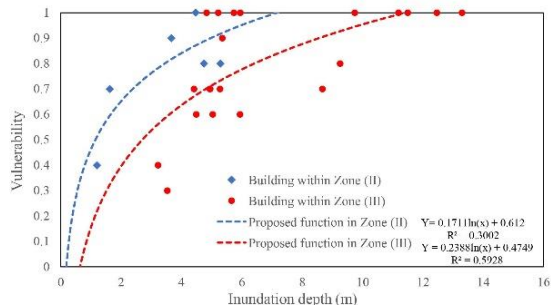
Figure 13 Proposed vulnerability functions based on the inundation depth in Zone (II) and Zone (III).
