The vulnerability of buildings to a large-scale debris flow and outburst flood hazard cascade that occurred on 30 August 2020 in Ganluo, Southwest China

Abstract: In mountainous areas, damage caused by debris flows is often aggravated by subsequent dam-burst floods within the main river confluence zone. On 30 August 2020, a catastrophic disaster chain occurred at the confluence of the Heixiluo Gully and Niri River in Ganluo County, Southwest China, consisting of a debris flow, the formation of a barrier lake and subsequent dam break that flooded the community. This study presents a comprehensive analysis of the characteristics of the two hazards and the resulting damage to buildings from the cascading hazards. The peak discharge of the debris flow in the gully mouth reached 1,871 m³/s. Following the dam break, the flood with a peak discharge of 2,737 m³/s, significantly altered the main river channel, causing a fourfold increase in flood inundation compared to an ordinary flood. Three hazard zones were established based on the building damage patterns: (I) primary debris flow burial; (II) secondary dam-burst flood inundation and (III) sequential debris flow burial and dam-burst in

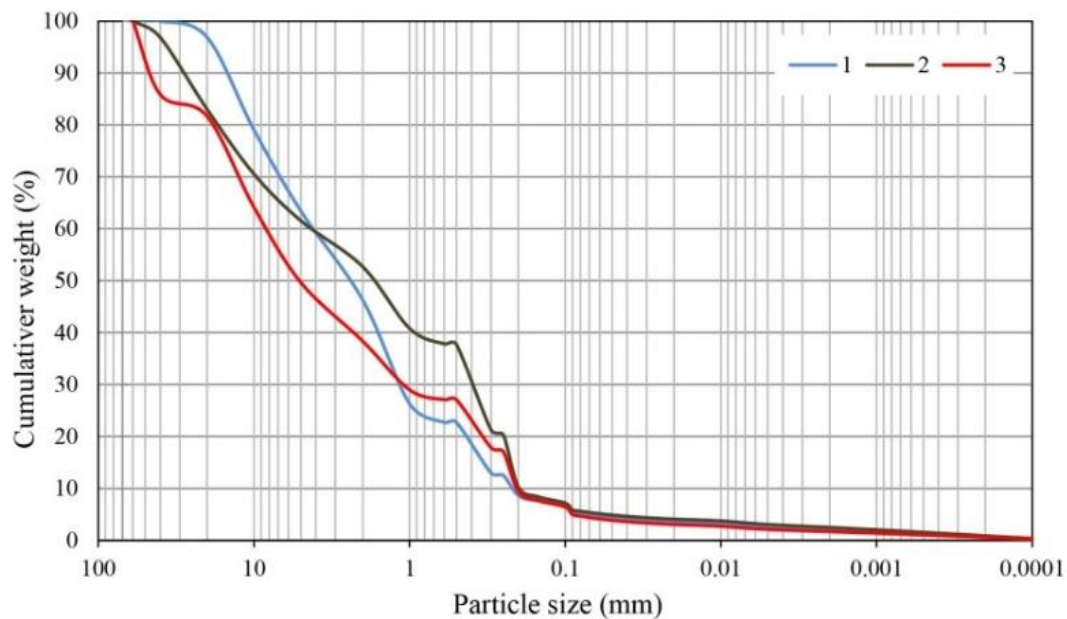
223 Samples of debris particles smaller than 10 cm were taken from three locations (see Fig. 4). The
224 particle size distribution of the debris flow samples is presented in Fig. 5. The calculated bulk
225 density of the debris flow is 1.825 g/cm³, which indicates a viscous debris flow (Kang et al., 2004).

229 **Figure 5** Particle size distribution of debris flow samples.
