The vulnerability of buildings to a large-scale debris flow and outburst flood hazard cascade that occurred on 30 August 2020 in Ganluo, Southwest China

Abstract: In mountainous areas, damage caused by debris flows is often aggravated by subsequent dam-burst floods within the main river confluence zone. On 30 August 2020, a catastrophic disaster chain occurred at the confluence of the Heixiluo Gully and Niri River in Ganluo County, Southwest China, consisting of a debris flow, the formation of a barrier lake and subsequent dam break that flooded the community. This study presents a comprehensive analysis of the characteristics of the two hazards and the resulting damage to buildings from the cascading hazards. The peak discharge of the debris flow in the gully mouth reached 1,871 m³/s. Following the dam break, the flood with a peak discharge of 2,737 m³/s, significantly altered the main river channel, causing a fourfold increase in flood inundation compared to an ordinary flood. Three hazard zones were established based on the building damage patterns: (I) primary debris flow burial; (II) secondary dam-burst flood inundation and (III) sequential debris flow burial and dam-burst in

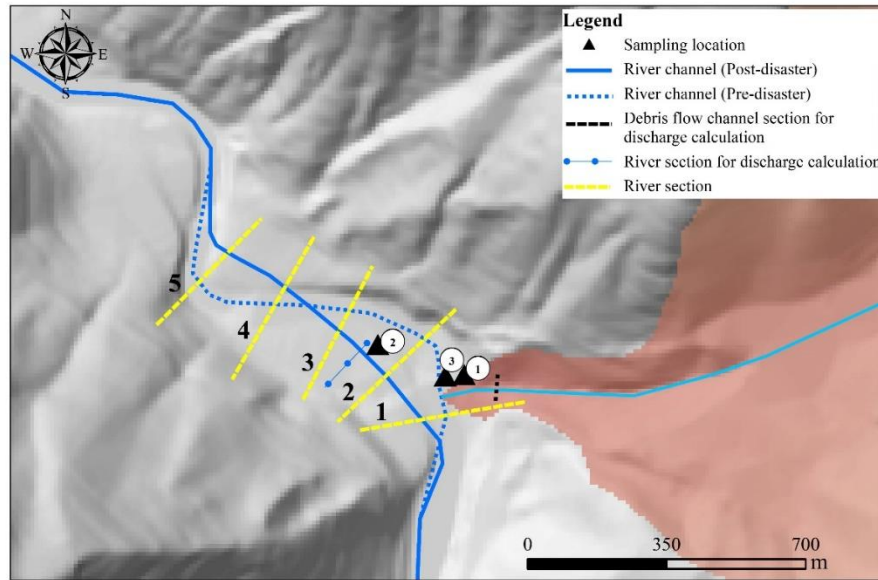
223 Samples of debris particles smaller than 10 cm were taken from three locations (see Fig. 4). The
224 particle size distribution of the debris flow samples is presented in Fig. 5. The calculated bulk
225 density of the debris flow is 1.825 g/cm³, which indicates a viscous debris flow (Kang et al., 2004).

227 **Figure 4** Distribution of river and debris flow channel sections and debris flow sampling locations.

295 and subsequently destroyed by the flood. The river terrace on the original right bank was strongly
296 eroded by the flood, leading to the collapse and demolition of buildings. Five river sections (Section
297 1 to Section 5) were selected to analyze the terrain changes (see Fig. 4). From Section 1 to Section
298 3, the main channel varied from the right bank to the left bank with a distance between 40 m and
299 100 m, the average width of the new river channel was 50 m, and the vertical distance between the
300 new riverbed and floodplain was 11.23 m. In Section 5, the channel migrated from the left bank to
301 the right bank due to the severe erosion of the original river terrace and had a maximum depth of
302 10 m (Fig. 10). The channel width increased to approximately 100 m, and the channel depth
303 decreased to less than 5 m.

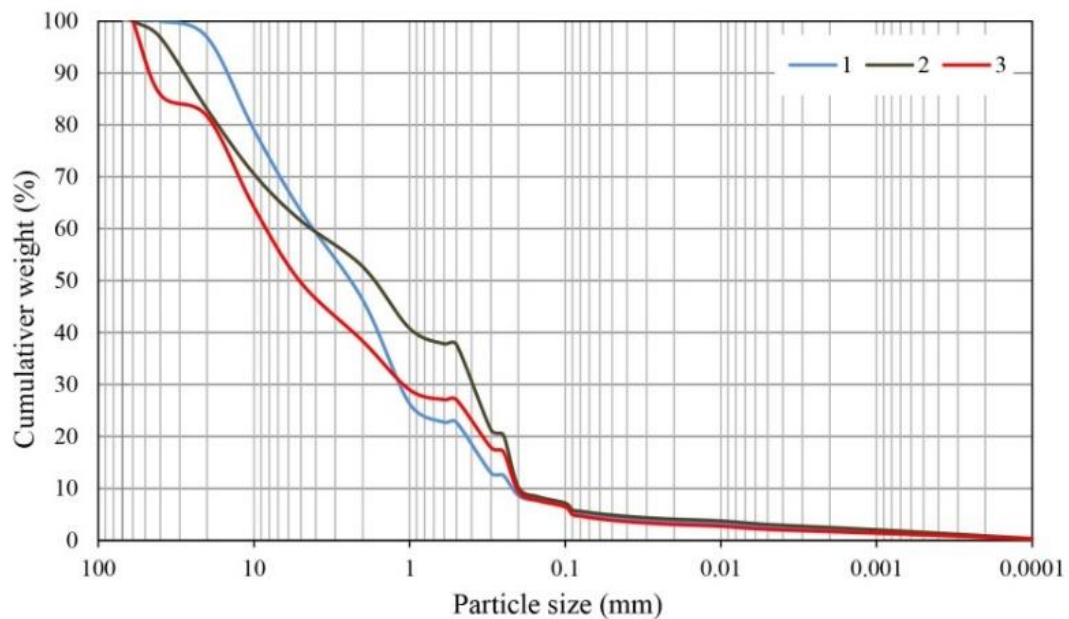
229 **Figure 5** Particle size distribution of debris flow samples.

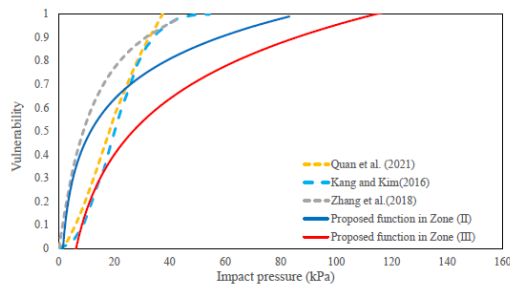
431 The vulnerability curves proposed for Zone (II) and Zone (III) were compared to the three
432 functions used in debris flow risk assessment (Fig.16, Fig.17). The functions developed by [Quan](#)
433 [et al. \(2011\)](#) and [Kang et al. \(2016\)](#) were calculated based on damage done to brick masonry and
434 nonreinforced concrete structures that had been impacted by the debris flows in South Korea and
435 Italy, respectively. The vulnerability curve proposed by [Zhang et al. \(2018\)](#) was developed for
436 buildings with brick-concrete structures from the Zhouqu debris flow event in China. The slope of
437 the two proposed vulnerability curves based on impact pressure is smaller than those of the three
438 curves. When the impact pressure is less than 20 kPa, the proposed curves show a similar increasing
439 trend compared to the three functions. However, when the impact pressure is greater than 20 kPa,

Figure 16 Comparison of the building vulnerability functions with the impact pressure functions proposed by [Quan et al. \(2011\)](#), [Kang et al. \(2016\)](#), and [Zhang et al. \(2018\)](#).

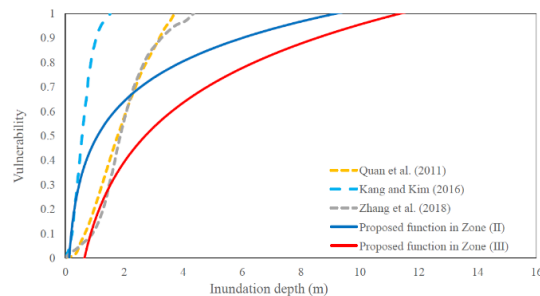
441 For the curves based on inundation depth, when the depth is less than 1.5 m, the slope is steeper
 442 than that of [Quan et al. \(2011\)](#) and [Zhang et al. \(2018\)](#) and slower than that of [Kang et al. \(2016\)](#).
 443 When the depth is greater than 2 m, the damage increases slower than the curves of [Quan et al.](#)
 444 [\(2011\)](#) and [Zhang et al. \(2018\)](#). This disparity may be attributed to the different damage patterns
 445 and structures of the buildings in this study. The three vulnerability functions were generated for a
 446 single debris flow event, whereas the mechanisms by which buildings impacted by floods fail are
 447 not the same when those buildings are subjected to a debris flow. The structures of most buildings
 448 in the study area are tougher than those in the three events, and nearly half of the buildings had
 449 been recently built by a more professional construction team. For example, the newly built four

450 building 7 was not completely damaged by hazard cascade under impact pressures greater than 63.5
 451 kPa.

Figure 17 Comparison of the building vulnerability functions with the inundation depth functions proposed by [Quan et al. \(2011\)](#), [Kang et al. \(2016\)](#), and [Zhang et al. \(2018\)](#).
