1 The vulnerability of buildings to a large-scale debris flow and outburst 2 flood hazard chain that occurred on 30 August 2020 in Ganluo, 3 Southwest China

11 **Abstract:** In mountainous areas, damage caused by debris flows is often aggravated by
12 subsequent dam-burst floods within the main river confluence zone. On 30 August 2020, a
13 catastrophic disaster chain occurred at the confluence of the Heixiluo Gully and Niri River in
14 Ganluo County, Southwest China, that consisted of a debris flow, the formation of a barrier lake
15 and subsequent dam breach that flooded the community. This study provides a comprehensive
16 analysis of the damage to buildings resulting from the sequential occurrence of debris flow and
17 dam-burst flood. The peak discharge of the debris flow in the gully mouth reached 1937 m³/s, and
18 the change in the main river channel resulting from the dam-burst flood, which had a peak
19 discharge of 2273 m³/s, resulted in a fourfold increase in the extent of flood inundation compared
20 to an ordinary flood. Three hazard zones were established based on the building damage patterns:

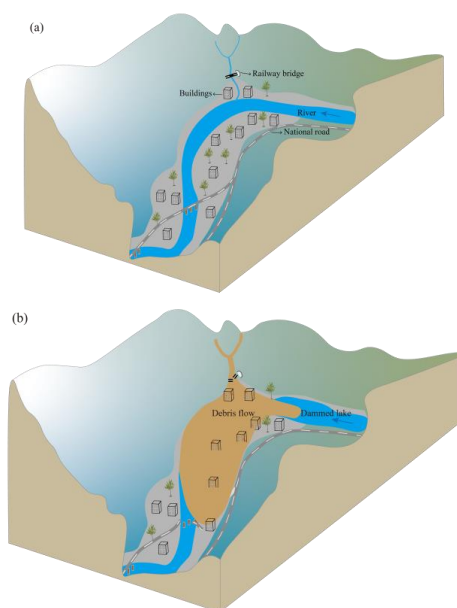
152 The debris flows transported approximately 1,050,000 m³ of material to the Niri River, forming
153 a temporary debris dam that breached after approximately 30 minutes, resulting in a massive flash
154 flood. The debris flow-flash flood event caused significant damages, including the destruction of
155 89 buildings, the Chengdu-Kunming railway bridge near the gully mouth, 1.2 km along national
156 road G245, and 5 highway bridges along the main river (Fig. 3).

160 **Figure 3** Illustration of the multi-hazard chain: (a) river flow before the occurrence of debris flow; (b)
161 debris flow blocks the river and forms a dammed lake that destroys the railway, roads and buildings; (c) the
162 bursting of the dammed lake and buildings and road were damaged or inundated by the flood.

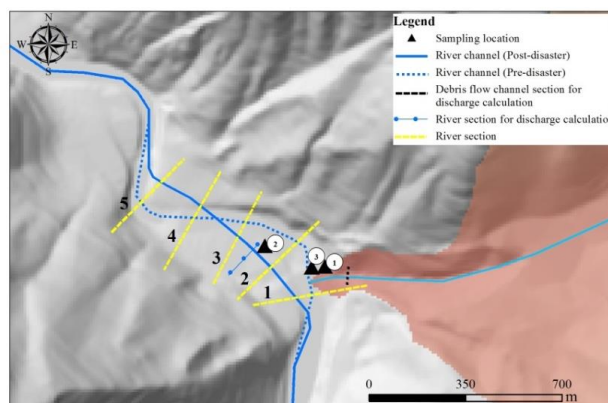
225 Samples of debris particles smaller than 10 cm were taken from three locations (see Fig. 4).
 226 The particle size distribution of the debris flow samples is presented in Fig. 5. The calculated bulk
 227 density of the debris flow is 1.825 g/cm³, which indicates a viscous debris flow ([Kang et al.,](#)
 228 [2004](#)).

Figure 4 Distribution of river and debris flow channel sections and debris flow sampling locations.

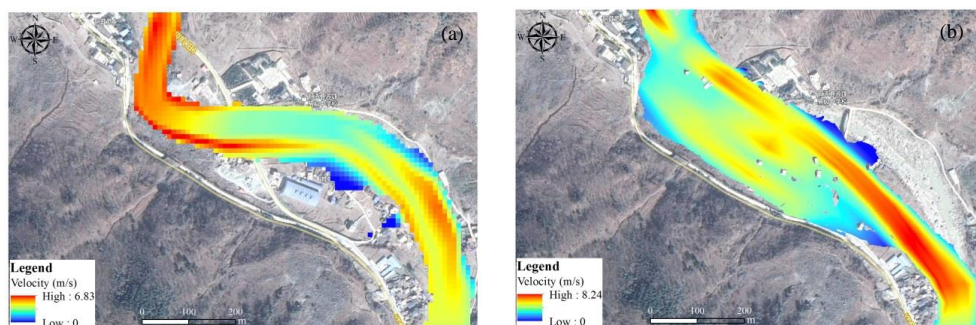
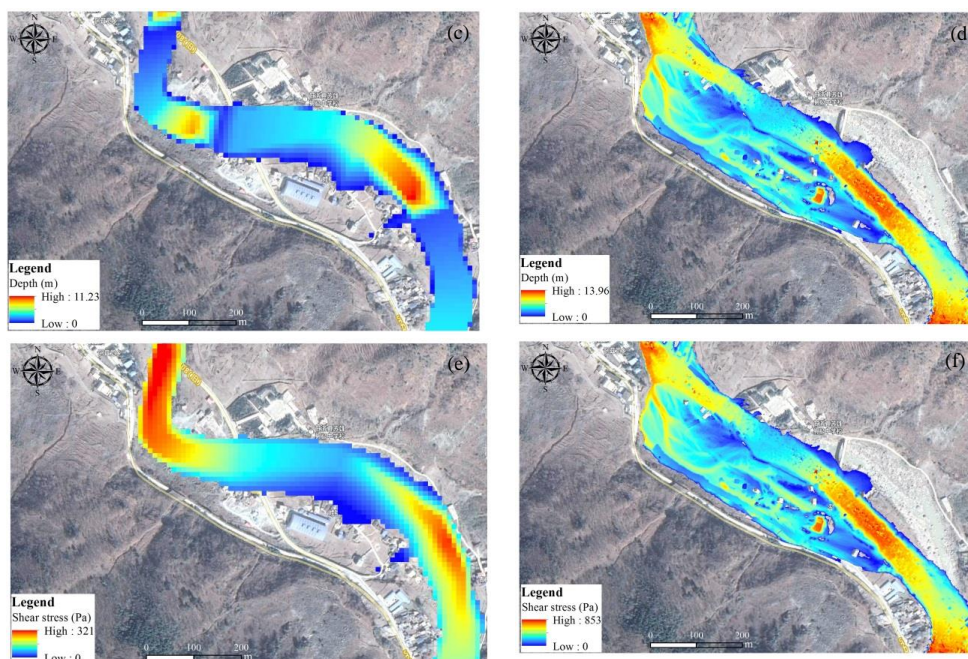
259 The temporal distributions of flood depth, velocity, and shear stress in the two scenarios are
260 presented in Fig. 6. The flood completely submerged all buildings on the left bank near the
261 middle of the river channel, and the buildings on the river terrace on the right bank were strongly
262 eroded. The maximum water depth and velocity of the dam-burst flood were 13.96 m and 8.24
263 m/s, respectively, which were 1.24 and 1.31 times higher than those of the ordinary flood,
264 respectively. The maximum shear stress of the flood in the main channel increased sharply from
265 320 Pa to 853 Pa, indicating a 2.67-fold increase compared to the ordinary flood. For the ordinary
266 flood scenario, the water depth and velocity were high in the channel and decreased in the
267 floodplain. In contrast, the high velocity and shear stress zones that resulted from the dam-burst
268 flood were mainly distributed in the main channel and along the left bank, indicating that the

269 material deposited by the debris flow and the original river bank are highly susceptible to erosion.

270 **Figure 6** Distribution of depth, velocity, and shear stress of ordinary flood and dam-burst flood: (a)
271 Maximum velocity distribution of ordinary flood; (b) Maximum velocity distribution of dam-burst
272 flood;(c) Maximum depth distribution of ordinary flood;(d) Maximum depth distribution of dam-burst
273 flood;(e) Maximum shear stress distribution of ordinary flood;(f) Maximum shear stress distribution of
274 dam-burst flood.

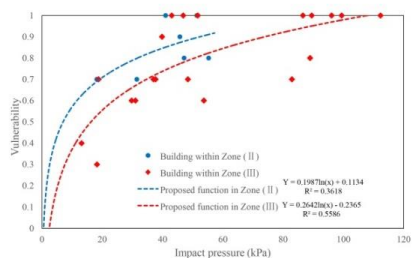
The vulnerability curve in Zone (II) and Zone (III) was developed by summing up the damage caused by the multiple hazards and impact pressure (Fig. 11). Logistic functions were proposed separately for the two hazard zones, and the corresponding determination coefficient (R^2) and root mean square error (RMSE) were also obtained. The determination coefficients of the two regression curves in Zone (III) have a higher R^2 . The RMSEs of the curves in Zone (II) and Zone (III) are 0.08 and 0.14, respectively. The correlation between vulnerability and inundation depth in the two zones is shown in Fig. 12, with an R^2 lower than impact pressure ($R^2=0.30$ for Zone (II) and $R^2=0.41$ for Zone (III)). Building vulnerability increases with increasing hazard intensity, and the trend is similar in the two zones. For the same impact pressure and inundation depth, the damage to buildings in Zone (II) is greater than that in Zone (III). The threshold of the impact pressure in Zone (II) and Zone (III) where vulnerability is equal to 1 is 88 kPa and 106 kPa, respectively, which is much greater than that of the three functions.

Figure11 Proposed vulnerability functions based on the impact pressure in Zone (II) and Zone (III).

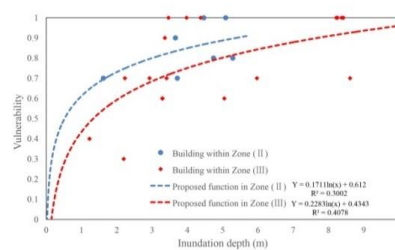
Figure12 Proposed vulnerability functions based on the inundation depth in Zone (II) and Zone (III).

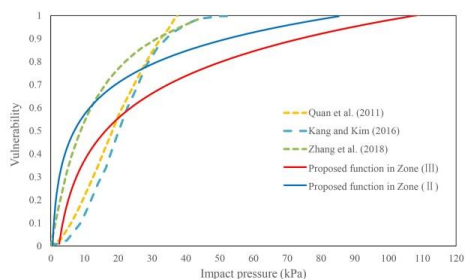
419 The vulnerability curves proposed for Zone (II) and Zone (III) were compared to the three
420 functions used in debris flow risk assessment (Fig.13, Fig.14). The functions developed by [Quan](#)
421 [et al. \(2011\)](#) and [Kang et al. \(2016\)](#) were calculated based on damage done to brick masonry and
422 nonreinforced concrete structures that had been impacted by the debris flows in South Korea and
423 Italy, respectively. The vulnerability curve proposed by [Zhang et al. \(2018\)](#) was developed for
424 buildings with brick-concrete structures from the Zhouqu debris flow event in China. The slope
425 of the two proposed vulnerability curves based on impact pressure is smaller than those of the
426 three curves. When the impact pressure is less than 20 kPa, the proposed curves show a similar
427 increasing trend compared to the three functions. However, when the impact pressure is greater

428 than 20 kPa, the slope of the two proposed vulnerability curves is much smaller than those of the
429 three curves. For the curves based on inundation depth, when the depth is less than 2 m, the slope
430 is steeper than that of [Quan et al. \(2011\)](#) and [Zhang et al. \(2018\)](#) and slower than that of [Kang et](#)
431 [al. \(2016\)](#). When the depth is greater than 2 m, the damage increases slower than the curves of
432 [Quan et al. \(2011\)](#) and [Zhang et al. \(2018\)](#). This disparity may be attributed to the different
433 damage patterns and structures of the buildings in this study. The three vulnerability functions
434 were generated for a single debris flow event, whereas the mechanisms by which buildings
435 impacted by floods fail is not the same when those buildings are subjected to a debris flow. The
436 structures of most buildings in the study area are tougher than those in the three events, and

437 nearly half of the buildings had been recently built by a more professional construction team. For
438 example, the newly built four buildings 6, 9, 10, and 15 were not completely damaged by hazard
439 chain under impact pressures greater than 40 kPa.

Figure 13 Comparison of the building vulnerability functions with the impact pressure functions proposed by [Quan et al. \(2011\)](#), [Kang et al. \(2016\)](#), and [Zhang et al. \(2018\)](#).

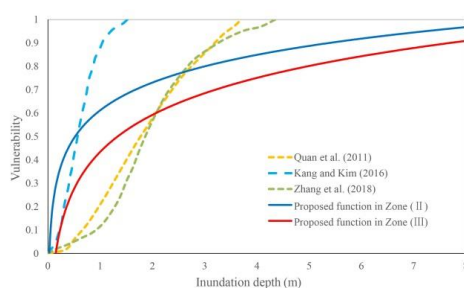
Figure 14 Comparison of the building vulnerability functions with the inundation depth proposed by [Quan et al. \(2011\)](#), [Kang et al. \(2016\)](#), and [Zhang et al. \(2018\)](#).

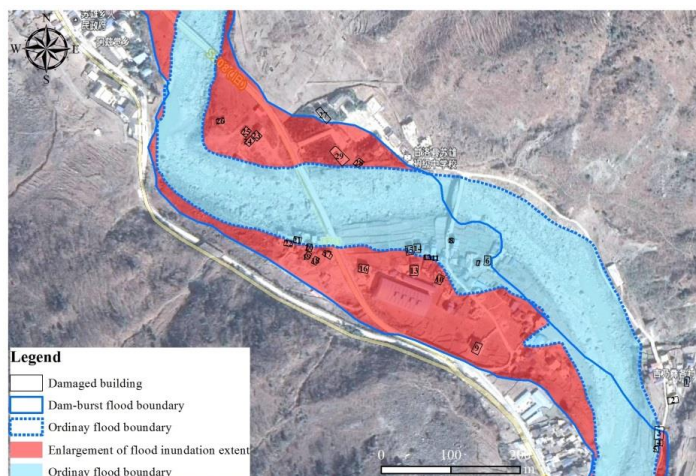
474 As a result of the confluence zone's location on a river bend, the dam-burst flood typically
475 flows in a straight direction and creates a new straight channel when the river channel becomes
476 completely blocked. This channel translocation leads to a larger flooded area and causes more
477 severe damage to buildings on the floodplain. The flood inundation zones in the village expanded
478 to 110^5 m², which is up to 4 times the area of an ordinary flood due to flood amplification (Fig.
479 16). In the expanded inundation zone, 41 buildings, a traffic road spanning 410 m, and farmland
480 with an area of 10×10^4 m² were submerged. The buildings located in the middle of the inundation
481 zones suffered the most severe damage due to the floodwater's high scouring capability and
482 sediment transport capacity. Many buildings near the flow collapsed, and most structures were
483 carried away by the water current.

Figure 16 The inundation extent of ordinary floods and dam-burst floods.
