Shaking table tests on strengthening of masonry structures against earthquake hazard

Abstract. Turkey and neighborhood countries like Greece and Iran are situated on an active earthquake region. Masonry type structures are very common on these countries, especially on the rural areas. During the last earthquakes, several masonry type houses were collapsed, causing loss of life and property. Strengthening methods of masonry houses were discussed in this study. The paper summarizes the results of a experimental programme carried out on models, scaled 1/10, of one-storey masonry buildings. First specimen tested was the reference specimen and used for comparison purposes. Other specimens contained several strengthening strategies. A total of 9 specimens were tested. The results allow to assess the efficiency of the various strengthening techniques employed.

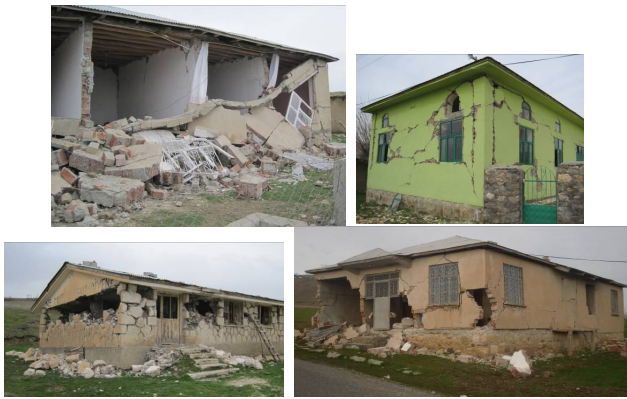
Fig. 1. Several failure of masonry houses observed after Elazig earthquake (2010).

ship and 18 people were killed and 25 people were injured, 1000 building affected from the earthquake (Bayraktar et al., 2007). Recently, a 6.0 magnitude earthquake has struck the eastern province of Elazig in Turkey on 8 March 2010. This is the most seismically hazardous zone according to the seismic classification criteria adopted for Turkey (Gulkan et al., 1993). The area is sparsely populated, with most dwellings having one or two stories constructed from masonry without timber reinforcement or adobe and brick (Sandikkaya et al., 2010). In Fig. 1, several damaged masonry houses were illustrated in Elazig Earthquake.

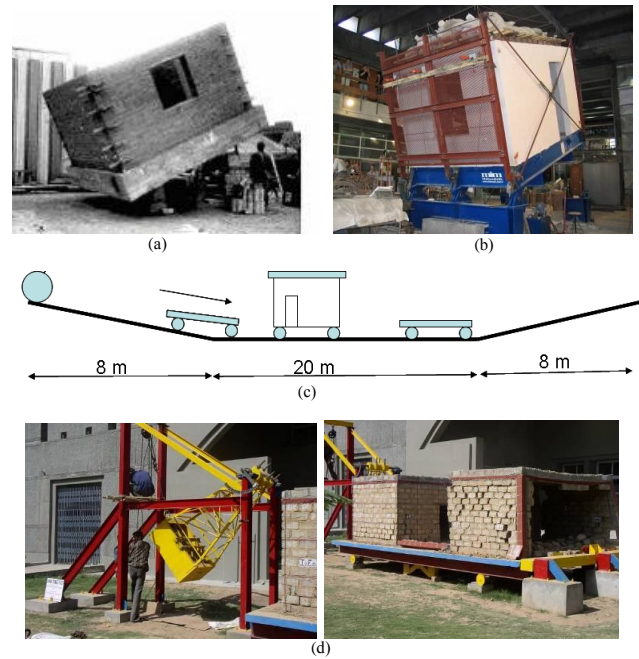
Fig. 2. Different masonry testing setups. (a) Tilting test setup (Zagarra, 2000). (b) Tilting test setup (Turer, 2004). (c) Roorke shock table (Keightley, 1986). (d) Pendulum and vibration table (source: Jagadish, 2002).

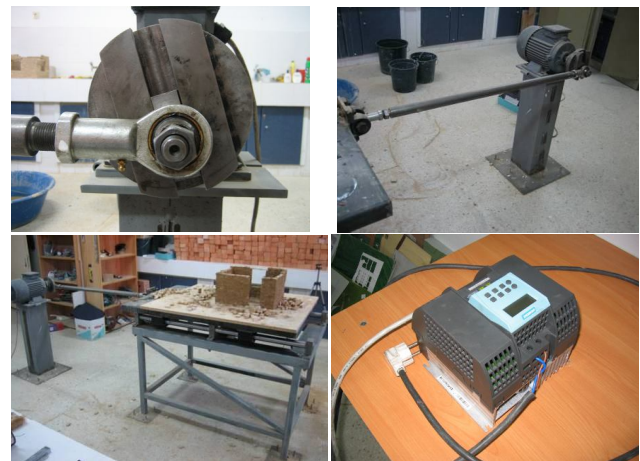
Fig. 3. Custom made shaking table test setup.

celerations. The setup consisted of a platform that can move in only forward and backward directions. The movement of the platform was driven by an electric motor and frequency control mechanism. The illustration of the mechanical system is shown in Fig. 3.

The frequency of the rotation and also platform motion can be adjusted by an AC motor controller. The stroke length of the shaking platform can be modified mechanically as the long bar connection location on the rotational disk is moved close or away from the disk centroid when the platform is

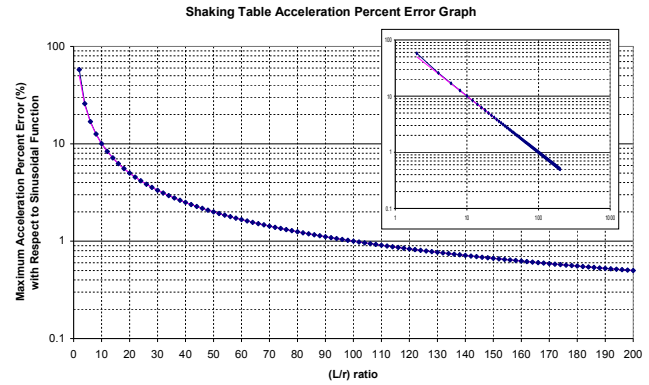
Fig. 5. Shaking table maximum acceleration error change as a function of L/r ratio.

The shaking table used in this study has an L/r ratio equal to 80 which generates close-to-sinusoidal waves with maximum error of 1.25%. The amplitude of the accelerations generated by the shaking table setup is a function of rotary disk radius (r) and square of rotation frequency (w^2) as seen in Eq. (3). The level of acceleration can only be increased by changing rotation speed or rotation frequency (w) since rotary disk radius (r) cannot be changed during testing. The natural vibration frequencies of the 1/10 scale test specimens are much higher than the testing frequency range of the shaking table; therefore, amplification errors due to resonance condition is not an issue. The levels of acceleration that cause failure of the test specimens are determined by using Eq. (3). The accelerations for the failure level of loading should also be corrected for their equivalent accelerations if the tests were conducted in full scale. The correction factor for a 1/N scale model can be calculated considering the stiffness, mass, and acceleration changes in a 1/N scale test. The lateral stiffness term of a 1/N scale model would

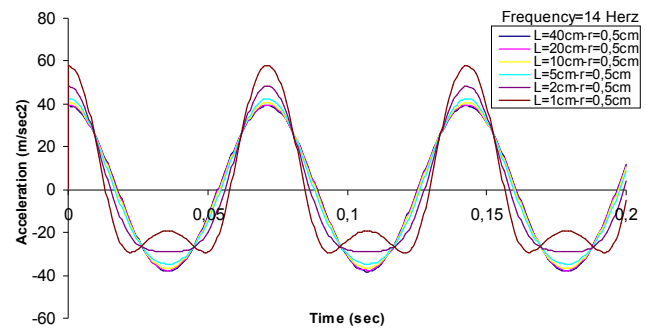
Fig. 7. Acceleration versus time graph of the platform for frequency 14 Hz.

During the testing a constant amplitude sinusoidal displacement was applied. Maximum velocity and acceleration were linear functions of w and w^2 . The frequency of the motion was started from low frequencies and increased with time. As the frequency of the motion was increased, also acceleration of the table was increased remembering the amplitude of the motion was constant during the testing. The failure instant and frequency of the failure was noted. The rate of increase is tried to be kept constant for all tests. The frequencies causing failure are noted for each test. The failure modes of the specimens were captured by three cameras located at the three corners of the laboratory. The acceleration versus time graphs of the platform was given in Fig. 7 for different L/r ratios.

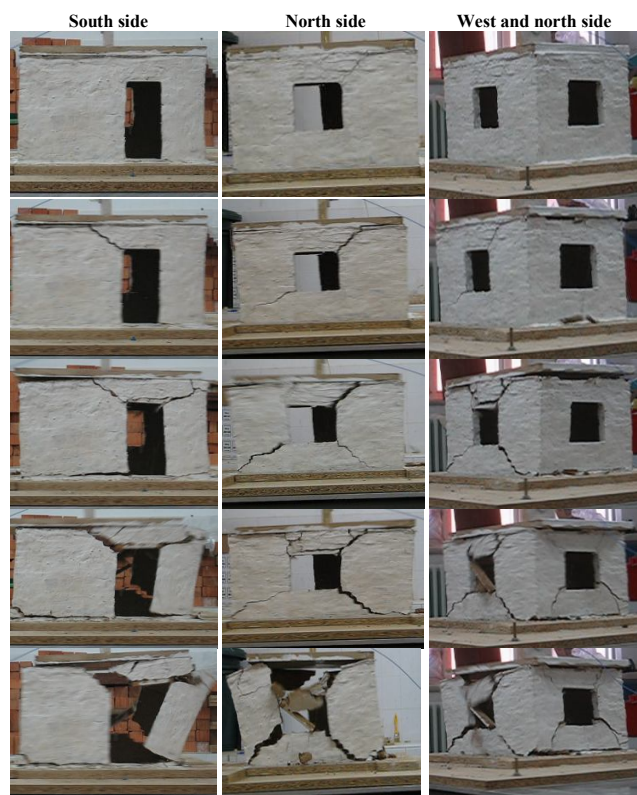
Fig. 8. Failure sequence of specimen Ref.

The first cracks were initiated diagonally above the North window and also above the door of the model. New diagonal cracks were formed perpendicular to the previous ones as the direction of the movements was reversed. This diagonal crack extended up to the bottom of the structure. As the frequency of the motion was increased, similar X type cracks were observed on the West window and previous cracks were widened. After that, a portion of the wall above the North window and door was separated and fell down. A horizontal shear crack was propagated above the door. After so much damage, stability of the structure was disturbed and a sudden and total collapse of the roof took place. Total collapse of the model was observed at the end of the test and classified as a brittle and sudden failure. The failure acceleration of this reference specimen was taken as 1. The failure sequence of the specimen was depicted in Fig. 8.

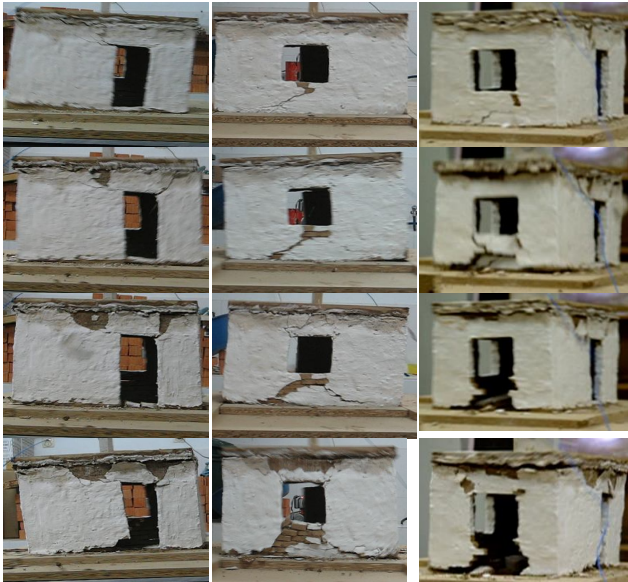
Fig. 10. Failure sequence of specimen CF1.

Testing of specimen CF1 was recorded with three cameras. Strips, simulating the CFRP, changed the damage and cracking modes of the specimen. First cracks were observed below the window openings (Fig. 10). These initial cracks could not propagate further and X type cracks could not form

due to polymer application. Instead, wall portions under the window openings were cracked like reversed V shape. More cracks were observed comparing the reference specimen and distributed over a larger area. The testing was stopped since the width of the cracks was widened and stability of the structure was lost. At the end of the test, specimen survived 2.5 times higher acceleration than the failure acceleration of the reference specimen.

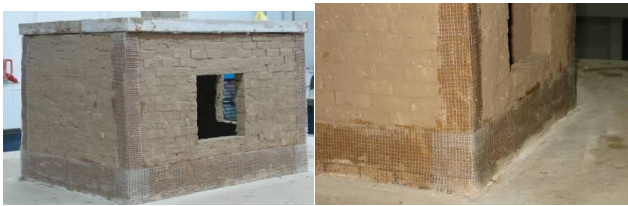
Fig. 11. Specimen CF2.

In specimen CF2, strips above the openings were removed and a horizontal strip was applied just above the ground level of the structure. The corners were also strengthened like CF1 (Fig. 11). The failure sequence of the test was depicted in Fig. 12. Initial cracks were observed above the openings like reference specimen Ref. X type cracks were formed but limited and could not reached to the foundation level. Oppositely, these cracks were extended parallel to the ground. This specimen was collapsed when the acceleration level was 2 times the reference specimens failure acceleration.

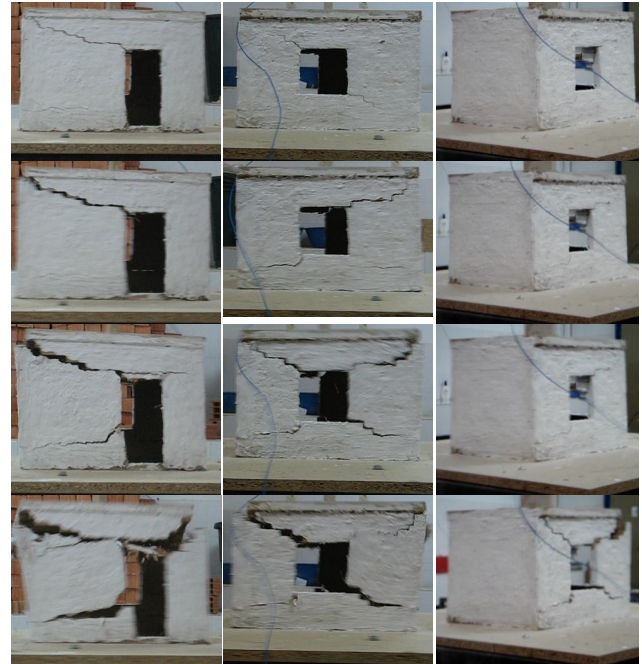
Fig. 12. Failure of specimen CF2.

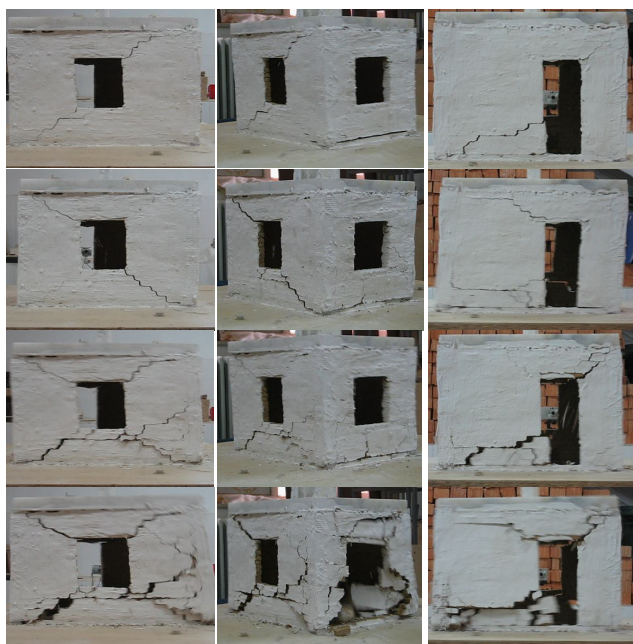
Fig. 14. Failure sequence of specimen CF3.

After obtaining satisfactory results in specimens CF1 and CF2, in specimen CF3, only corner of the structure was covered with strengthening material. In this manner, more economic application was maintained (Fig. 13). Initial cracks were formed in the corners of the openings and X type cracks were formed. Also horizontal shear crack parallel to the ground was formed. Comparing with the reference specimen, more cracks were formed and distributed on a larger wall area. The wall, which was loaded in the out of plane direction, was failed and the test was stopped. This specimen could withstand 1.5 times acceleration according to the reference specimen. In Fig. 14, failure and damage mode of the specimen was given.

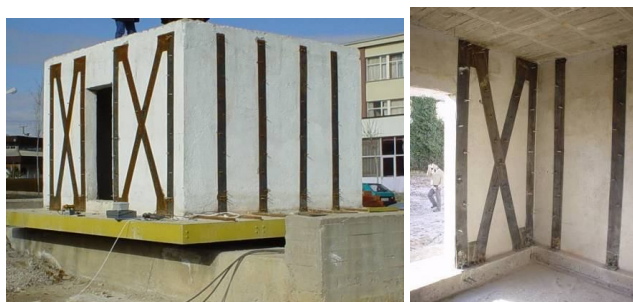
Fig. 15. Outer and inner steel strips (Altin, 2005, 2008).

Altin et al. (2005), studied 1/1 scale ordinary masonry house on the shaking table (Fig. 15). They applied a thin (5 mm in thickness) steel strip on the inner and outer surfaces of the

walls. Inner and outer steel strips were connected through the wall section with several rivets. The width of the steel plates were 150 mm. At the end of the test, they obtained satisfactory results and stated that this method is effective for strengthening of masonry structures. The specimen SwSP was strengthened with this idea. In order to represent steel plates, very thin steel plates were found and cut to obtain strips. Strips were placed vertically on the walls. Four strips were placed on the long walls and three strips were placed on the short walls (Fig. 16).

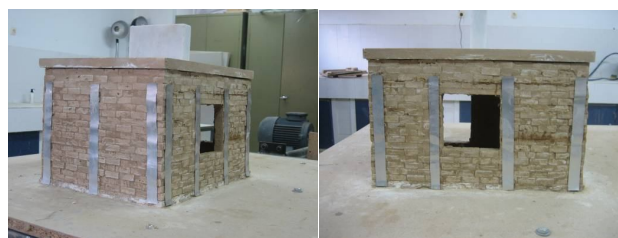
Fig. 16. Steel plate application for model house.

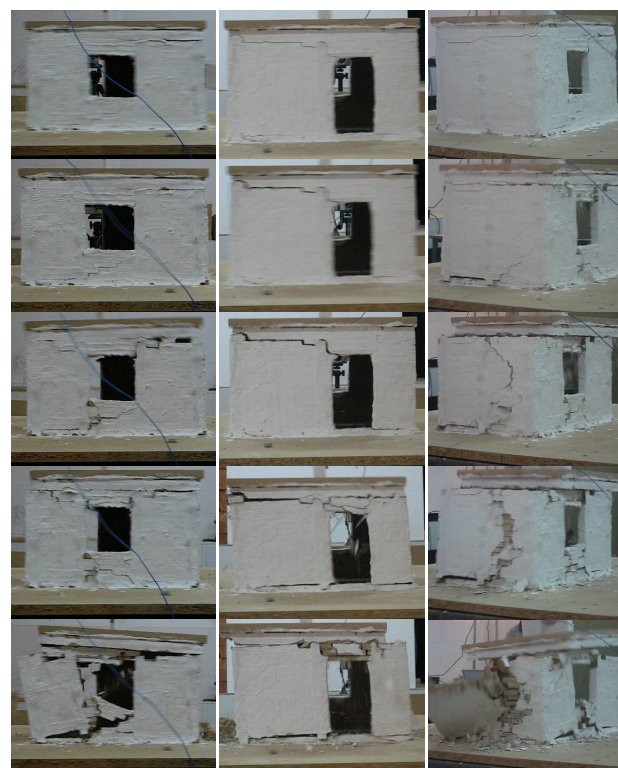
Fig. 17. Failure sequence of specimen SwSP.

After attaching the steel plates, thin plaster was applied over the wall surfaces. The first crack formed above the door corner and could not reached to the roof level diagonally due to steel strip (Fig. 17). Rather, this crack extended horizontally and reached to the corner of the structure. Similar condition was valid for the cracks formed on the corner of the window. Damage was concentrated above and below the window openings and X type cracks could not form. At

the end of the test, roof was separated from the structure and experiment was stopped. The maximum acceleration applied to this specimen was 1.4 times higher than the failure acceleration of the reference specimen.

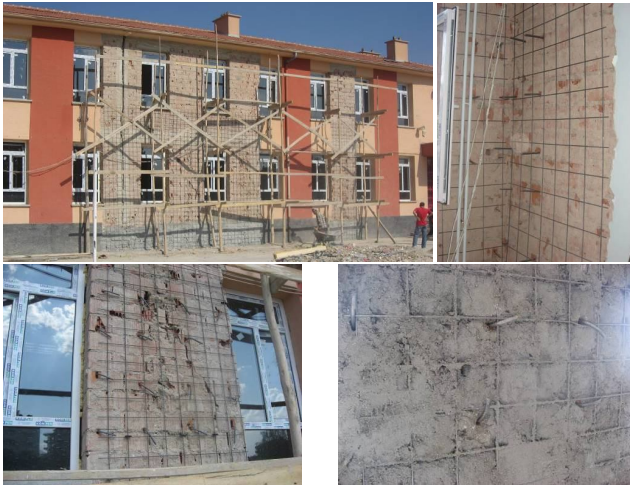
Fig. 18. Welded wire mesh application on a masonry school building.

The third method used was the mesh reinforcement and plaster application over the masonry walls. This method is commonly used by many contractors and specialist to improve the seismic behavior of masonry structures. In Fig. 18 an application case in a school building was given. The mesh reinforcement was applied over the surface of the wall and several holes were drilled to fix the anchorages through the existing walls. Cement based plaster was applied over the mesh. Same method was also used for adobe structures after the Aksehir Earthquake in 2002 (Fig. 19).

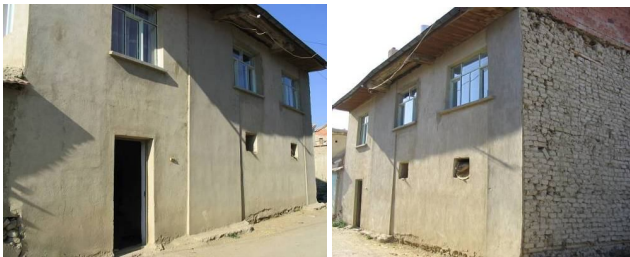
Fig. 19. Welded wire mesh application on adobe structure.

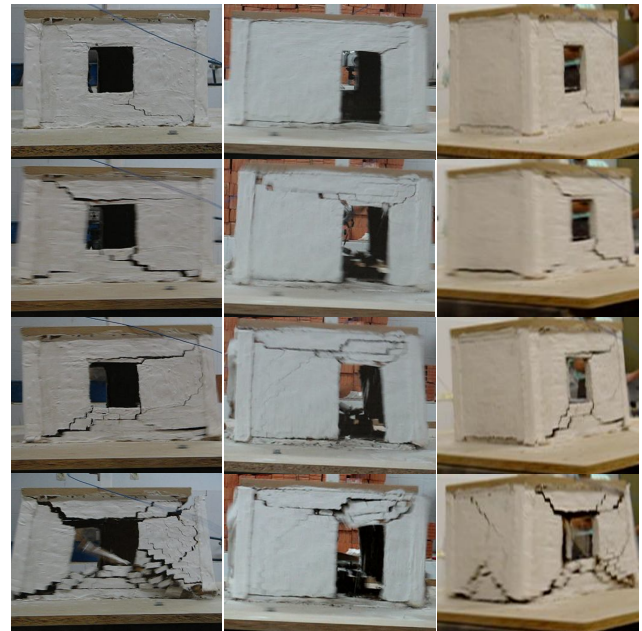
Fig. 21. Damage conditions of specimen SM.

Specimen SM was tested execution starting from low frequencies and applied acceleration was increased up to the failure. First diagonal cracks were observed on the corners of the openings and X type cracks were formed. Due to strengthening application, corner disintegration did not formed. The cracks are rather horizontal at the bottom and at the top of the openings. Failure acceleration of this specimen was 1.7 times higher than the reference specimen. Failure condition of the specimens was illustrated in Fig. 21.

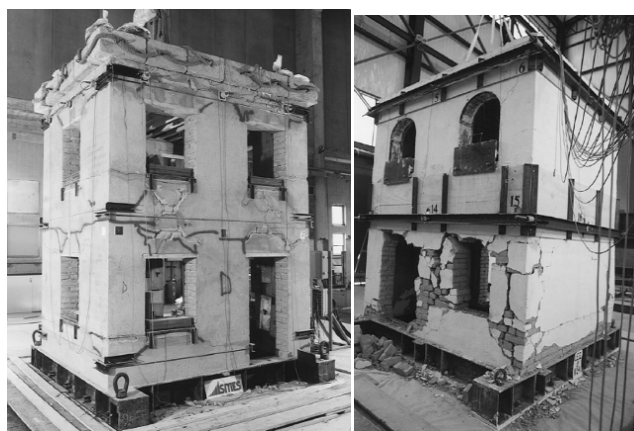
Fig. 22. Post tensioning application on masonry specimens by Benedetti et al. (1998).

separations. For this purpose, horizontal post tensioning was applied on the specimen P1. Benedetti et al. (1998) tested 2 storey model houses on the shaking table setup (Fig. 22).

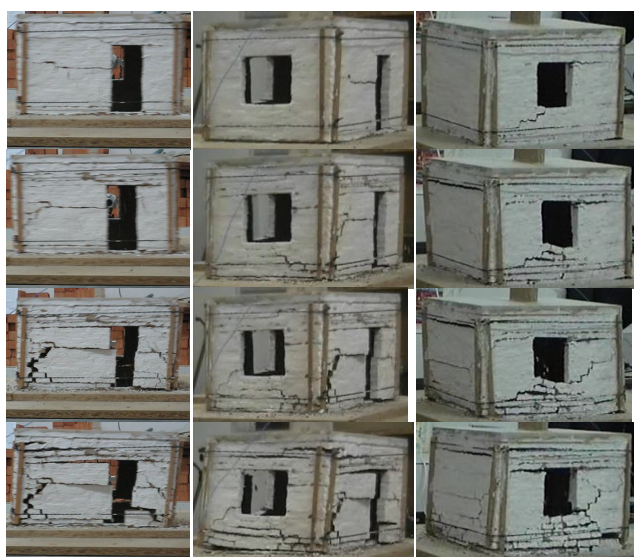
Fig. 23. Failure of specimen P1.

In order to apply horizontal post tensioning and to distribute the stress over the wall, wooden logs were used on the corners of the structure. The cost of the wooden logs in real application is not expensive. Steel rods were used to apply tension forces on the structure. The structure was wrapped at the roof and foundation levels. At this point door of the structure created problem from architectural point of view. The failure condition of the specimen was given in Fig. 23. Diagonal cracks replaced with horizontal shear cracks. Comparing with the reference specimen, more and distributed cracks can be pronounced. This specimen exposed 1.8 times higher acceleration than reference specimen. The behavior of the specimen was more ductile than the reference specimen. Horizontal ties are very efficient in preventing collapse due to the separation of walls. Such devices were accomplished by steel ties, steel beams and RC bands. It was found that the best effects are achieved by an appropriate distribution of the retaining forces due to horizontal ties (Benedetti et al., 1998).

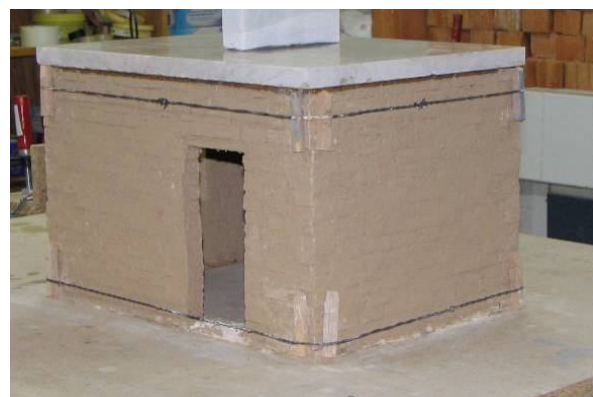
Fig. 24. Specimen P2 and horizontal post tensioning application.

Specimen P2 was identical to P1. After obtaining satisfactory results in specimen P1, wooden logs were replaced with shorter wooden pieces (Fig. 24). The post tensioning was applied at the same positions. Similarly horizontal cracks observed just above the openings. At the end of the test, rigid body motion of the roof limited the capacity of the specimen. The failure of the specimen was given in Fig. 25. The maximum acceleration reached at this specimen was less than the acceleration of P1 and 1.7 times higher than the that of reference specimen.

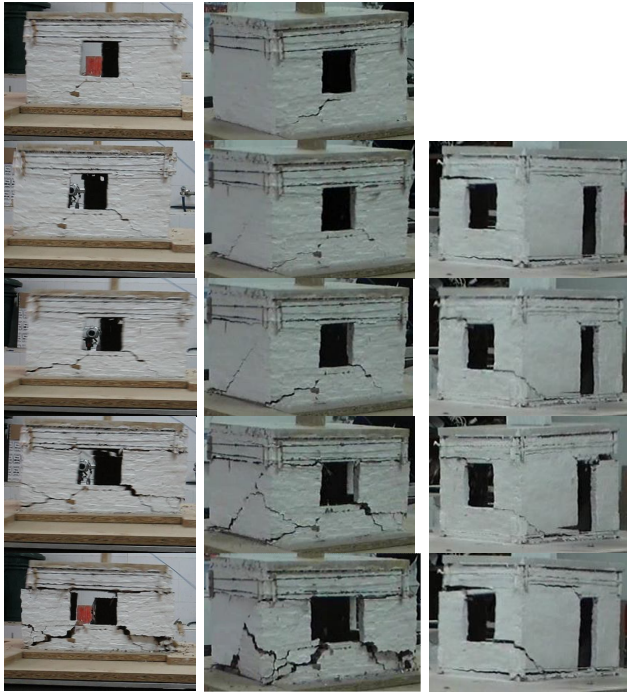
Fig. 26. Failure sequence of specimen P3.

The post tensioning just above the foundation level was architecturally very difficult due to door entrance. In specimen P3, horizontal wrapping was applied only at the roof level. The structure was wrapped by steel rods and a box type behavior was obtained. The crack patterns of this specimen were different than P1. Initially diagonal cracks were formed

and reached to the ground level. But corner failure was delayed due to horizontal rods and horizontal shear cracks were observed just below the window openings (Fig. 26). At the last stages of the failure, secondary horizontal cracks above the openings and corner failure near to the ground was observed. The specimen survived 1.5 times higher acceleration than reference specimen Ref.

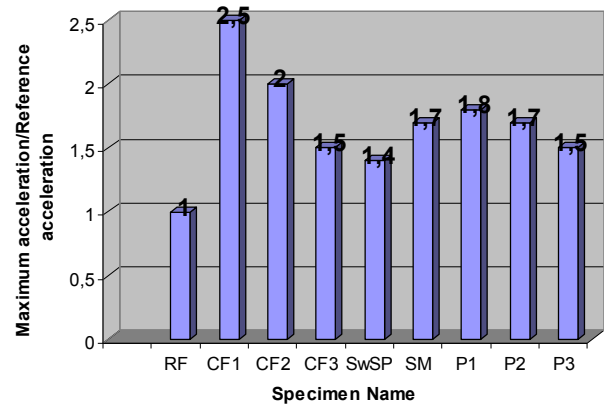
Fig. 27. Comparison of test results.

In this study, seismic performance improvement methods of masonry structures were evaluated experimentally. The performance of 1/10 scale shaking table tests were compared against each other. Failure accelerations were given in reference to the original un-strengthened specimen Ref. The comparison of applied final accelerations in terms of reference specimens acceleration was presented in Fig. 27.

This application increased the failure acceleration approximately 150%. CF1 survived 2.5 higher accelerations than the reference specimen Ref. The amount of strength improvement remained at about 100% for the test specimen with only vertical strips at the corners and horizontal cover below the openings. Relatively inferior strength enhancement was achieved by application of only vertical coverage at the corners (CF3) with a total failure acceleration improvement of 50%. The width of the CFRP strips were taken as constant. In future study, the width can be taken as a parameter of the study but not included in the current paper.
