The Konya earthquakes of 10–11 September 2009 and soil conditions in Konya, Central Anatolia, Turkey

R. Aksoy¹ and A. Demiröz²

Abstract. Earthquakes registering magnitudes $M_d = 4.5$ and 4.7 struck the city of Konya, Central Anatolia, on 10–11 September 2009, causing very slight damages. The earthquake epicenters were located at the east of Sille District along the Konya Fault Zone, a dip-slip fault. The nature and seismicity of the fault zone indicates that it is capable of producing earthquakes of moderate magnitudes. This paper summarizes the geologic data along the fault zone and documents groundwater conditions and analyzes borehole and geotechnical data of the Konya city. The residential area of the city covers an area of approximately 1150 square kilometers and consists almost entirely of flat land except for a small part of rugged land in the southwestern corner. Groundwater and geotechnical data were collected and analyzed to evaluate the liquefaction potential of deposits under the Konya city. This preliminary investigation indicates that areas for liquefaction are generally limited to the eastern and east central parts of the city.

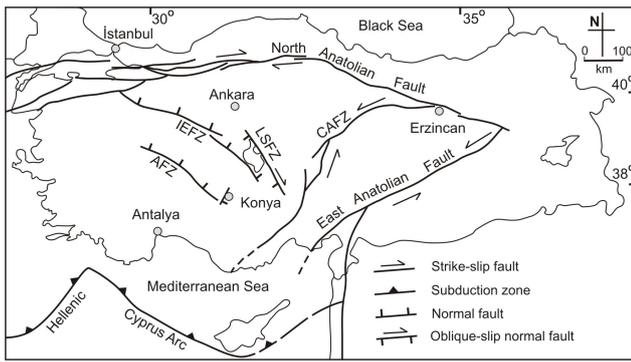
Fig. 1. Major neotectonic structure of Turkey and location of the study area (simplified after Koçyiğit and Özacar, 2003). AFZ, Akşehir Fault Zone; CAFZ, Central Anatolian Fault Zone; IEFZ, İnönü-Eskişehir Fault Zone; LSFZ, Lake Salt Fault Zone.

The study area is located in Central Anatolia (Fig. 1). The neotectonic regime of Central Anatolia is known as the “Ova Regime” (Şengör, 1980) and “Central Anatolian neotectonic regime” (Koçyiğit et al., 2000). The extensional tectonic regime is currently active in the region (Şengör, 1980; Koçyiğit, 1984; Toprak and Göncüoğlu, 1993; Koçyiğit and Beyhan, 1998; Koçyiğit et al., 2000; Koçyiğit and Özacar, 2003). In the vicinity of Konya, late Miocene-early Pliocene extensional tectonic regime-generated faults are widespread. One of these faults is the normal slip Konya Fault Zone (Koçyiğit, 1984; Özcan et al., 1990; Aksoy and Eren, 2004).

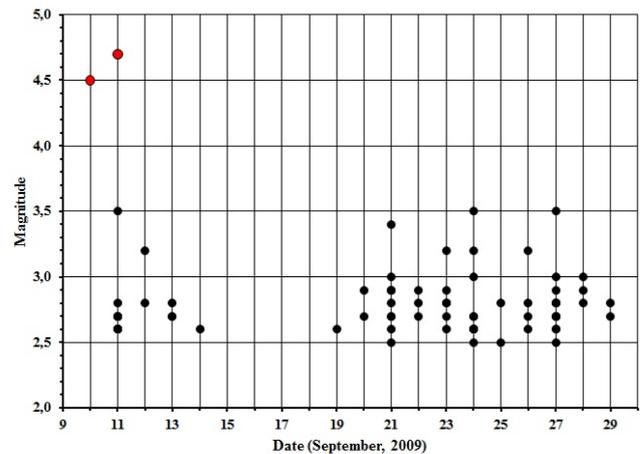
Fig. 2. History of the main shocks and aftershocks with magnitudes greater than or equal to 2.5 occurring between 9–30 September 2009 (data from Koeri, <http://www.koeri.boun.edu.tr>).

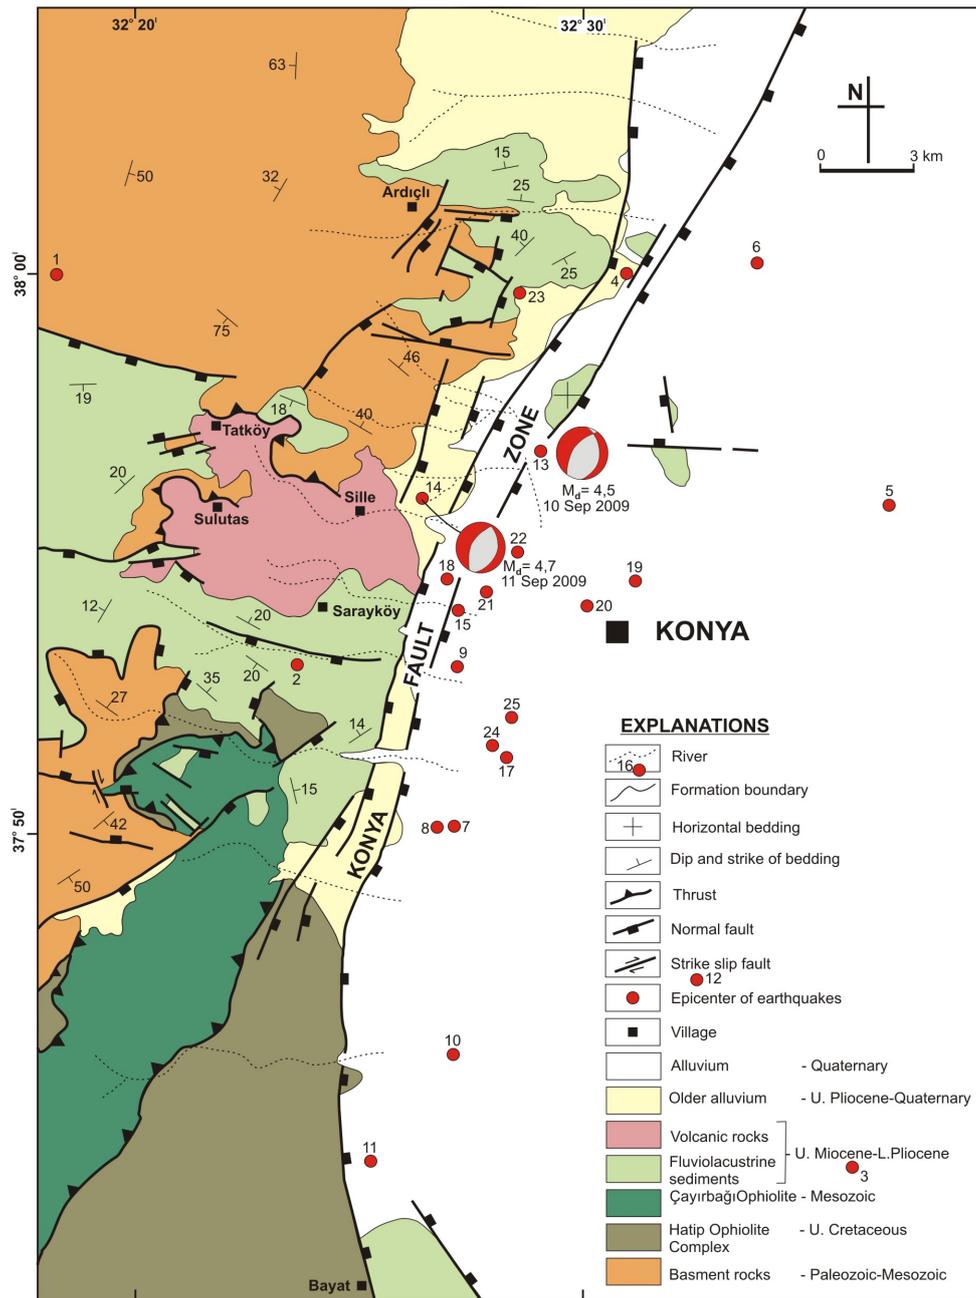
Fig. 3. Geologic map of the Konya Fault Zone (modified from Aksoy and Eren, 2004; with added new data). Map shows fault plane solution of two earthquakes (data from Italian INGV). Numbers 1 through 25 indicate epicenters of earthquakes.

The study area located in Central Anatolia lies on the northern margin of the Menderes-Tauride platform (Şengör, 1984). Geologic features in the region were mapped during the previous studies by Wiesner (1968), Göğçer and Kırıl (1969), Özcan et al. (1988, 1990) and Eren (1993). Rock units near the Konya Fault Zone were mapped in detail in this study (Fig. 3).

The upper Miocene-lower Pliocene fluviolacustrine sediments, volcanoclastics and volcanic rocks unconformably cover all the older units. During this time these sedimentary and volcanic rocks covered large areas in western Konya (Fig. 3). That was also the time of initiation of extensional tectonic regime in Central Anatolia (Şengör, 1980; Koçyiğit, 1984; Toprak and Gönçüoğlu, 1993; Koçyiğit and Beyhan,

The Konya fault zone comprises a set of northeast trending subparallel breaks along the eastern front of the foothills bordering the west side of the Konya plain. It extends for nearly 65 km from Hatunsaray south to its northern termination north of Konya city (Fig. 3), and may extend in either direction beyond these limits. It has been delineated by Koçyiğit (1984), Özcan et al. (1990) and Koçyiğit et al. (2000) and well described by Aksoy and Eren (2004). Fault geometry and complexity changes towards the south. These changes include a gradual 35° bend to the south from about N 15° E along the northeastern section to N–S in the central section and N 20° W in the southern section. It consists of a 5 km wide, rather long, eastwardly facing step-like normal faults. Movement along the fault zone is predominantly dip-slip, with a minor dextral strike-slip component. In addition, thrusting of east side over the west side was observed in a road-cut exposure at the southwestern part of the chromium magnesite facility. In the footwall area, the upper Miocene-lower Pliocene fluviolacustrine sediments have been faulted, uplifted and tilted as fault terraces lying at different elevations up to 520 m above the present day elevation (1040 m) of the Konya alluvial plain in the hanging wall of the fault zone (Fig. 3). A well drilled by Konya Water and Sewerage Administration through the Quaternary alluvium in the hanging wall of the Konya fault zone did not encounter the bottom of the same unit at depth of 765 m below the present-day elevation of the Konya depression (H. Kahveci, personal communication, 2010). This suggests that the vertical throw on the fault zone is about 1285 m. Aksoy and Eren (2004) determined a minimum slip rate of 0.25–0.6 mm yr⁻¹ based on correlating offset fluviolacustrine sediments since the late Miocene.

is shown in Fig. 3 and Table 1. During this period, 25 seismic events $M \geq 3$ occurred in the area. It is evident from this figure that earthquake epicenters are concentrated along the Konya fault zone. Beside this, all these seismic events are shallow-focus earthquakes.

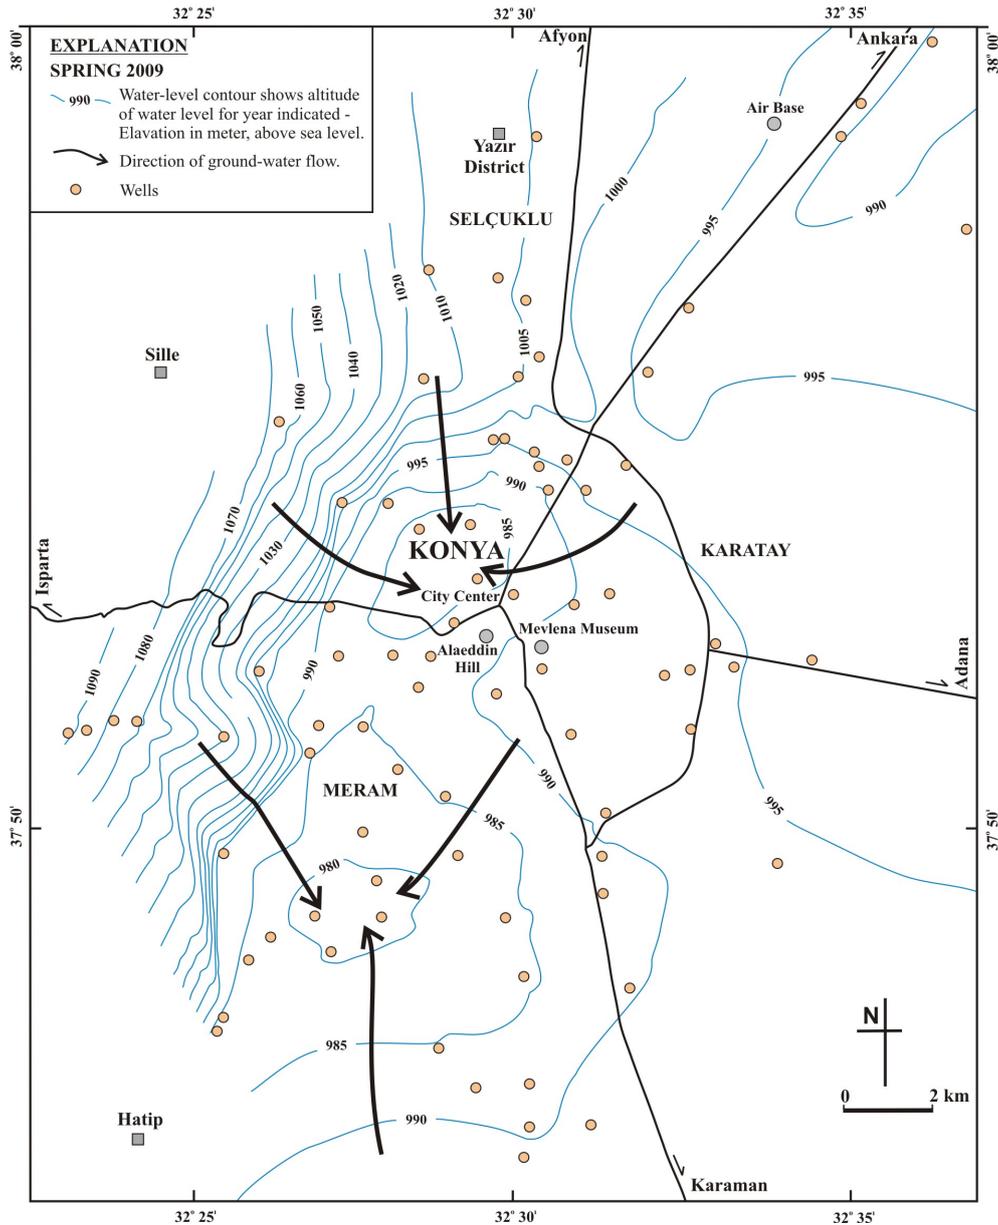
Fig. 4. Ground water table map of the Konya sub-basin (modified from Bulduk, 2009).

Groundwater elevations for spring 2009 were contoured (Bulduk, 2009). This map delineates that the groundwater typically flows in the general direction of ground surface topography, from west to east towards the interior of the Konya subbasin (Fig. 4). The largest source of discharge from the groundwater flow system in the basin is pumpage. Pumpage has caused water-levels to decline year after year. The intense pumpage in some local areas has caused change in the direction of ground-water flow. Since about 1967, water levels have declined more than 30 m. Depth to water level was measured for 83 wells in this basin in 2009 and varies 40–50 m in the west to 3–10 m in the east central portion of the subbasin.

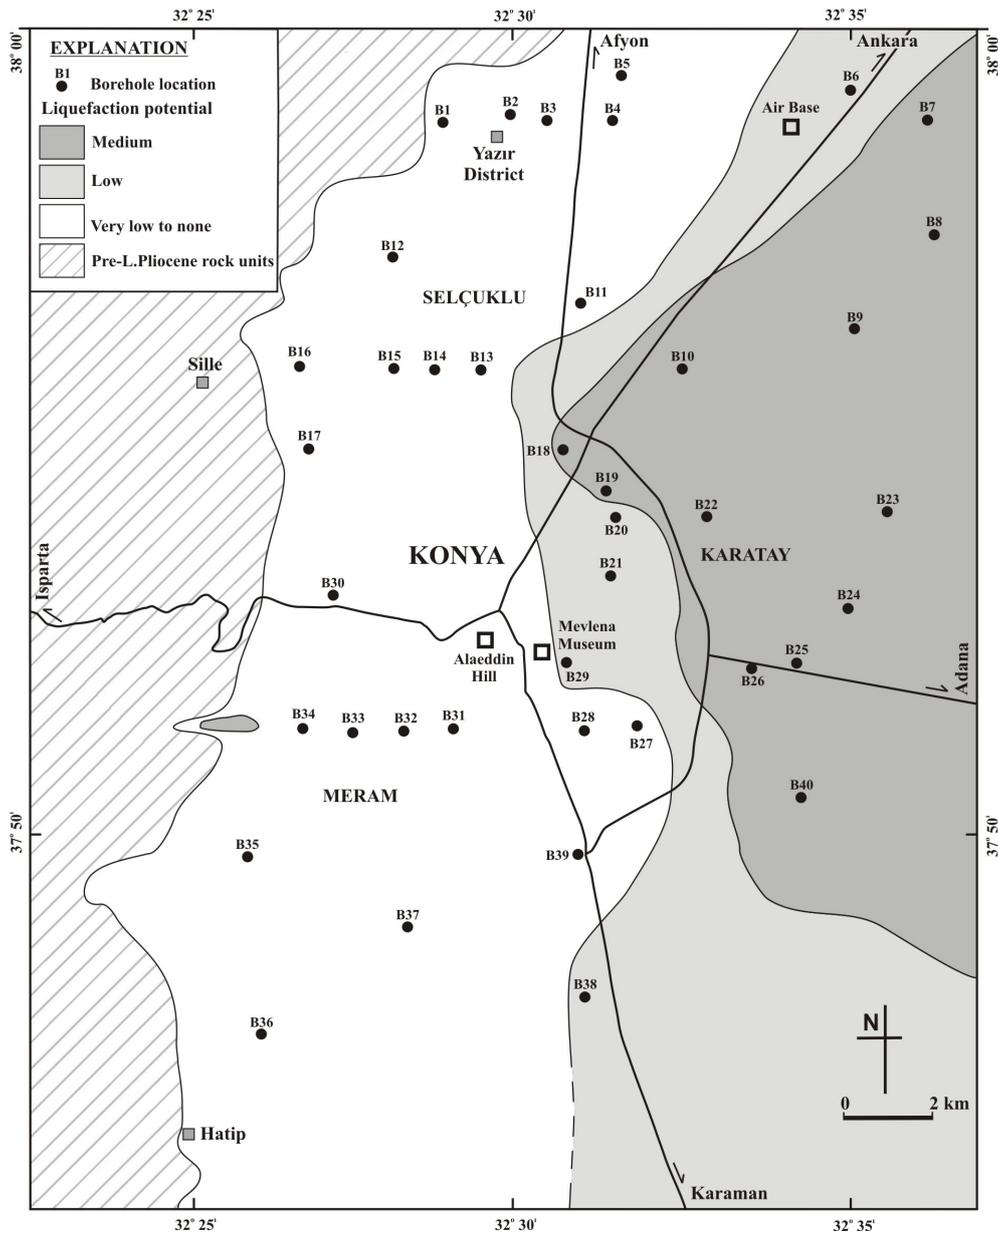
Fig. 5. Liquefaction potential map of the Konya city.

logic and engineering characteristics of sedimentary deposits in the Konya sub-basin. General geotechnical characteristics and liquefaction susceptibility of Quaternary sedimentary deposits in the Konya depression, acquired from borehole logs, are summarized in Table 2. A total of 40 borings were evaluated for liquefaction potential. The locations of drilled and collected geotechnical boreholes are shown on Fig. 5. The majority of the borings have low liquefaction potential. The consequences of liquefaction susceptibility based on SPT N-values, material type and ground water depth are evaluated to map the liquefaction potential areas (Fig. 5). Areas with very low and low liquefaction potential are located in

the west, central and southeastern parts of the city. Areas with moderate liquefaction potential are mainly located in the east and east central regions of the city (Fig. 5). A small area near the present stream channel of Meram-Dere may also be moderately susceptible to liquefaction because this area contains loose, recently deposited sediments and shallow groundwater. Liquefaction may occur in water-saturated
