# Seismic vulnerability of dwellings at Sete Cidades Volcano (S. Miguel Island, Azores)

A. Gomes, J. L. Gaspar, and G. Queiroz

Centro de Vulcanologia e Avaliação de Riscos Geológicos Universidade dos Açores, Rua Mãe de Deus, 9500-801 Ponta Delgada, Portugal

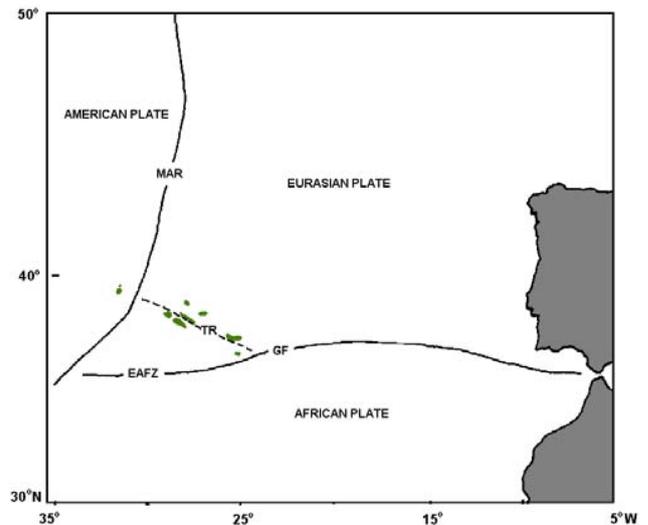
**Fig. 2.** Main tectonic structures in the Azores region. MAR – Mid-Atlantic Ridge; EAFZ – East Azores Fracture Zone; TR – Terceira Rift; GF – Gloria Fault (Gaspar et al., 1999)

The geological setting of the Azores region is dominated by the role of the American, Eurasian and African lithospheric plates fault boundaries (Searle, 1980). The most important tectonic structures recognised in the area are the Mid-Atlantic Ridge and the Terceira Rift (Fig. 2), that correspond to the main source of the seismic and volcanic activity registered in the region (Machado, 1959; Weston, 1964).

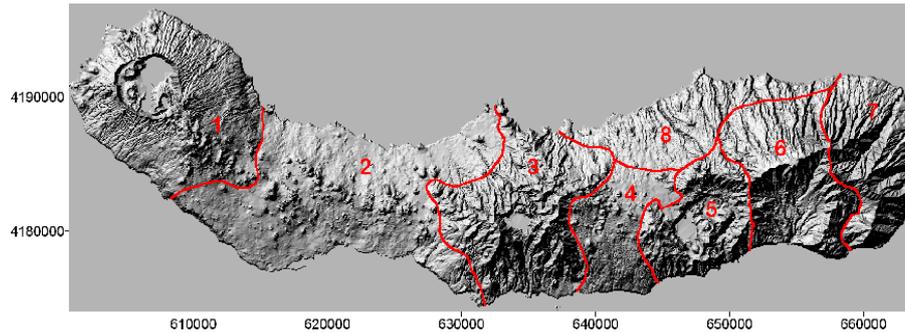
**Fig. 3.** Main morphological provinces of S. Miguel Island (Zbyszewski, 1961, Wallenstein, 1999): 1 – Sete Cidades Volcano; 2 – Picos Volcanic System; 3 – Fogo Volcano; 4 – Achada das Furnas Volcanic System; 5 – Furnas Volcano; 6 – Povoação Volcano; 7 – Nordeste Volcanic Complex; 8 – North Platform.

S. Miguel is the largest and most populated island of the Azores archipelago and is located in the eastern part of the Terceira Rift. The island is formed by several volcanic edifices placed along a general E-W direction (Fig. 3) and is crossed by NW-SE, NE-SW, WNW-ESE and E-W regional tectonic structures. Sete Cidades Volcano is an active central volcano with a summit caldera and is located in the westernmost part of S. Miguel, occupying an area of about 110 km<sup>2</sup> and representing 15% of the total area of the island and has as highest point the Pico das Éguas, located at SE of caldera hole, with 874 m.

Figure 5 shows the epicentre distribution of the best-located events in S. Miguel region for the last 20 years. It is clear that the central part of the island is the most seismically active, corresponding to the graben-like structure that extends between Fogo and Furnas volcanoes (Fig. 3). To the west, also the Sete Cidades volcano presents a significant level of seismic activity on land. All these main active central volcanoes and their related volcano-tectonic structures that extend into sea were the place of major earthquakes and seismic swarms in the past. Events occurring in any of these seismogenic zones can have an important impact in S. Miguel Island, namely in the Sete Cidades region, allowing to conclude that seismic hazard need to be considered during emergency planning and land use planning.

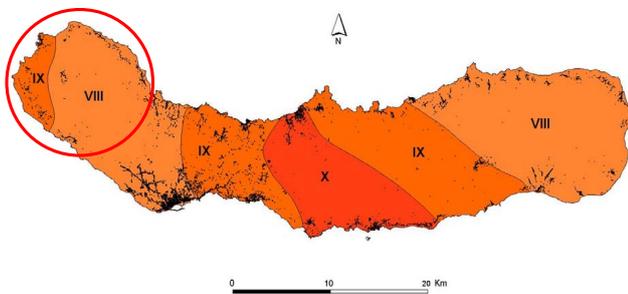
**Fig. 4.** Maximum historical seismic intensity map (EMS-98) of S. Miguel Island (Silveira et al., 2003). Legend: – study area.

volcanic origin also occurred on the island and in neighbouring submarine volcanic structures. Recent studies (Silveira et al., 2003) concluded that the maximum historical seismic intensity registered on the island was X (EMS-98), as result of the 1522 earthquake (Fig. 4).

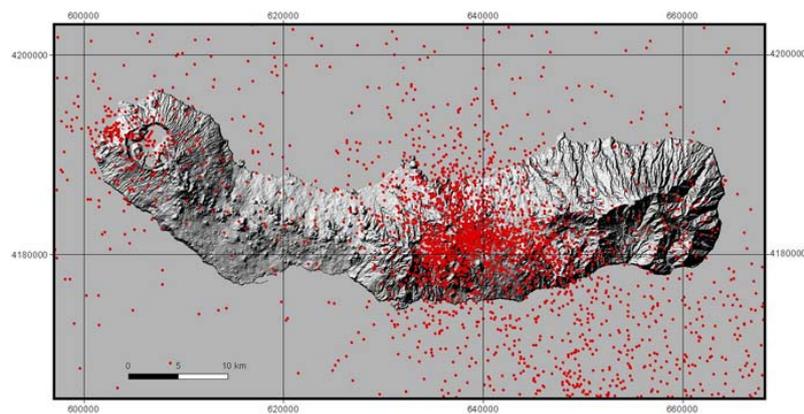
**Fig. 5.** Map of the seismic activity in S. Miguel Island in the last 20 years (data from SIVISA, 2004).

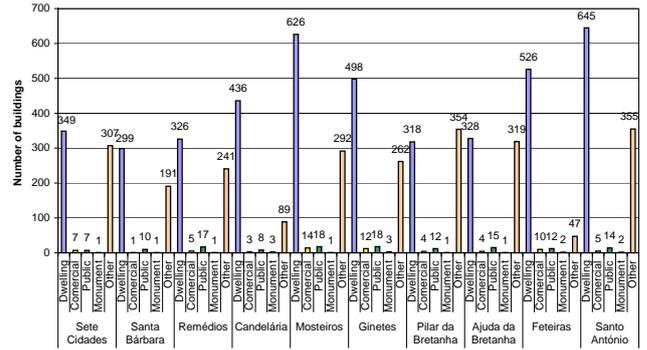
**Fig. 7.** Number of buildings by type of use in each parish (Gomes, 2003). Legend: A – Dwelling; B – Other; C – Commercial; D – Public; E – Monument.

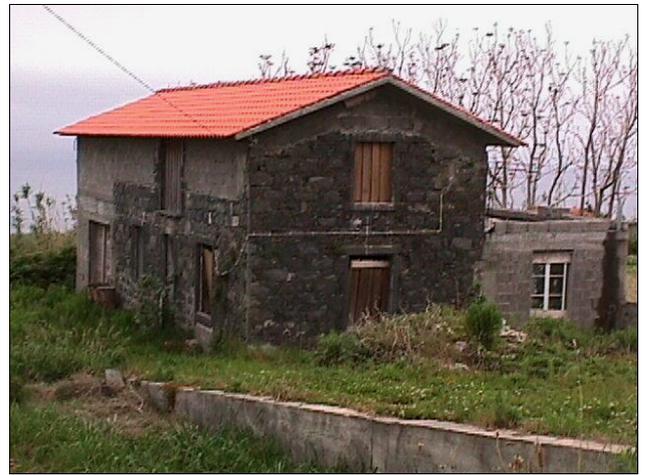
**Fig. 8.** Dwelling with external walls in stone and in concrete blocks.

however the majority of the recent houses are built with blocks of concrete mixed with fine volcanic materials, such as basaltic lava and scoria fragments. Another point that came up during the field survey was related to the observation that several old dwellings had suffered recent interventions, in most of the cases to increase the number of rooms or even floors. For example, it was detected that some dwellings have sections where the external walls are made from loose or weakly cemented stones, while other sections are built with concrete blocks (Figs. 8 and 9). Houses in these conditions were considered to be of class A, due to the different behaviour of the structure in response to a seismic solicitation.

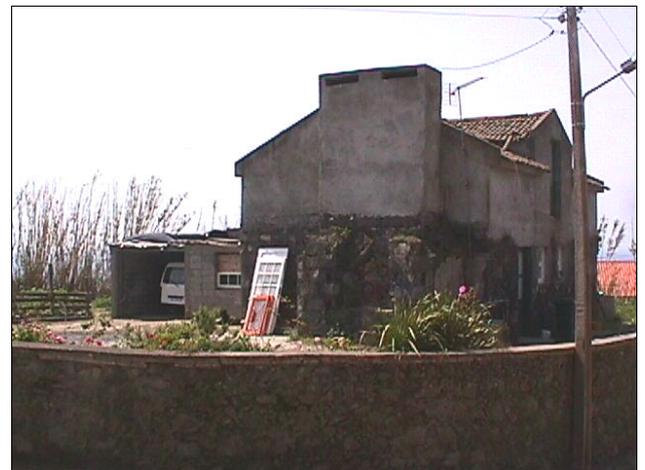
**Fig. 9.** Dwelling with external walls both in stone and in concrete blocks.
