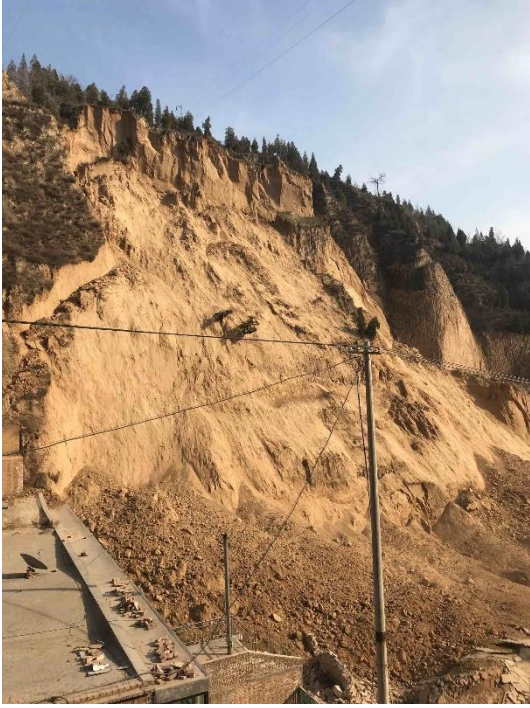
**Figure 1.** The cracking-sliding failure occurred in Shilou County of Shanxi Province on March 10, 2018 ( $110^{\circ}50'48.54''\text{E}$ ,  $36^{\circ}59'54.76''\text{N}$ ).

57 Shanxi Province on March 10, 2018, and destroyed 36 houses (Fig. 1). The original loess slope  
58 was characterized by slope gradient of 60°, height of 50 m and aspect of 280°. The scarp of this  
59 failure was dominated by near-vertical tensile cracks with average gradient of 85°. The displaced  
60 mass reached 7600 m<sup>3</sup>.

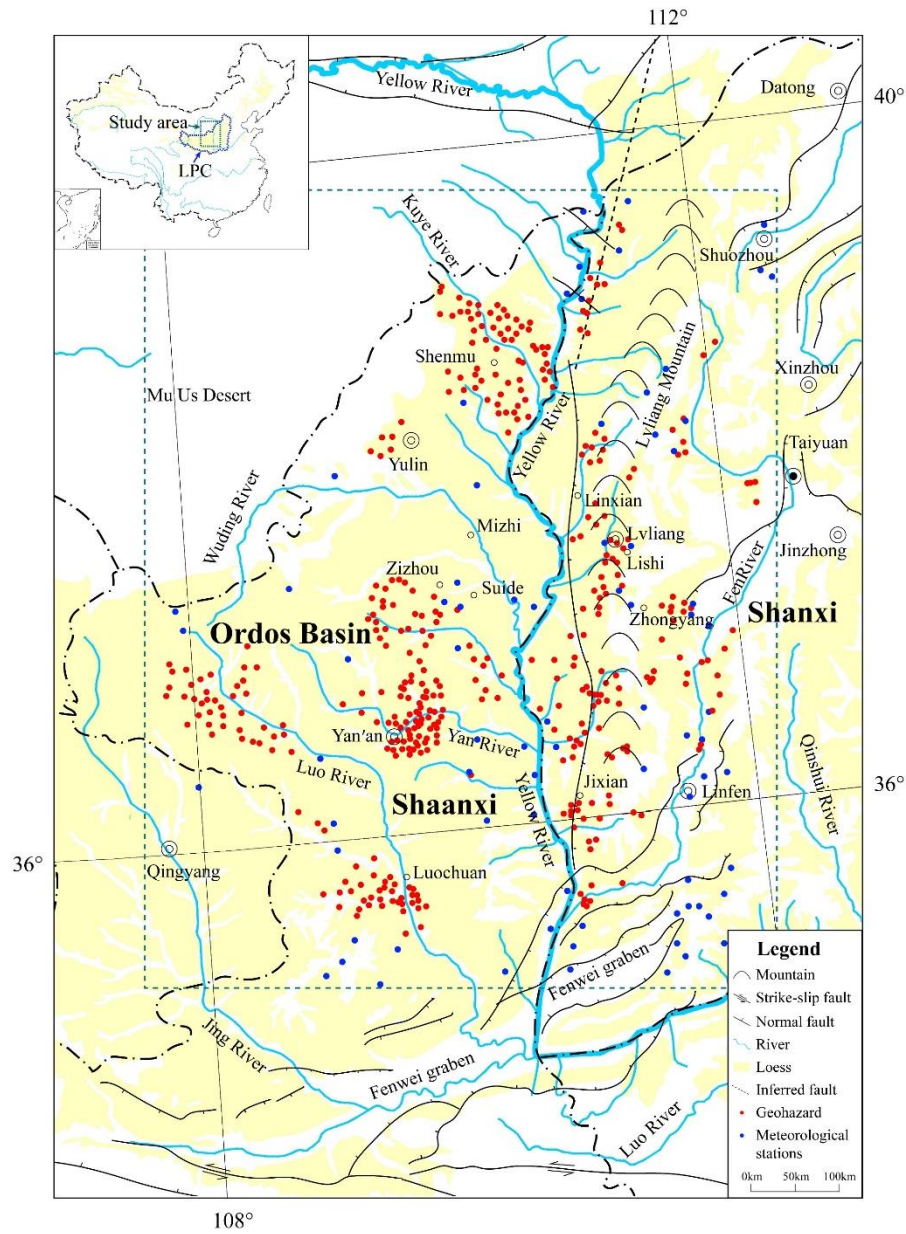
**Figure 2.** Geological map of the study area. The red dots denote the cracking–sliding failure cases, and the blue dots indicate the meteorological stations in the study area.

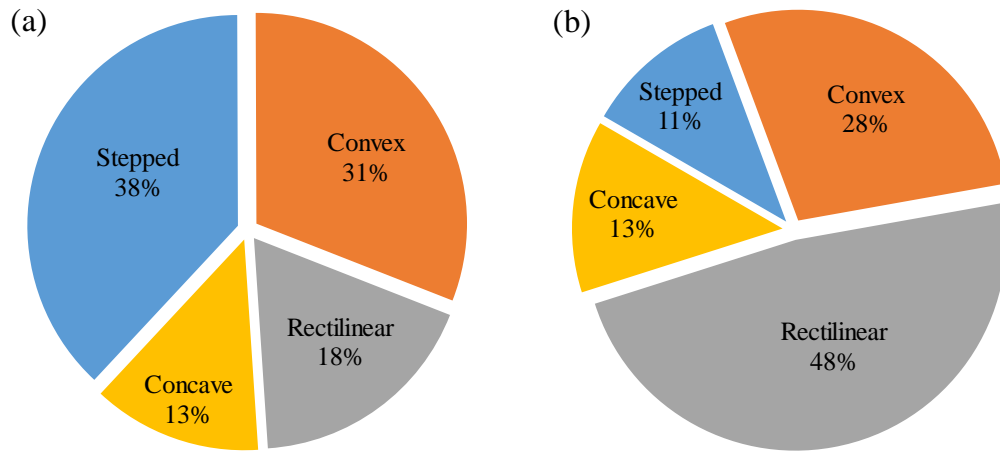
**Figure 3.** Statistical analysis results: a) classification of loess slopes in Lishi City, Shanxi Province, China, on the basis of a field survey of 212 loess slopes, indicating that stepped slopes are dominant in the study area. b) Percentage of cracking-sliding failures that occurred in different types of loess slopes across the study area, showing that rectilinear slopes are highly susceptible to loess failures.

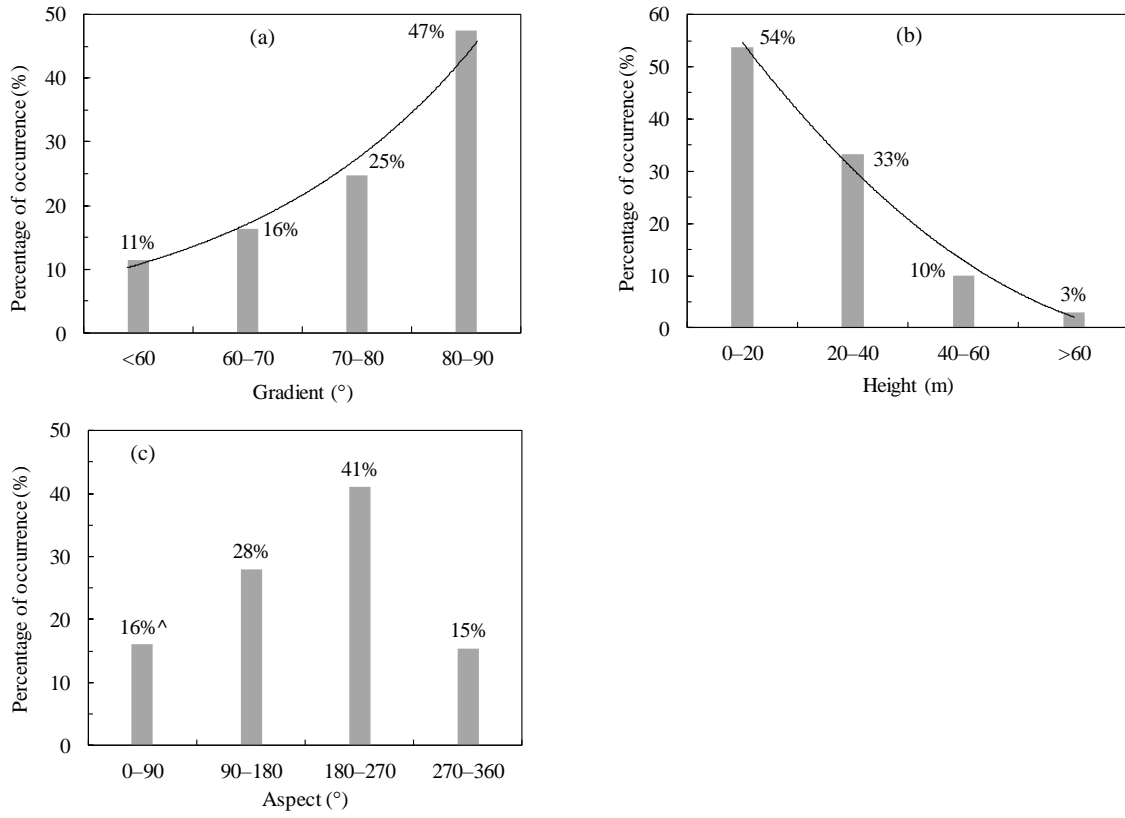
**Figure 4.** Effect of slope features on cracking-sliding failures.

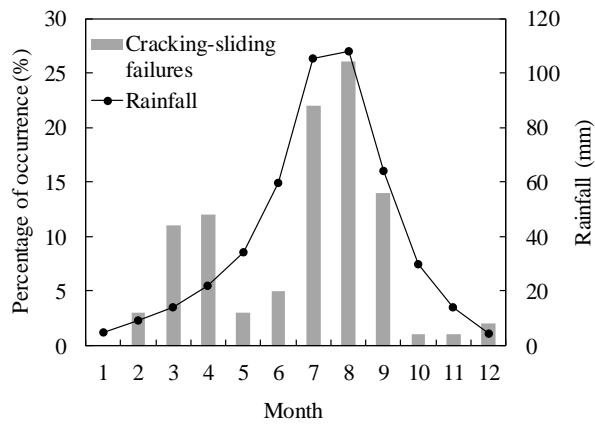
**Figure 6.** Occurrence of cracking–sliding failures mainly in July to September and consistent with the average monthly rainfall.

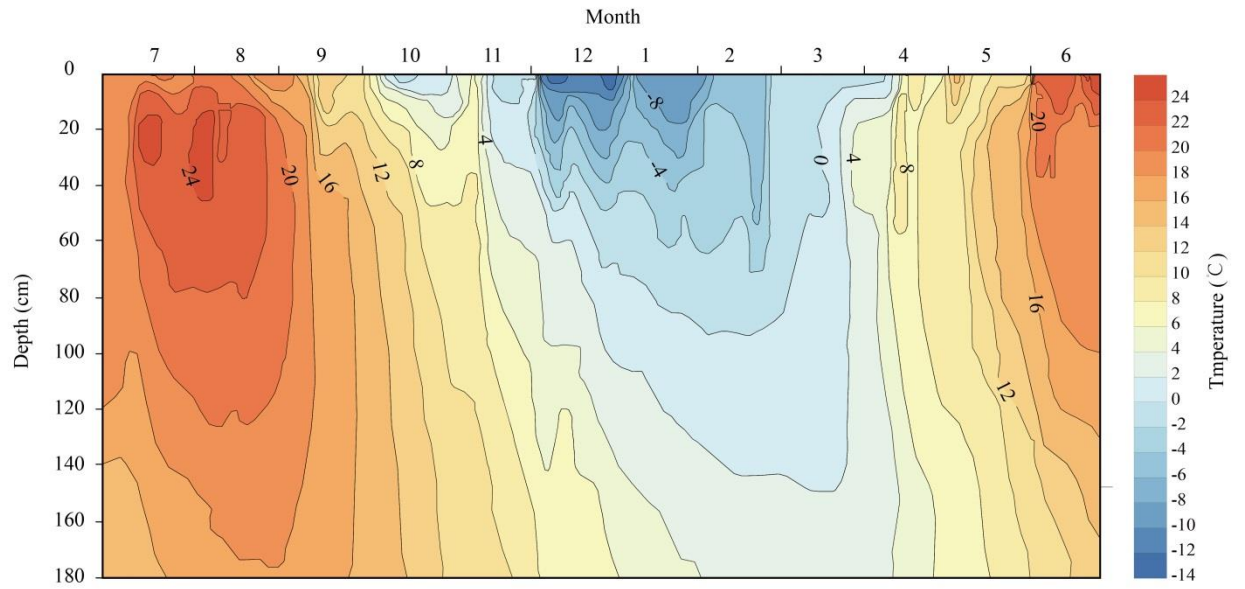
**Figure 7.** Annual variation of temperature (°C) within a shallow zone of a typical loess slope (Yang and Shao, 1995).

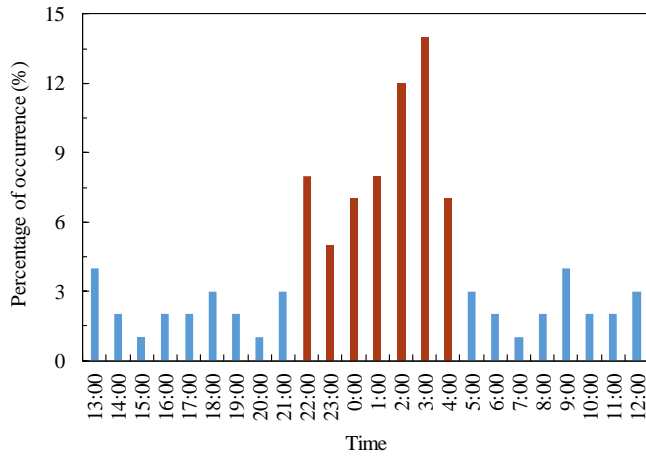
**Figure 8.** Temporal distribution of cracking–sliding failures in a day between 10 pm and 4 am.

194 Consistent with previous findings (Wei, 1995), our results indicate a relatively high  
195 frequency of occurrence of cracking–sliding failures between 10 pm and 4 am (Fig. 8). The  
196 difference in temperature between day and night in the loess area is more obvious than that in  
197 other regions at the same latitude in China (Sun and Zhang, 2011), and variations in air  
198 temperature in a day can occasionally reach 30 °C. The soil at a 50 cm depth shows an average  
199 daily temperature difference of approximately 5 °C in summer (Fig. 9). Thermal expansion and  
200 shrinkage occur during the rapid change in day and night temperatures. Under the cyclic  
201 functioning of shrinkage and expansion stresses, a soil structure loosens.

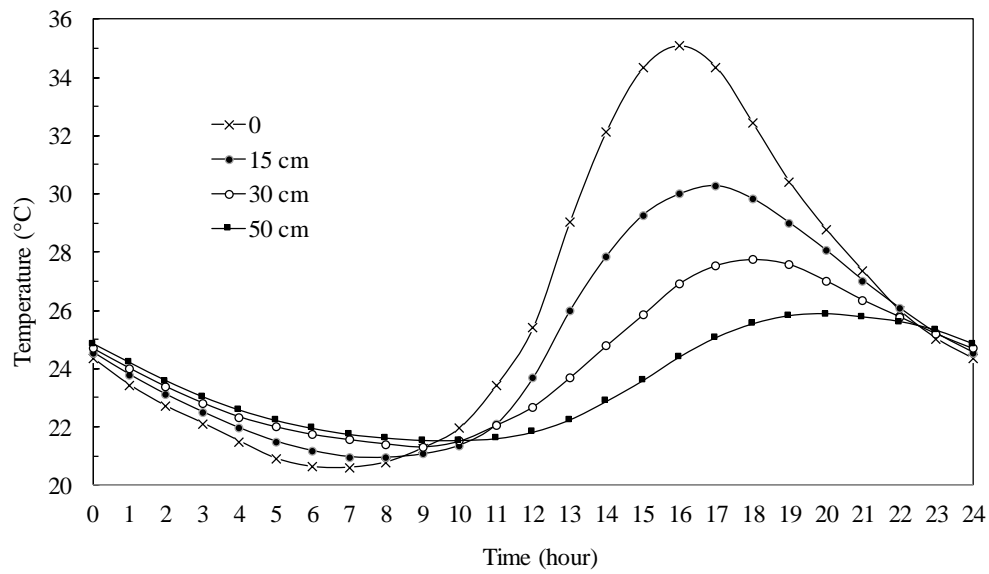
**Figure 9.** Daily soil temperature variation in loess areas of China in summer. Data are from the field monitoring during April 2014 to September 2017 in Linxian County, Shanxi, China.

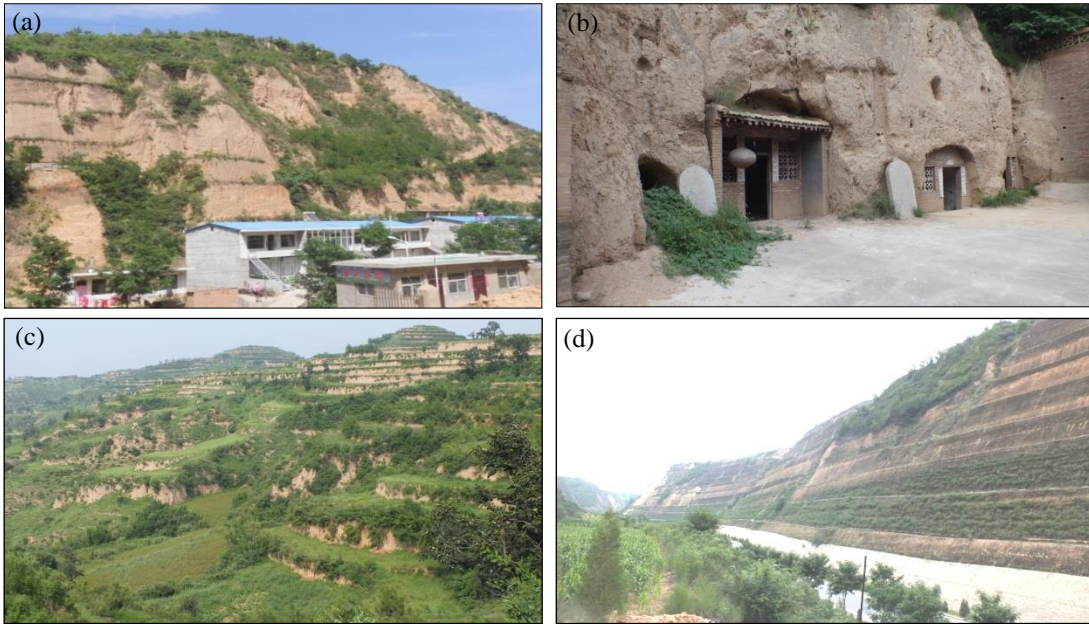
**Figure 10.** Typical engineering activities in loess areas in China: a) cut slopes for buildings; b) excavations for cave dwellings; c) terraced fields for farming; and d) cut slopes for highways.

203 Loess areas in China have a population of more than 200 million. Human engineering  
204 activities frequently occur and mainly involve cutting slopes for buildings, excavation for cave  
205 dwellings, and construction of terraced fields and roads (Del Prete and Parise, 2013). Cutting  
206 slopes for buildings causes the side slope to become steep. Unloading-induced tensile fractures  
207 are usually produced on the trailing edge of slopes during the rapid adjustment of a stress field  
208 within a slope (Fig. 10a). When a cave is excavated, roof damage (normally caving) happens  
209 because of a local tensile stress concentration if the design of a geometric section of a cave is

210 inappropriate (Fig. 10b). Terraced fields change the original path of surface runoff and enhance  
211 rainfall infiltration. Together with irrigation, terraced fields increase the water content of loess  
212 slopes and increase their phreatic level (Fig. 10c). The majority of traffic lines in the loess area  
213 stretch along valleys and bank slopes. Slope cutting and excavation during road construction  
214 result in a large number of high and steep side slopes, which provide a suitable environment for  
215 failures (Fig. 10d).
