Response to Reviewers #2

The Niedów dam on the Witka river (in km 2.2) is located in the south-west Poland, near the Polish-Czech and Polish-German borders. It was constructed in 1962 to supply water to the Turów coal power station for cooling purposes and for drinking water supply to nearby settlements, including the town of Bogatynia. In essence, the reservoir function was not to mitigate the flood hazard.

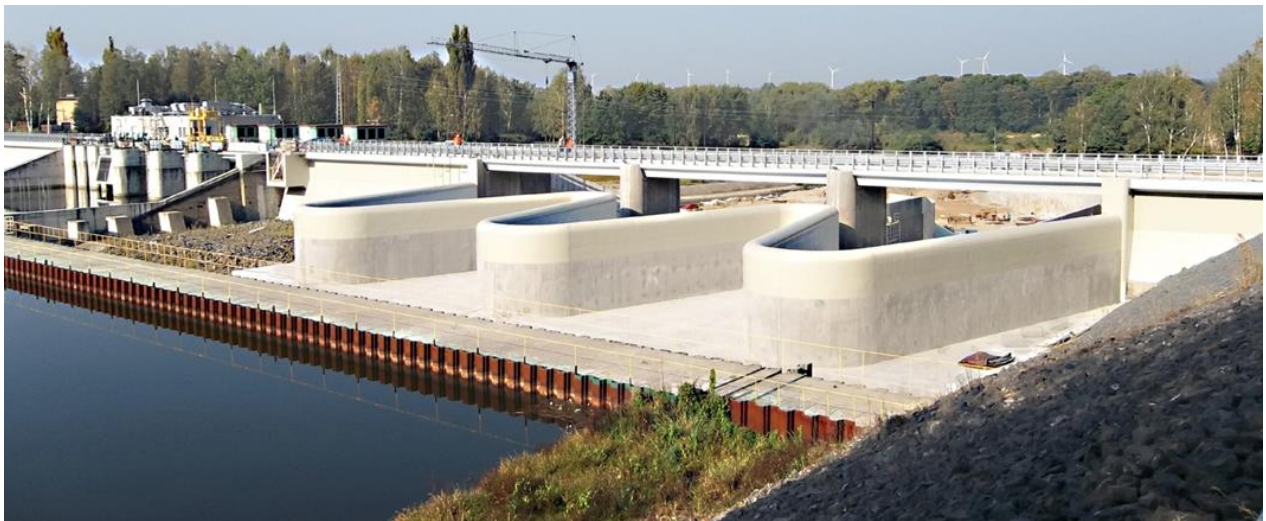
The dam has been reconstructed by 2016. The new dam is a concrete dam equipped with an labyrinth overflow structure in place of the right side dam, as shown in figure below. Information on the design and construction of the new dam are in a technical report Kostecki, S., Rędownicz, W. (2011). Physical model testing for the reconstruction of the Niedów dam (in Polish). Institute of Geo- and Hydraulic Engineering, Wrocław University of Science and Technology.

Figure 1: The Niedów dam after reconstruction (fot. Wojciech Rędownicz)
