Vulnerability and Site Effects in Earthquake Disasters in Armenia (Colombia). II – Observed Damages and Vulnerability

Francisco J. Chávez-García¹, Hugo Monsalve-Jaramillo², Joaquín Vila-Ortega³

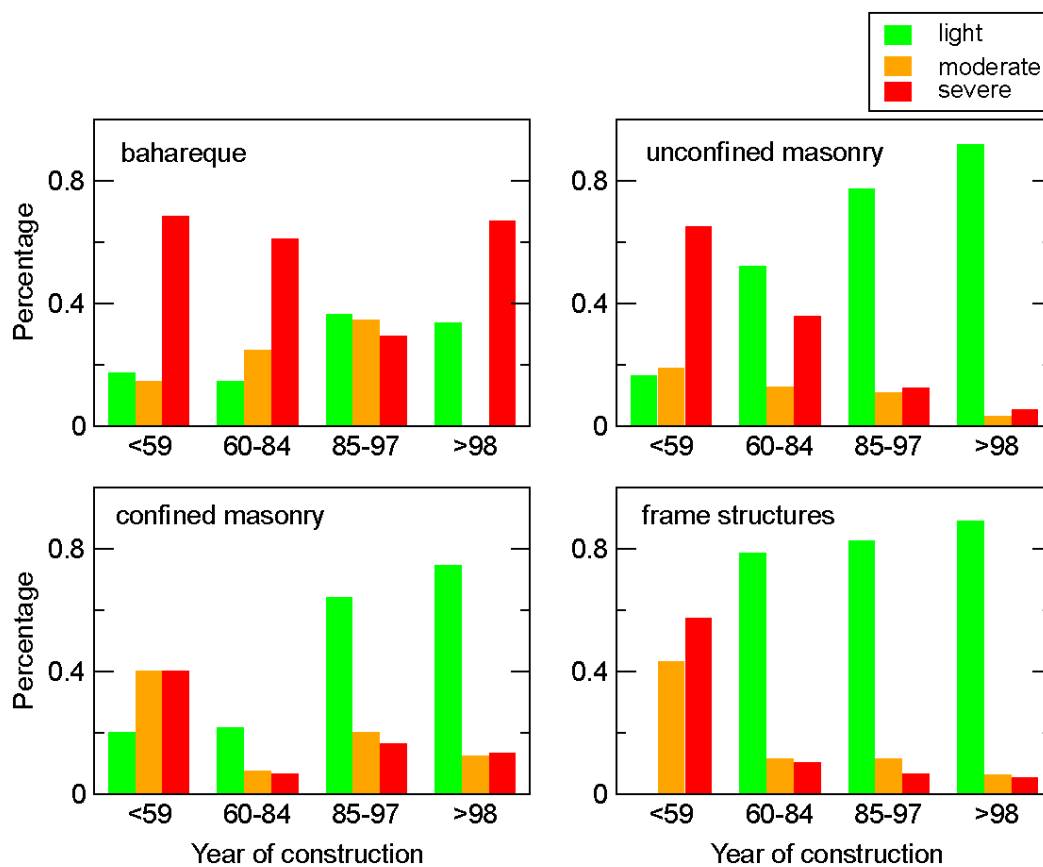
Figure 5 Histograms of observed damage in Armenia for the January 25, 1999, earthquake. Each diagram corresponds to the given structuring type and shows the relative incidence of light, moderate, and severe damage as a function of the time period where the structure was built (before 1959, between 1960 and 1984, between 1985 and 1997, and later than 1998). The data shown corresponds to the downtown district whose outline is shown in Figure 2.

215
216 Figure 5 shows damage distribution as a function of structuring type and construction period, again for the small
217 downtown district. Our division of time corresponds to the evolution of construction practice in Colombia, as discussed
218 above. Severe damage in bahareque structures do not show a clear trend with time; it is larger than 60% for all periods,
219 except for the period 1985-1997. The period later than 1998 is not representative for bahareque structures as there is only
220 one light, zero moderate, and two severely damaged structures. In contrast, severe damage for frame and unreinforced
221 masonry structures shows a steady decrease with time (and the number of structures is significant). The relative number
222 of structures suffering light damage increases with decreasing age of the structure, while the relative frequency of severe
223 damage decreases significantly, showing the benefit of building code improvements. The number of confined masonry
