Nat. Hazards Earth Syst. Sci., 17, 1961–1979, 2017 https://doi.org/10.5194/nhess-17-1961-2017 © Author(s) 2017. This work is distributed under the Creative Commons Attribution 3.0 License.

## A method for using unmanned aerial vehicles for emergency investigation of single geo-hazards and sample applications of this method

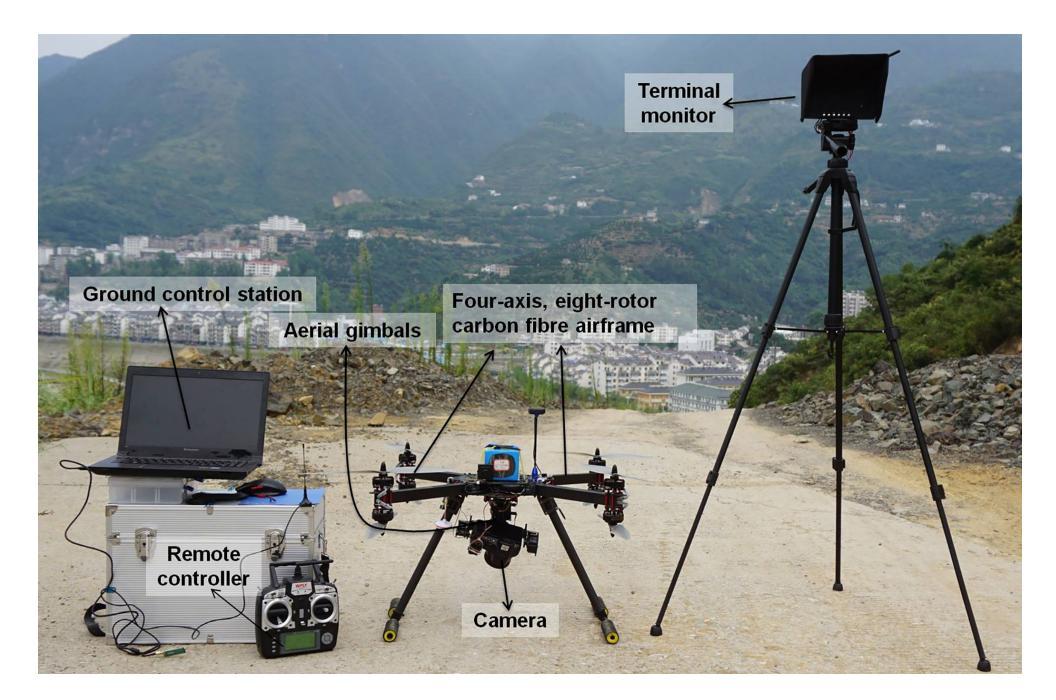
Figure 1. A photograph showing the customized UAV system used for emergency investigation of single geo-hazards in the Three Gorges Reservoir area, China.

The customized UAV system consists of four subsystems, including a multi-rotor UAV subsystem, an aerial photography subsystem, a ground control subsystem and a ground surveillance subsystem, which are described in detail below.

- A customized four-axis and eight-rotor carbon fibre airframe is used. The outstanding advantages of this design include its high strength and power and light weight (the whole aircraft with its camera and the aerial gimbal system is less than 5 kg). In addition, compared with fixed wing aircraft, it is smaller and has better manoeuvrability and enhanced fixed-point hovering capability. In particular, special sites for taking off and landing are not required, which is very important for using UAVs to quickly investigate single geo-hazards, which are usually located in complex environments. Although the battery life is poor (it provides approximately 20 min of flight time), if an average flight speed of  $5 \text{ m s}^{-1}$  is considered, the resulting flight distance of approximately 5 km guarantees that one flight is sufficient to cover the whole area of most single geo-hazards. Even if multiple flights are required, only the battery needs to be replaced.

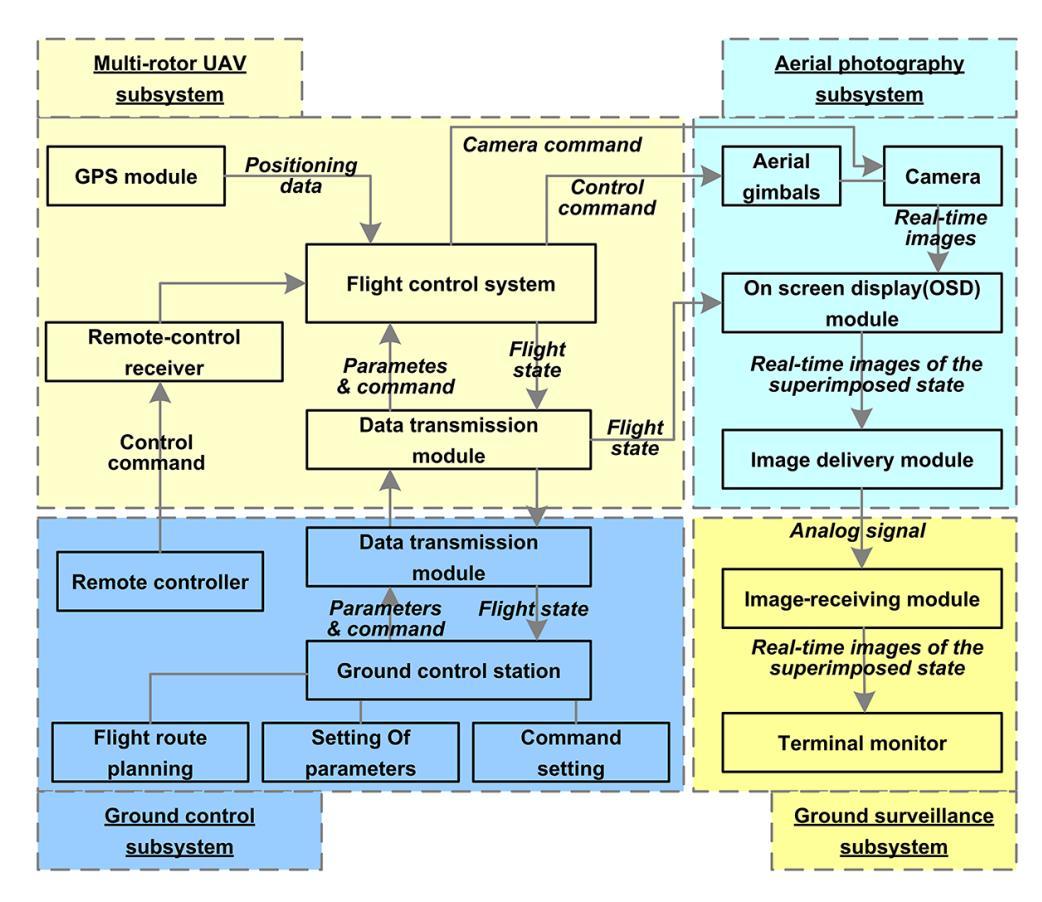
Figure 2. A diagram showing the architecture and main function modules of the customized UAV system.

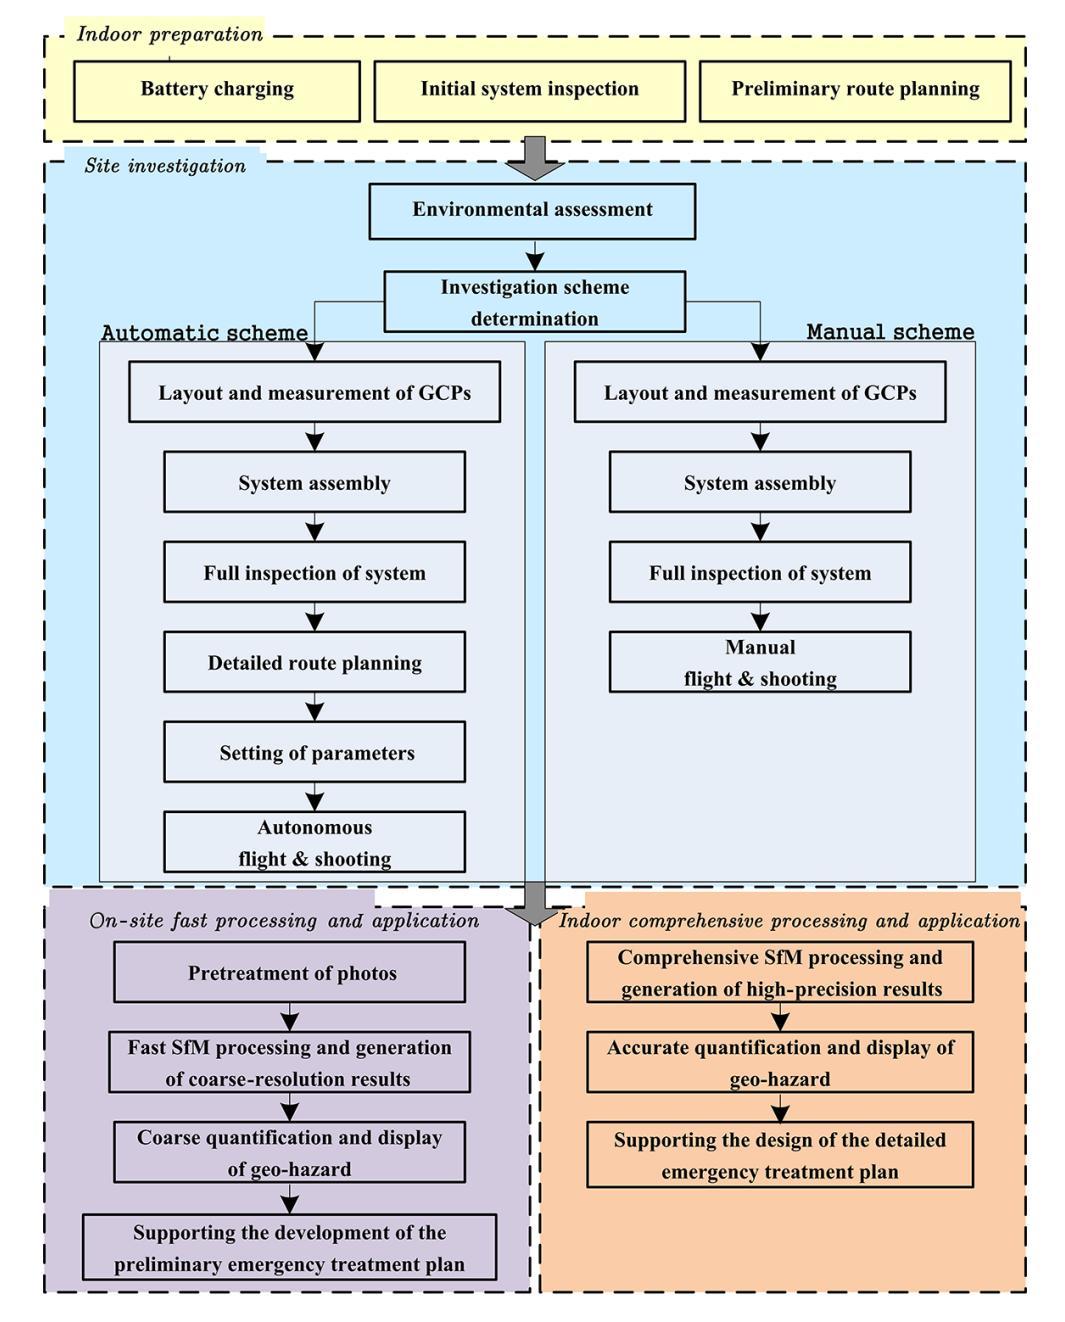
Figure 3. The process of using UAVs for emergency investigations of single geo-hazards.

overlap ratios between photographs. In view of this, as long as there are more than five stable GNSS satellite signals in the geo-hazard area, the vast majority of emergency investigations should use the automatic investigation scheme. In addition, this scheme is divided into six steps (Fig. 3), which are described below.

In the manual scheme, the entire UAV flight and the process of photo image collection has to be manually controlled using the remote controller. This scheme requires no route planning, which can save time in site investigation. However, it requires excellent piloting skills, and the flight safety and image quality are frequently degraded; accordingly, the flight process should be monitored intensively. Therefore, use of the manual scheme should be avoided, although, in some places, such as mountainous areas or canyons, where the GNSS signals are unstable or even absent, or the scope of the geo-hazard is extremely limited, the manual scheme may be more suitable. In addition, this scheme is divided into four steps (Fig. 3), which are briefly described below.

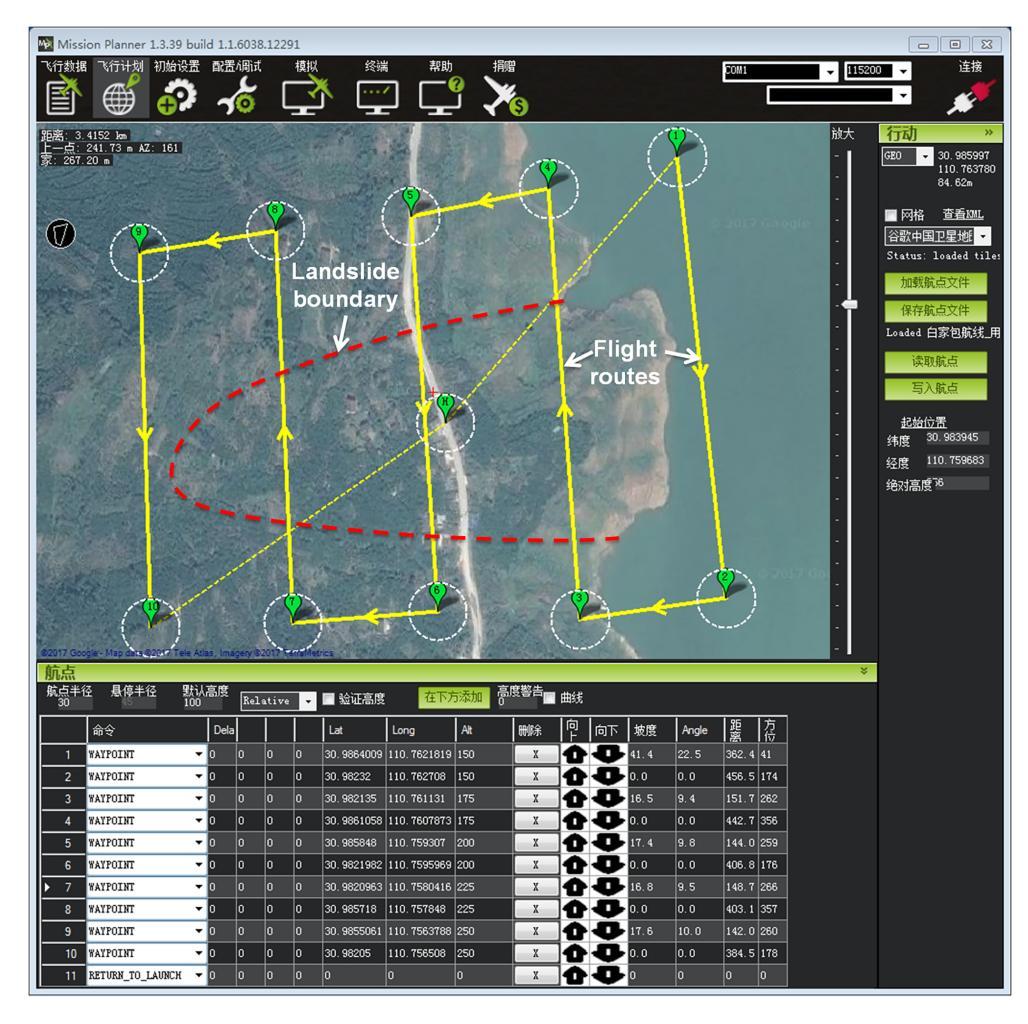
Figure 4. The planning of a route involving a typical regular grid pattern in plane view using Mission Planner software.

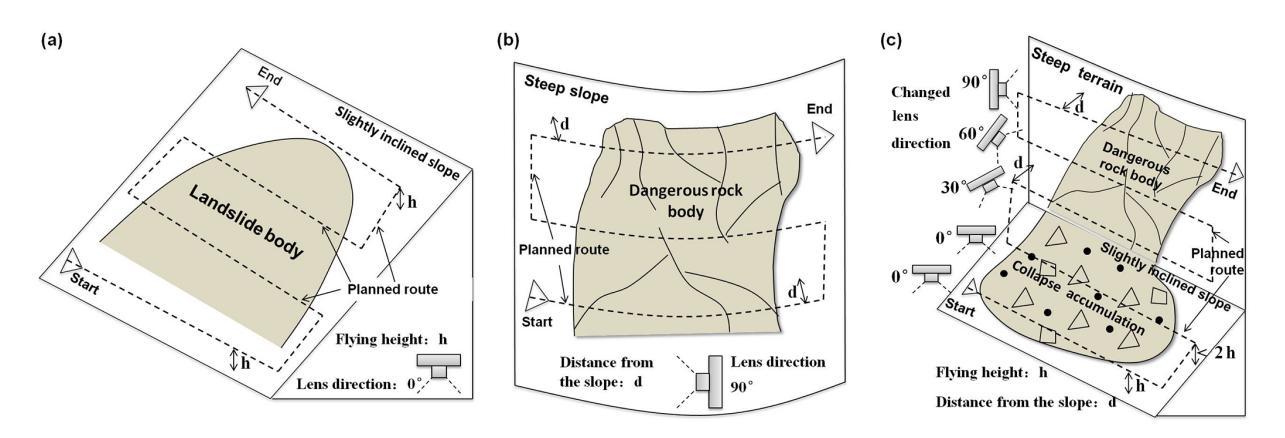
Figure 5. Three typical route types for UAV-based emergency investigation of single geo-hazards. (a) Planar grid pattern for slightly inclined slopes; (b) vertical grid pattern for steep slopes; (c) combined grid pattern for transitional terrain.

According to the characteristics of individual geo-hazards, proper route type selection and accurate motion design are key in ensuring the safety and efficiency of UAV-based emergency investigations. Based on a number of examples, three typical route types are summarized as follows (Fig. 5).

- Planar grid pattern for slightly inclined slopes (Fig. 5a). This pattern is suitable for geo-hazards that cover large areas (typically several million square meters) on the gentle slopes (typically less than 40°), such as gently inclined landslide bodies. The primary purpose of the emergency investigation for this kind of disaster is to obtain a digital terrain model and an orthophoto. Therefore, the planned route consists of a regular planar grid that covers the whole planar area of the geo-hazard. In addition, the camera lens always points vertically down to the ground (i.e., the lens orientation is held at  $0^{\circ}$ ). It is worth noting that the flying height of the route should be dynamically adjusted to meet the elevation changes of the disaster and slope. In principle, it is advisable to maintain the UAV's flying height at a constant distance (i.e., the h in Fig. 5a) from the ground, and practice shows that an h value of 50–100 m is proper. Lower flights require longer routes and increased flight time, and flight safety decreases; conversely, higher flights increase the mean ground sampling distance (GSD) of the acquired images, thus providing for lower spatial resolution of the final photogrammetric products.

- Vertical grid pattern for steep slopes (Fig. 5b): This pattern is suitable for geo-hazards that are developed on steep slopes (typically greater than 60°), such as dangerous rock masses on cliffs. Emergency investigations of this kind of disaster should aim at obtaining orthophotos of the facade and 3-D models, rather than digital terrain and vertically downward orthophotos. In this case, the planned route consists of a regular vertical grid which

that covers the whole facade area of the geo-hazard. In addition, the camera lens always points horizontally to the disaster body (i.e., lens orientation is held at 90°). The plane positions of all of the horizontal routes can overlap, but they are at different altitudes. In addition, it is advisable to keep the UAV flying at a constant distance (i.e., the *d* in Fig. 5a) from the area affected by the disaster (practice shows that a *d* of 40–80 m is proper).

- Combined grid pattern for transitional terrain (Fig. 5c): This pattern is suitable for geo-hazards that are located on transitional terrain and include both gentle and steep slopes, such as a dangerous rock mass on a cliff and the corresponding collapse accumulation mass on the gentle slope below. The main purposes of emergency investigation for this kind of disaster are to obtain a digital terrain model and an orthophoto, as well as a facade orthophoto and a 3-D model. Therefore, the combined grid pattern should be adopted for the planned route. That is, a regular planar grid is used to cover areas with gentle slopes, and a vertical grid is used to cover areas with steep slopes. Accordingly, the camera lens points vertically down to the ground within the part with the planar grid (i.e., the lens orientation remains at 0°) and gradually rises from the low position to the high position in the part with the vertical grid (i.e., the lens orientation changes from 0 to 90°). The flying height h and flying distance d in Fig. 5c can be set as in the planar and vertical grid patterns, respectively.

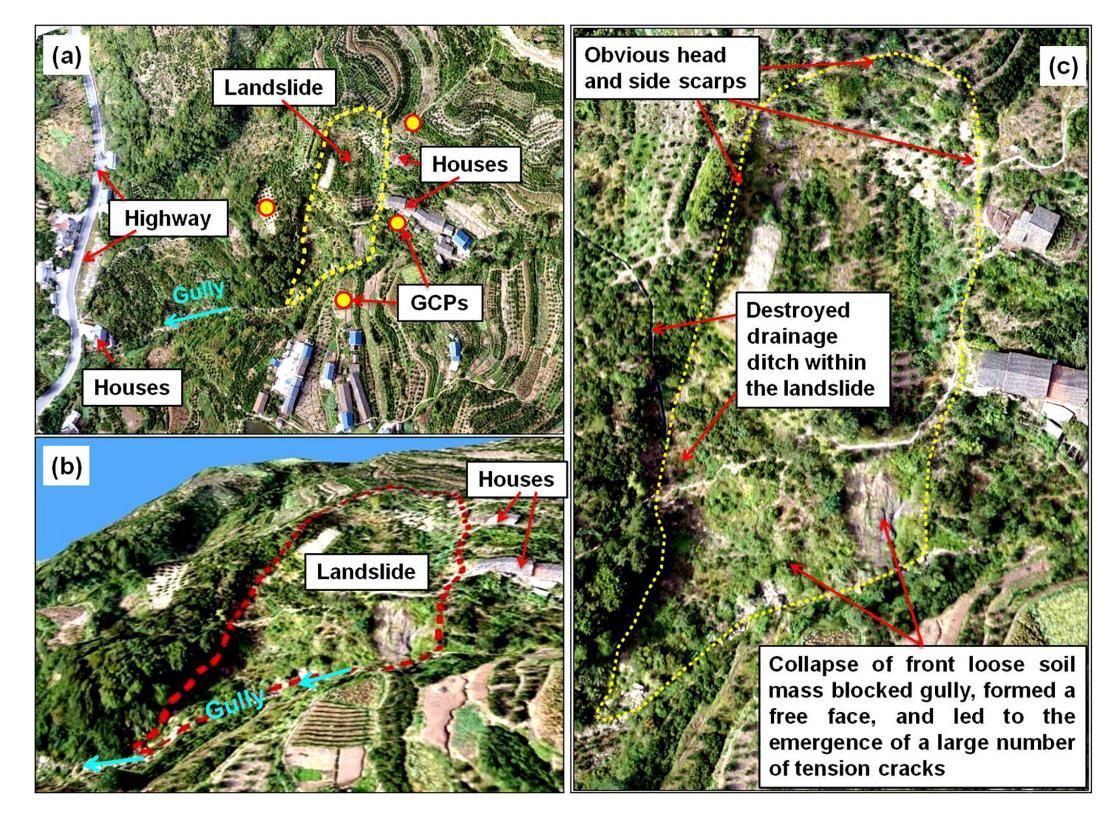
Figure 6. The results of a UAV-based emergency investigation of a slightly inclined landslide. (a) The digital orthophoto; (b) the 3-D texture model; (c) interpretation of the destruction.

First, a route was planned according to the pattern of Fig. 5a based on the position of the mass movement and its extent. At the same time, four GCPs were selected around the landslide (Fig. 6a), and the RTK-DGPS with a nominal positioning accuracy of 2 cm was used to measure the 3-D coordinates of these GCPs. The establishment and measurement of the GCPs took approximately 50 min. Then, by autonomous flight and automatic photo image collection, 66 photographs were captured, and the mean GSD of the original images was  $3.67 \,\mathrm{cm}\,\mathrm{pixel}^{-1}$ . Including route planning and UAV preparation, the entire working time using the UAV required only approximately 30 min. Finally, using SfM photogrammetric processing, an orthophoto with a spatial resolution of 4.25 cm (Fig. 6a) and a 3-D texture model (Fig. 6b) were generated. Usually, a rigorous accuracy assessment should be performed by using external and independent check points, but for simplicity and efficiency, the four GCPs were used also as the checkpoints for accuracy assessment, and the mean, standard deviation (sigma), and root-meansquare error (RMSE) values were calculated. The results showed that the fast SfM processing required only 28 min, but the planar errors were about 2.6 m (Error\_X<sub>mean</sub> = 2.327 m,  $\text{Error}_{\text{Mmean}} = 2.862 \,\text{m};$  $Error_X_{sigma} =$  $0.166 \text{ m}, \text{ Error}_{Y_{sigma}} = 0.114 \text{ m}; \text{ Error}_{X_{RMSE}} = 2.331 \text{ m},$  $Error_Y_{RMSE} = 2.864 \text{ m}$ ), and the vertical error was

more than 4.0 m (Error\_ $Z_{mean} = 4.165$  m, Error\_ $Z_{sigma} =$ 0.211 m, Error\_Y<sub>RMSE</sub> = 4.169 m). In contrast, the comprehensive processing took 65 min, and, because the GCPs were introduced during the SfM photogrammetric processing, the planar errors were reduced to about 0.035 m (Error\_X<sub>mean</sub> = 0.031 m, Error\_Y<sub>mean</sub> =  $\text{Error}_X_{\text{sigma}} = 0.009 \,\text{m},$ 0.038 m;  $Error_Y_{sigma} =$  $0.014 \text{ m}; \text{ Error}_X_{\text{RMSE}} = 0.032 \text{ m}, \text{ Error}_Y_{\text{RMSE}} = 0.04 \text{ m}),$ and the vertical error was less than 0.05 m (Error\_Z<sub>mean</sub> =  $0.045 \text{ m}, \text{Error}_{Z_{sigma}} = 0.012 \text{ m}, \text{Error}_{Y_{RMSE}} = 0.046 \text{ m}).$ In short, all of the on-site work, including the UAV-based investigation, the layout and measurement of the GCPs, and the fast photogrammetric processing, required a total of 78 min. In addition, an orthophoto and a 3-D texture model with an error of approximately 3 m were generated on site. These products provided macro-level information about the landslide and its surroundings.

Based on the results of the above emergency investigation, combined with ground investigations, the characteristics and effects of the landslide were quickly interpreted (Fig. 6c) and evaluated. These products revealed the formation of obvious head and side scarps. Moreover, the drainage ditch that was located within the landslide was completely destroyed, and the front loose soil mass collapsed and blocked the gully, forming a free face and leading to the emergence of a large number of tension cracks. All of these indications suggested

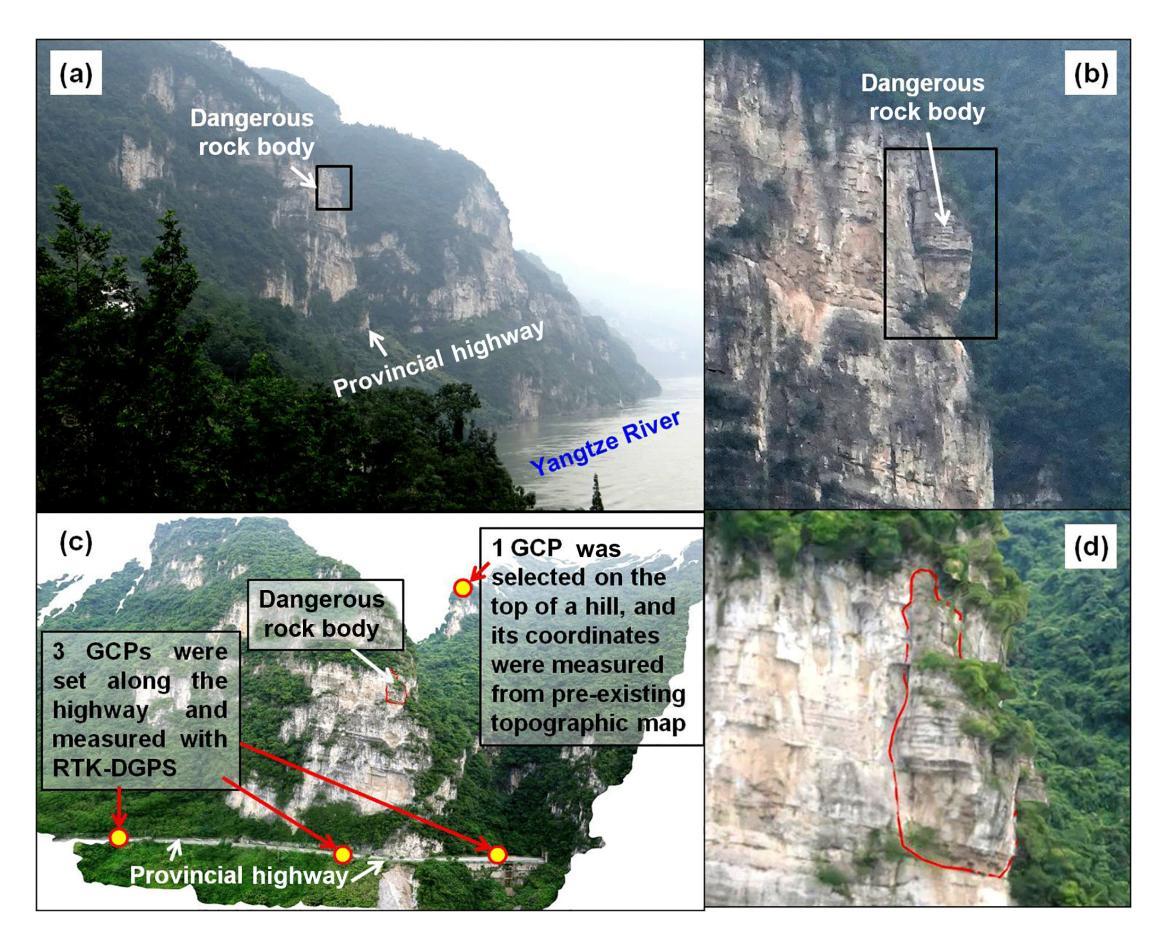
Figure 7. The results of a UAV-based emergency investigation for a dangerous rock mass on steep cliff. (a) Overview photo; (b) right side photo of the dangerous rock mass; (c) 3-D texture model of the whole scene; (d) 3-D texture model of the dangerous rock mass.

First, route planning was performed according to the pattern shown in Fig. 5b. At the same time, three GCPs were established along the highway and measured with the

RTK-DGPS technique (Fig. 7c). In addition, it should be noted that, because the three GCPs were located in nearly a straight line, given the limited environment, which could not meet the processing requirements, another GCP was established on top of a hill behind the cliff (Fig. 7c), and its coordinates were measured according to the pre-existing topographic map. The layout and measurement of the three GCPs took only approximately 25 min. The camera lens direction was then set at approximately 45° to the steep cliff. Through autonomous flight and automatic photo image collection, 104 photographs were captured, and the mean GSD of the original images was  $4.92 \text{ cm pixel}^{-1}$ . Together with route planning and UAV preparation, the entire working time using the UAV took 35 min. Finally, in order to obtain highprecision results for the design of the detailed emergency response plan, the comprehensive SfM processing was used directly, which took approximately 100 min, and a DSM and a 3-D texture model (Fig. 7c, d) with a spatial resolution of 5.47 cm were generated. Similarly, the four GCPs were used as checkpoints for accuracy assessment. The results showed that the spatial errors were 0.237 m (Error\_X<sub>mean</sub> = 0.218 m.  $\text{Error}_{\text{Ymean}} = 0.183 \text{ m},$  $Error_Z_{mean} =$  $\text{Error}_X_{\text{sigma}} = 0.348 \text{ m},$ 0.310 m;  $Error_Y_{sigma} =$  $0.292 \text{ m}, \text{ Error}_{Z_{sigma}} = 0.410 \text{ m}; \text{ Error}_{X_{RMSE}} = 0.372 \text{ m},$  $\text{Error}_{\text{RMSE}} = 0.312 \text{ m}, \text{Error}_{\text{ZRMSE}} = 0.471 \text{ m}), \text{ i.e., the}$ accuracy was sub-meter-level, primarily because the GCP on the hilltop could not be accurately measured. Even so, the sub-meter-level accuracy was able to meet the requirements of quantifying the size and generating large-scale topographic maps of the dangerous rock mass for use in the design of emergency control measures and did not have a substantial impact on the conclusions. Moreover, all of the investigative work, extending from the on-site UAV-based investigation to the generation of high-precision results, required only approximately 2 h and 15 min. Such a short time period could not be achieved through ground-based investigation, especially for an isolated dangerous rock mass on a cliff.

In view of the DSM and the 3-D model, the results showed that the dangerous rock mass was 24 m high, 12 m wide, and 12 m thick and had a volume of 3456 m<sup>3</sup>, and its exact distance from the highway was 110 m. The lower and upper part of the rock mass had fallen, so it was completely unsupported. The left and right boundary cracks were fully connected. All of these signs indicated that the dangerous rock mass was in an unstable state. Therefore, the relevant emergency investigation results described above were submitted to the technical department to support the design of a detailed emergency response plan.

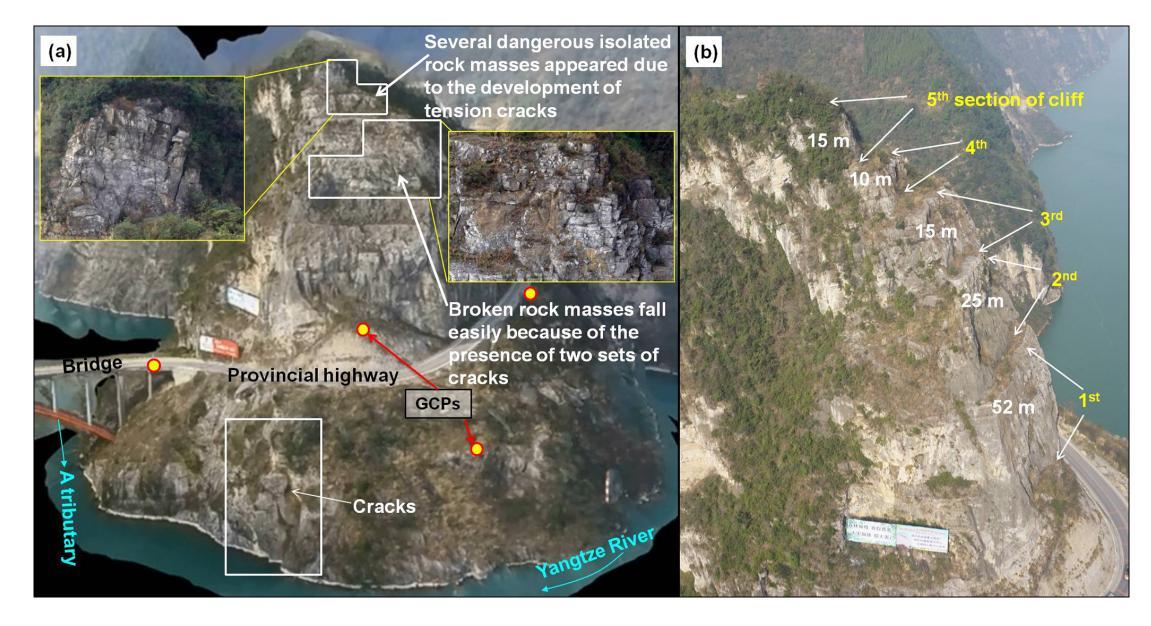
Figure 8. The results of a UAV-based emergency investigation for a combined slope on transitional terrain. (a) The 3-D texture model and the identified potential geo-hazards; (b) the quantitative characteristics of the steep slope above the highway.

it was surrounded by rivers on three sides. Geomorphologically, the slope above the highway consisted of five steep cliffs (Fig. 8b), whereas the portion of the slope below the highway has a gentle slope but is surrounded by rivers. It could be seen that it was almost impossible to implement a ground-based investigation to identify all of the potential geo-hazards, so the UAV was used and the automatic investigation scheme was adopted.
