A huge deep-seated ancient rock landslide: recognition, mechanism and stability

M. G. Tang^{1,2}, Q. Xu¹, Y. S. Li², R. Q. Huang¹, and G. Zheng¹

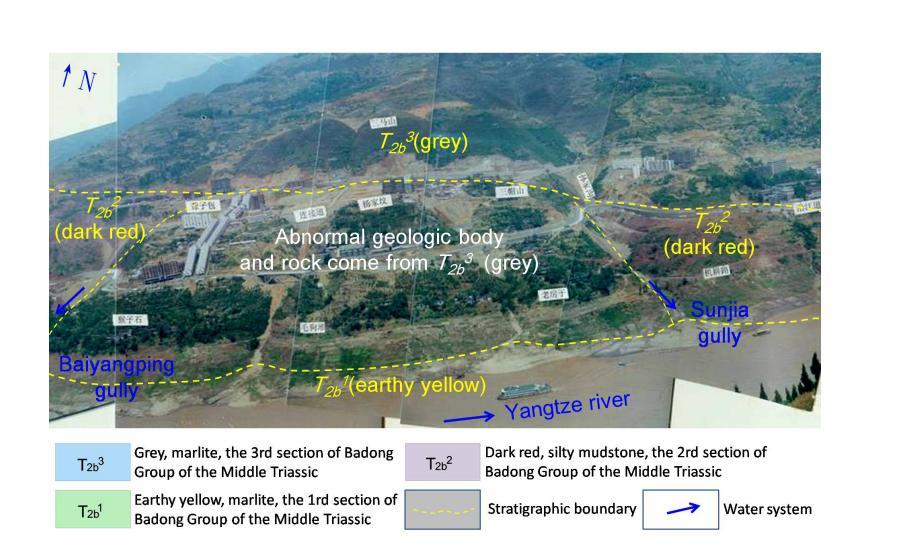
Figure 2. The abnormal geomorphologic and geological phenomenon at Sanma Mountain in the new city of Fengjie (photograph taken in 1998).

upriver on the northern bank of the Yangtze River, was recommended as a site for the new city of Fengjie (Fig. 1). However, during the construction process, it was found that there is a large-scale abnormal phenomenon of geomorphy and geological structure. It contains a discontinuous stratum in output and color (Fig. 2). This strata

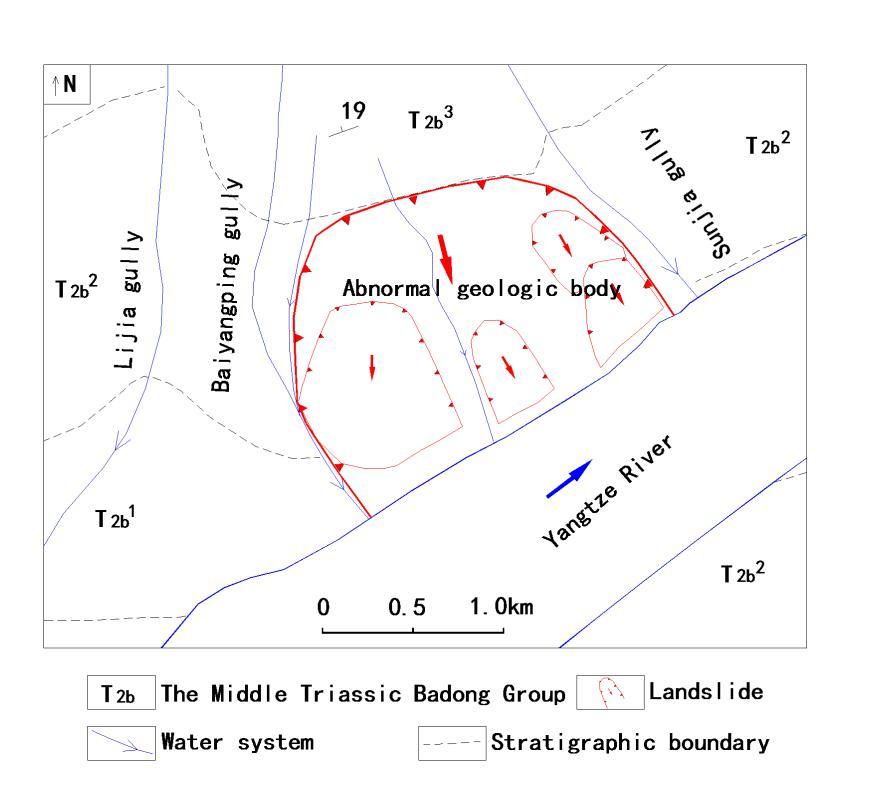
Figure 3. The abnormal geological phenomenon at Sanma Mountain speculated as a landslide.

- ⁵ discontinuity has been speculated to be the result of an ancient landslide (Wu, 1998; Nanjiang Geological Team, 1999) (Fig. 3). However, Li et al. (2002) put forward the hypothesis that it was caused by tectonic activity, and the surrounding area and the base of the body are cut by four normal faults (F8, F20, F19, and F26), that is to say it is a local fault graben (Fig. 4), and this idea was supported by Wang et al. (2006). We

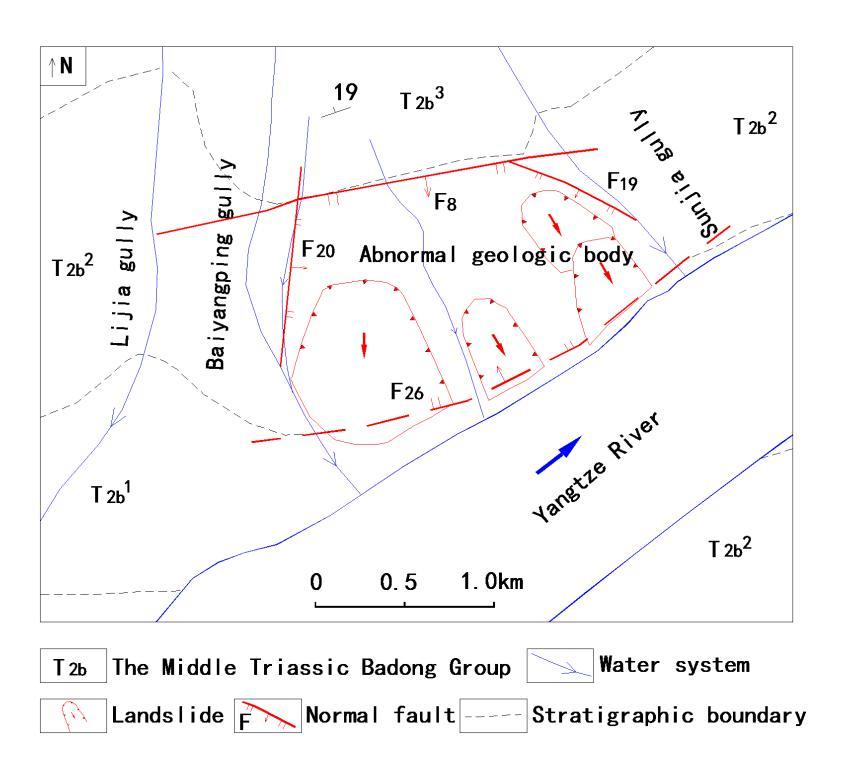
Figure 4. The abnormal geological phenomenon at Sanma Mountain explained as a fault graben (Li et al., 2002).

- In field we found that the four tension faults, F_8 , F_{20} , F_{19} , and F_{26} (Li Huizhong, 2002) (Fig. 4), share some common characteristics. The fault extension length is not long (F_8 : 1110 m, F_{19} : 150 m, F_{26} : 100 m), and the fault fracture zone width is not large (F_8 : 3.5 m, F_{19} : 0.1–1.1 m, F_{26} : 1–2 m; conversely, fault displacement is very large (F_8 :

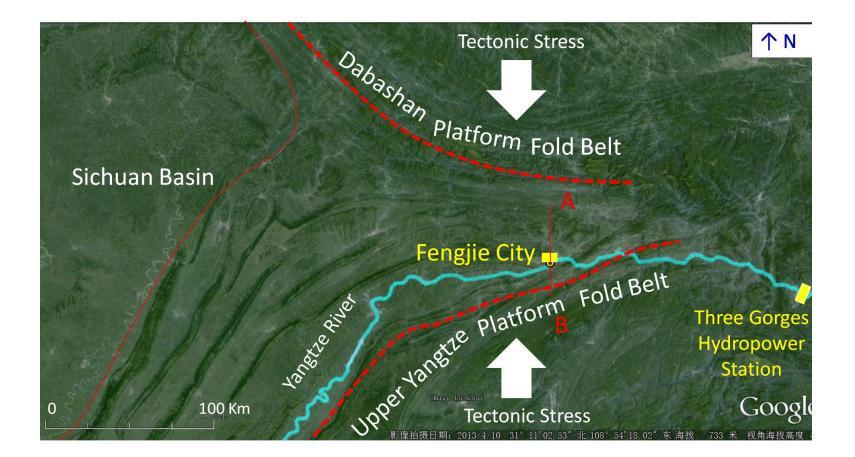
Figure 5. Outline of regional tectonics and stress.

- intrusions of magmatic rocks. The overlying sedimentary rocks, which were deposited during the Triassic Period, were folded during uplift as part of the Yanshan Movement at the end of the Jorgenie Period. As a result, secondary tectonic units, including the upper Yangtze platform fold belt, the marginal depression of the Sichuan Basin, and the Dabashan platform fold belt, were formed. These secondary tectonic units converge in
- ¹⁵ Fengjie under compressive north-south stress (Figs. 5–7)

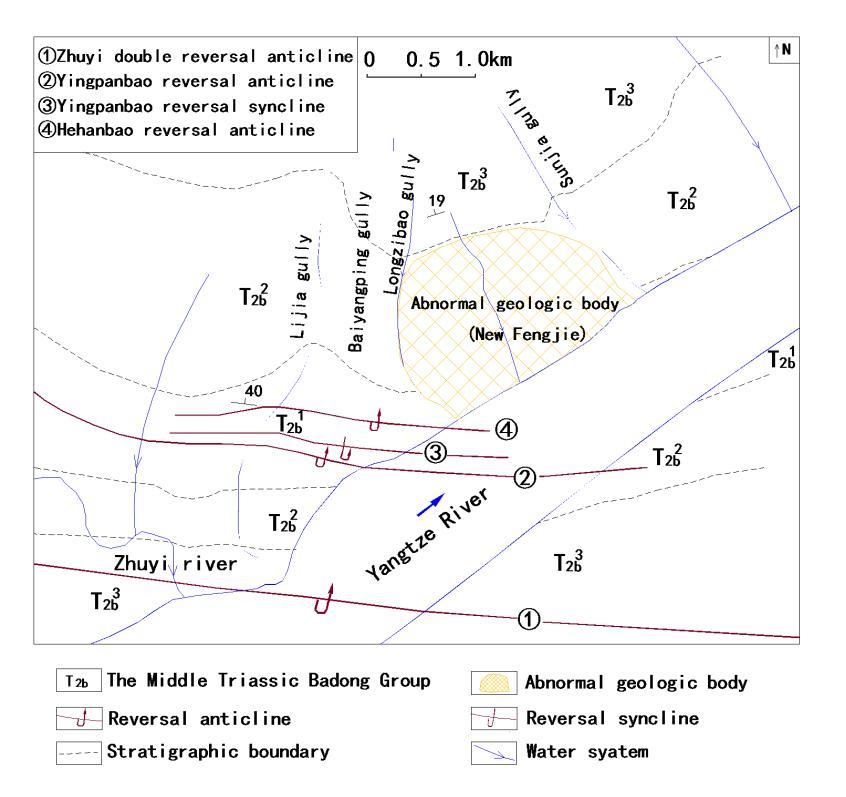
Figure 7. Outline geological map of the new city of Fengjie.

The rocks of the Sanma Mountain are sedimentary rocks of Triassic age (Fig. 7). The Jialingjiang Group (T_{1j}) , which is of Early Triassic age, was deposited in shallow lagoon fac and contains sedimentary limestone, dolomitic limestone, and marlite. These

The Zhuyi anticline at Sanma Mountain is a duplex inverted anticline (an overturned and closed fold, axial plane slanting, and overturned strata occur) (Figs. 7–9), and there is strong crumpling of strata in the core of the Zhuyi anticline (Figs. 7 (2), (3),

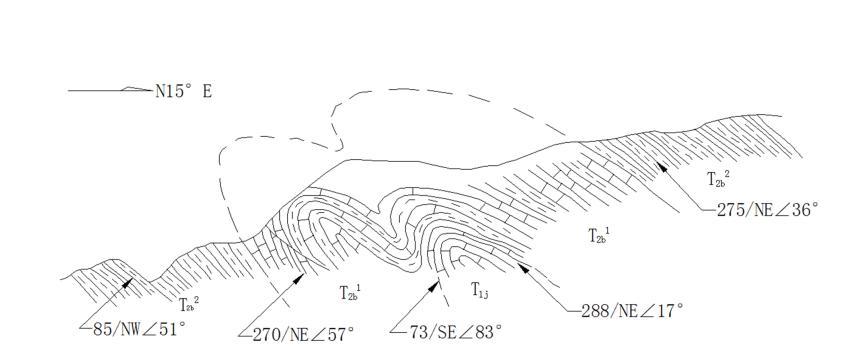
Figure 8. The geological profile of a duplex inverted anticline in the core of the Zhuyi anticline.

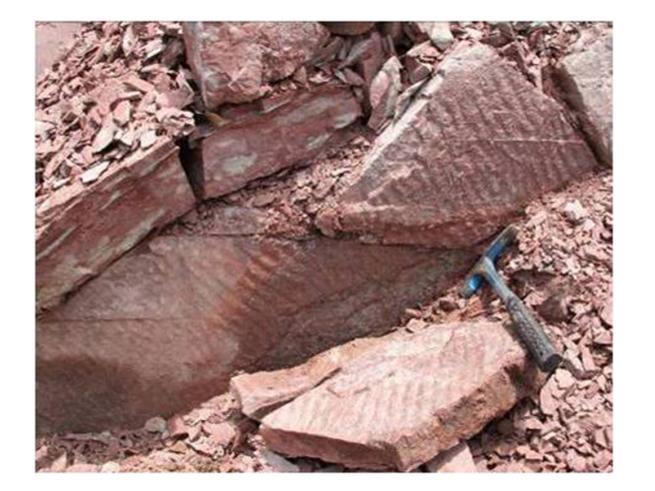
Figure 9. Ripples displaying reversal rock.

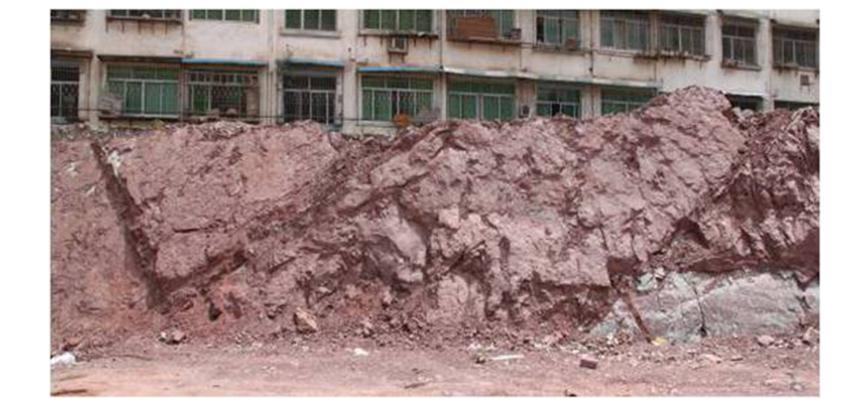
Figure 10. Conjugate shear jointing.

- (4) and 9). We investigated and measured the Zhuyi anticline tectonic stress field, the conjugate shear joint structural stress (Fig. 10) and the compression structural stress. The regional maximum principal stress direction is 344–352.5° by means of stereographic projection analysis of occurrence of conjugate shear jointing and reversal stratum (Fig. 11). The result is the new city of Fengjie has a N-S compressive stress

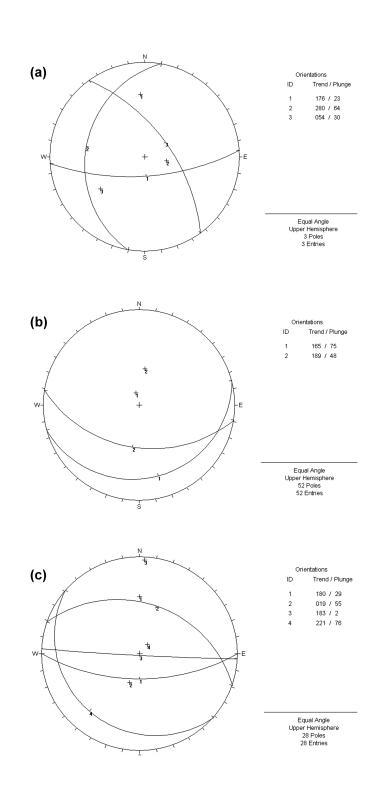
Figure 11. Stereographic projection analysis. (a) Occurrence of conjugate shear jointing. (b) Occurrence of stratum in the north wing. (c) Occurrence of stratum in the south wing.

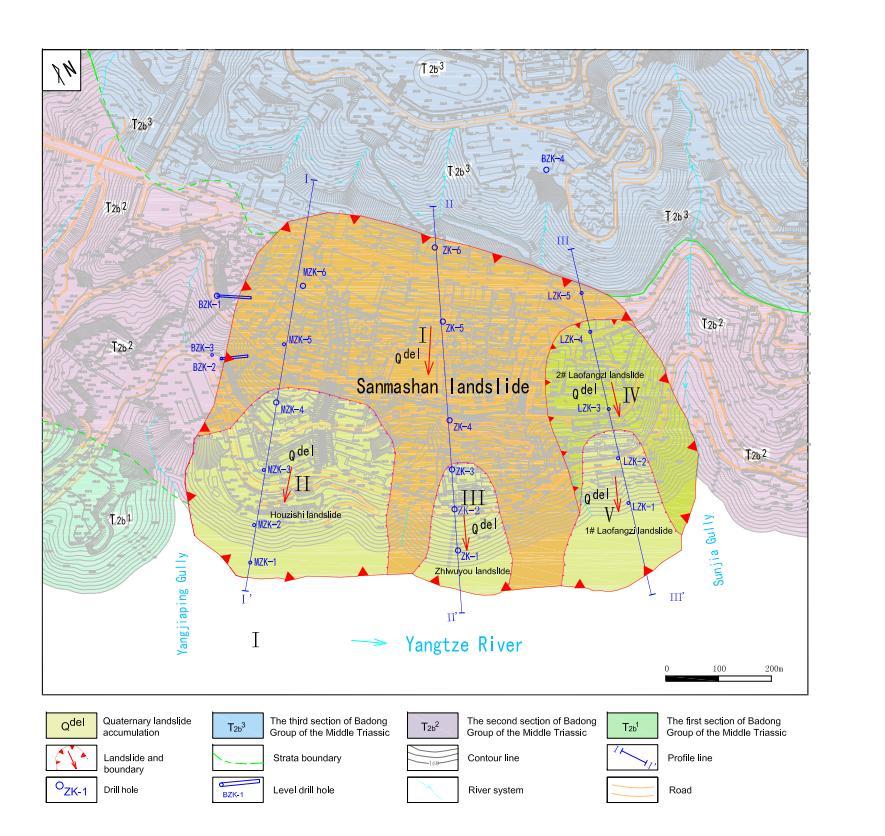
Figure 12. The geological map of the Sanmashan landslide (topographic map in October 2002).

- ¹⁰ There is a steep cliff over 100 m height in the trailing edge of the landslide, and a gully called Baiyangping at the western lateral edge, and a gully called Sunjia at the eastern lateral edge, and the Yangtze River in front of the landslide. The terrain gradient of the landslide is 15–20°. The length of landslide is over 780 m, the width is about 1020 m, the maximum thickness is 170 m, the average thickness is about 125 m, and the volume
- ¹⁵ is about 100 million m³. We subdivided the landslide into five domains (I–V) based on differences in morphology, geological structure, and inferred failure mechanics (Figs. 12 and 13).

Based on regional geological mapping, drill holes, and a large excavation at the site, six engineering geological units were identified in the landslide. The units are as follows (Figs. 12 and 20):

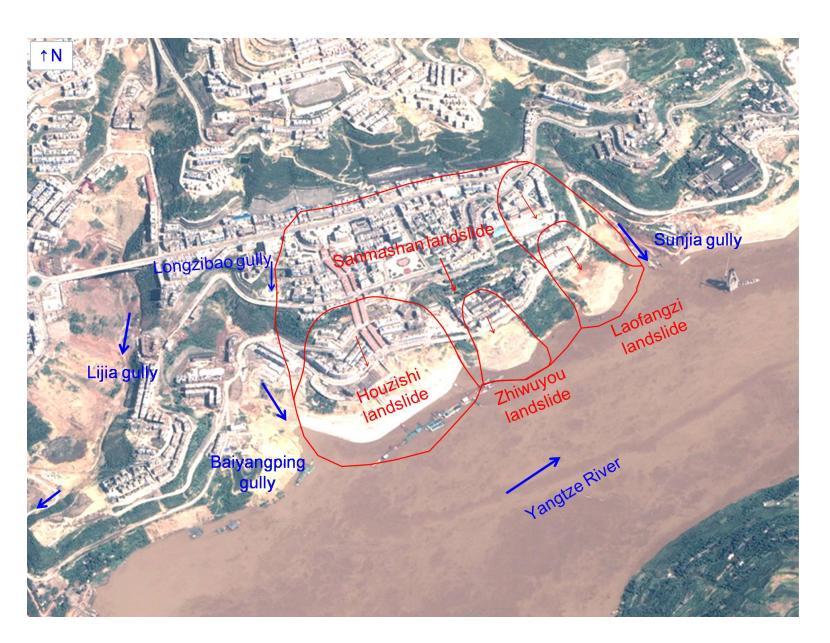
Figure 13. The remote image of the Sanmashan landslide (Satellite image in September 2004).

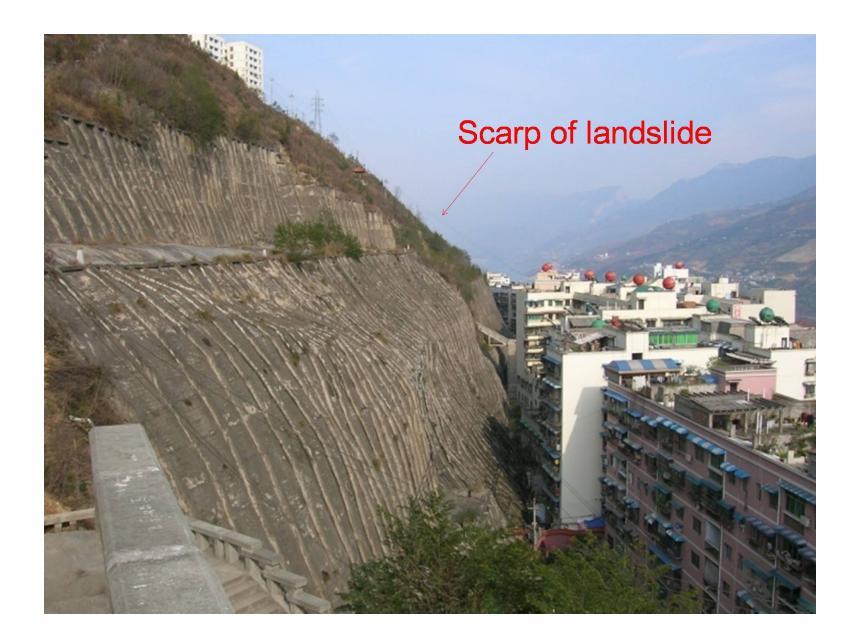
Figure 14. The scarp of the Sanmashan landslide (March 2006).

Crown or head scarp (Fig. 14): there is a steep (about 70°) scarp, which has an elevation of 300-410 m. During an foundation excavation in the construction of new

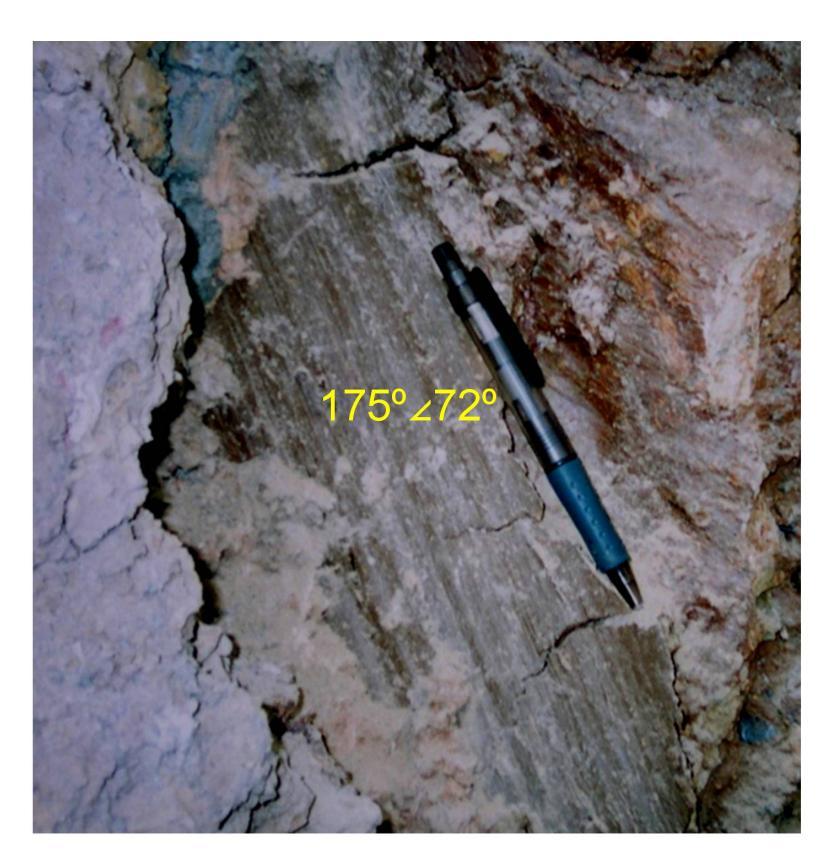
Figure 15. The sliding scrape of the scarp be revealed by foundation excavation.

Fengjie city, the sliding face and scar in the end of the landslide were exposed (Fig. 15). Eastern lateral edge: a deep gully, called Sunjiagou, is present at this edge of the landslide (Fig. 16). A sliding zone and marks are very obvious (Fig. 17), which have been misidentified as fault F₁₉ in the past (Li et al., 2002). Western lateral edge: there is a shallow groove called Longzibaogou leading into Yangjiaping gully (Fig. 18). Sliding scratches were observed during level drilling (Fig. 19).

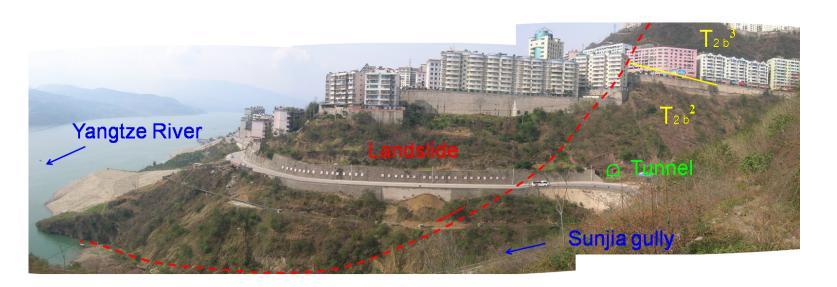
Figure 16. The eastern lateral edge of the Sanmashan landslide.

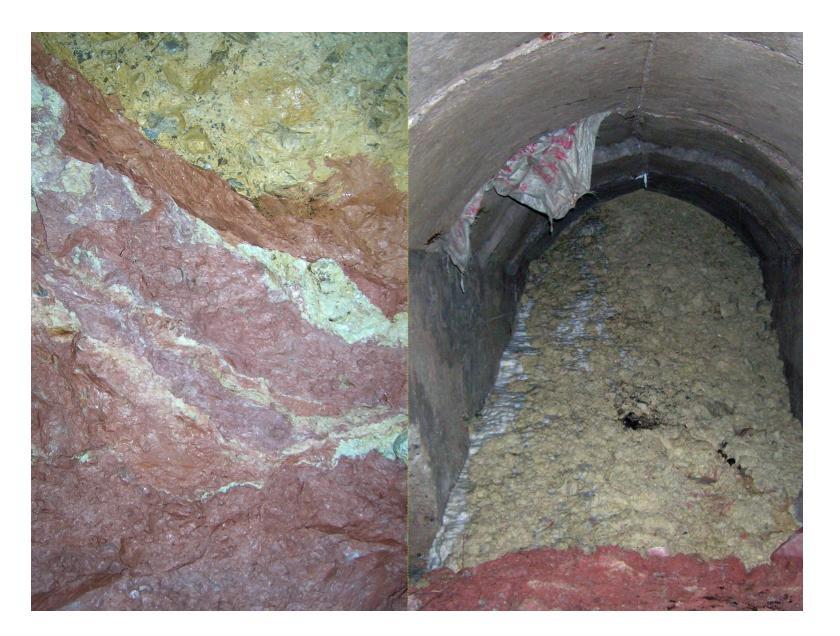
Figure 17. The sliding zone and slip mass in tunnel near by the eastern lateral edge.

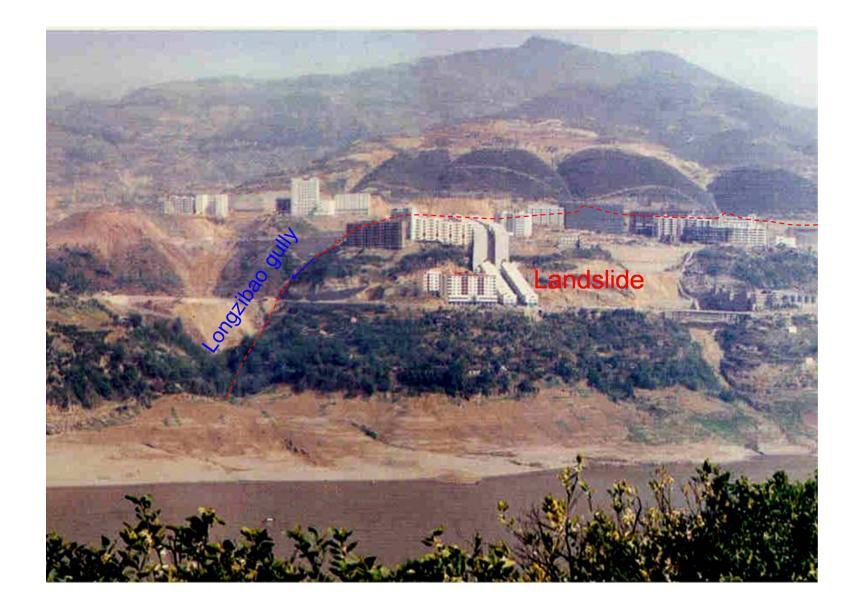
Figure 18. The western lateral edge of the Sanmashan landslide.

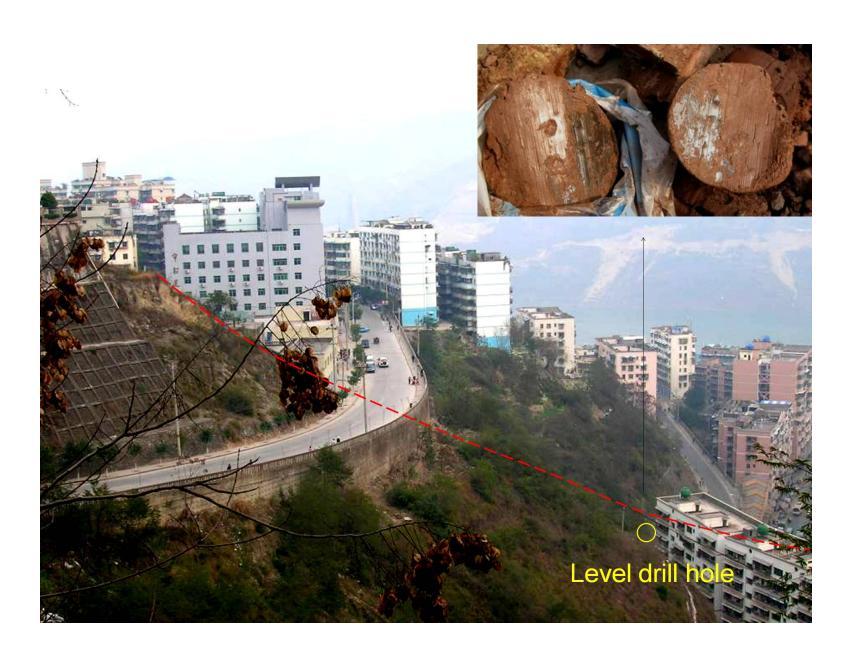
Figure 19. The sliding scrape in level drill hole near by the western lateral edge.

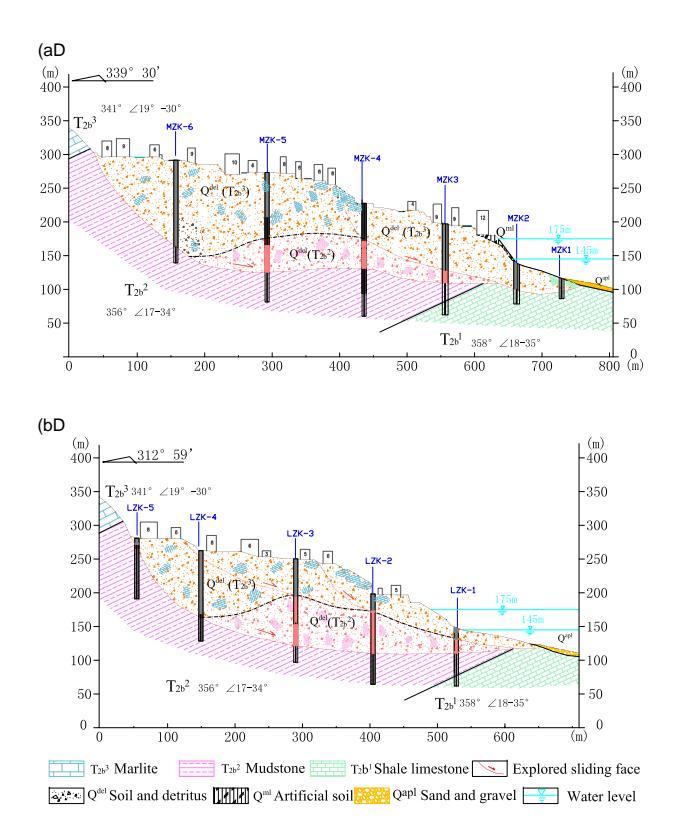
Figure 20. The geological profile of the Sanmashan landslide. (a) Section of I–I'. (b) Section of III–III'

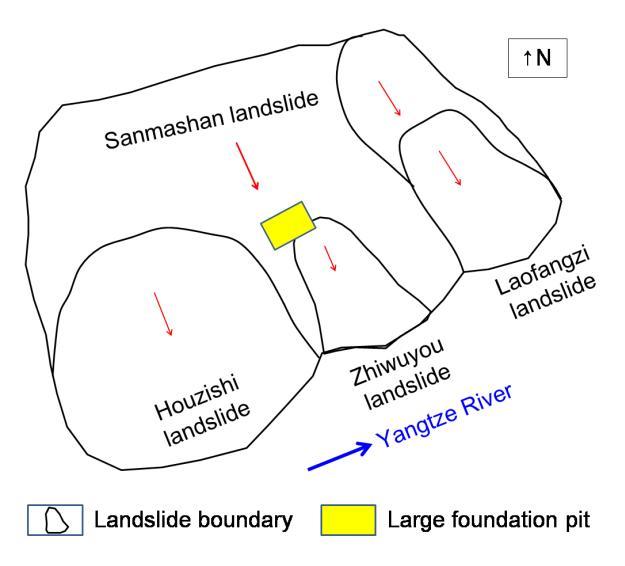
Figure 21. Location of the large foundation pit in the center of the landslide.

The crushed stone is derived from limestone and maritie (T_{2b}^3) . A large foundation pit was constructed in the center of the landslide during field surveys (Figs. 21 and 22). The slide zone of the Zhiwuyou secondary landslide is exposed in the eastern wall (Figs. 23 and 24), and the rock masses in the western wall have anomalous attitudes

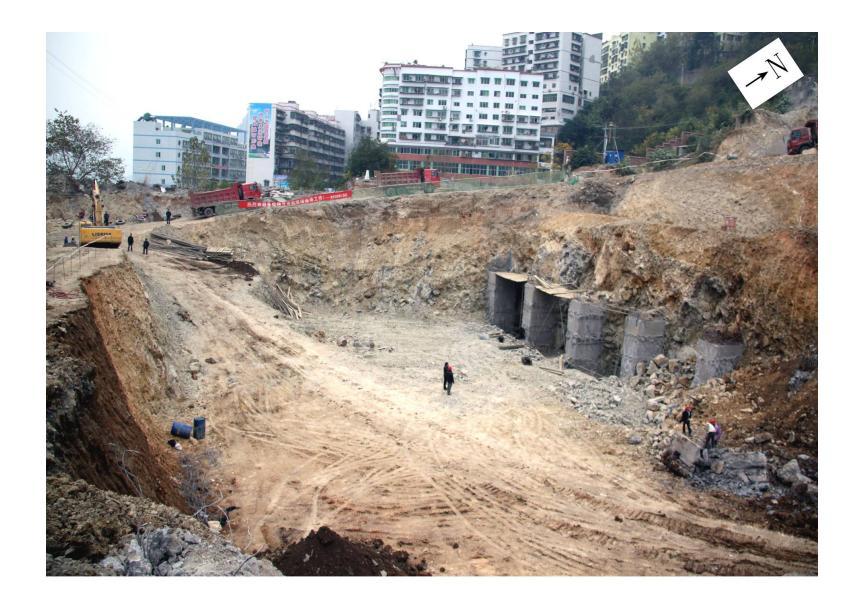
Figure 22. Overview of the foundation pit (photograph taken in 2013).

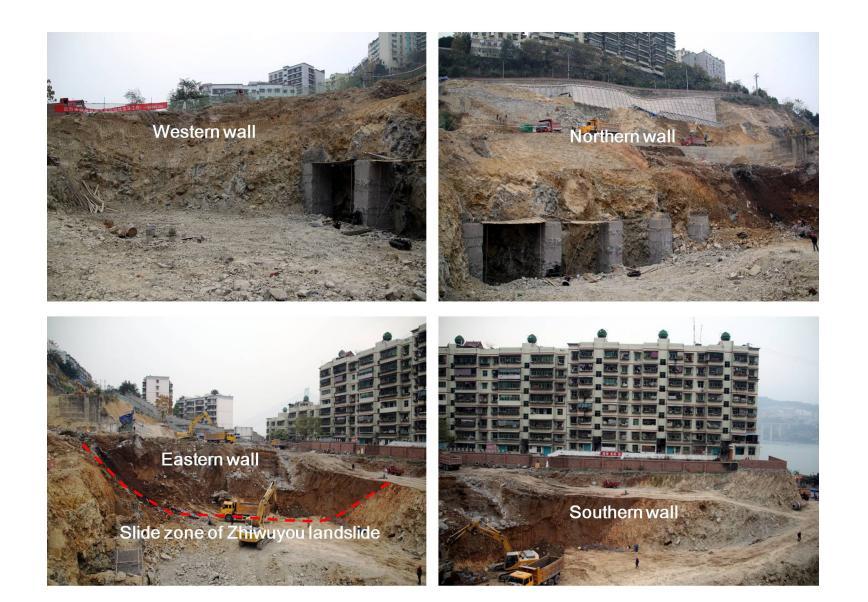
Figure 23. The geologic structure of four walls in the foundation pit.

with respect to each other (Figs. 23 and 25). (2) The second unit is denser, reddish or dark red-brown, and contains crushed stone, within clay and silty clay. The crushed stone is derived from mudstone and silty mudstone (T_{2b}^2) . (3) The third unit is denser, earthy yellow or light gray, and contains crushed stone, within sand and silty clay. The crushed stone is derived from limestone and shalv limestone (T_{2b}^1) . (3) The third unit is denser,

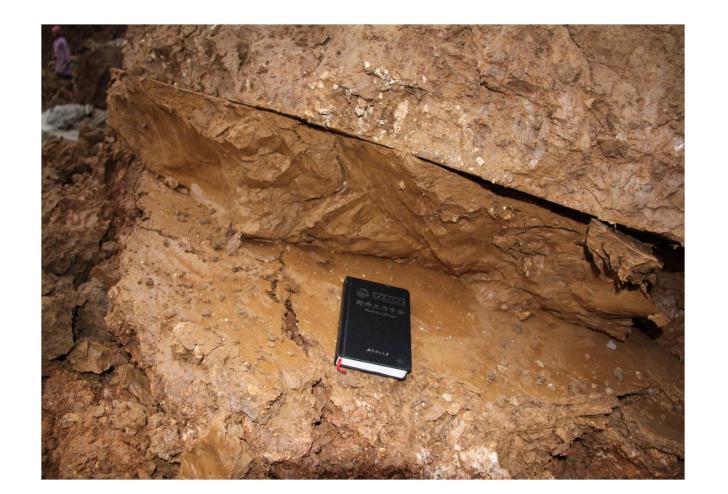
Figure 24. Close-up view of the slide zone of the Zhiwuyou secondary landslide.

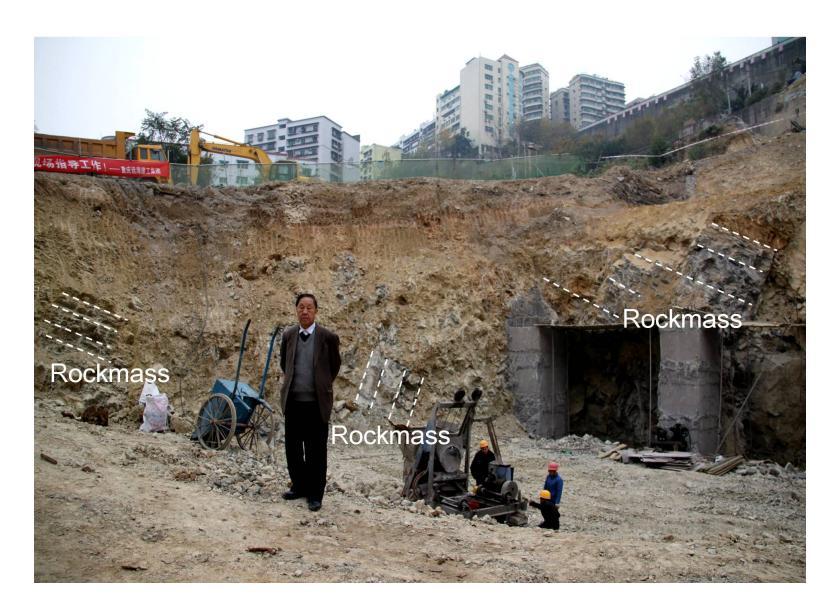
Figure 25. Rockmass showing their anomalous attitudes each other in the western wall of the foundation pit, and this kind of geologic structure is only generated by landslides.

- their anomalous attitudes each other in the western wall of the foundation pit, this kind of geologic structure is only generated by landslides. The results of this study have confirmed that the Sanma Mountain in the new city of Fengjie is a large-scale ancient deep-seated landslide. From analysis of the slope deformation process and failure in centrifuge experiment model, it is reasonable to summarize the deformation and failure

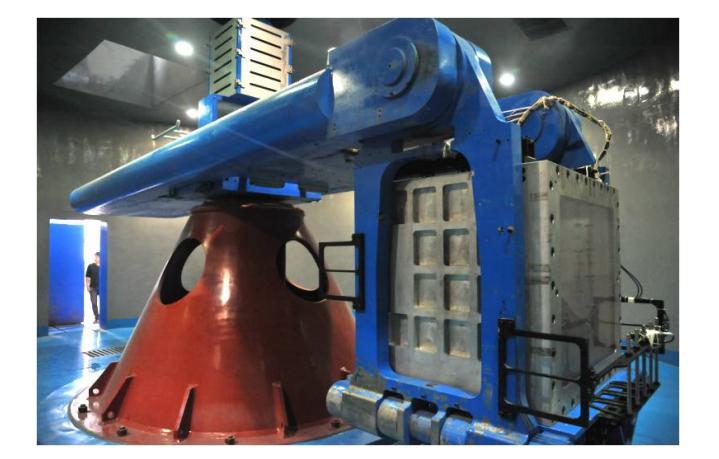
Figure 26. The geotechnical centrifuge used in experimental modeling.

- spin (outward). Geotechnical centrifuge modeling is used for physical testing of models involving soils and rock. Centrifuge acceleration is applied to scale models to scale the gravitational acceleration and enable prototype scale stresses to be obtained in scale models. Problems such as building and bridge foundations, earth dams, tunnels, and slope stability, including effects such as blast loading and earthquake shaking.
- Large centrifuges are used to simulate high gravity or acceleration environments. This experimental modeling used a centrifuge at the State Key Laboratory of Geohazard Prevention and Geoenvironment Protection in China (Fig. 26). Its maximum acceleration is 500 gt, and it is the largest geotechnical centrifuge in Asia.

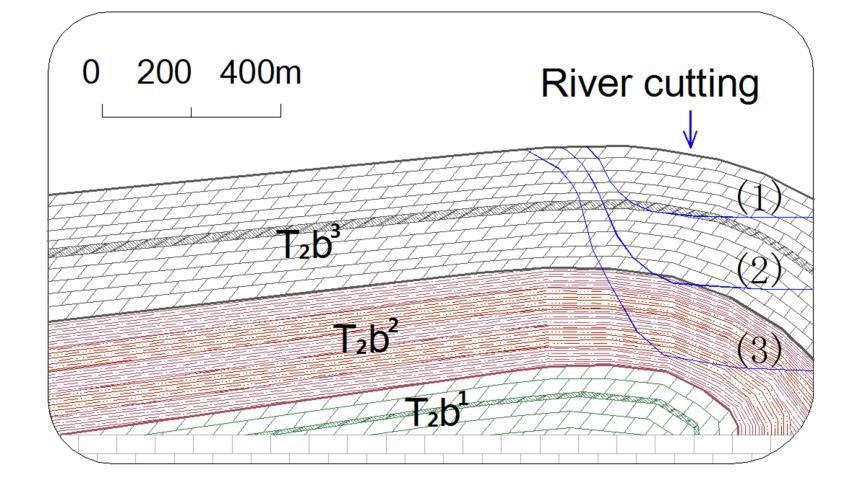
Figure 27. The geological model of slope.

coefficient is deduced (Table 1). The geological model (Fig. 27) was generalized into a test model (Fig. 28). Rock parameters were obtained from physical and mechanical geotechnical engineering tests (Table 2).

- ⁵ The experiment situations and observed results were as follows. First, there was a quiet period in which the Yangtze River cut into the central part of T_{2b}^3 . Tension cracking appeared at the surface of the slope, extending and scaling down (Figs. 27 and 29). Second, an intense period of incision in the bottom part of T_{2b}^3 occurred. Shear creep took place along the bottom weak zone, and there was rapid expansion of the upper
- ¹⁰ crack (Figs. 27 and 30). The third phase was a short and intense period of cutting into the bottom part of T_{2b}^2 . The crack cut through the bottom of the unit, and a landslide swiftly occurred (Figs. 27 and 31).

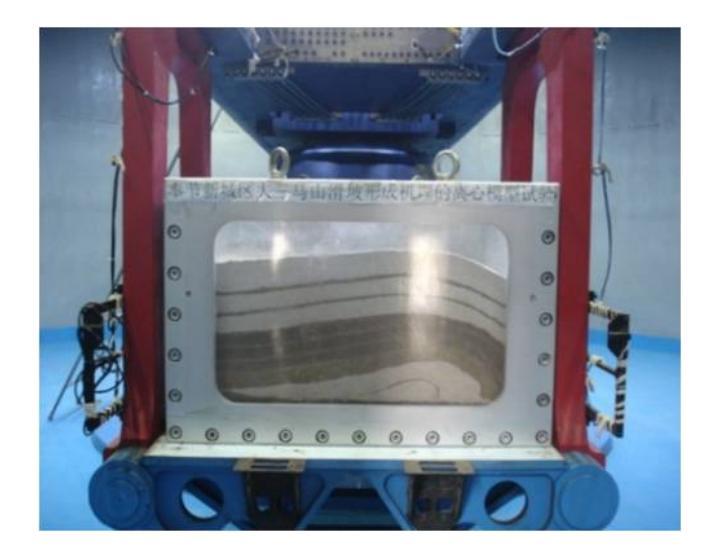
Figure 28. The experimental model.

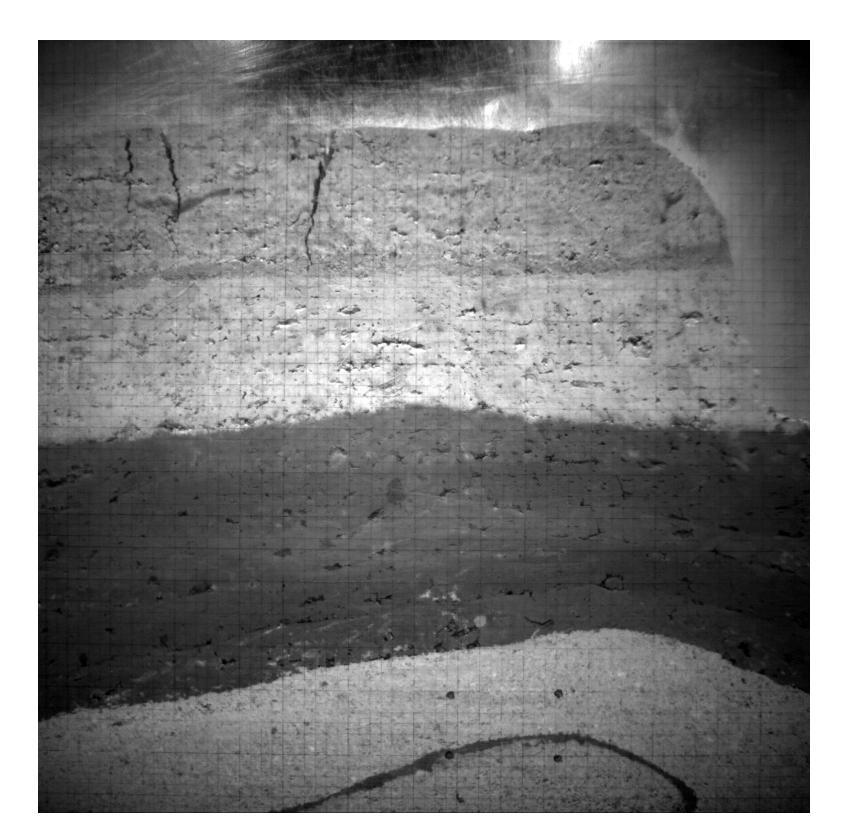
Figure 29. Tension cracking in trailing edge and top.

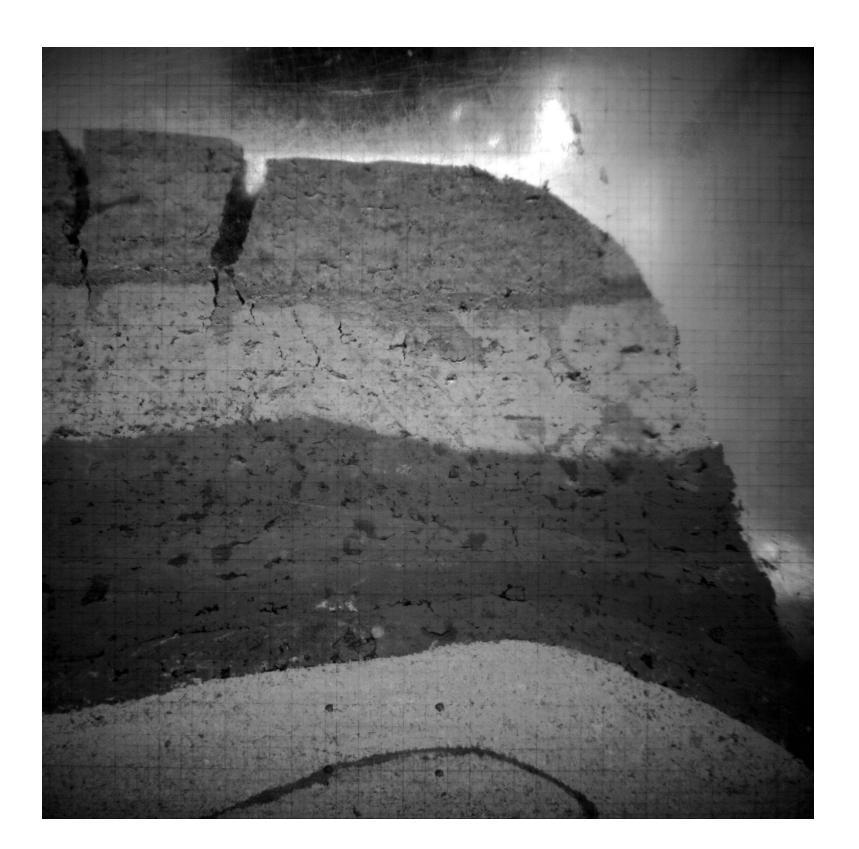
Figure 30. Going cracking and shear creeping at the bottom.

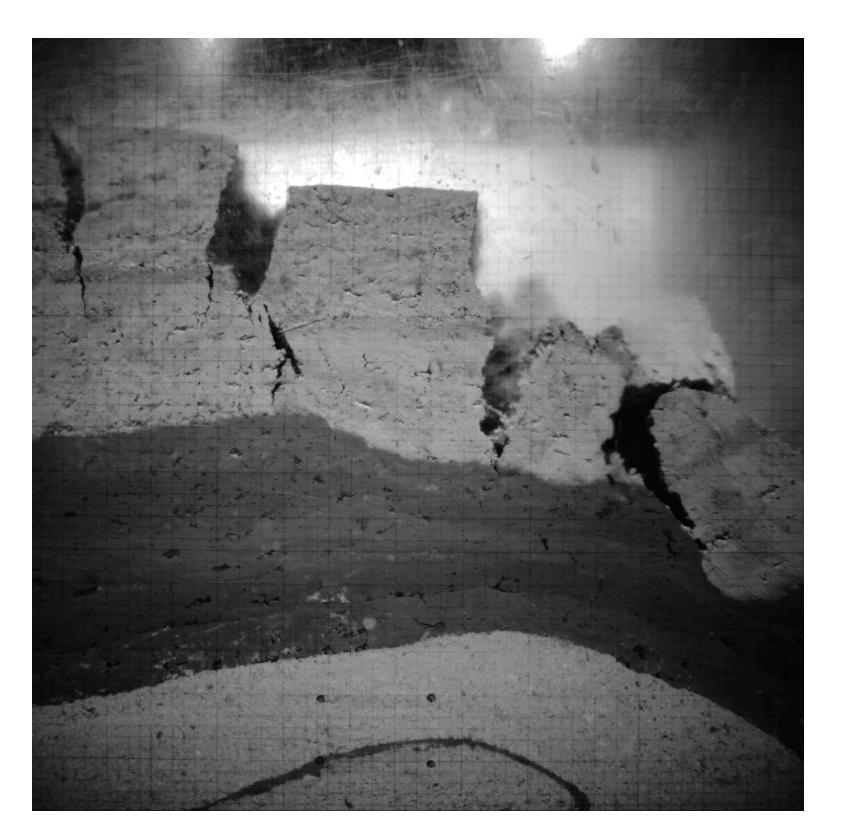
Figure 31. Whole sliding, breaking up and collapsing.

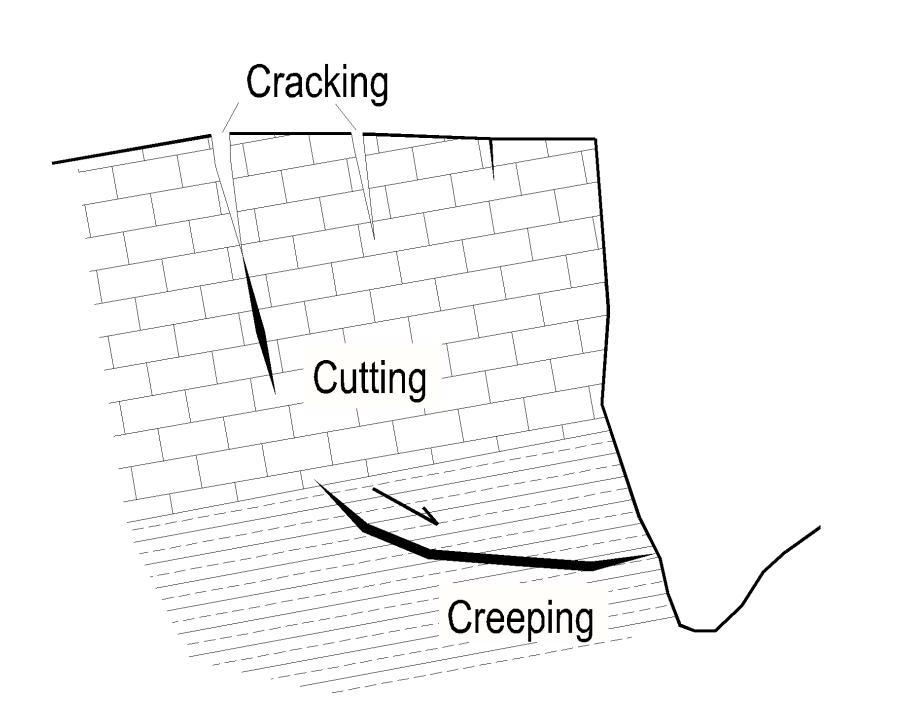
Figure 32. Sketch of failure type of the landslide.

The deformation and failure mechanism can be summarized as "Creep–Crack–Cut" (Fig. 32). This failure mode generally occur as a result of river incision into a nearly

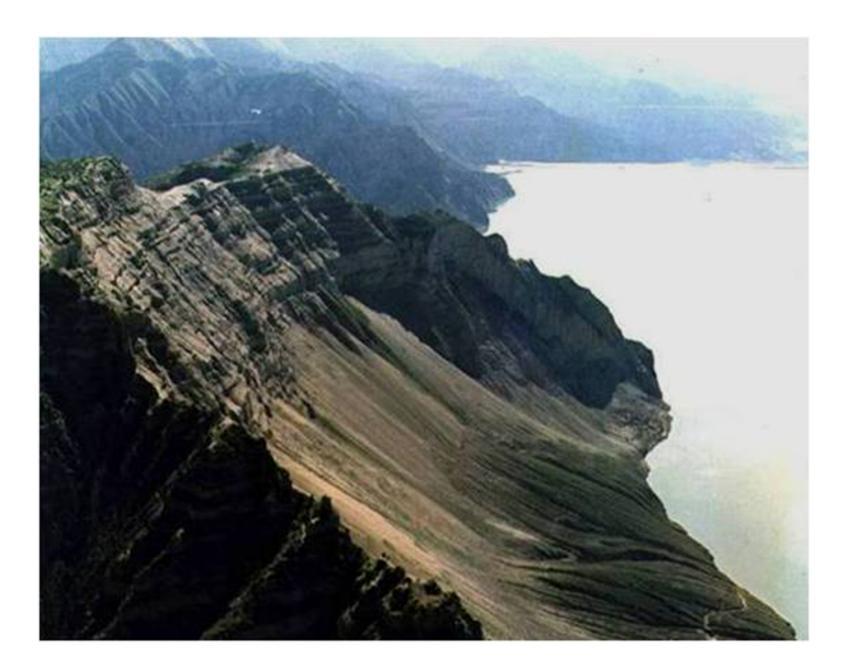
Figure 33. The Chana landslide, Longyangxia, China.

¹⁵ level layered slope with hard rock overlying soft rock. Such as the Chana landslide, Longyangxia in the Yellow River (Fig. 33) and the Yanchihe landslide of Hubei Province, China. In order to early recognition and warning of such landslides, key hazard factors and failure precursors of slope failure are discussed (Table 3).

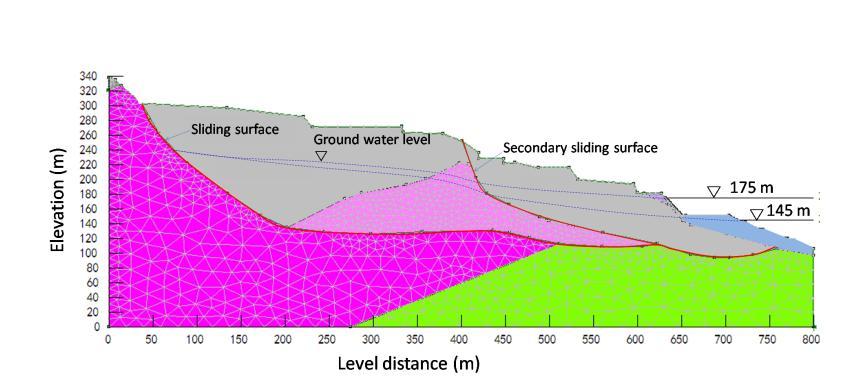
Figure 34. Stability analysis model of the Sanmashan landslide.

On the basis of the research above, we analyzed the seepage and stability of the Sanmashan deep-seated landslide using Geostudio 2007 (Fig. 34). The results of the analysis are discussed below.

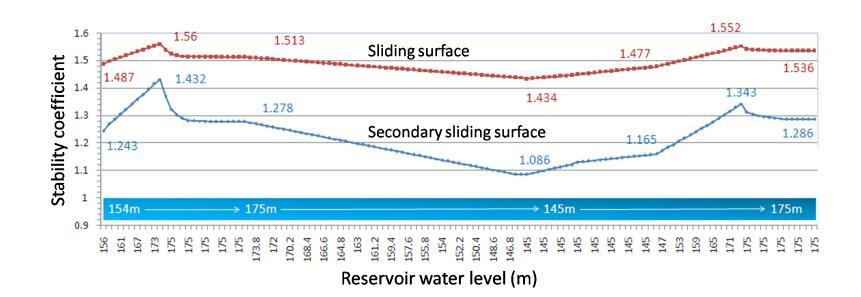
Figure 35. Stability changes with water level of the Three Gorges reservoir.

If the reservoir water level increases from 145 to 175 m, using the current rate of reservoir scheduling, landslide stability will increase as a result of a rise in the

level of the reservoir to 175 m, landslide stability will begin to decrease with further rises in groundwater level. If the reservoir water level is reduced from 175 to 145 m, at the current rate of reservoir scheduling, the resulting decline in the groundwater level behind the water level of the reservoir will cause landslide stability to decrease. After

reduction of the water level of the reservoir to 145 m, further decline of the groundwater level will cause landslide stability to increase gradually. (Fig. 35).

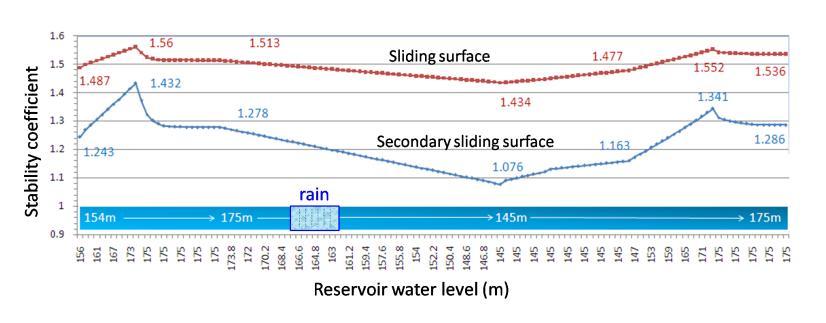
Figure 36. Stability changes with water level of the Three Gorges reservoir and rainfall.

Considering the amount of rainfall $(120 \text{ mm d}^{-1}, 3 \text{ days})$ during the period when the reservoir water level changes from 175 to 145 m, and comparing with the situation with no rain, rainfall has little effect on the stability of the whole landslide, but has a large

¹⁰ influence on the occurrence of secondary landslides at the front of the main slide. (Fig. 36).
