1	Risk Factors and Perceived Restoration in a Town Destroyed by the 2010 Chile Tsunami
2	
3	Carolina Martínez ^{1, 6} , Octavio Rojas ² , Paula Villagra ³ , Rafael Aránguiz ^{4, 6} , Katia Sáez-Carrillo ⁵
4	
5	
6	¹ Instituto de Geografía, Pontificia Universidad Católica de Chile, Santiago, 8320000, Chile
7	² Departamento de Planificación Territorial, Universidad de Concepción, Concepción, 4030000, Chile
8	³ Instituto de Ciencias Ambientales y Evolutivas, Universidad Austral de Chile, Valdivia, 5090000, Chile
9	⁴ Departamento de Ingeniería Civil, Universidad Católica de la Santísima Concepción, Concepción,
10	4030000, Chile
11	⁵ Departamento de Estadística, Universidad de Concepción, Concepción, 4030000, Chile
12	⁶ National Research Center for Integrated Natural Disaster Management (CIGIDEN), Santiago, 8320000,
13	Chile
14	
15	Correspondence to: Carolina Martínez (camartinezr@uc.cl)
16	
17

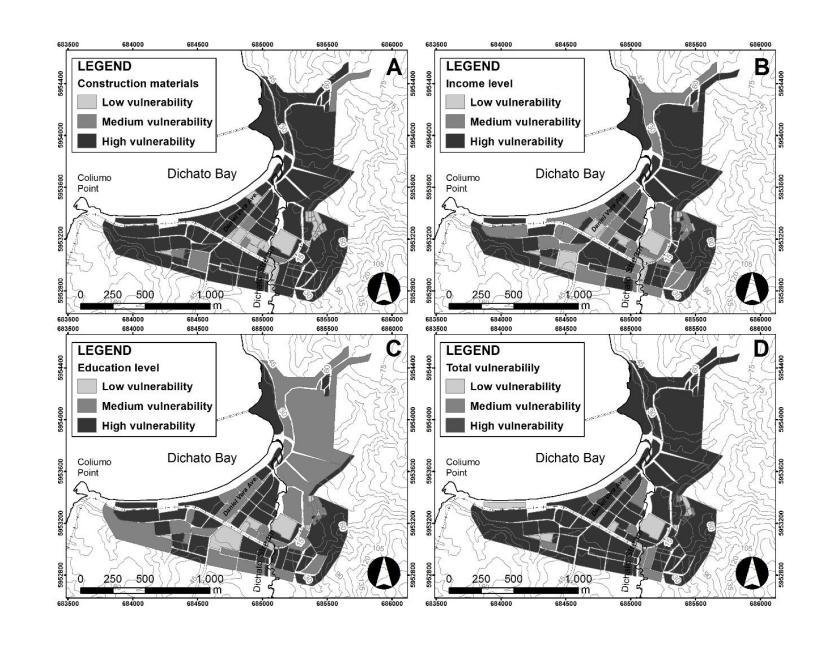
Fig. 6. Post-event Tsunami vulnerability of the town of Dichato
