Experimental study of embankment breach based on its construction parameters

Sachin Dhiman¹, Kanhu Charan Patra¹,

¹Civil Engineering Department, National Institute of Technology Rourkela, Rourkela, 769008, India

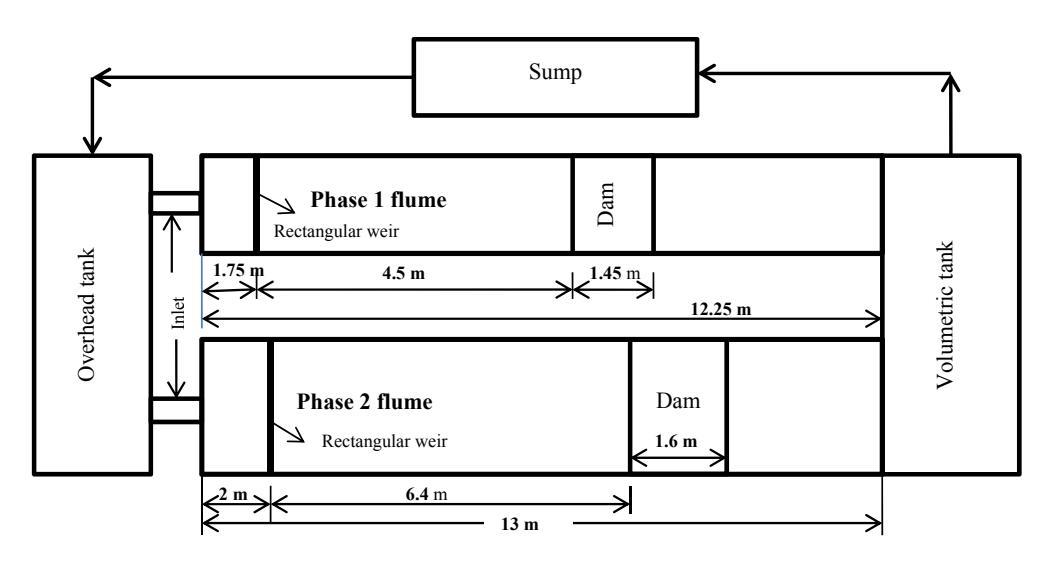
5 Figure 1: Experimental setup (not to scale)

- 5 Eight experiments of overtopping failure of cohesive embankments were carried out in two phases. Five experiments were conducted in phase 1 in a small width flume having a dimension of 17 m long, 0.6 m wide and 0.6 m high. In phase 2, three experiments were carried out on large width flume having aspects of 13 m long, 1.75 m wide and 0.5 m high at the Hydraulics Engineering Lab of NIT Rourkela. Figure 1 shows the schematic diagram of experimental setup for Phase 1 and Phase 2. A recirculating water supply system was established from an underground sump to an RCC overhead tank into the

- 10 flumes and back to the sump through the volumetric tank. The operating valves were calibrated for different openings to get the desired discharge before the experiments. In all the experiments of phase 1, a constant inflow of 0.9 L/s was maintained, while in Phase 2 experiments inflow hydrograph was provided to the reservoir for maintaining constant head condition throughout the experiment. For obtain continuous video documentation of each experiment, two video cameras were used; one camera was placed in front of downstream slope of the embankment to provide an oblique view, while another was set at

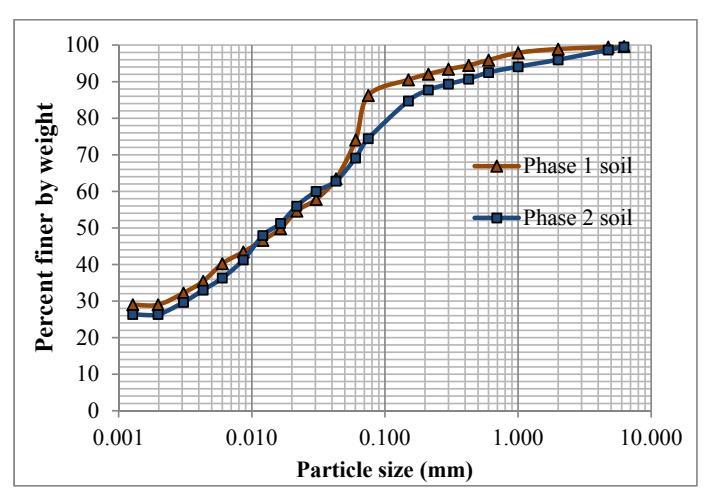
Figure 2: Gradation curve

- 20 size distribution of the soil used in phase 1 embankment construction had 29% clay, 57% silt, and 14 % sand. In case of phase 2 embankments, the particle size distribution was 26% clay, 48% silt and 26% sand. The average particle size (*d₅₀*) of soil type 1 and soil type 2 was 0.018 mm and 0.019 mm respectively. The gradation curves for both soils are shown in Fig. 2. Before the experiments the standard proctor test [IS: 2720 (Part 8) 1983] was performed for constant compaction effort on soils to obtain the maximum dry density and optimum moisture content (OMC). These soil properties were necessary to

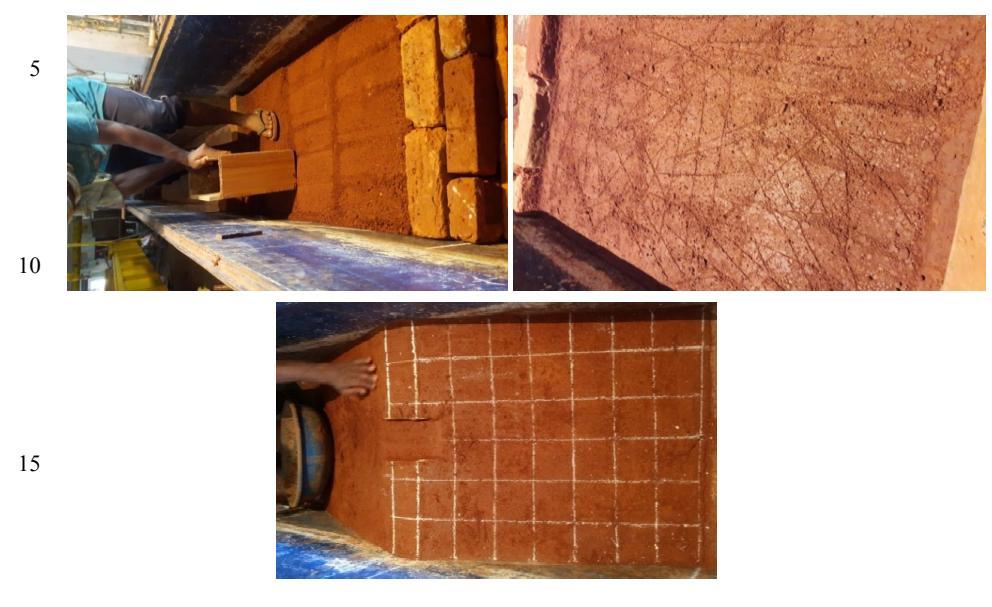
Figure 3: Images of embankment construction for Phase 1 experiments

- 5 The embankments were built in six horizontal layers of 0.05 m each, compacted with manual soil temper of 30 x 10 (length x width). Before compaction, the required amount of water was mixed thoroughly with dry soil to attain the moisture content and emphasis was given for maintaining constant drop height throughout the dam construction for achieving uniformity. After achieving the predetermined height of the dam, it was trimmed to get the desired shape on the top width, upstream and downstream slope of the embankments. Fig. 3 shows few images of embankment construction for Phase 1.

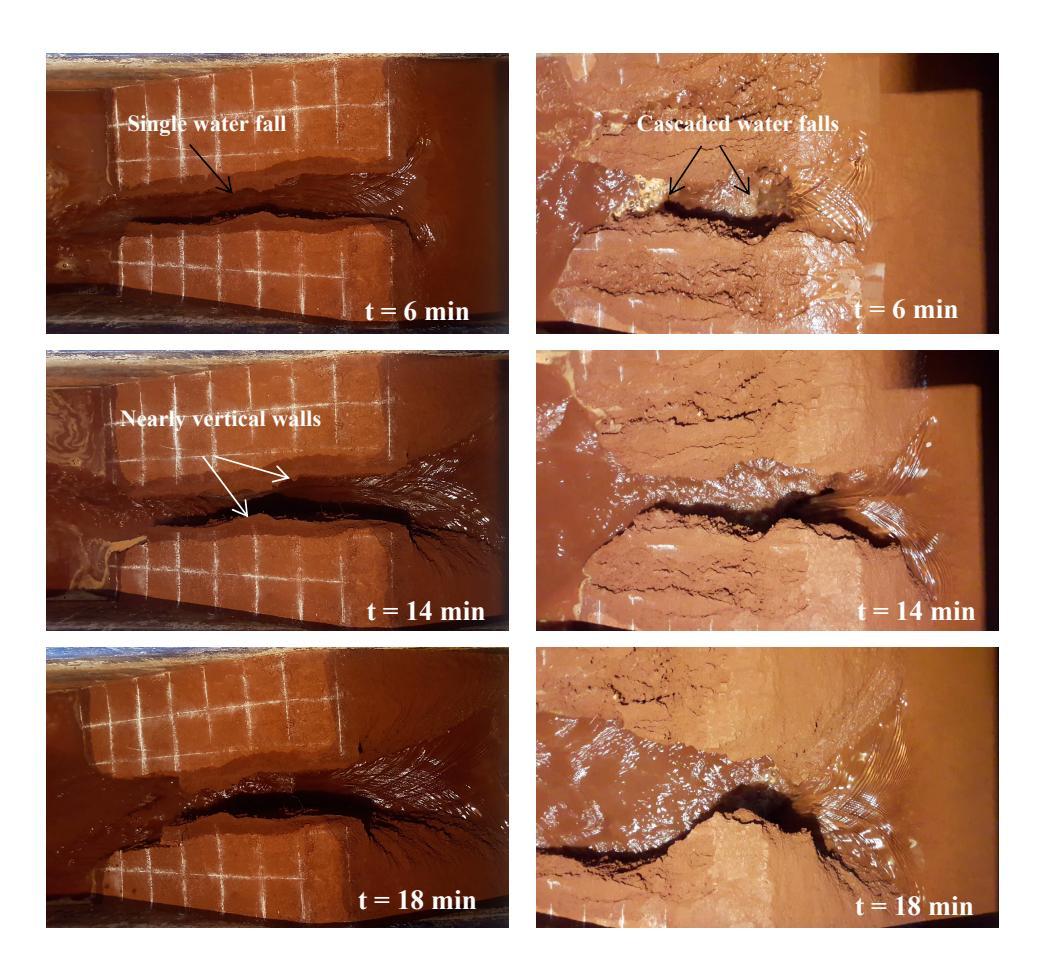
Figure 4: Photograph showing comparison between experiment P1.2 (Left) and P1.3 (Right) at t= 6, 14, and 18 min

The headcut migration rate for all the experiments was obtained and analysed from the recorded videos of embankment failures. Snapshot of headcut locations for experiment 2 and 3 for different time lapses are shown in Fig. 4. The cascading waterfalls last long in the embankment compacted with 75% of moisture content than the embankment with 50% moisture

- content. As seen in Fig 5 at time t = 6 min, cascaded water fall observed in the P1.3 experiment, while in case of P1.2 20 experiment a single smoothed water fall is present. It has been noted from the experiments that reduction in moisture content from the optimum moisture content by 25% and 50%, the evolution pattern was different with a very slight change in headcut migration rate.

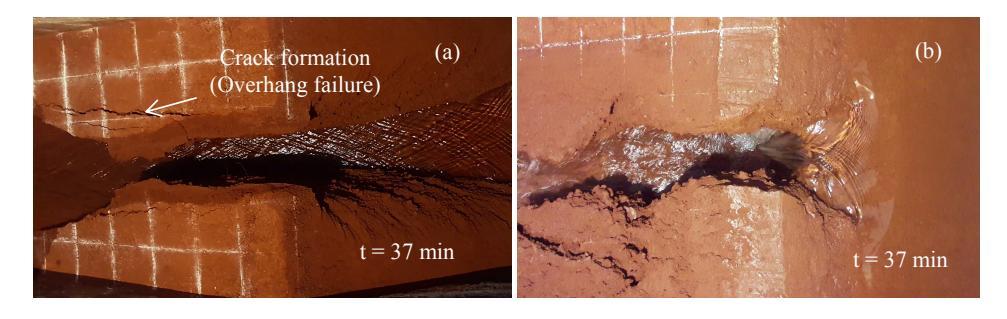
Figure 5: Photograph showing comparison between experiment P1.2 (a) and P1.4 (b) at t=37 min

- (50% reduction in moisture content) and P1.4 experiment (50% reduction in compaction effort) at 37 min is shown in Fig. 5. 30 Headcut migration rate for P1.2, P1.3, and P1.4 are shown in Fig. 6.

The cracks due to undercutting of breach channel side slope by water was observed in unsaturated embankments (P1.2 and

- 10 P1.3), which leads to the overhang material (Fig 5 (a)) and when the holding capacity of overhang materials decreased it fail into the breached channel (mass erosion) leading to the partial blockage. Mostly, this blockage was at the downstream of the embankment and did not obstruct the flow as much. This mass erosion leads to the sudden increase in breach width. A similar observation was reported on non-cohesive embankments by Pikert et al. (2011). The breach width expansion rate in saturated embankments (P1.4 and P1.5) was negligible and remains constant as of the pilot channel width provided at the top
- 15 of embankment crest.

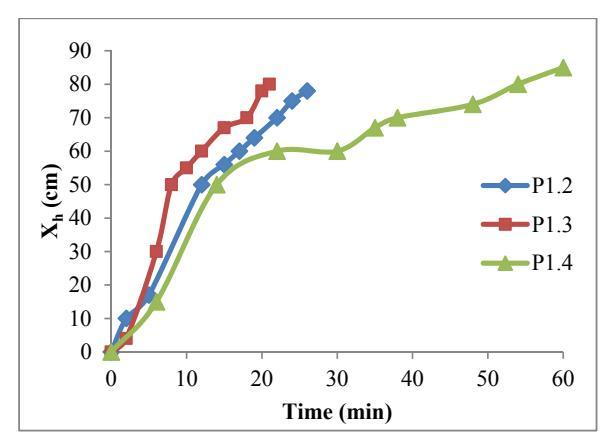
5 Figure 6: Headcut migration rate for experiment P1.2, P1.3, and P1.4

For a decrease of 24% in compaction moisture content from the optimum moisture level, there was ten times increase in average headcut migration rate. Further reduction in moisture content to 50% shows little change in headcut migration rate. In first breach scenario of embankment, the headcut migration rate for experiment P1.3 was slow as compared to the headcut migration rate in experiment P1.2 but in second breach scenario, there was an increase in headcut migration rate as well as

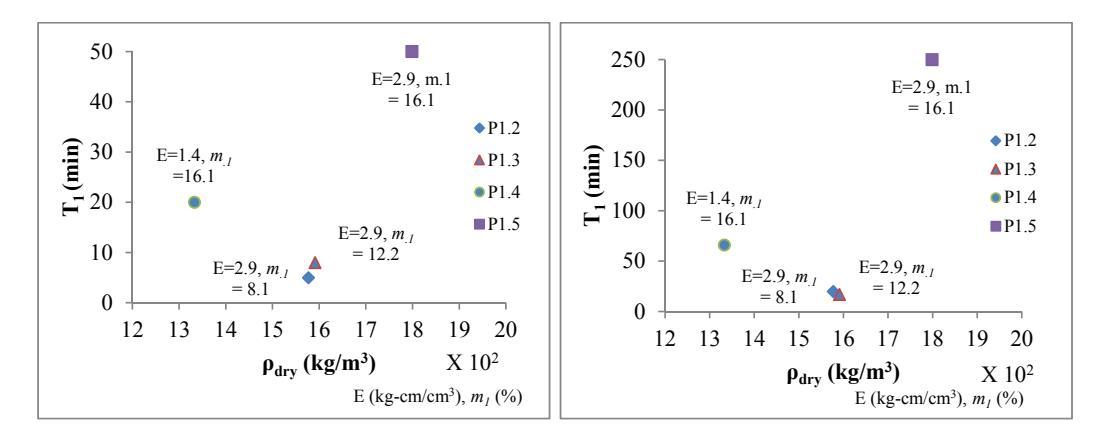
Figure 7: Phase 1 (a) breach Initiation time; (b) breach formation time

5 surface erosion for P1.3 experiment as compared to experiment P1.2 was noticed leading to the quick failure of the embankment. The above discussion was observed in the variation of breach initiation time and breach formation time as shown in Fig. 7. The experiment P1.2 and P1.3 conclude that the compaction moisture content played an important role in soil erosion.

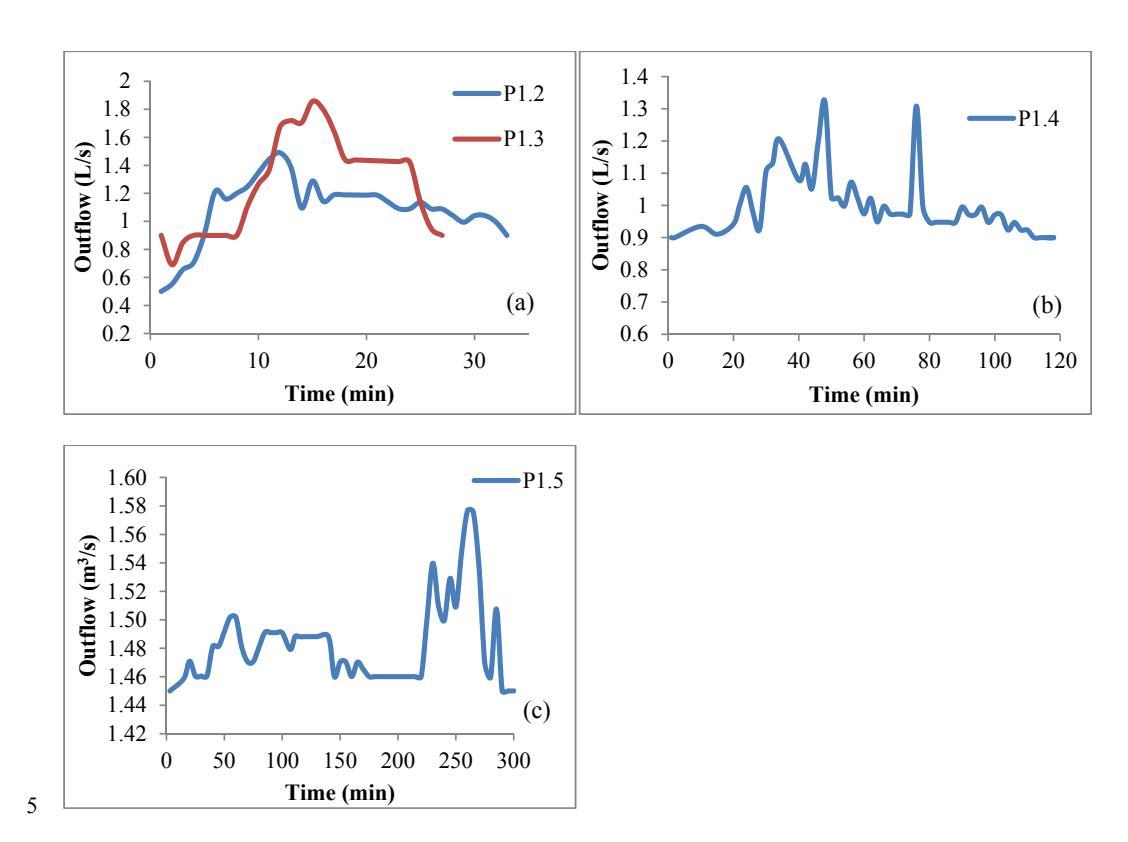
Figure 8: Breach discharge for experiments; (a) P1.2 &P1.3; (b) P1.4; (c) P1.5

- 20 on decreasing with the progression of the breach. It can be seen that time duration of outflow hydrograph of experiment P1.2 and P1.3 is nearly same so, plotted in a single graph [Fig. 8 (a)]. The outflow hydrograph for experiment P1.4 and P1.5 are shown in Fig. 8 (b) and (c) respectively. A constant inflow of 0.9 L/s was maintained throughout the experiment P1.3 and P1.4. For experiment P1.2 and P1.5, the inflow was 0.74 l/s, and 1.4 L/s was maintained respectively. The breach outflow was strongly dependent on the construction parameters. It was observed from the overtopping failure of unsaturated

- 25 embankments P1.2 and P1.3 that there was 2 times increase in the peak outflow from their respective inflow peaks. It has been observed that reduction in compaction water content from 25% to 50% in embankment construction, the difference in peak outflow and time to peak was very less. Maximum change in peak outflow and time to peak was noticed in embankments compacted for more than 75% moisture content. There were 20 times decrease in time to peak when 25% reduced the compaction moisture content from the optimum moisture content. Further reduction of 25% in moisture content

- 30 during construction decreases time to peak by 7.6%. Reduction of compaction water content from 25% to 50% shows a little change in peak outflow and time to peak. More investigation on the overtopping failure of embankments constructed between the ranges of 0 to 25 % reduction in compaction water content from the optimum moisture content is required. For the saturated embankment P1.5, compacted with compaction effort of 2.9 kg-cm/cm³, there was 12.8% increase in outflow

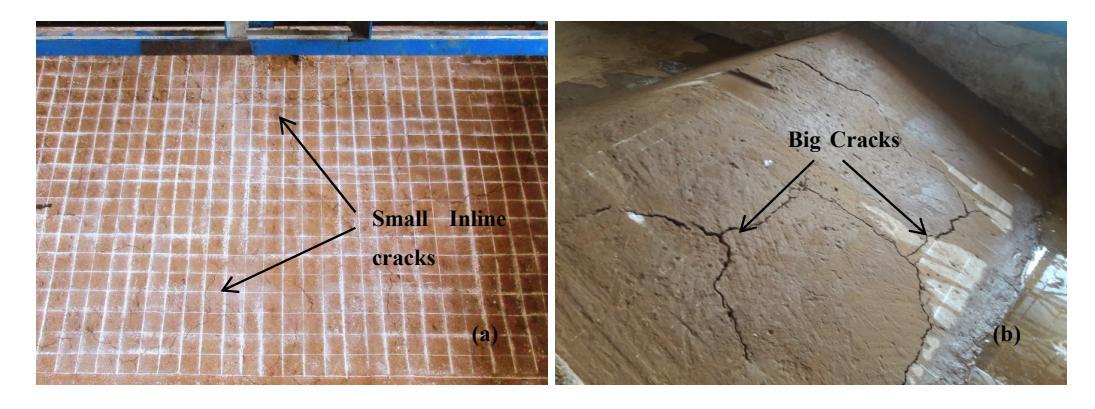
Figure 9: Crack formation in embankments (a) P2.1 and (b) P2.2

- 10 for 240 hours to remove its water content for developing cracks, which were visible to naked eyes. During this duration, the embankments were made wet and dried several times. The water content of embankment P2.1 and P2.2 after air dried was nearly half of the compaction water content. The cracks developed in embankments P2.1 and P2.2 are shown in Fig 9. The construction parameters are shown in Table 3. The soil samples were collected from the top surface and inner layers of the embankment for finding out the moisture content present at the time of the experiment. The water content of embankment

5 6.9 L/s. Fig 10 (b) shows the comparison between inflow hydrograph to the outflow hydrograph. As the compaction moisture content was more than the optimum moisture content, the development of large cracks in the embankment was observed. The cracks formed were approximately 3 mm wide, 5 cm deep and the effect of these cracks on breach time, breach evolution, and peak outflow was observed.

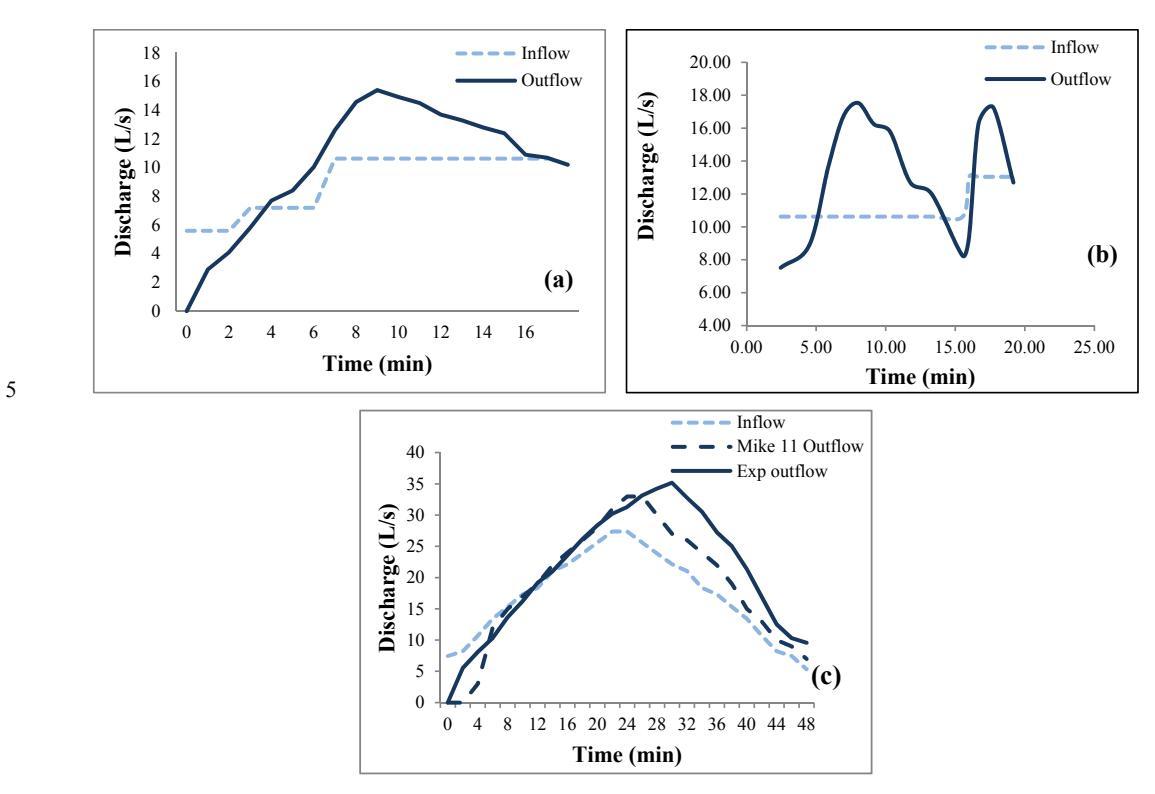
Figure 10: Comparison between inflow and outflow hydrograph for the embankment: (a) P2.1, (b) P2.2 and (c) P2.3

25 from the inflow peak. The time difference between the inflow peak and outflow peak is known as lag time. When breach formation takes place, the reservoir water starts contributing to the breached outflow causing the higher peak values of outflow. The attenuation and lag time observed was 3758.5 cm³/s and 120 sec respectively. The comparison between the inflow hydrograph *verses* the outflow hydrograph is shown in Fig. 10 (a).

- 20 from the inflow peak. The attenuation and lag time observed was 7781.55 cm³/s and 6 min respectively. Figure 10 (c) show comparison between inflow hydrograph w.r.t the outflow hydrograph.

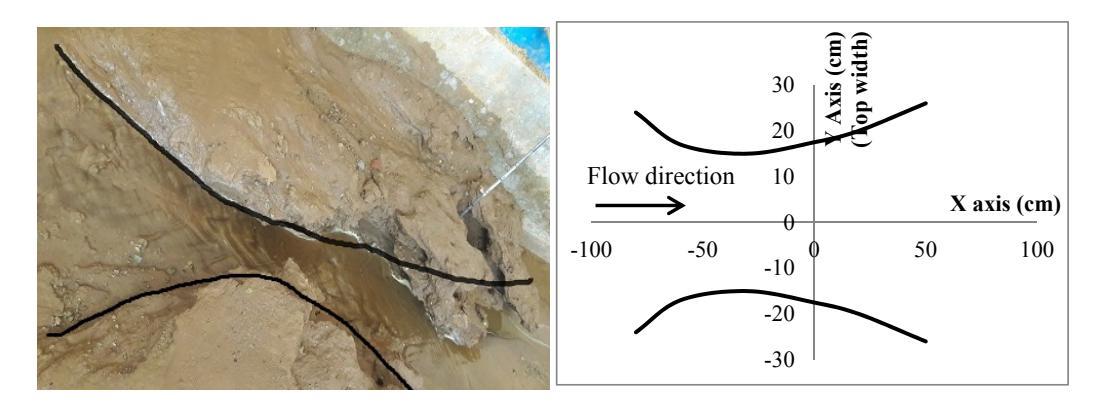
Figure 11: Embankment P2.3; (a) Parabolic shape of breach; (b) Scaled diagram of parabolic breach

- 10 The time taken for complete failure or breach formation was 35 min. Breach initiation time and breach formation time was 10 min and 24 min respectively. The final breach depth was 27 cm. The crest height of embankment after overtopping was 22 cm, i.e., up to 8 cm of crest height along the whole length of the embankment was eroded. The formation of final breach width can be explained and understood by dividing the breach process into three parts. Part 1, was the upstream slope; Part 2, was the crest width; and Part 3, was the downstream slope of the embankment. Breach width noticed in part 1 at a distance

- 15 of 10 cm, 30 cm, and 60 cm from the upstream toe end was 48 cm, 30 cm, and 27 cm respectively. At the center (part 2), breach width was 35 cm, and in part 3, breach width at 10 cm and 40 cm from the downstream slope toe end was 54 cm and 40 cm respectively. The breach shape geometry formed in this test was shown in (Fig. 11a & 11b). For further analysis, we take an average of breach width, of 40 cm as final breach width (Table 5). The inflow hydrograph of 50-minute duration was provided to the reservoir for maintaining the constant head. There was 28.42% increase in the outflow peak was observed
