1									
2	Geophysical and Geodetical Investigation of A Landslide Area (Koyulhisar-Sivas,								
3	Turkey)								
4	Sevda ÖZEL ¹ , Demet ÖVER ² and Kemal Özgür HASTAOĞLU ³								
5	^{1.2} Cumhuriyet University, Engineering Faculty, Department of Geophysical Engineering, 58140, Sivas, Turkey, sozel@cumhuriyet.edu.tr.								
6	³ Cumhuriyet University, Engineering Faculty, Department of Geomatics Engineering, 58140, Sivas, Turkey, khastaoglu@cumhuriyet.edu.tr.								
7	Abstract								
8	This study includes geophysical studies carried out in the last section in the close south of Koyulhisar								
9	(Sivas) landslide site. Additionally, the study area is in the most active location where landslide's displacement								
10	amount is the highest. The landslide site basically has been examined geophysics (SRT, GPR) and geodesic								
11	(GNSS) methods. According to the geophysical results, within ~20 m of investigation depth (a) rs with the

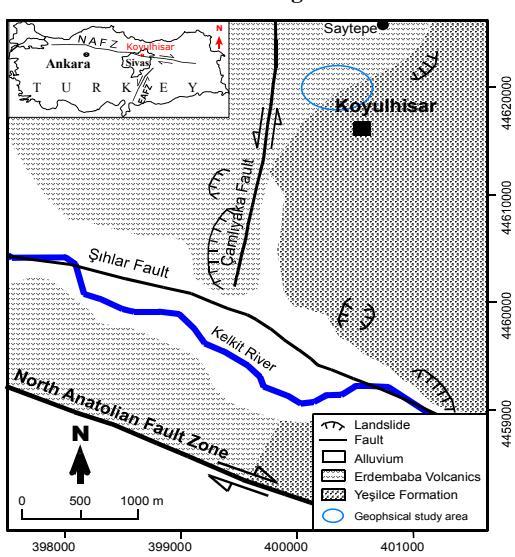
449 Figure 1. Geological map of study area arranged from Sendir and Yılmaz (2002) and Hastaoğlu (2016).

101 The study area is about 180 km away from Sivas city center and is in the west of Koyulhisar district center which 102 is located in the north of the NAFZ (Fig. 1 and 8). The rocks in the region usually have fractures and 103 discontinuities and are crushed because of the NAFZ which is tectonically active in south of the study area 104 (Tatar et al., 2005). There are also many old and new landslides in the study area depending on the high tilted 105 topography. For these reasons, the directions of movement of the landslides generally threaten the settlement 106 areas (Sendir and Yılmaz, 2001). The geological investigation of Koyulhisar has been carried out regionally or 107 locally by various researchers (Terlemez and Yılmaz, 1980; Toprak, 1989; Uysal, 1995; Sendir and Yılmaz, 108 2002; Duman et al., 2005; Hatiboğlu, 2009). According to these studies, the Plio-Quaternary aged Koyulhisar 109 Formation is the youngest unit in the region. It was stated that the youngest unit consisted of the talus (slope or 110 deposit) and fluvial conglomerates and was seen along the strike-slip faults (Toprak, 1989).

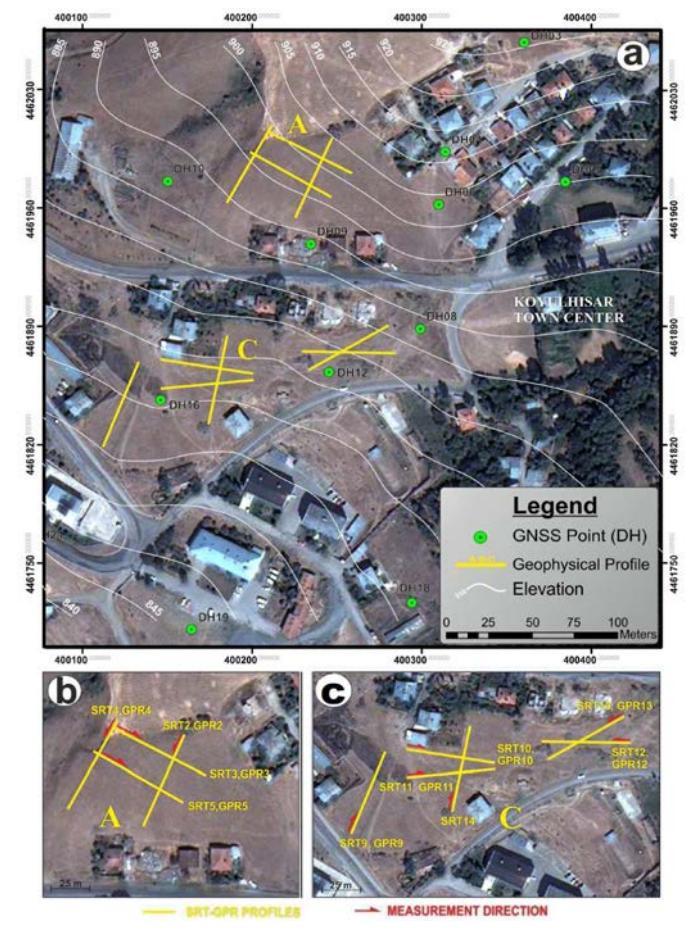
- 451 Figure 2. (a) Geophysics and geodetic data collection locations in the study area. (b), (c) and (d) geophysics
- 452 profile details.
- 453

133	the study area was named as A-C and the geophysical measurements were collected separately in these areas
134	(Fig. 2). Then, the geophysical profiles were processed to the satellite map according to the coordinates along
135	with the topographical elevation curves and GNSS measurement locations for the ease of interpretation (Fig. 2a).
136	Geophysical measurements were taken as both NE-SW and NW-SE oriented due to the geologic bedding and
137	topographic features (Fig. 2b-c). However, SRT12-GPR12 profiles were selected as about E-W oriented due to
138	rugged topography in area C. The profile lengths usually range from 40 to 60 m according to the method applied.
139	10 SRT measurements were taken in all areas in the seismic study for geophysical measurements. 10 profile
140	GPR measurements were taken in areas A and C in the electromagnetic study. Drofile shooting technique in
141	the field, hammer and iron plate of 8 kg weight as the source and 12 P geophones of 14 Hz and Geometrics

152	profiles, and SRT9 and SRT14 profiles in the close NE-SW direction in the same area and GPR9 and GPR14
153	profiles located over them (Fig. 2c). There are E-W oriented SRT12 and close NE-SW oriented SRT13 and
154	GPR12 and GPR13 profiles located over them in the east direction of the area.
C	In addition, the landslide cracks on the surface, displacement traces, and structural damages in the study
100	area and its immediate surroundings can be monitored clearly by field observations (Fig. 3). Some landslides in
157	the study area and a portion of the landslide crack traces and the damaging effects of still active or old landslides
158	on buildings can easily be observed in Fig. 3 All damaged structures across the region cannot be used. Therefore,
159	new landslide cracks will emerge over time both on the ground and the existing structures in the region which
160	active in terms of landslide and seismicity, and the formation of new landslides will continue in the area.

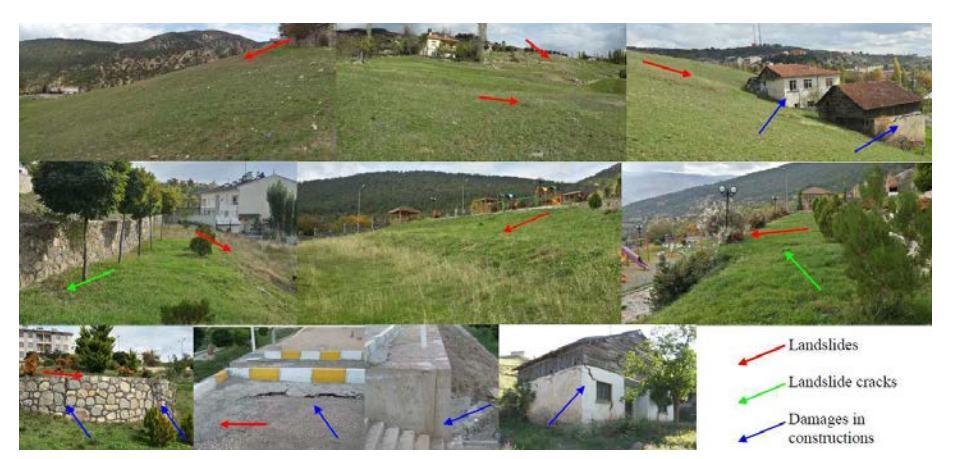
Figure 3. Landslide scene photos (landslide, lanslide cracks and constructional damages).

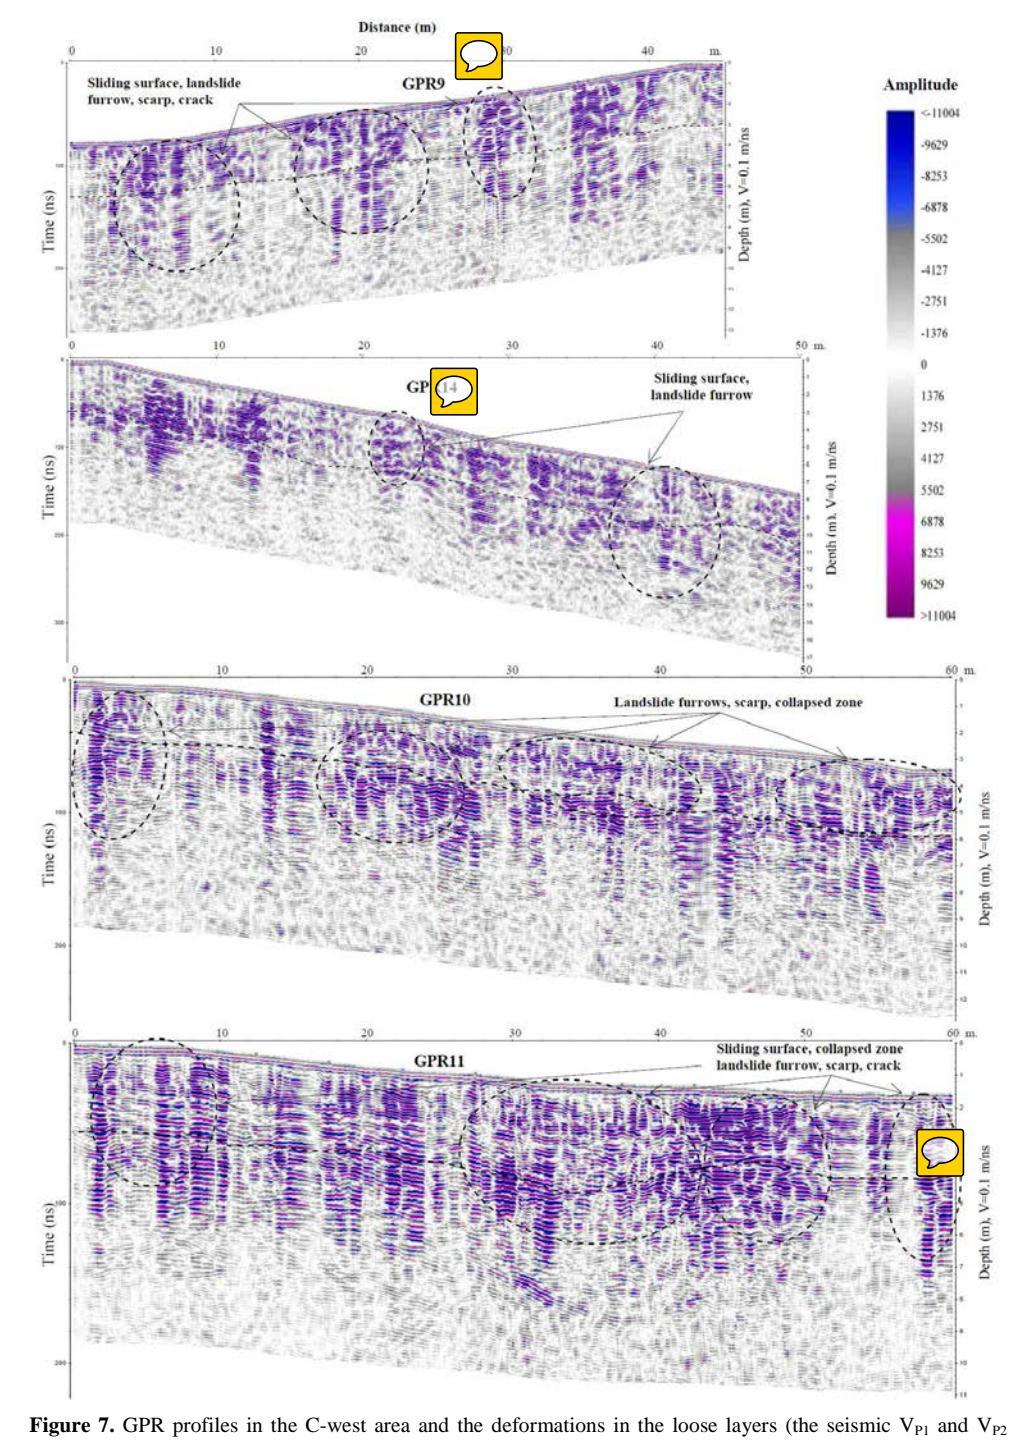
493 layers).

187	sections could be obtained as high resolution for about the first 10 m depth after inversion processing of the GPR
188	data (Fig. 6 and 7). Therefore, it could be said that the GPR and SRT sections are compatible for the first 10 m
189	depth. Besides, the profile lengths of the GPR3 and GPR5 sections in Fig. 7 were evaluated as about 25-35 m.
190	According to the GPR sections in Fig. 6 and 7, there is a layer with a varying thickness of about 3 mm at
191	the uppermost. It is seen that the second layer under this layer proceeds until about 7-10 m depth. These layers
192	are weak, loose and reworked layers with refractions that lost their thickness with low seismic velocity.
193	However, three layers were identified in seismic sections, and their seismic velocity was observed to increase
194	towards the depth (0.30<1.00<2.00< km/s). Accordingly, the fact that the problems seen in the first two layers

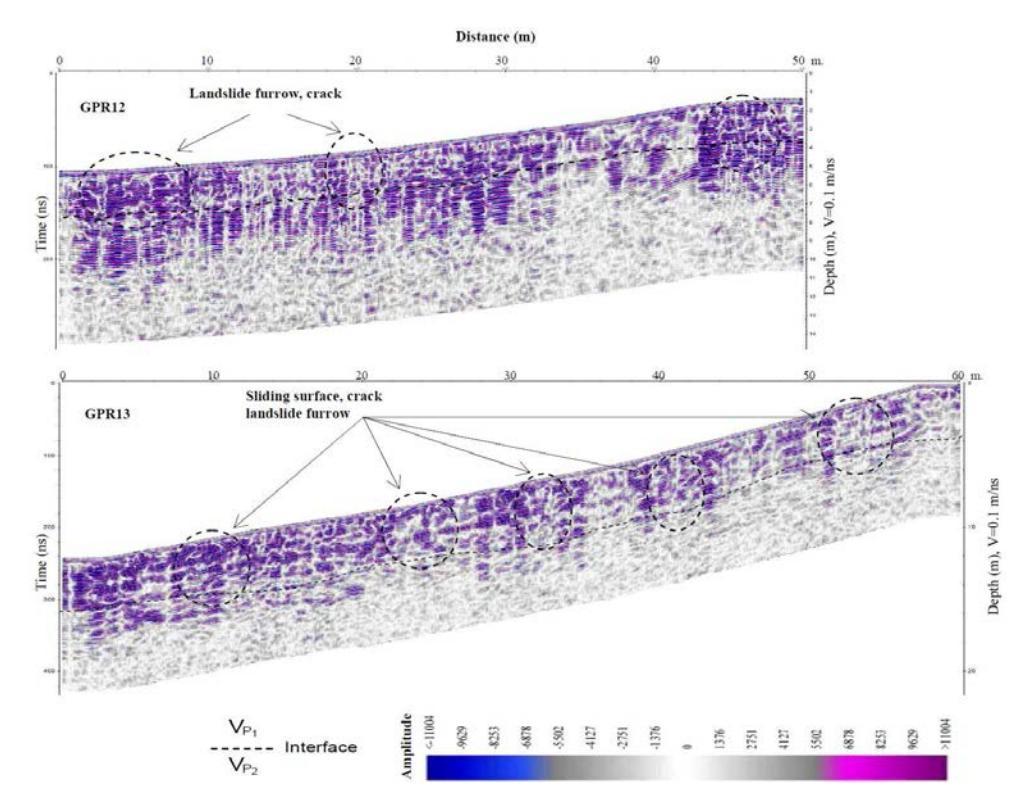
496 Figure 7. (...contiune) GPR profiles in the C-east area and the deformations in the loose layers (the seismic V_{P1} 497 and V_{P2} layers).

202 conductive units such as clay and shale decrease the penetration depth of the signal transmitted and lead to 203 absorption (Annan et al., 1988; Davis and Annan, 1989). Hatiboğlu (2009) and Hastaoğlu et al. (2015) generally 204 observed two geological units in the wells in the study area. They observed that the upper unit was silty sandy 205 clay and sand interbedded silty clay in some places up to about 10 m, and advanced as sand interbedded silty 206 clay and sand interbedded clay in some places towards deeper than 10 m. Therefore, it was understood that this 207 velocity value was compatible with the units and electromagnetic waves led to rapid absorption due to the layers 208 with clay content. Furthermore, sliding surfaces, landslide furrows, scarps, cracks was observed in the GPR 209 cross-sections, in A and C area (Fig. 6 and 7). In other words, the geological unit, the layer or topography slope 210 and precipitation cause deformations in the loose upper unit. Therefore, these structures may develop or occur in 211 the landslide mass, as shown in Fig. 6 and 7.

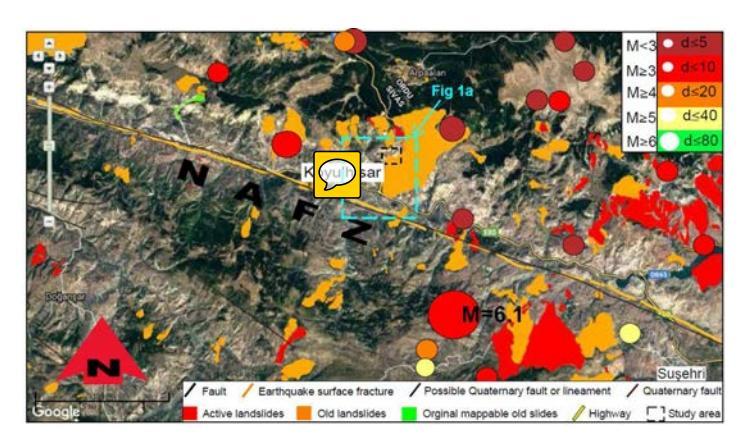
Figure 8. Seismic activity of the study area and its surroundings by the data between 1900-2015 and the 501 landslide areas (UDIM, 2016; MTA, 2018).

213 The study area is located in an active area in terms of seismicity. The seismological history, the magnitude (M) 214 of which is greater than 2.5, of the examined area and its surrounding between 1900-2015 were investigated for 215 this article (Fig. 8). The map in Fig. 8 was prepared with the seismological data between 1900-2015 (UDIM, 216 2016). Particular attention was paid to the earthquakes before 2005 in the seismological interpretation. This is 217 because the largest and most recent landslide occurred in the area in 2005 and it was aimed to investigate its 218 relationship with displacements and previous landslides. The type of magnitude which is calculated from 219 seismological data is usually the local magnitude. The depths (d) of these earthquakes with higher M>2.5 vary 220 between approximately 5 and 80 km (Fig. 8). According to the seismic data of the years examined, Koyulhisar 221 and its surroundings have always been active seismically. It was observed that this frequency of earthquakes 222 usually occurred on the NAFZ in the south of the study area. Additionally, it has been analyzed the seismic 223 activity of the region at least for the last 112 (1904-2016) years by Demir (2018). In this study, he express that 224 the most notable is probably the relationships between the magnitude of the earthquake to the number of 225 landslides and the area affected by the landslides and between the magnitude and the maximum distance of 226 landslide observations from the epicenter in different geological, topographical, and climatic conditions (Demir, 227 2018).

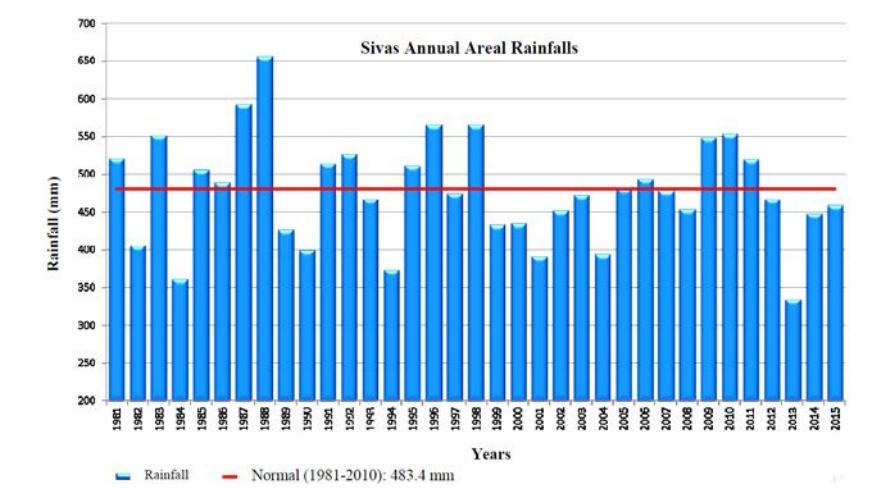
Figure 9. Precipitation distribution in between 1981-2015 years of Sivas (MGM, 2016).

The data regarding the rainfalls with the effects of triggering the landslides are presented in Table 1 and Fig. 9 (MGM, 2016). With these data, the rainfall status of the study area and its surrounding was examined by months as average annual rainfalls and the annual areal amount of rainfall. According to the data obtained between 1950-2015 in Table 1, the rainy periods are generally between October-November-December and January-February-March-April. The highest total daily amount of rainfall in the rainiest years was observed as snowfall in 1950 (110 cm) and as rain in 1991 (55 kg/m²).

249 According to Fig. 9, the annual normal average rainfall value calculated for the years between 1981-2010 250 was calculated as over 483.4 mm. However, 1987-1988 and 1997-1998 were the rainiest years. It is seen that the 251 annual areal amount of rainfall exceeded the normal values and was higher than 550 mm in these rainy years that 252 took place in every 10 years. Similarly, it is also seen that there were high rainfalls for 3-4 years after the years 253 of 1985-1995-2005 with an interval of 10 years. Therefore, annual areal rainfalls were observed to be more 254 before some large landslides like the landslide in 1998. When geological features of the region are taken into 255 account, it is remarkable that the landslide in 1998 and 2000 occurred in the summer months after the winter 256 with a heavy fall of snow. However, the landslide in 2005 occurred during the rainy season. Therefore, rainfalls 257 have always been considered as a factor triggering these landslides in many studies and articles (Tatar et al., 258 2007; Hastaoğlu et al., 2015). Similarly, the authors of this article have always considered rainfalls as a 259 triggering factor in the formation of Koyulhisar landslides. As it is seen, the various studies and the results of 260 this article have proved that Koyulhisar landslides are generally caused by the known reasons that trigger the 261 landslide. Because the seismic activity, the meteorological data and the other conditions mentioned in the 262 landslide area have shown that the landslides could be triggered there.

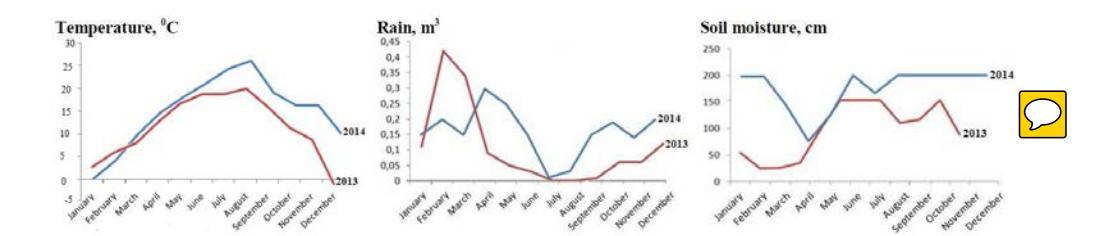
Figure 10. Average monthly temperature (T, 0 C), rainfall (m³) and soil moisture content (cm) change graphics of the study area and its surrounding for 2013-2014. It was prepared from the project data (Hastaoğlu et al., 2015).

264 📶 aoğlu et al. (2015) have carried out multi-disciplinary studies and GNSS studies for many years (about 6 265 years) to determine the deformation and annual sliding amounts especially after the landslides in 1998-2000-266 2005. It was determined that the tension cracks that occurred in the landslides in 1998 and 2000 in the region 267 were filled with the waters consisting of melting snow and rain waters which are the most important component 268 of the hydrological cycle, lakes were formed in the buttress of each sliding mass, and the changes in the 269 groundwater level were the main causes of deformation (Sendir and Yılmaz, 2001; Topal and Hatiboğlu, 2015; 270 Hastaoğlu et al., 2015). The seismological and meteorological data, which were updated by the geodetic (GNSS 271 (DH), geological (IDH (Inclinometer Drilling Holes)) and meteorological data collected in the local study of 272 Hastaoğlu et al. (2015), were reorganized and evaluated. Fig. 2, 9, 10 and Table 1 which were reprepared for the 273 study which is the subject of this article were associated with the results of GNSS studies (Fig. 10). Then, they 274 were compared with geophysical results in interpretation.

The monthly and annual meteorological data should certainly be evaluated particularly within the scope of monitoring activities because the area which is the subject of the study is a landslide area. Hastaoğlu et al. (2015) performed monitoring in IDH wells in the area in 2013-2014 (Fig. 10). If Fig. 2 is examined, there are seven IDH point in the nearest of the geophysical profiles. The graphics in Fig. 10 were prepared from the combined data (unpublished data in the project) and the temperature (⁰C), precipitation (m³) and soil moisture content (cm) were compared in these graphics. Accordingly, the temperature and precipitation were observed to be inversely

proportional during the summer months called as a dry period. It is seen that the soil moisture is changeable apart from the rainy period and has very high water content during the rainy periods. On the other hand, it was understood that the precipitation increased by the decrease in temperatures. It is also seen that the total annual amount of rainfall increased about 2-fold in 2014 compared to 2013 (Fig. 9 and 10). According to all results, rainfalls are considered to be effective in triggering of the landslide because the ground of this landslide area, which is filled with loose units and old cracks, is supersaturated with water due to the rainfalls.
