Nat. Hazards Earth Syst. Sci. Discuss., https://doi.org/10.5194/nhess-2018-177-AC1, 2018 © Author(s) 2018. This work is distributed under the Creative Commons Attribution 4.0 License.

Interactive comment on "Brief communication: Remotely piloted aircraft systems for rapid emergency response: road exposure to rockfall in Villanova di Accumoli (Central Italy)" by Michele Santangelo et al.

This document contains a point-to-point answer to the comments of reviewer #1. Reviewer comments (RC) are reported. Responses (AR) follow each RC. Quotations from the manuscript are in italics between inverted commas.

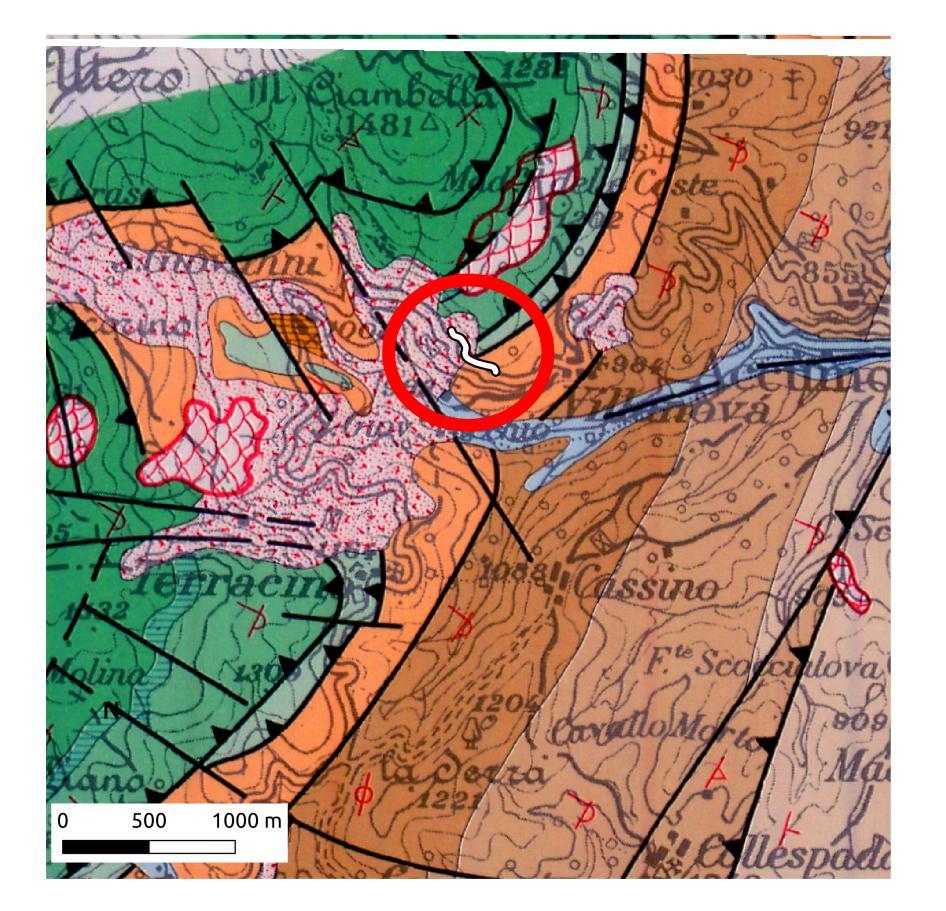
Fig. 1.

Attached is a figure (Figure 1) that contains an excerpt of the available geological map. The red circle locates the study area, whereas the white polygons is the portion of the road that was studied.

AR: The scale of the available published geological map is 1:100,000, which is quite disproportionate compared to the extent of the study area. That is why we did not add a geological map since it was not really useful to the understanding of the paper. We still maintain this idea. Given its scale, the readability of the area would require to add a figure to the paper, going beyond the requirements of a brief communication, and not really improving the readability of the paper.
