#### **Responses to Reviewer #1 comments:**

Abstract. Transportation infrastructure is crucial to the operation of society, particularly during post-event response and recovery. Transportation assets, such as roads and bridges, can be exposed to tsunami impacts when near the coast. Using fragility functions in an impact assessment identifies potential tsunami effects to inform decisions on potential mitigation strategies. Such functions have not been available for transportation assets <u>exposed to tsunami hazard</u> in the past due to limited empirical datasets. This study <u>develops fragilityprovides a suite of observations on the influence of tsunami inundation depth</u>, road use-type, culverts, inundation distance, debris and coastal topography. Fragility functions are developed for roads, considering: inundation depth; road use-type; and coastal topography, and for bridges, considering only inundation depth above deck base height. Fragility functions are developed for roads and bridges through combined survey and remotely sensed data for the 2011 Tohoku Earthquake and Tsunami, Japan and using post-event field survey data from the 2015 Illapel Earthquake

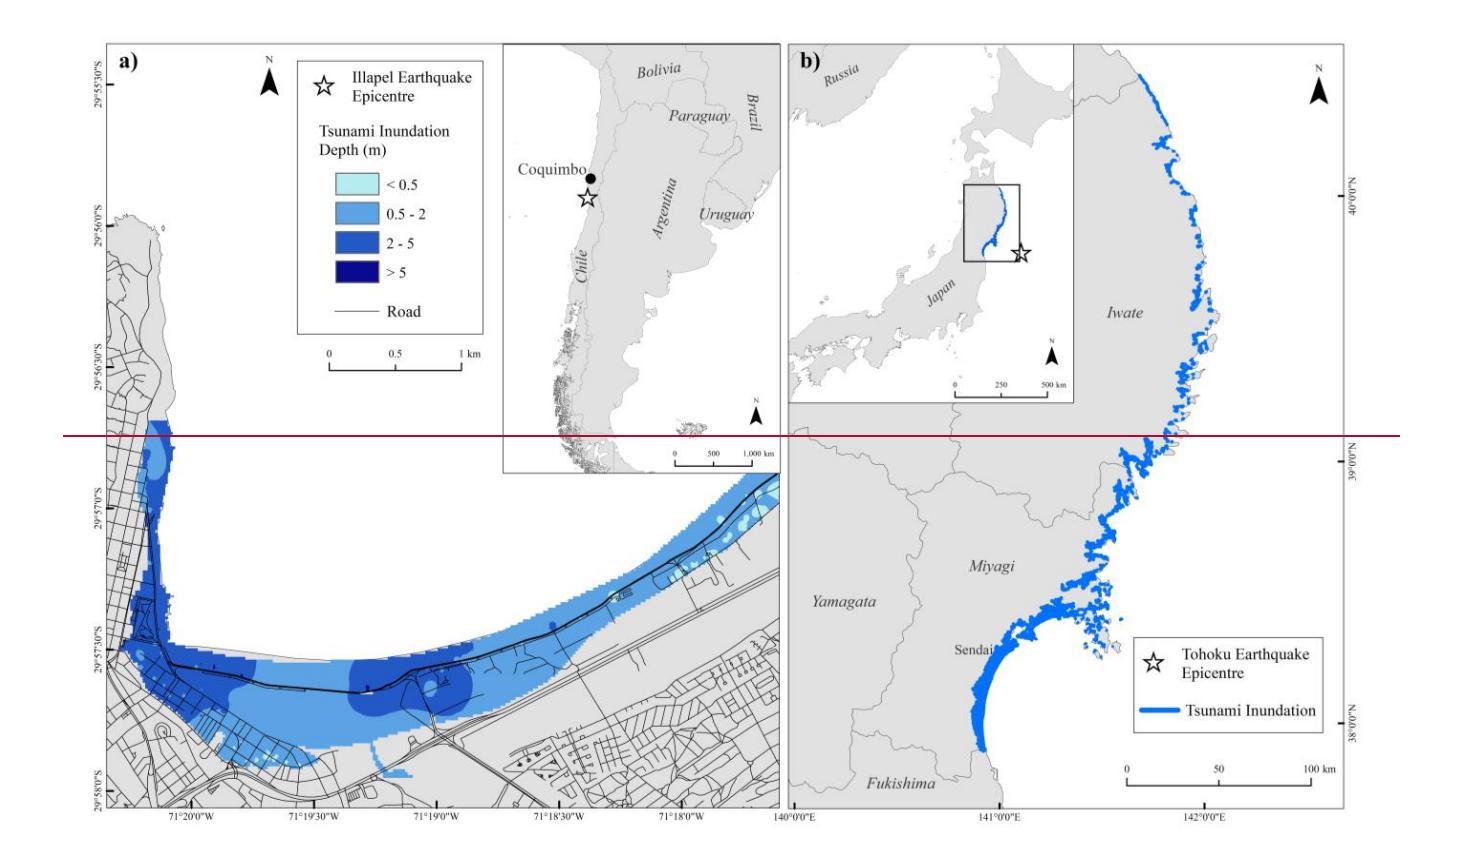
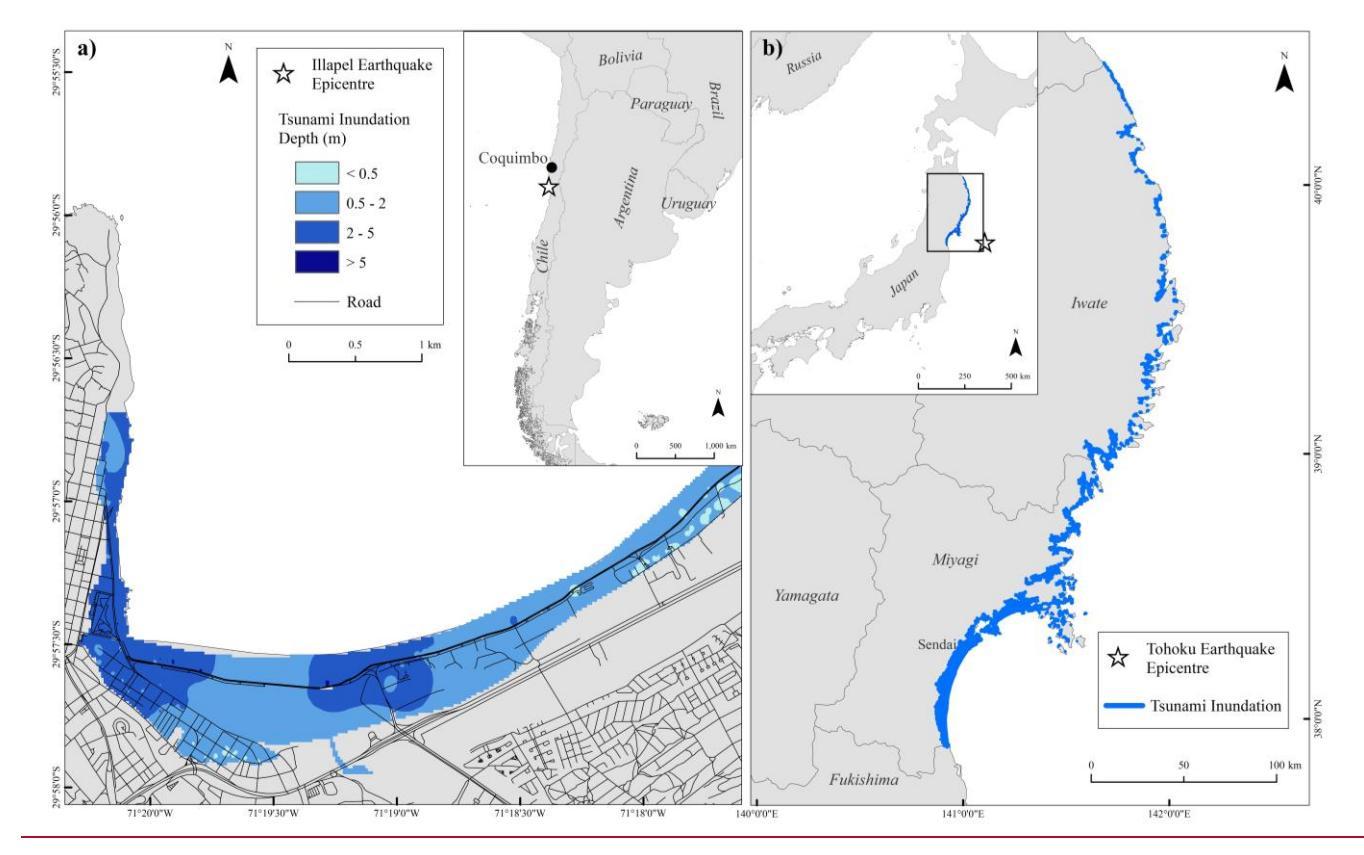
Figure 1: Tsunami inundation in Coquimbo for the 2015 Illapel tsunami, Chile (a), and in Miyagi and Iwate Prefectures for the 2011 Tohoku Tsunami, Japan (b), © OpenStreetMap contributors 2015. Distributed under a Creative Commons BY-SA License.

The Mw 9.0 Tohoku earthquake in the Pacific Ocean, east of Japan (Figure 1b), caused tsunami waves exceeding 30m30 m inundation depth, in some extreme cases, and affecting much of Japan's eastern coast which was also earthquake-affected (Kazama and Noda, 2012; MLIT, 2012). (MLIT, 2012). Transportation infrastructure were extensively damaged throughout the exposed region during this event (Eguchi et al., 2013; Graf et al., 2014; MLIT, 2012). The Illapel event took place on

- 370 September 16, 2015 in northern-central Chile, triggered by a Mw 8.3 earthquake of the coast of the Talinay Peninsula, (Figure 1a), (Aránguiz et al., 2016; Contreras López et al., 2016; Ye et al., 2015).(Aránguiz et al., 2016, 2018; Contreras-López et al., 2016; Izquierdo et al., 2018; Ye et al., 2015). This event caused localised inundation of up to 7 m, with severe impacts to the transportation infrastructure, the most significantgreatest of which waswere in Coquimbo. While the Tohoku dataset represents the largest tsunami damage survey for roads, the Illapel dataset represents the first known census style survey of roads impacted
- 375 by tsunamis. All exposed assets in the Illapel study area (Figure 1a) were surveyed, not only those with observed damage, which was not the case following the Tohoku event.

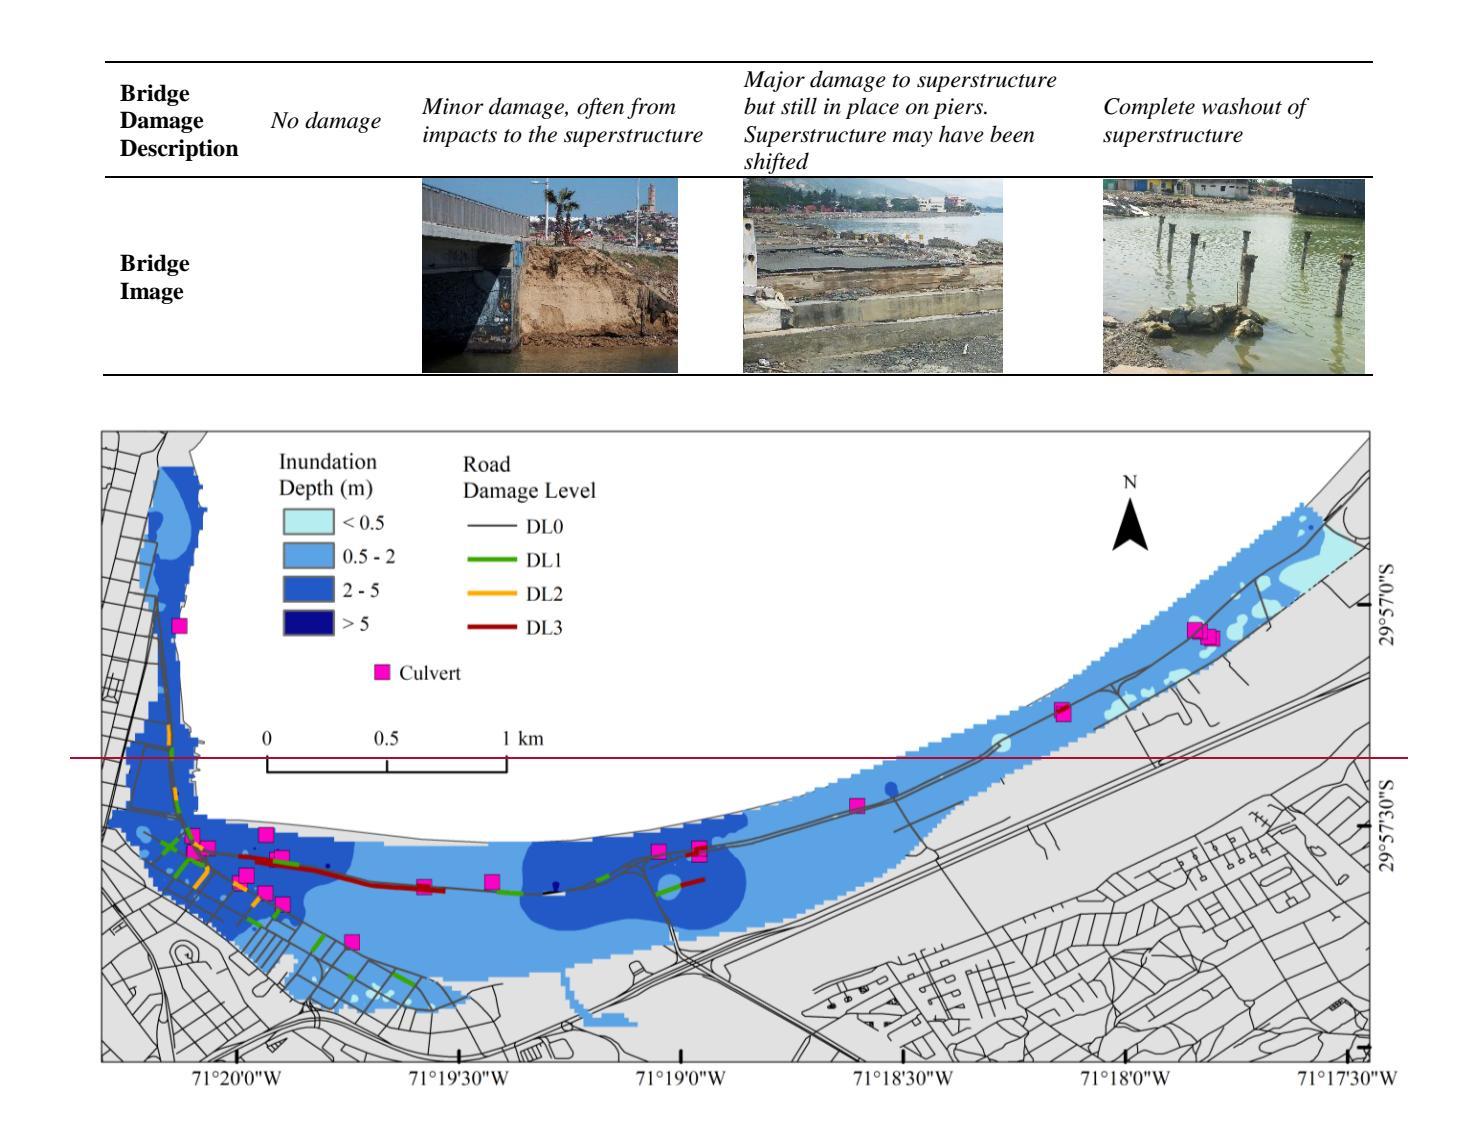
920 Table 1: MLIT damage classifications for roads and bridges (MLIT, 2012) and field examples of road damage levels from the 2015 Illapel Earthquake and Tsunami, Coquimbo, Chile, and equivalent bridge examples from the 2018 Sulawesi Earthquake and Tsunami, Indonesia, respectively

Damage Level	0	1	2	3
Damage State	No Damage	Minor	Moderate	Severe
Road Damage Description	No damage	Minor damage to road surface. All lanes passable	Major damage to one lane. One lane impassable	Major damage to whole carriageway. All lanes impassable
Road Image

- 430 discussion between the field survey team and members of the public. Road damage was defined using a four-tier damage-level classification in accordance with the MLIT classification structure (Table 1). This was done to be consistent with the Tohoku dataset, which was already available and represented the largest damage repository of tsunami impacts on roads and bridges, as outlined in the subsection below. Although this classification of damage level could have been refined, the field team decided it still represented a relatively efficient method in-field and at a resolution high enough to incorporate the range of

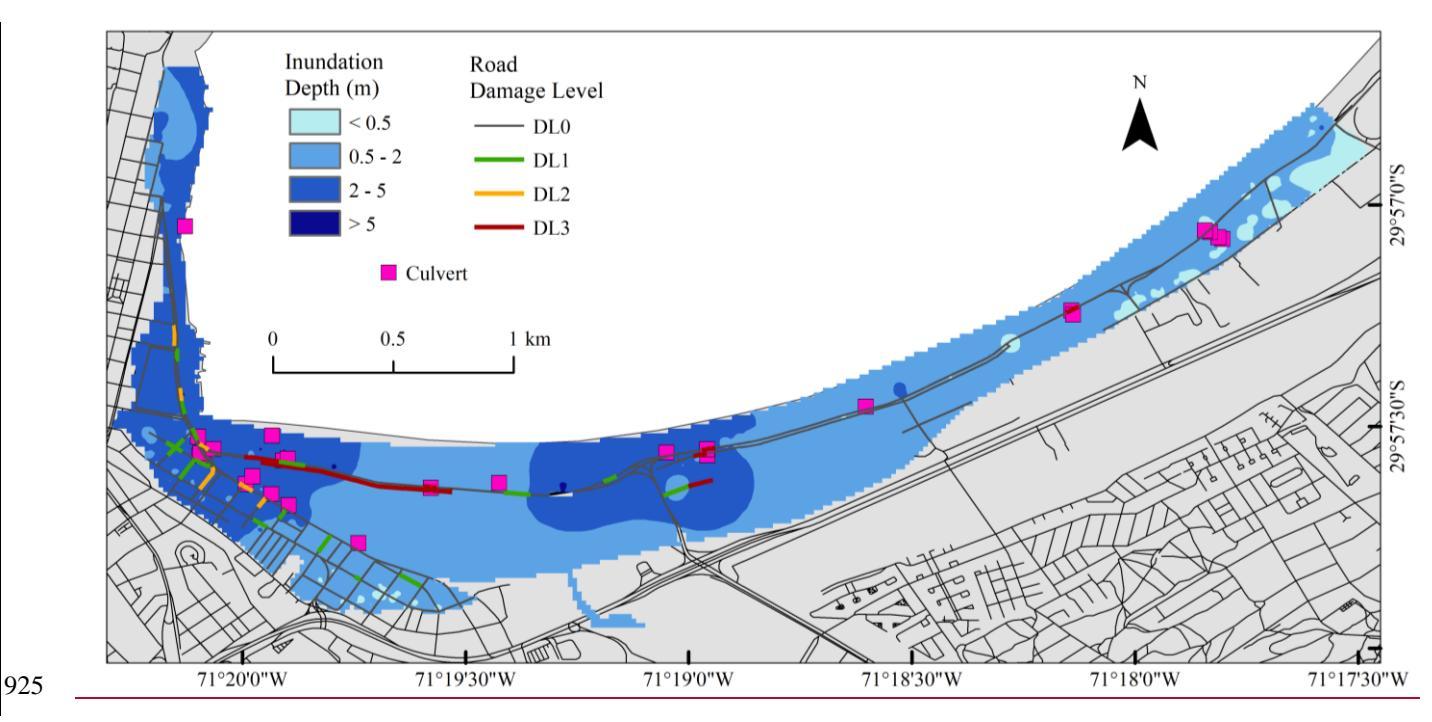
Figure 2: Tsunami inundation, road damage level and culvert locations in Coquimbo, Chile following the 2015 Illapel Earthquake and Tsunami, © OpenStreetMap contributors 2015. Distributed under a Creative Commons BY-SA License.

- 445 attribute information are the two key variables when considering vulnerability and both are considered, independently and in tandem, to define vulnerability of assets. The most common HIM is inundation depth, and the first step was to use this data to calculate fragility functions for mixed construction assets. With the Coquimbo dataset, roads were separated into approx. 50 m sections, and assigned the corresponding damage level (DL0-DL3) and inundation depth, through the watermark interpolation, at the centre of each feature (Figure 2) using inundation depth bins of 0.25 m (0.0 0.25 m, 0.25 0.5 etc.). The

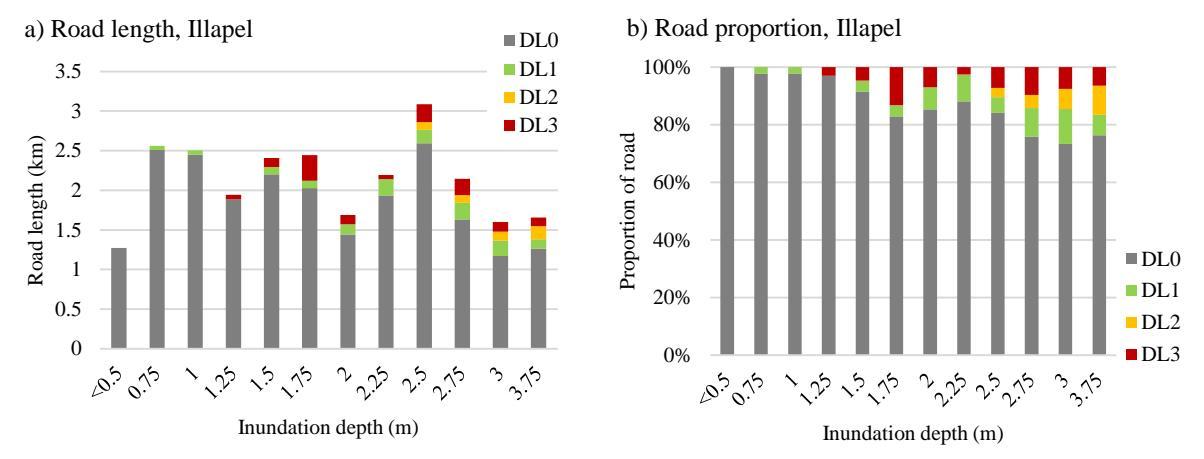
Figure 3: Total length (a) and proportion (b) of exposed roads, by inundation depth, for the 2015 Illapel Earthquake and Tsunami

- 450 total length of road (in km) for each depth bin and for each damage level was tabulated for each HIM by count and proportion (Figure 3). Once inundation depth had been considered, other HIM were used to define vulnerability more holistically. Fragility functions were then developed, as described in more detail in sub-section 2.3.

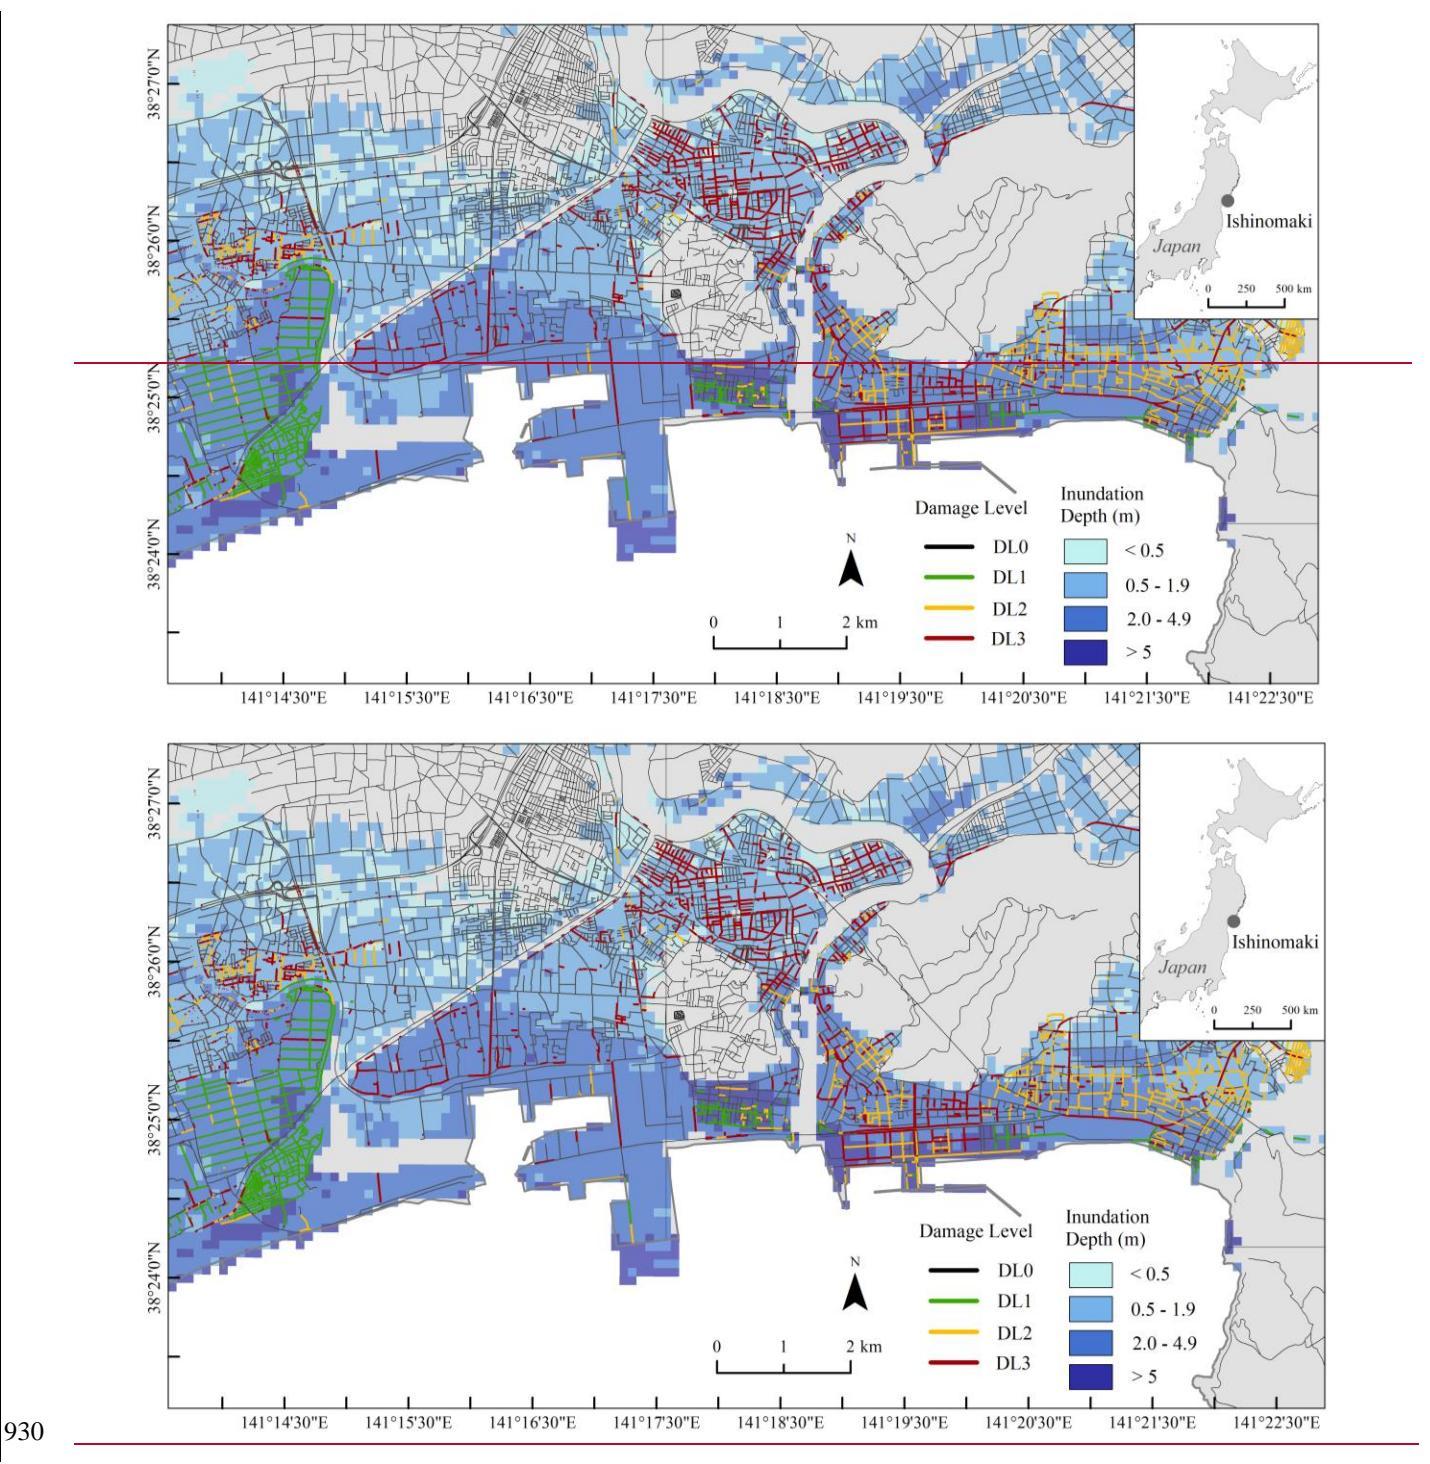
Figure 4: Tsunami inundation and road damage in Ishinomaki, from the 2011 Tohoku Earthquake and Tsunami, Japan. Roadimpact data modified from MLIT, 2012, © OpenStreetMap contributors 2015. Distributed under a Creative Commons BY-SA License.

Lines 169, 190 and Figure 4 and 6 captions: it took me a while to realise that the area shown in Figure 4 and 6 is not the whole study area for the Tohoku event. Particularly when I was comparing the data in Figure 5a which shows thousands of bridges and Figure 6 which shows 20+ bridges. I would

Lines 174-175: "(Figure 4)." changed to "Figure 4 shows an example of observed damage levels for roads in the town of Ishinomaki within the study area."

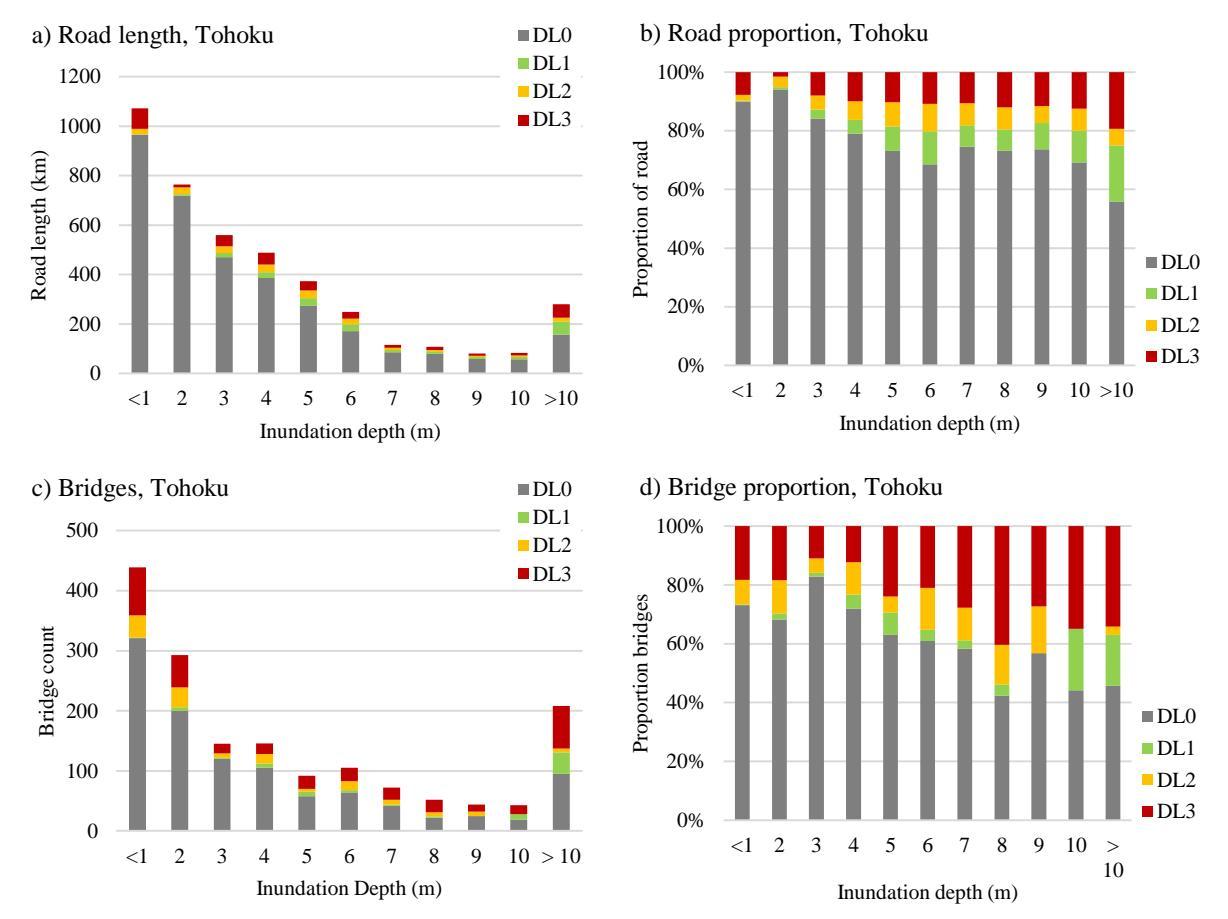
Figure 5: Total length (a) and proportion (b) of exposed roads and number (c) and proportion (d) of exposed bridges, by inundation 935 depth, in Miyagi and Iwate Prefectures for the 2011 Tohoku Earthquake and Tsunami

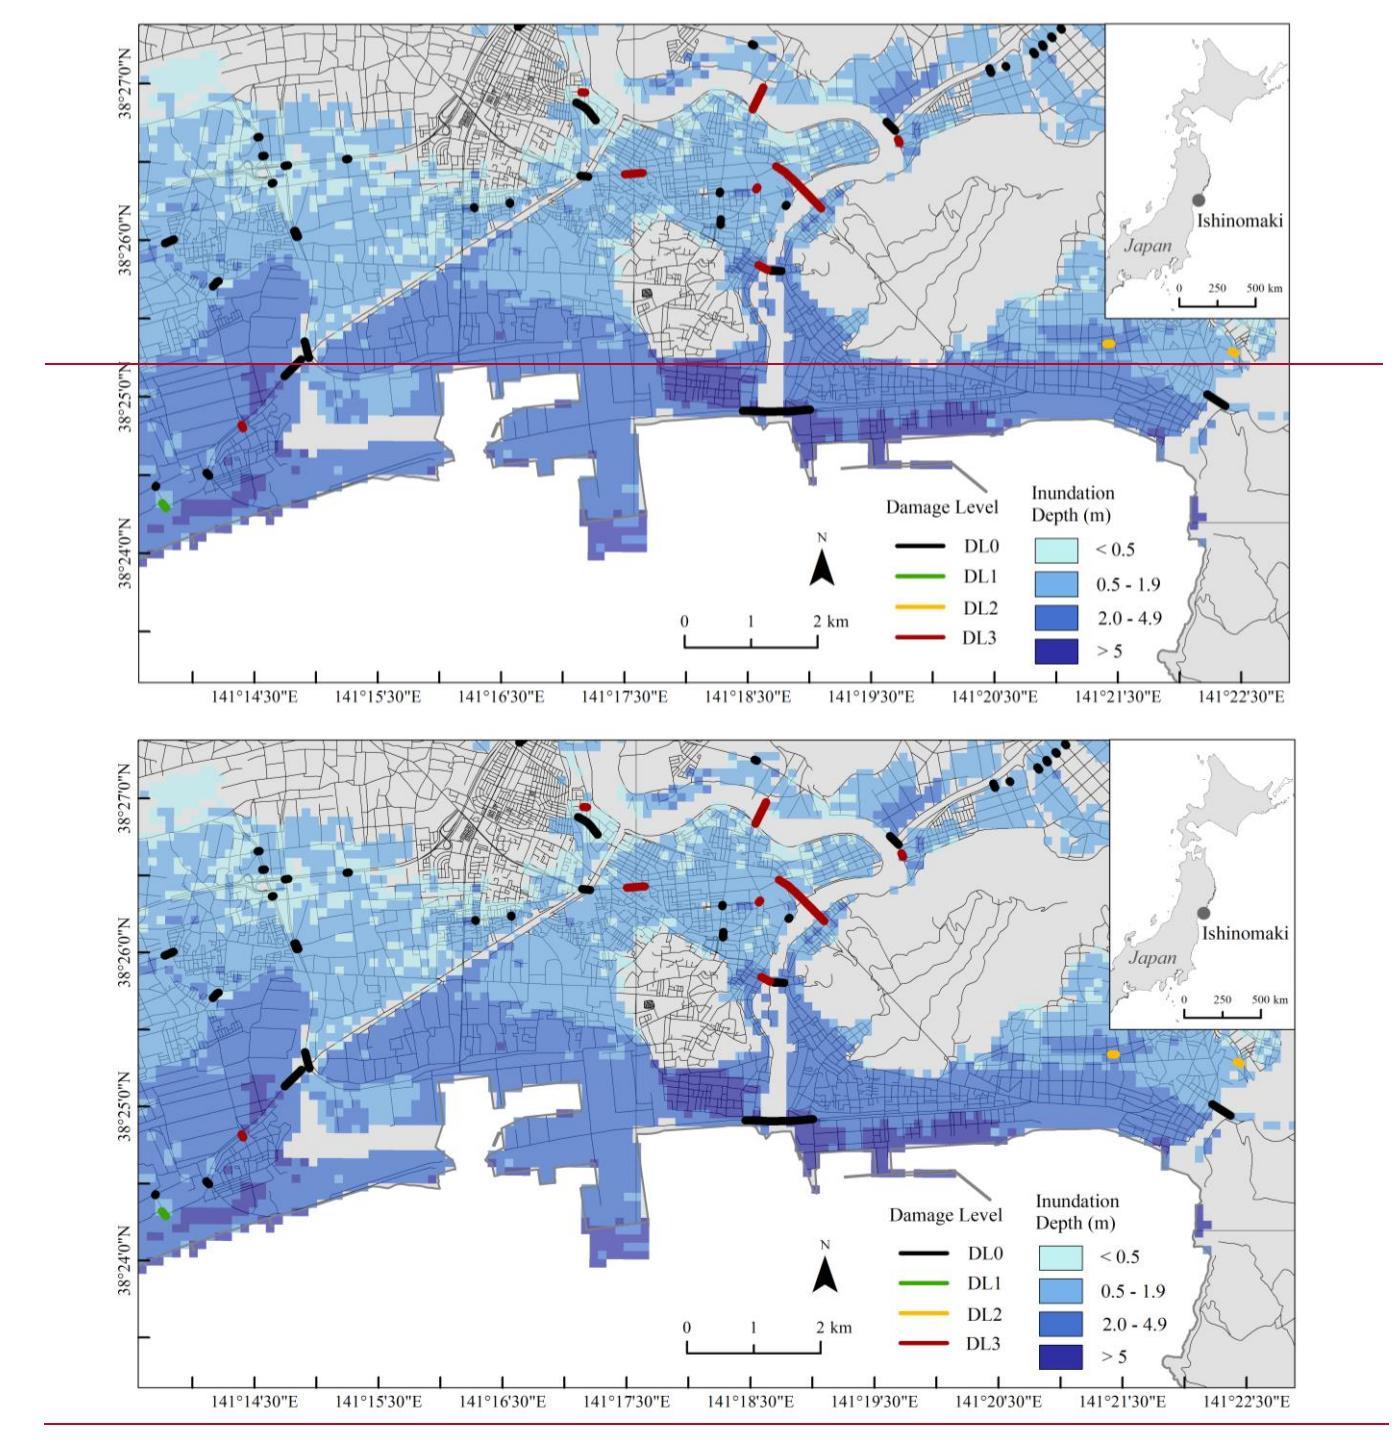
Figure 6: Damage states for inundated bridges in Ishinomaki, Japan, for the 2011 Tohoku Earthquake and Tsunami. Bridge impact data modified from MLIT, 2012. © OpenStreetMap contributors 2015. Distributed under a Creative Commons BY-SA License.

## Lines 197 - 198: "(Figure 6)." changed to "Figure 6 shows an example of observed damage levels for bridges in the town of Ishinomaki within the study area."

- 480 The MLIT dataset had an assigned bridge damage level between DL1 & DL3 (Table 1). All non-surveyed bridges in the inundation area were assumed to be undamaged and consequently assigned DL0-(. Figure 6). shows an example of observed damage levels for bridges in the town of Ishinomaki within the study area. Modelled tsunami inundation depth was assigned at the centre point of each bridge to avoid a bridge falling within multiple inundation depth bins. Since deck base height was not included in the dataset and in many cases the hazard layer did not include depths within river channels, to estimate the

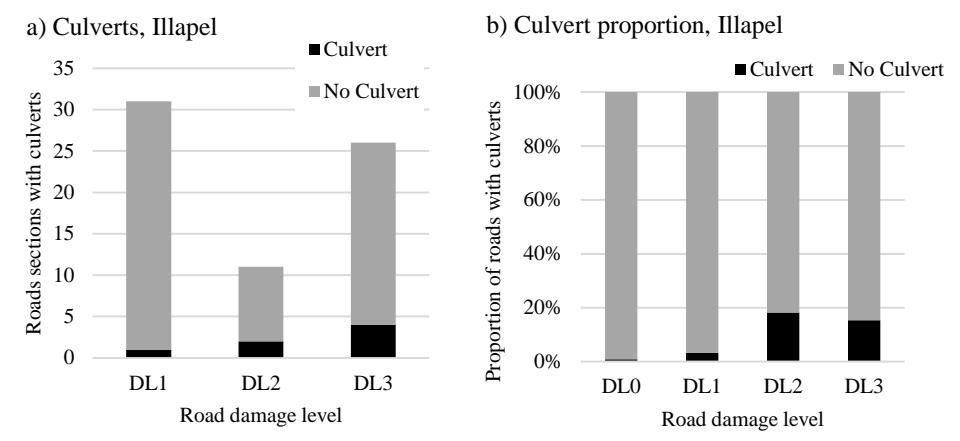
Figure 7: Number (a) and proportion (b) of road sections with or without a culvert, by damage level, for the 2015 Illapel Earthquake and Tsunami. Note: DL0 had a count of 573 road sections (too many to represent in Figure 7a), with five having a culvert.

Line 208 and Figure 7 caption: incorporate a similar phrase "DL0 had a count of 573 road sections (too many to represent in Figure 7a), with five having a culvert." into the caption of Figure 7.

*Figure 7 caption: "Note: DL0 had a count of 573 road sections (too many to represent in Figure 7a), with five having a culvert." Added.*

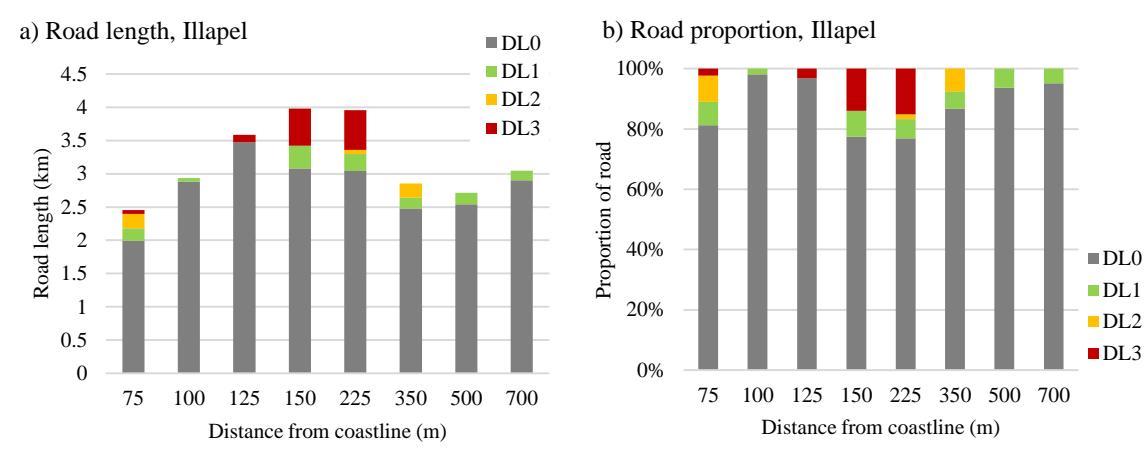
Figure 8: Total length (a) and proportion (b) of exposed roads, by distance from the coastline (as a proxy for inundation energy), for the 2015 Illapel Earthquake and Tsunami

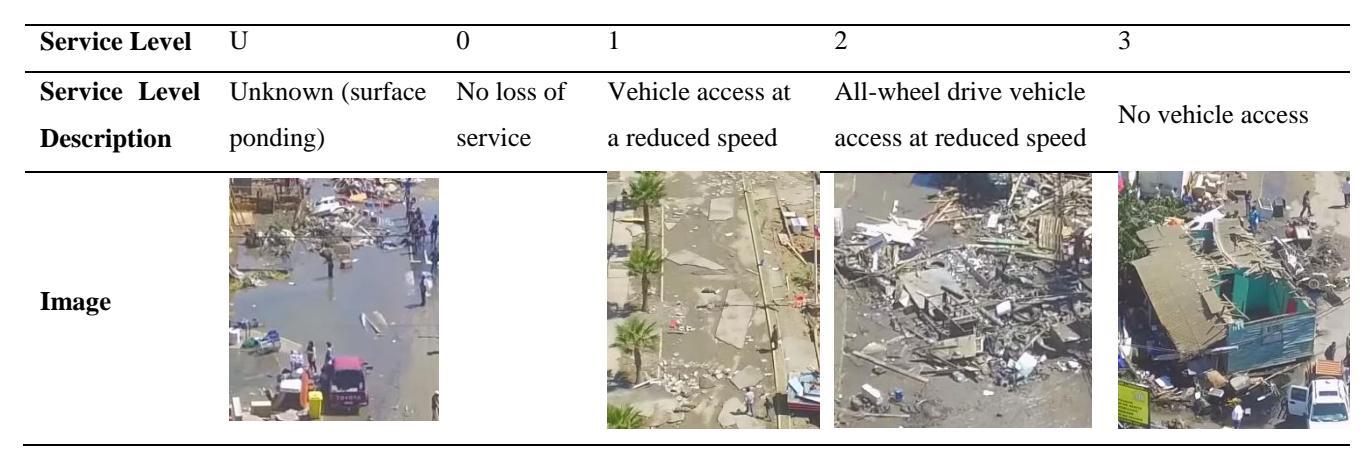
945 Table 2: Classification schema for road level of service for the 2015 Illapel Earthquake and Tsunami. Images taken as screenshots sourced from Puerto Creativo, 2015

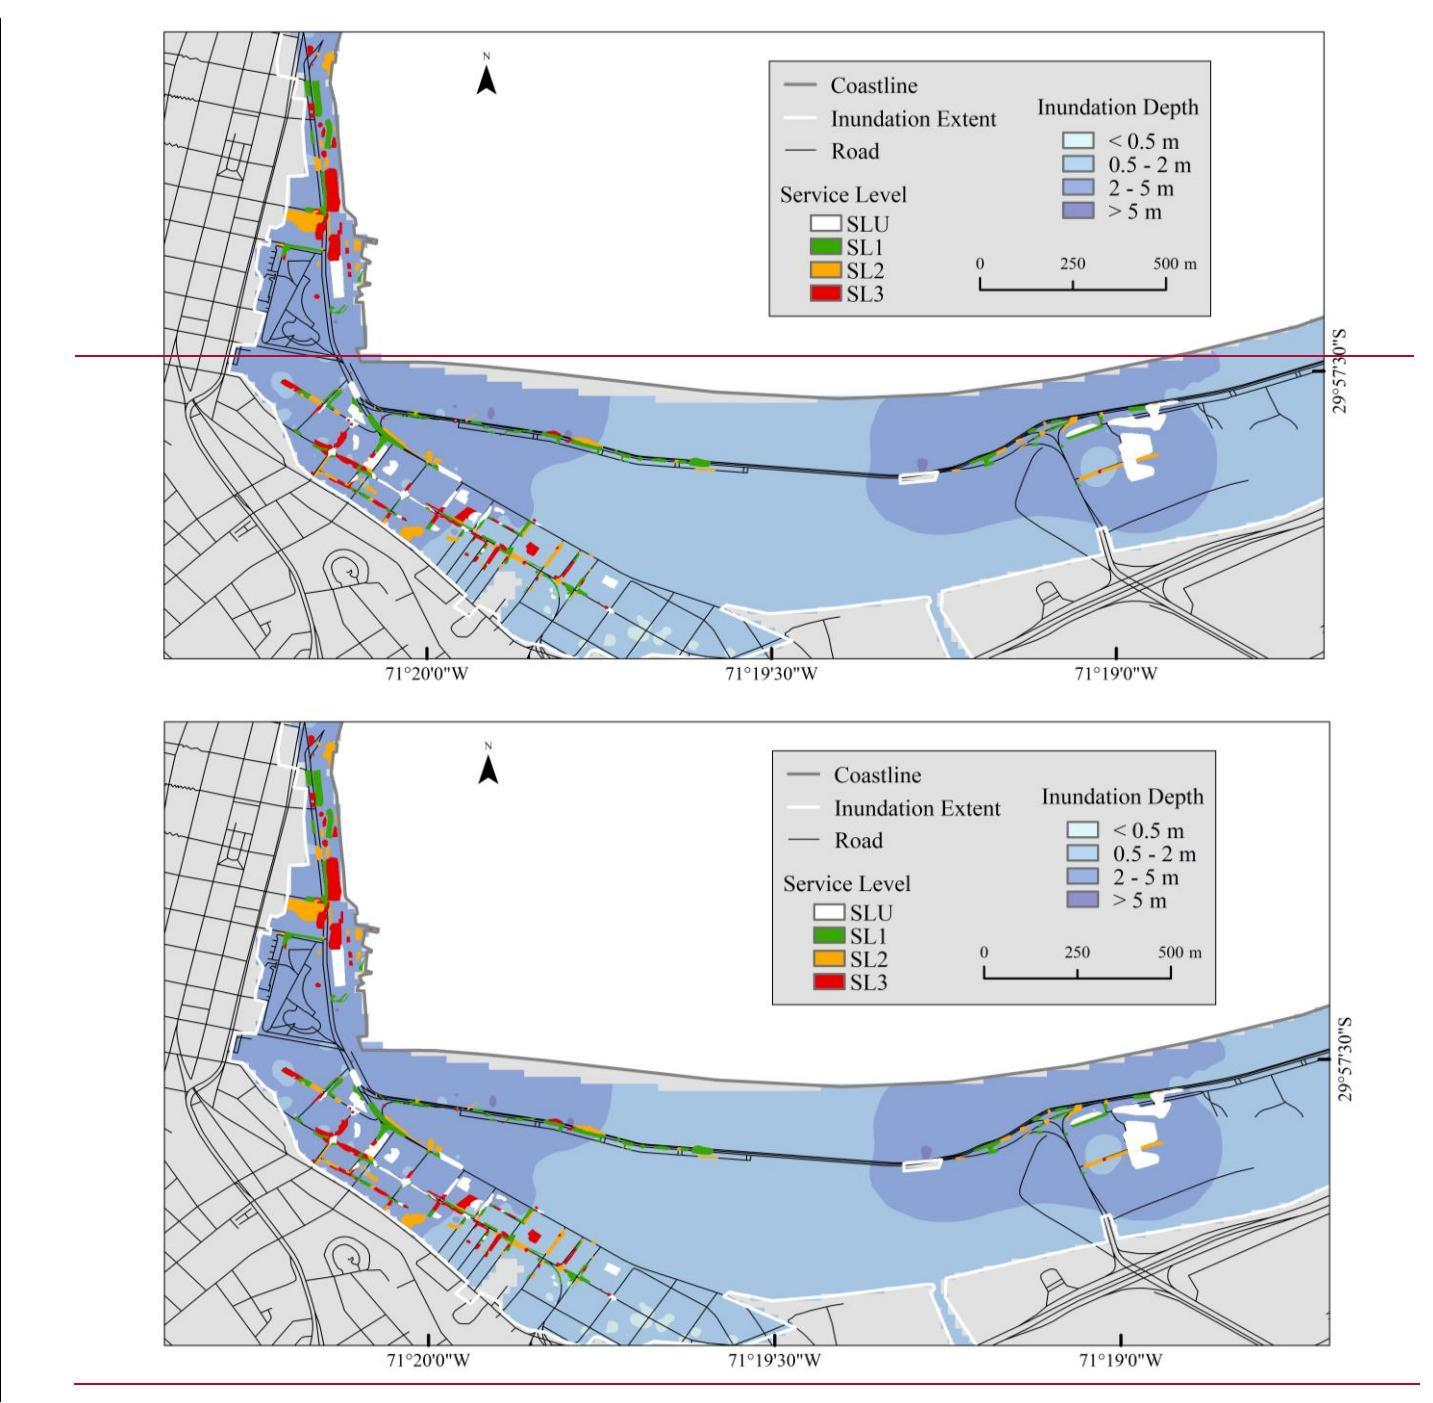
Figure 9: Service levels associated with debris on roads in Coquimbo following the 2015 Illapel Earthquake and Tsunami, Chile, © 950 OpenStreetMap contributors 2015. Distributed under a Creative Commons BY-SA License.

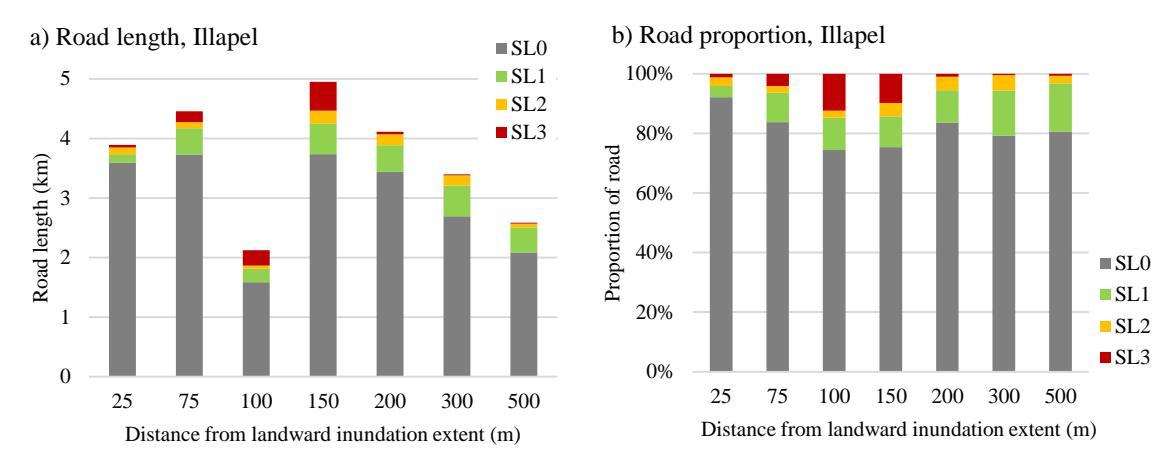
Figure 10: Total length (a) and proportion (b) of exposed roads, considering levels of service, by distance from the landward inundation extent, for the 2015 Illapel Earthquake and Tsunami. Note SLU is not considered in analysis

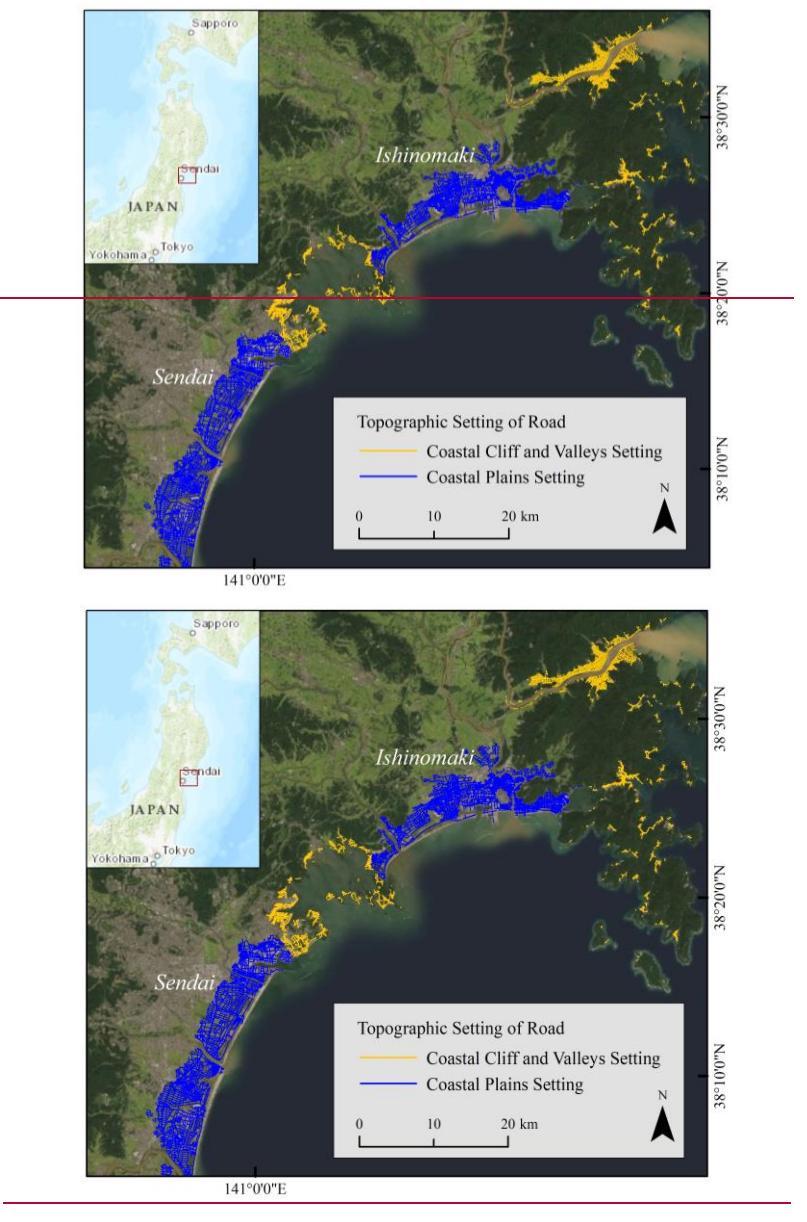
955 Figure 11: Coastal topographic settings for inundated roads in Miyagi and Iwate Prefectures for the 2011 Tohoku Tsunami, Japan. Note: all roads North of Ishinomaki are Coastal Valleys; all roads South of Sendai are Coastal Plains. Road data modified from MLIT, 2012 and © OpenStreetMap contributors 2015. Distributed under a Creative Commons BY-SA License. Japan topographic imagery sourced from ESRI contributors, 2019a, Tohoku regional satellite imagery sourced from <u>ESRI contributors, 2019b ESRI</u> contributors, 2019b

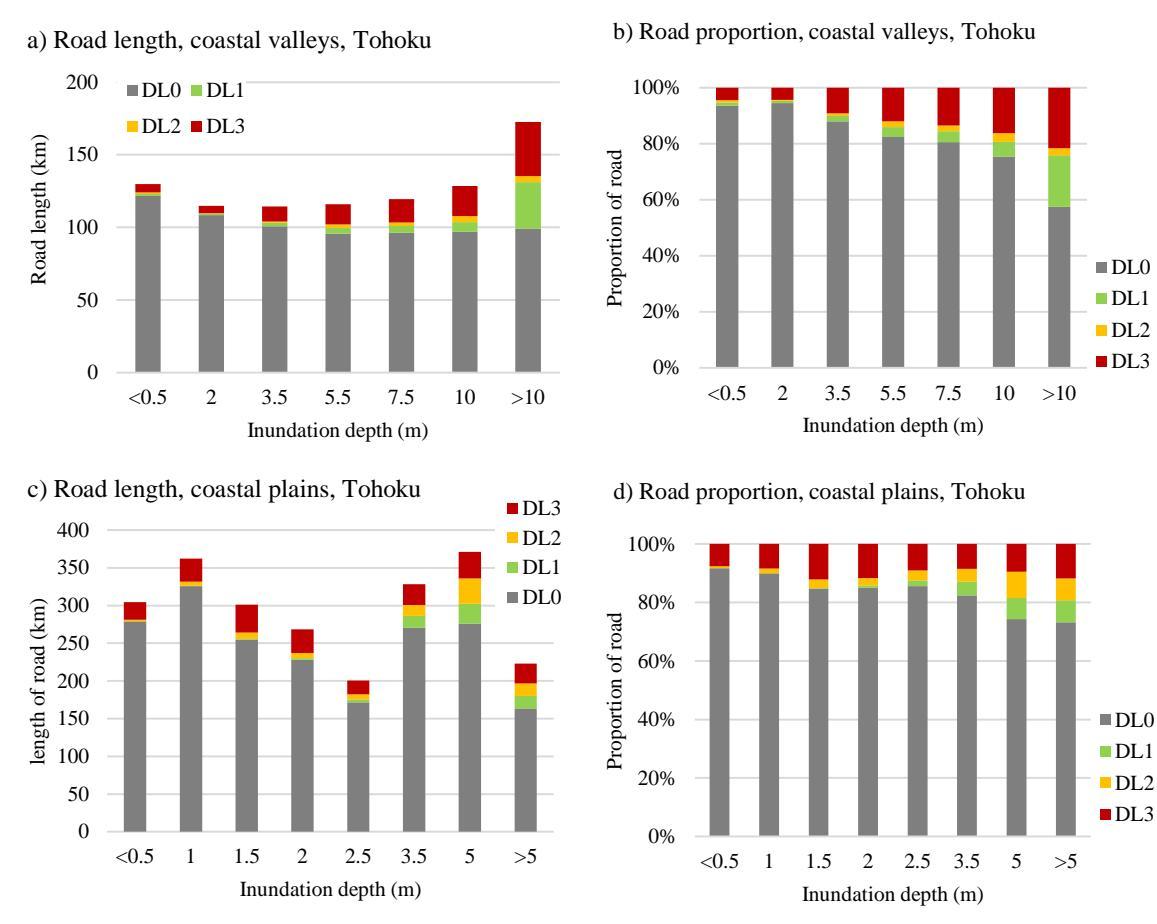
960 Figure 12: Total length (a) and proportion (b) of exposed roads in a coastal valley topographic setting and total length (c) and proportion (d) of exposed roads in a coastal plain topographic setting, by inundation depth, for the 2011 Tohoku Earthquake and Tsunami

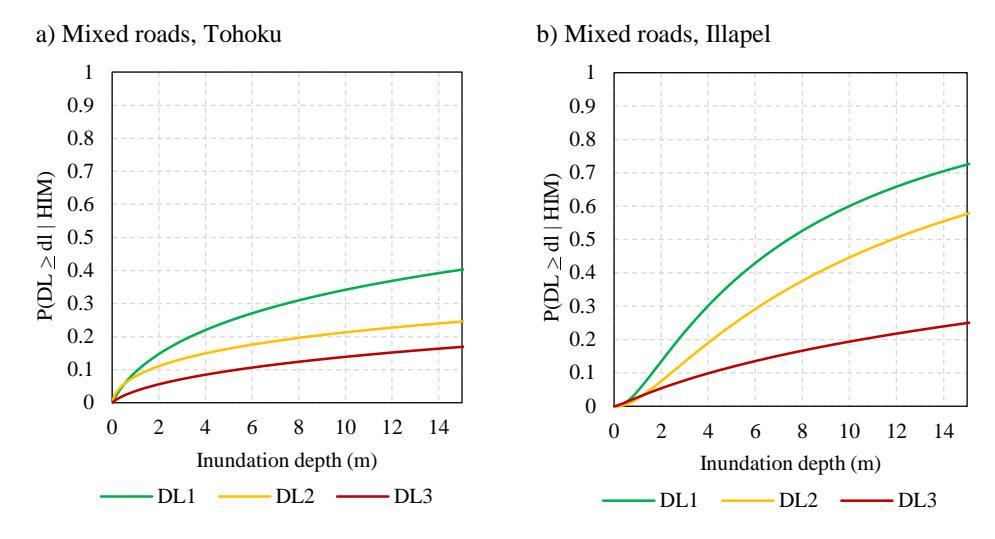
Figure 13: Fragility functions for mixed construction roads (a) for the 2011 Tohoku Earthquake and Tsunami, Japan and for mixed construction roads (b) for the 2015 Illapel Earthquake and Tsunami, Chile

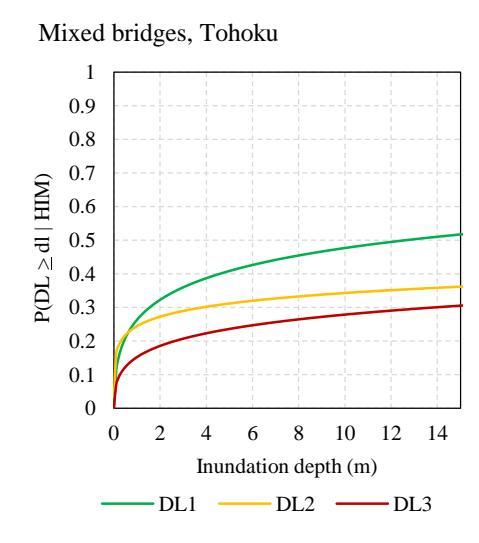
970 Figure 14: Fragility function for mixed construction road bridges for the 2011 Tohoku Earthquake and Tsunami, Japan

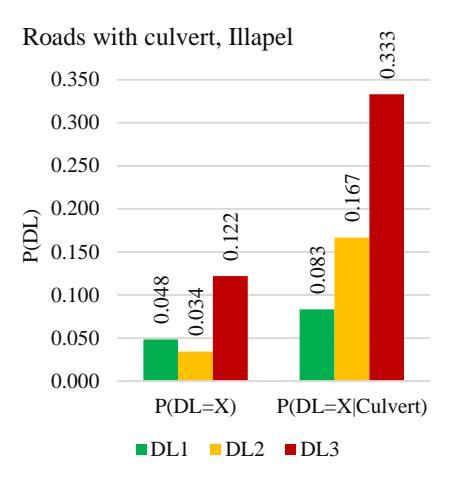
Figure 15: Total road damage probability and increased total road damage probability with the presence of a culvert

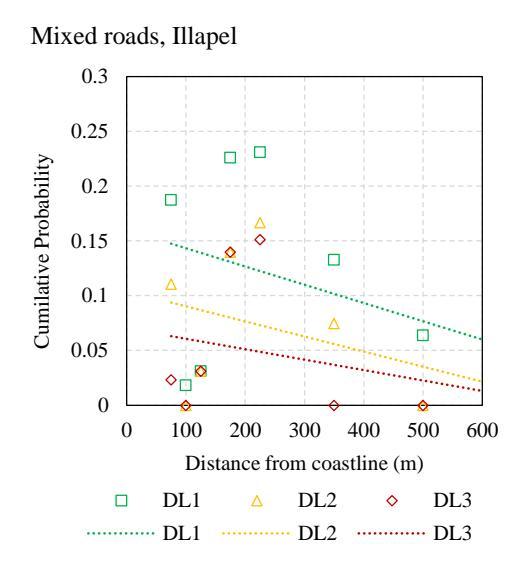
Figure 16: Linear best fit probability of reaching or exceeding a given damage level, by distance from coastline (as a proxy for inundation energy, for the 2015 Illapel Tsunami, Coquimbo, Chile

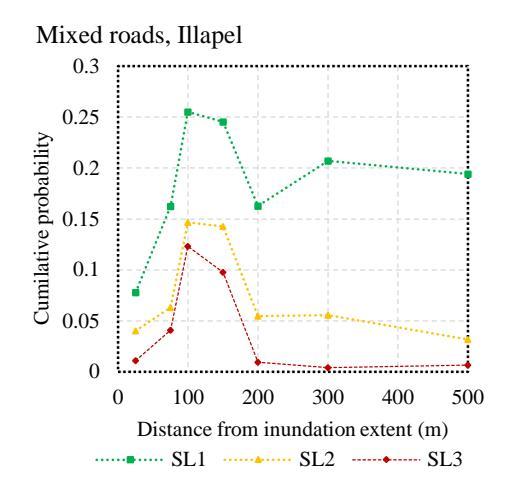
Figure 17: Cumulative probability plot of road service levels compared with a distance from the in-land extent of tsunami inundation (as an indication of debris density sorting) for the 2015 Illapel Tsunami, Coquimbo, Chile.

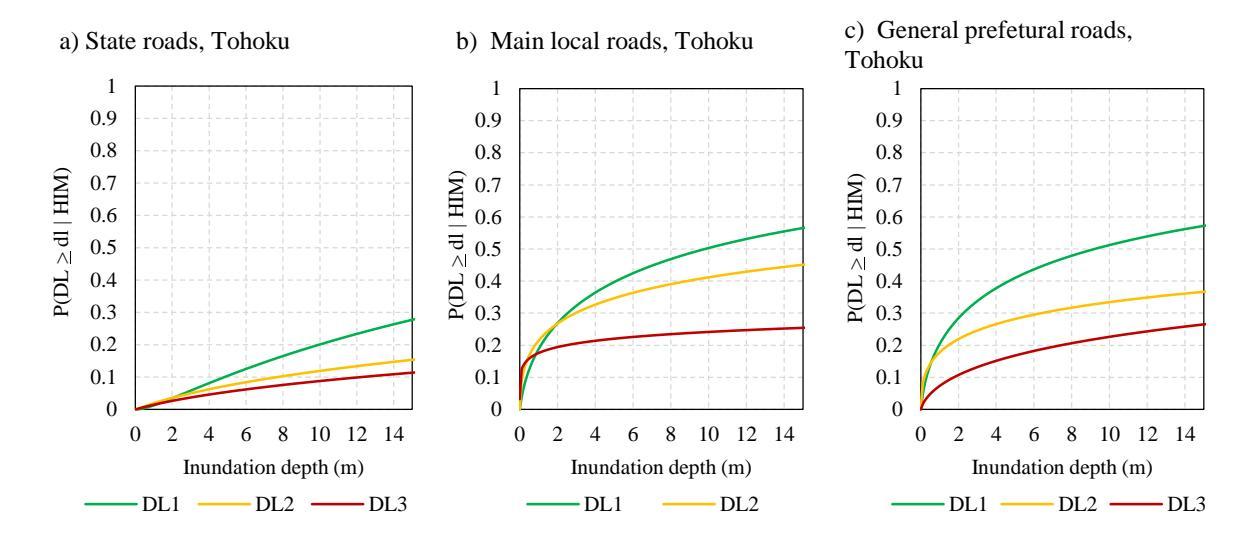
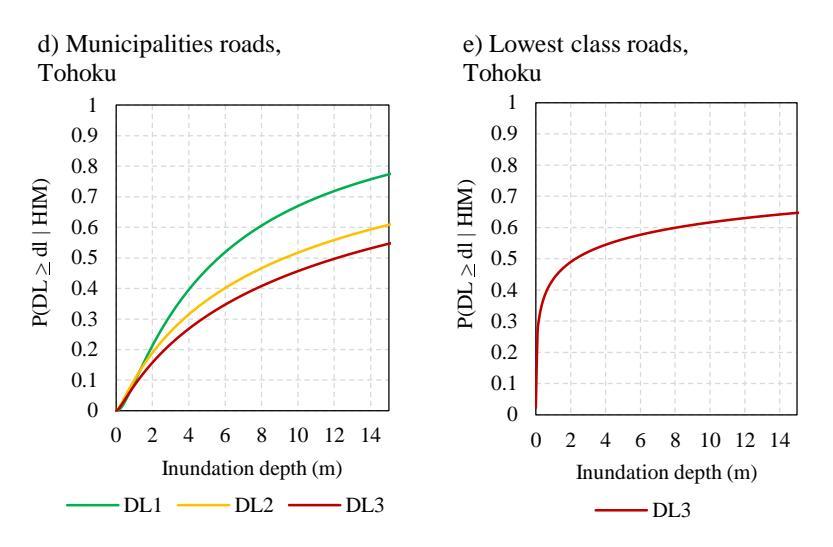
Figure 18: Fragility functions for inundated State Roads (a), Main Local Roads (b), General Prefectural Roads (c), Municipalities Roads (d) and Lowest Class Roads (e) (as an indicator of construction type and materials) in Miyagi and Iwate prefectures following the 2011 Tohoku Earthquake and Tsunami, Japan.
