#### **Responses to Reviewer #1 comments:**

Abstract. Transportation infrastructure is crucial to the operation of society, particularly during post-event response and recovery. Transportation assets, such as roads and bridges, can be exposed to tsunami impacts when near the coast. Using fragility functions in an impact assessment identifies potential tsunami effects to inform decisions on potential mitigation strategies. Such functions have not been available for transportation assets <u>exposed to tsunami hazard</u> in the past due to limited empirical datasets. This study <u>develops fragilityprovides a suite of observations on the influence of tsunami inundation depth</u>, road use-type, culverts, inundation distance, debris and coastal topography. Fragility functions are developed for roads, considering: inundation depth; road use-type; and coastal topography, and for bridges, considering only inundation depth above deck base height. Fragility functions are developed for roads and bridges through combined survey and remotely sensed data for the 2011 Tohoku Earthquake and Tsunami, Japan and using post-event field survey data from the 2015 Illapel Earthquake

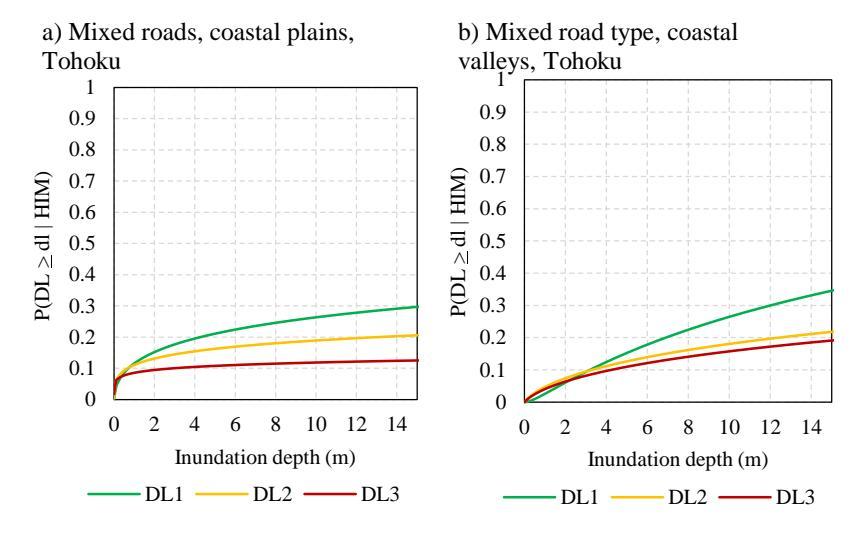
Figure 19: Fragility functions for roads on coastal plains (a) and coastal valleys (b) for the 2011 Tohoku Earthquake and Tsunami, Japan

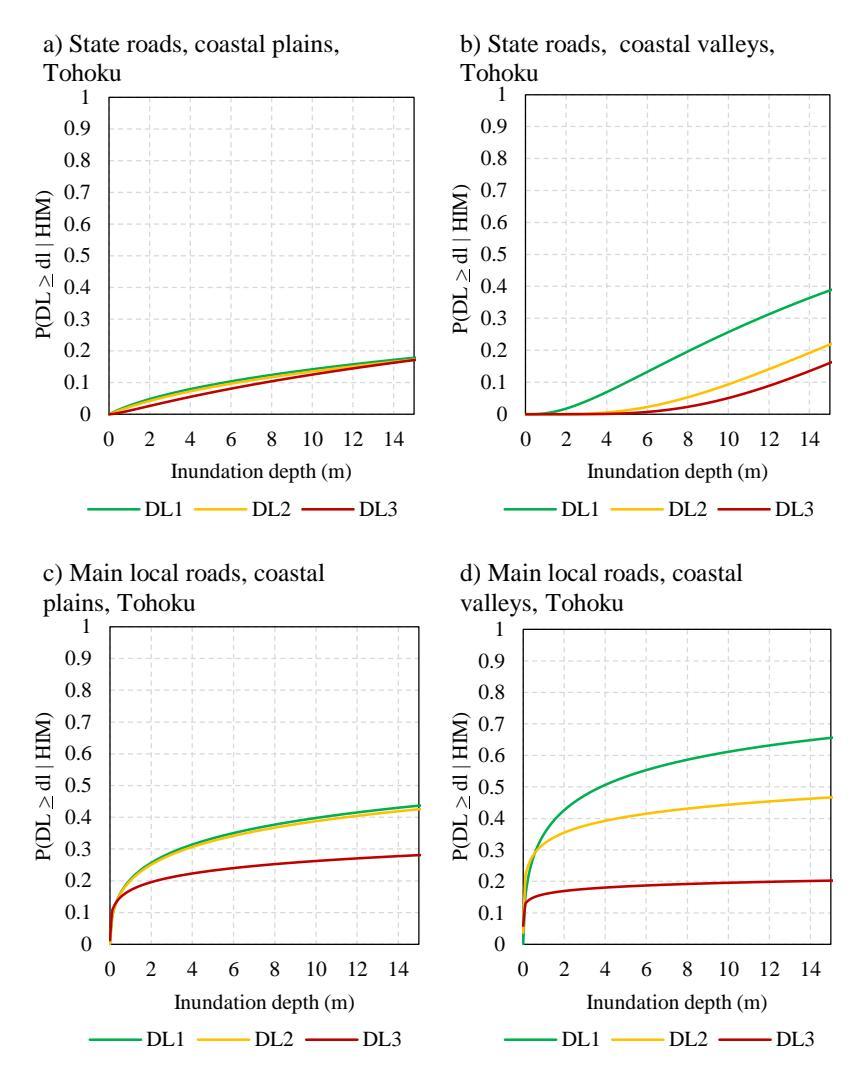
Figure 20: Fragility functions for road State Roads on coastal plains (a) and coastal valleys (b), and for Main Local Roads on coastal plains (c) and coastal valleys (d) for the 2011 Tohoku Earthquake and Tsunami, Japan
