# Assessing Transportation Vulnerability to Tsunamis: Utilising Postevent Field Data from the 2011 Tohoku Tsunami, Japan, and the 2015 Illapel Tsunami, Chile

Abstract. Transportation infrastructure is crucial to the operation of society, particularly during post-event response and recovery. Transportation assets, such as roads and bridges, can be exposed to tsunami impacts when near the coast. Using

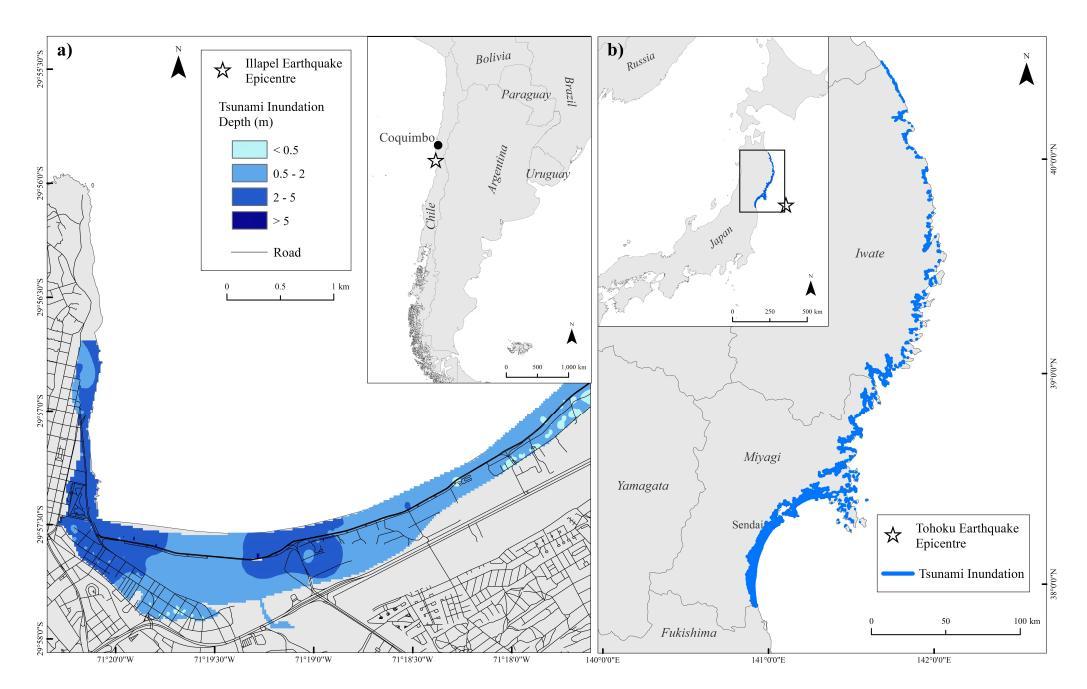
Figure 1: Tsunami inundation in Coquimbo for the 2015 Illapel tsunami, Chile (a), and in Miyagi and Iwate Prefectures for the 2011 Tohoku Tsunami, Japan (b), © OpenStreetMap contributors 2015. Distributed under a Creative Commons BY-SA License.

The Mw 9.0 Tohoku earthquake in the Pacific Ocean, east of Japan (Figure 1b), caused tsunami waves exceeding 30m inundation depth, and affecting much of Japan's eastern coast which was also earthquake-affected (Kazama and Noda, 2012;
MLIT, 2012). Transportation infrastructure were extensively damaged throughout the exposed region during this event (Eguchi et al., 2013; Graf et al., 2014; MLIT, 2012). The Illapel event took place on September 16, 2015 in northern-central Chile, triggered by a Mw 8.3 earthquake of the coast of the Talinay Peninsula, (Figure 1a), (Aránguiz et al., 2016; Contreras-López et al., 2016; Ye et al., 2015). This event caused localised inundation of up to 7 m, with severe impacts to the transportation infrastructure, the most significant of which was in Coquimbo. While the Tohoku dataset represents the largest tsunami damage

- 85 survey for roads, the Illapel dataset represents the first known census style survey of roads impacted by tsunamis. All exposed assets in the Illapel study area (Figure 1a) were surveyed, not only those with observed damage, which was not the case following the Tohoku event.

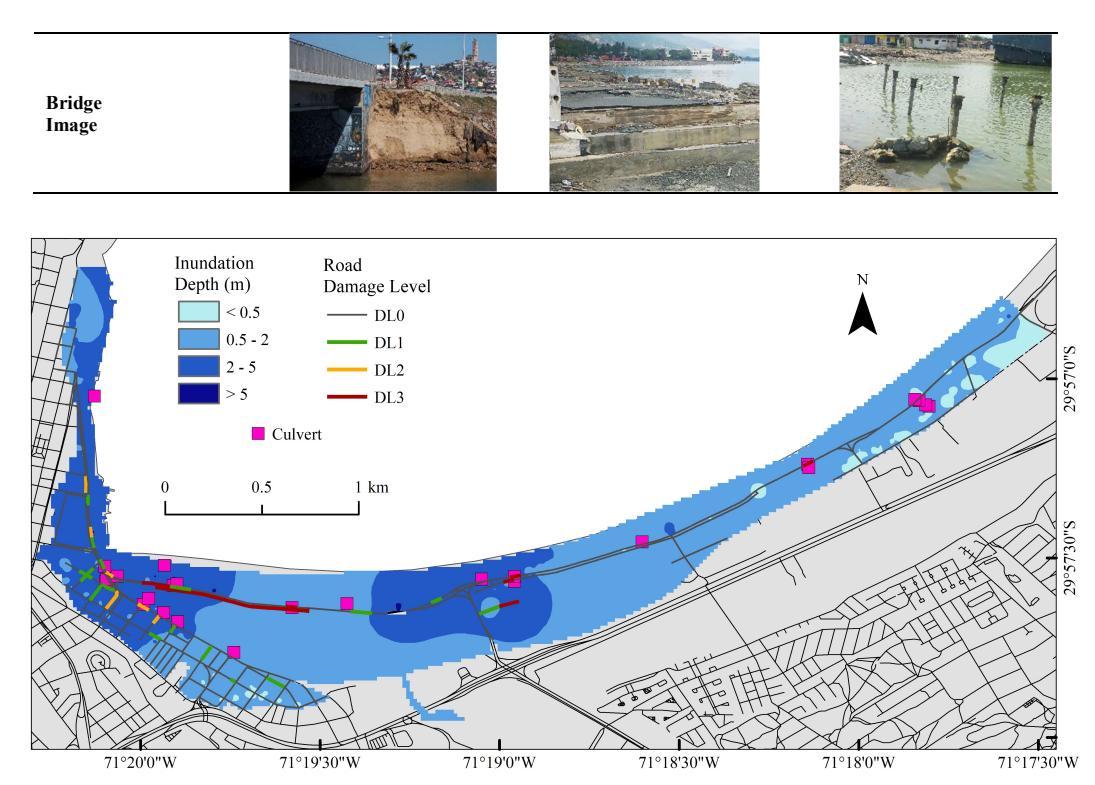
Figure 2: Tsunami inundation, road damage level and culvert locations in Coquimbo, Chile following the 2015 Illapel Earthquake and Tsunami, © OpenStreetMap contributors 2015. Distributed under a Creative Commons BY-SA License.

- 160 interpolation, at the centre of each feature (Figure 2) using inundation depth bins of 0.25 m (0.0 0.25 m, 0.25 0.5 etc.). The total length of road (in km) for each depth bin and for each damage level was tabulated for each HIM by count and proportion (Figure 3). Once inundation depth had been considered, other HIM were used to define vulnerability more holistically. Fragility functions were then developed, as described in more detail in sub-section 2.3.

While inundation depth has been used as the HIM, as outlined above, other potential metrics that might have a bearing on asset vulnerability were also considered. As mentioned in Sub-section 2.1, in Coquimbo, Chile, road damage was observed at many culvert openings especially along the coastal esplanade (Figure 2). This damage is consistent with the principle of contraction

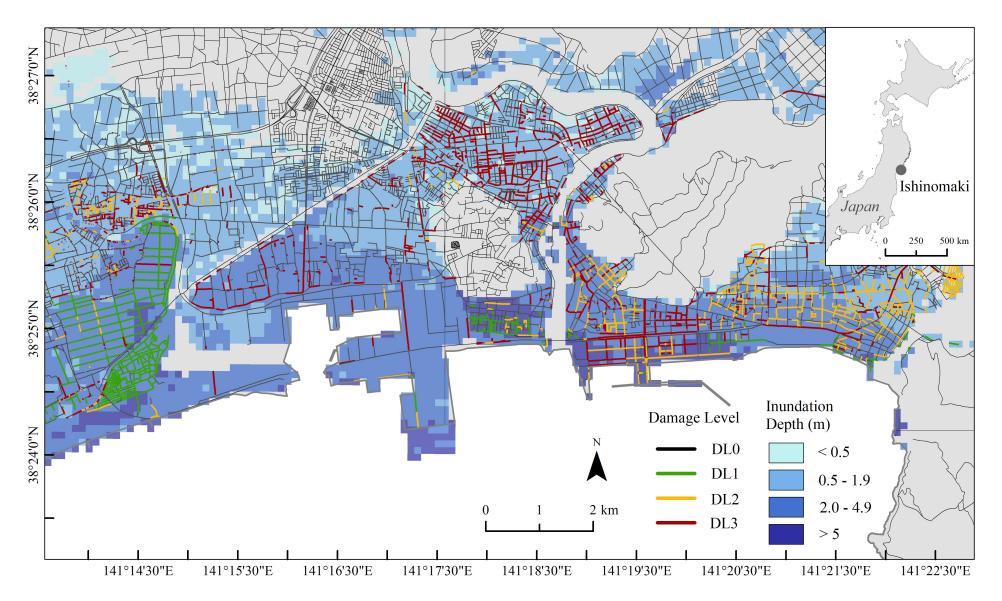
605 Figure 4: Tsunami inundation and road damage in Ishinomaki, from the 2011 Tohoku Earthquake and Tsunami, Japan. Roadimpact data modified from MLIT, 2012, © OpenStreetMap contributors 2015. Distributed under a Creative Commons BY-SA License.

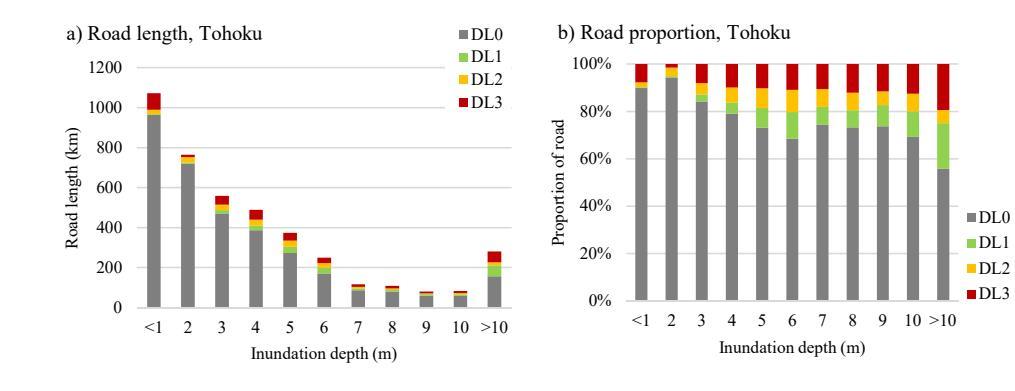
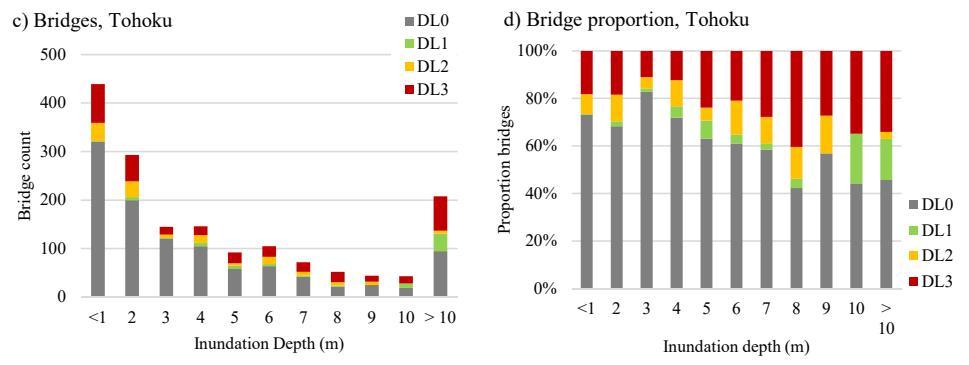
Figure 5: Total length (a) and proportion (b) of exposed roads and number (c) and proportion (d) of exposed bridges, by inundation depth, in Miyagi and Iwate Prefectures for the 2011 Tohoku Earthquake and Tsunami

- 170 1 m inundation depth bins (i.e. 0.0 1.0 m, 1.0 2.0 m etc.). Road length totals in each hazard intensity bin were tabulated for each damage level) by count and proportion (Figure 5). The results of this analysis are presented in Section 3 as fragility functions.

assumption made that in most cases the deck would be relatively level with the abutment, although the deck height (thickness
of beams and roadway) is still not considered. Bridges in each hazard intensity bin were tabulated for each damage level by count and proportion (Figure 5) and resulting fragility functions are presented in Section 3.

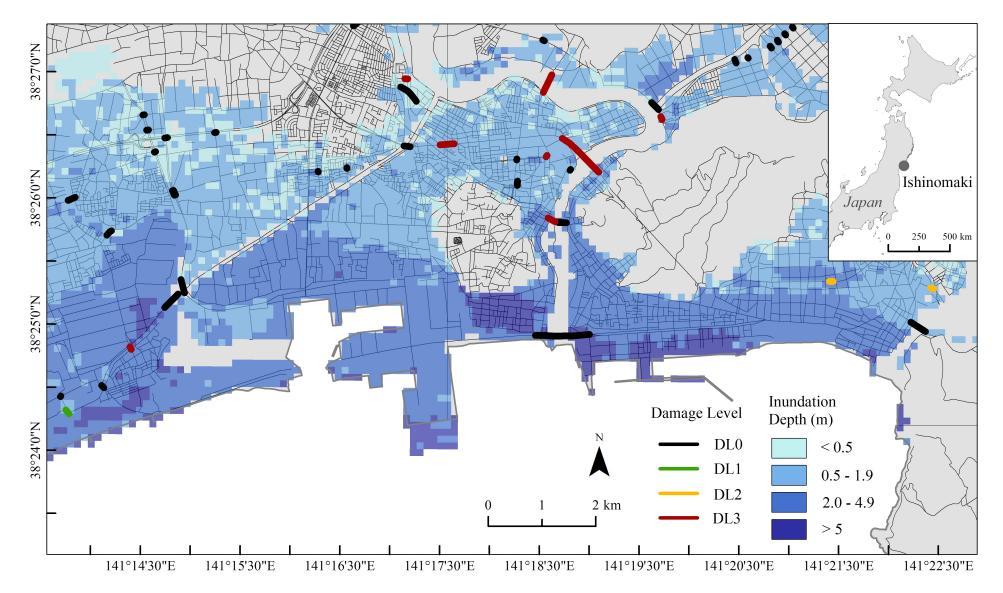
Figure 6: Damage states for inundated bridges in Ishinomaki, Japan, for the 2011 Tohoku Earthquake and Tsunami. Bridge impact data modified from MLIT, 2012. © OpenStreetMap contributors 2015. Distributed under a Creative Commons BY-SA License.

The MLIT dataset had an assigned bridge damage level between DL1 & DL3 (Table 1). All non-surveyed bridges in the inundation area were assumed to be undamaged and consequently assigned DL0 (Figure 6). Modelled tsunami inundation depth was assigned at the centre point of each bridge to avoid a bridge falling within multiple inundation depth bins. Since deck base height was not included in the dataset and in many cases the hazard layer did not include depths within river channels, to estimate the inundation depth above deck base height the inundation depth at the bridge abutment was used and the

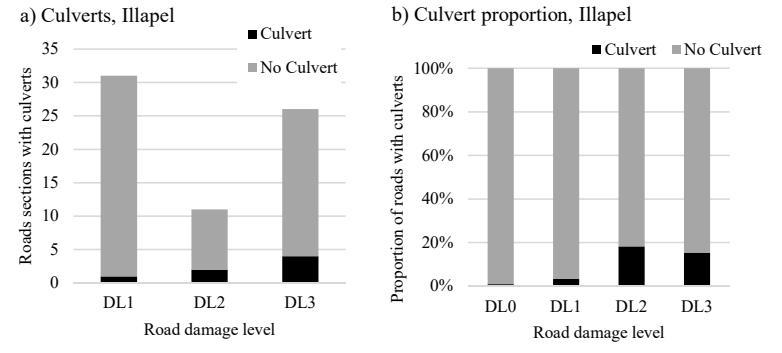
Figure 7: Number (a) and proportion (b) of road sections with or without a culvert, by damage level, for the 2015 Illapel Earthquake and Tsunami

- 205 vortex formation in this inundation. Scour around culverts can also be caused by the back-inundation after a tsunami has receded. Recorded culvert locations were used to assign the presence of a culvert/outfall pipe (present '1', not present '0') to each 50m section of road. The frequency and proportion of road sections with a culvert was tabulated for each damage level (Figure 7). DL0 had a count of 573 road sections (too many to represent in Figure 7a), with five having a culvert. This analysis is not conducive with fragility functions, due to the limited number of culverts surveyed, so none are developed in this study.

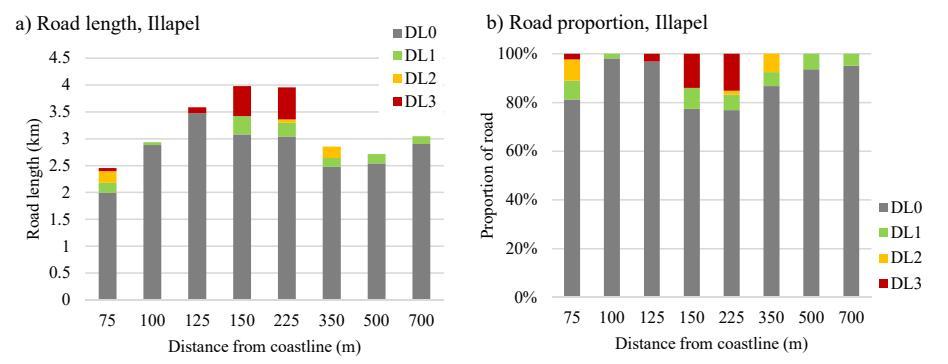
Figure 8: Total length (a) and proportion (b) of exposed roads, by distance from the coastline (as a proxy for inundation energy), for the 2015 Illapel Earthquake and Tsunami

215 reduced with distance from the coast. A measure of distance from the coast was calculated at 25 m inundation distance bins (i.e. 0.0 - 25.0 m, 25 - 50 m etc.). Each road section was assigned the associated distance from coastline value and the results were tabulated for each damage level as counts and proportions of damage (Figure 8). This analysis is not conducive with fragility function, so none are developed.

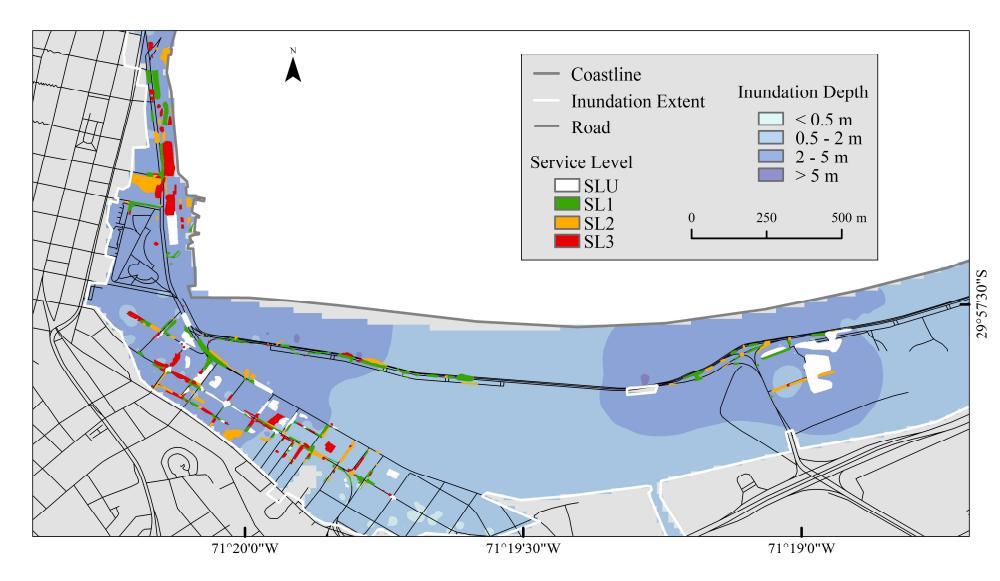
Figure 9: Service levels associated with debris on roads in Coquimbo following the 2015 Illapel Earthquake and Tsunami, Chile, © OpenStreetMap contributors 2015. Distributed under a Creative Commons BY-SA License.

225 2016) was used to map out debris density on roadways. These were classified into five levels of service (Table 2). SLU represents areas of ponding observed and is classed separately since the depth and amount of debris entrained is not known. If a road was not associated with debris deposition, it was assigned SL0. To account for potential horizontal sorting of debris the distance from tsunami inundation extent (i.e. the greatest recorded landward observations of tsunami inundation) and each road was assigned an associated value. The tsunami exposed area in Coquimbo was predominantly flat topography, with only a few instances of a retaining wall or incline bounding the landward inundation extent.

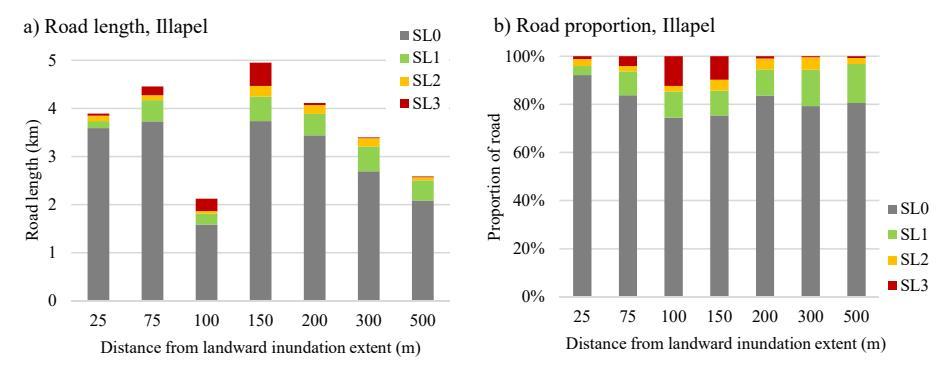
Figure 10: Total length (a) and proportion (b) of exposed roads, considering levels of service, by distance from the landward inundation extent, for the 2015 Illapel Earthquake and Tsunami. Note SLU is not considered in analysis

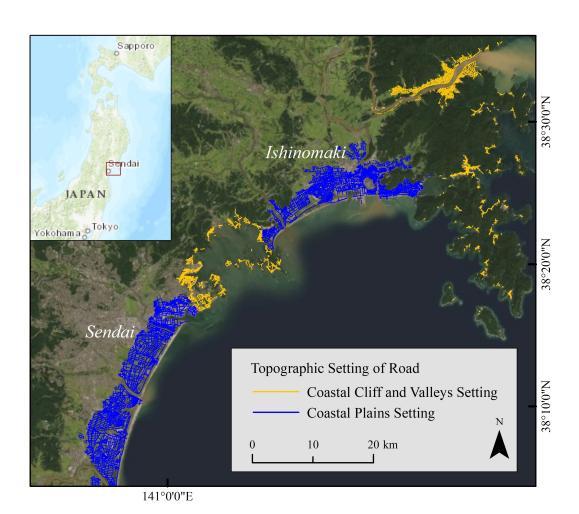
Figure 11: Coastal topographic settings for inundated roads in Miyagi and Iwate Prefectures for the 2011 Tohoku Tsunami, Japan. Note: all roads North of Ishinomaki are Coastal Valleys; all roads South of Sendai are Coastal Plains. Road data modified from MLIT, 2012 and © OpenStreetMap contributors 2015. Distributed under a Creative Commons BY-SA License. Japan topographic imagery sourced from ESRI contributors, 2019a, Tohoku regional satellite imagery sourced from ESRI contributors, 2019b

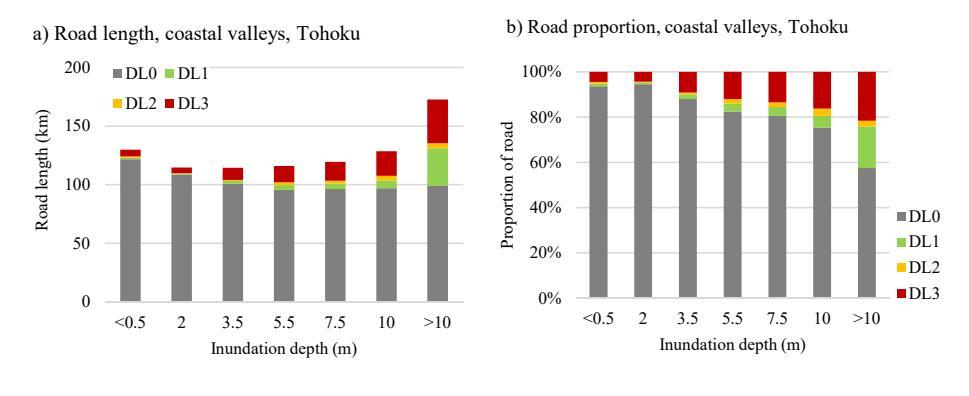
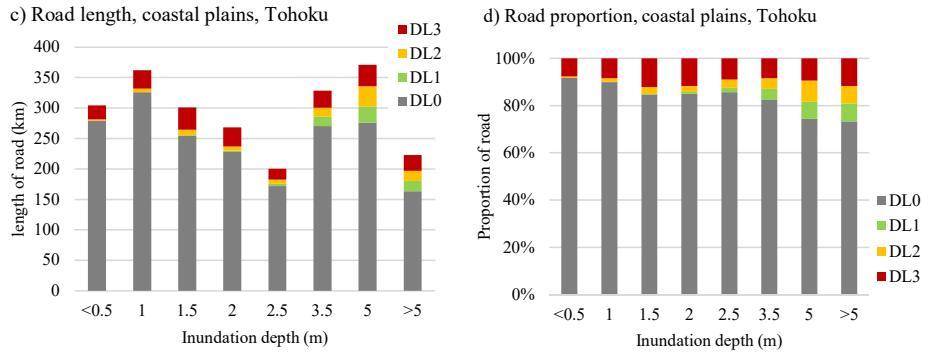
630 Figure 12: Total length (a) and proportion (b) of exposed roads in a coastal valley topographic setting and total length (c) and proportion (d) of exposed roads in a coastal plain topographic setting, by inundation depth, for the 2011 Tohoku Earthquake and Tsunami

240 and 'coastal valleys', to develop specific vulnerability curves similarly to De Risi et al. (2017) and Suppasri et al. (2013). The data for Tohoku roads, presented above, was further refined by assigning each road section an applicable topographic setting (Figure 11). For the two different topographic settings, the number and proportion of road sections in each damage level were tabulated against inundation depth (Figure 12). The resulting fragility functions are presented in Section 3.

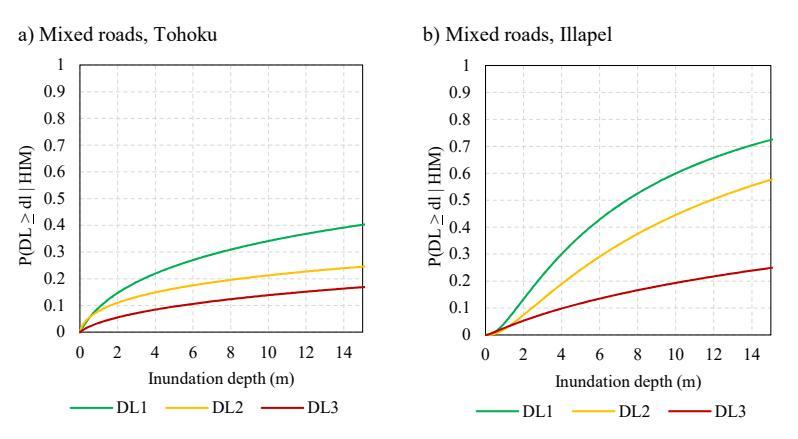
Figure 13: Fragility functions for mixed construction roads (a) for the 2011 Tohoku Earthquake and Tsunami, Japan and for mixed construction roads (b) for the 2015 Illapel Earthquake and Tsunami, Chile

- 270 The exposed roads assessed in this study in general perform well, even under the highest inundation depths. There is less than 0.2 and less than 0.3 probability of complete washout (DL3) at 15 m inundation depth for roads and bridges, respectively, in the Tohoku dataset (Figure 13a and Figure 14). Roads in Coquimbo have less than 0.25 probability of complete damage (DL3) at 15 m (Figure 13b). By comparison, a reinforced concrete building has a 0.4 probability of reaching or exceeding complete damage at the same inundation depth (Suppasri et al., 2013). All Tohoku road damage levels are at a lower probability than

- 280 connections. A higher flexibility in the substructure will also reduce horizontal tsunami loadings (Istrati et al., 2017; Istrati and Buckle, 2014). The Coquimbo roads are at a higher probability of damage compared with the Tohoku roads and bridges. This is to be expected given the differing levels of construction standards in Japan in comparison to even Chile. The Illapel study area did not contain any roads that could be considered equivalent in capacity to the likes of Japanese State Roads, which would be given the highest design standards in terms of maximum flexibility and loading design. This will have resulted in a

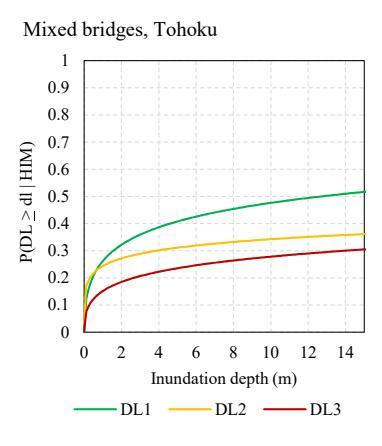
640 Figure 14: Fragility function for mixed construction road bridges for the 2011 Tohoku Earthquake and Tsunami, Japan

results (i.e. up to 15m inundation). This is a reasonable interpretation as roads and bridges, although particularly vulnerable under certain conditions, are far more resistant to tsunami impacts than many other assets (Williams et al., 2019). As a comparison, mixed construction buildings in the 2011 Tohoku Earthquake and Tsunami had a probability of 1.0 at all damage

290 levels when inundation exceeds 10m (Suppasri et al., 2013). Bridge piers and abutments are designed with scour, horizontal loading and vertical loading from moving water in mind, although not specifically for tsunami forces, whereas the foundations and structures of buildings are typically not, making them more vulnerable to tsunamis.

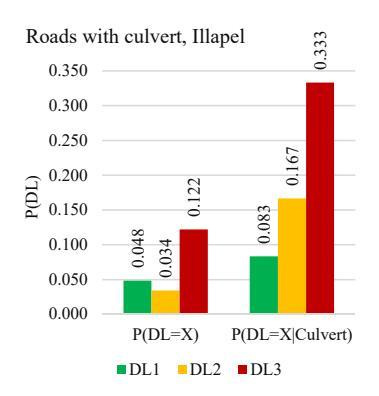
Figure 15: Total road damage probability and increased total road damage probability with the presence of a culvert

The results of the analysis on culvert locations and the associated road damage levels in Coquimbo indicate a correlation with the presence of a culvert and an increased damage level (Figure 15). This indicates that all instances of a culvert in this event have resulted in road damage to some extent, and in most cases moderate or severe damage (DL 2 and DL3).

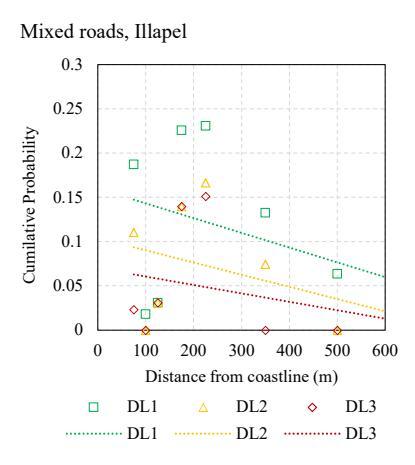
Figure 16: Linear best fit probability of reaching or exceeding a given damage level, by distance from coastline (as a proxy for inundation energy, for the 2015 Illapel Tsunami, Coquimbo, Chile

The analysis for distance from the coast (Sub-section 2.2.2), as a proxy for inundation energy, did not warrant the development of vulnerability curves. However, the results (Figure 16) show a clear trend between higher probabilities of damage occurring

300 closer to the coastline. This may be an indicator for deteriorating wave energy (due to surface friction and gravity) but could simply be an indicator of increased inundation depths at the coast since there is no empirical evidence of hydrodynamic forces in the Illapel event.

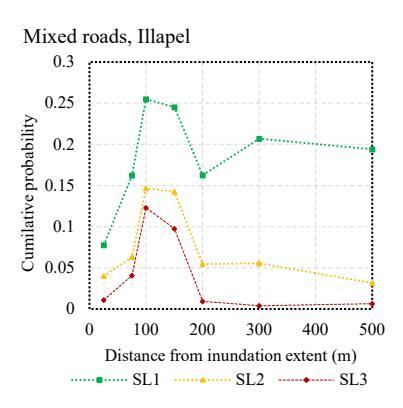
Figure 17: Cumulative probability plot of road service levels compared with a distance from the in-land extent of tsunami inundation (as an indication of debris density sorting) for the 2015 Illapel Tsunami, Coquimbo, Chile.

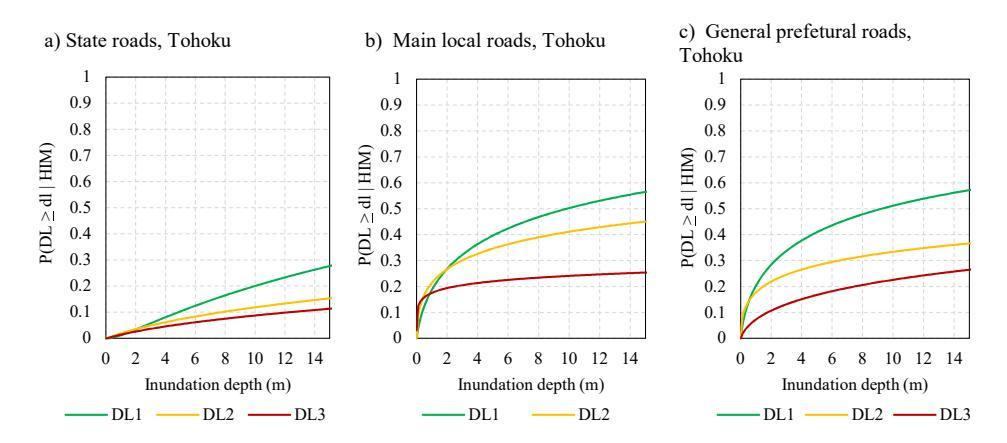
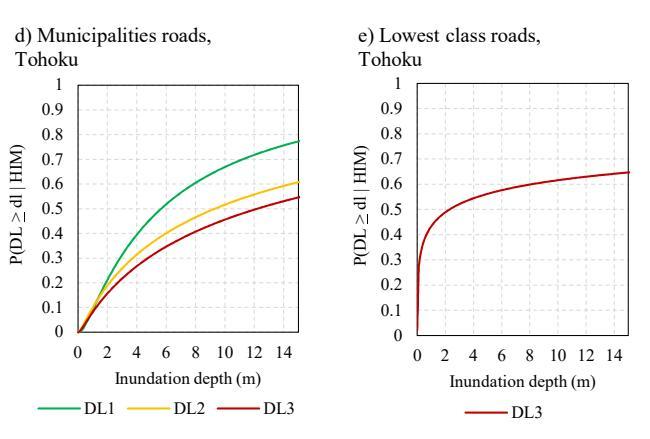
Figure 18: Fragility functions for inundated State Roads (a), Main Local Roads (b), General Prefectural Roads (c), Municipalities
 Roads (d) and Lowest Class Roads (e) (as an indicator of construction type and materials) in Miyagi and Iwate prefectures following the 2011 Tohoku Earthquake and Tsunami, Japan.

functions (Figure 18). The most resistant use category, with respect to tsunami impacts, is State Roads (Figure 18a), with all damage levels being of a lower probability than the other use categories. This is followed by Main Local Roads and General

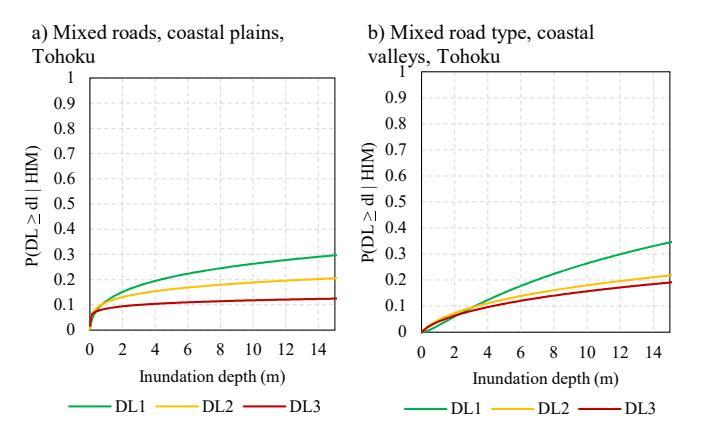
Figure 19: Fragility functions for roads on coastal plains (a) and coastal valleys (b) for the 2011 Tohoku Earthquake and Tsunami, Japan

The previous fragility functions for the Tohoku event, presented above, represent an average of the data for the whole of the tsunami-exposed area. This sub-section presents the results of the analysis looking at the effects of two different topographic settings on tsunami damage to roads. An example of the difference in these coastal topographic settings is that at 2m of

- 335 inundation depth there is ~0.08 probability of DL3 on plains, whereas only ~0.05 in valleys (Figure 19a & b). The damage probability in plains increases to ~0.11 at 10 m inundation depth, while the damage probability is ~0.16 for valleys. It is noted that the damage probability for the plains abruptly increases from 0 to 0.08 (at around 2m) while for valleys 0.08 is not reached until 4m. However, the least squares regression analysis scores (r<sup>2</sup> values) for coastal valleys are particularly low, so the comparisons between each coastal setting my not be entirely representative of true vulnerability.
- 340

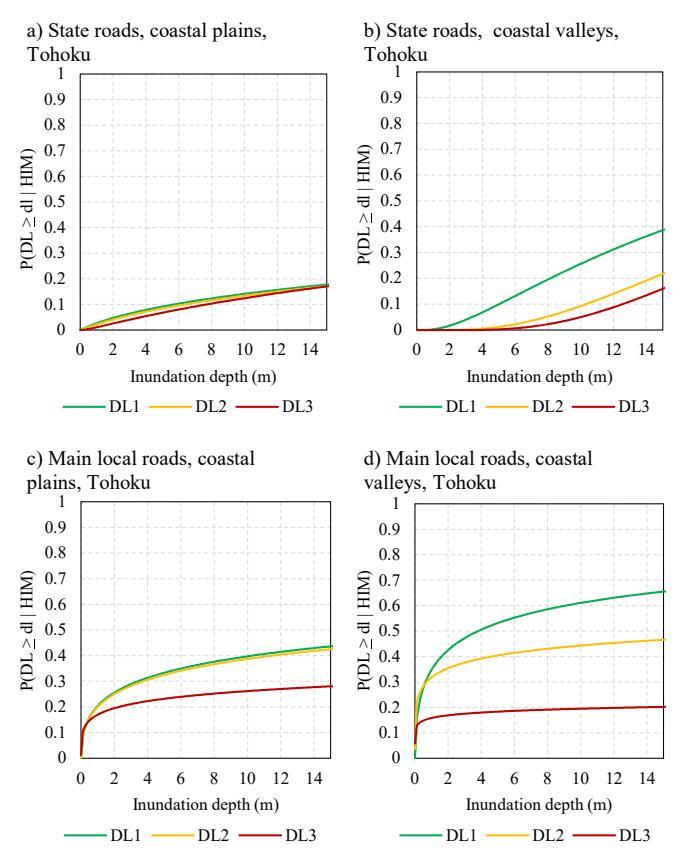
Figure 20: Fragility functions for road State Roads on coastal plains (a) and coastal valleys (b), and for Main Local Roads on coastal plains (c) and coastal valleys (d) for the 2011 Tohoku Earthquake and Tsunami, Japan

345 to warrant fragility functions. In general, the damage probabilities for roads in the valleys are higher than those on plains for each inundation depth.
