# Response to the Comments of Reviewer No. 1

# Response to the Comments of Reviewer No. 2

# Response to the Comments of Professor Taubenböck

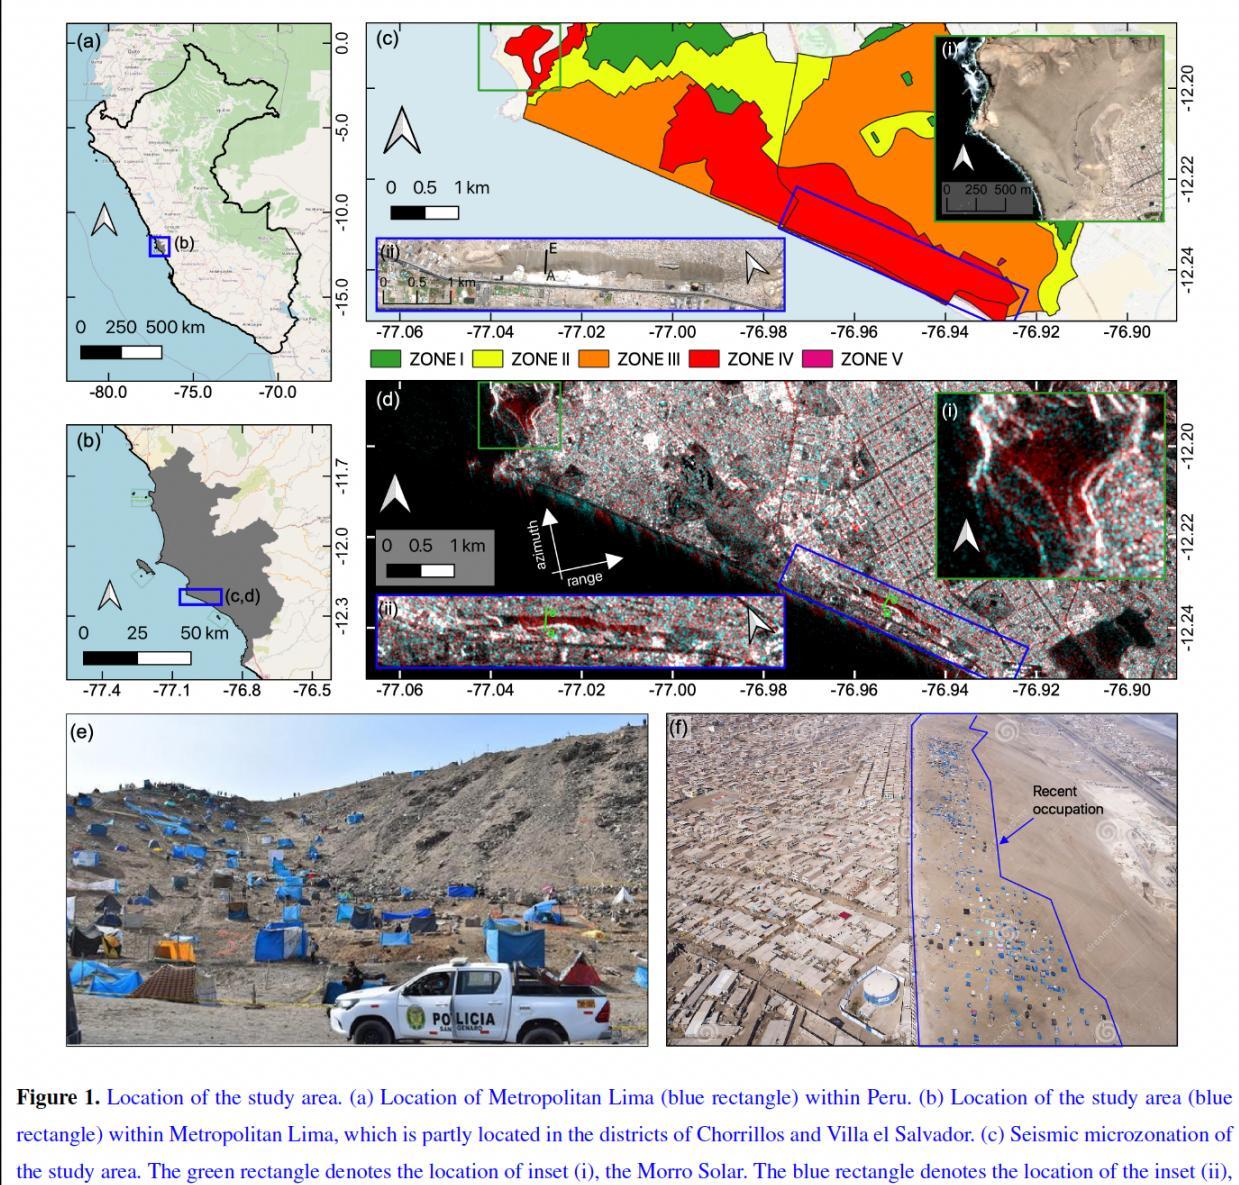
Change in manuscript: Figure 1:

the study area. The green rectangle denotes the location of inset (i), the Morro Solar. The blue rectangle denotes the location of the inset (ii), the Lomo de Corvina. (d) Color composite of SAR backscattering intensity images. Red band: image recorded on April 14, 2021; Green and blue band: image recorded on December 03, 2020. (e) Photograph of the squatter settlement in Morro Solar recorded by Gestion (2021). (f) Photograph of the squatter settlement in Lomo de Corvina (modified from Inga (2021)).

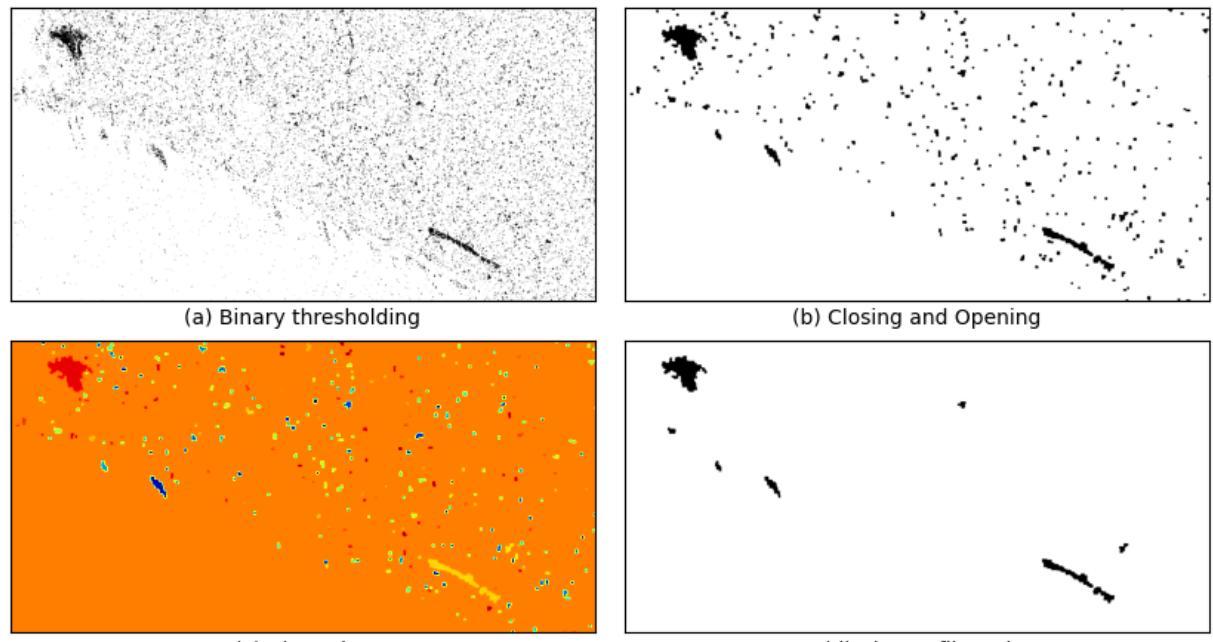
Figure R1. (a) Binary thresholding. (b) Closing and opening operators with kernel-size 5x5. (c) Clustering. (d) Clusters of less than 200 pixels are filtered.

The reviewer is right, performed further analysis to reduce the effect of the speckle noise in SAR images. We apologize for missing such details. The further processing is explained as follow: After the thresholding (Figure R1a), the morphological operators "opening" and "closing" with a kernelsize of 5x5 pixels applied were (https://docs.opencv.org/master/d3/dbe/tutorial opening closing hats.html), see Figure R1b. Then, we identified the pixel clusters, where a cluster is a set of neighbor pixels, and two pixels are neighbor if they share a common side (Figure R1c). finally, clusters consistent of less than 200 pixels were filtered out. Note that a pixel has an area of about 100m2, which is less than the average area of informal buildings in Lima; furthermore, the number of people that participate in such informal occupations is in the order of thousands. Therefore, we consider that a threshold size of 200 pixels to filter out small clusters is a reasonable choice. Note also that the final results (Fig R1d) include additional clusters that are easy to discriminate because some (the three small clusters on the left) are located in the sea and some are located in existing urban areas (the two small clusters on the right).

(c) Clustering

(d) Cluster filtered

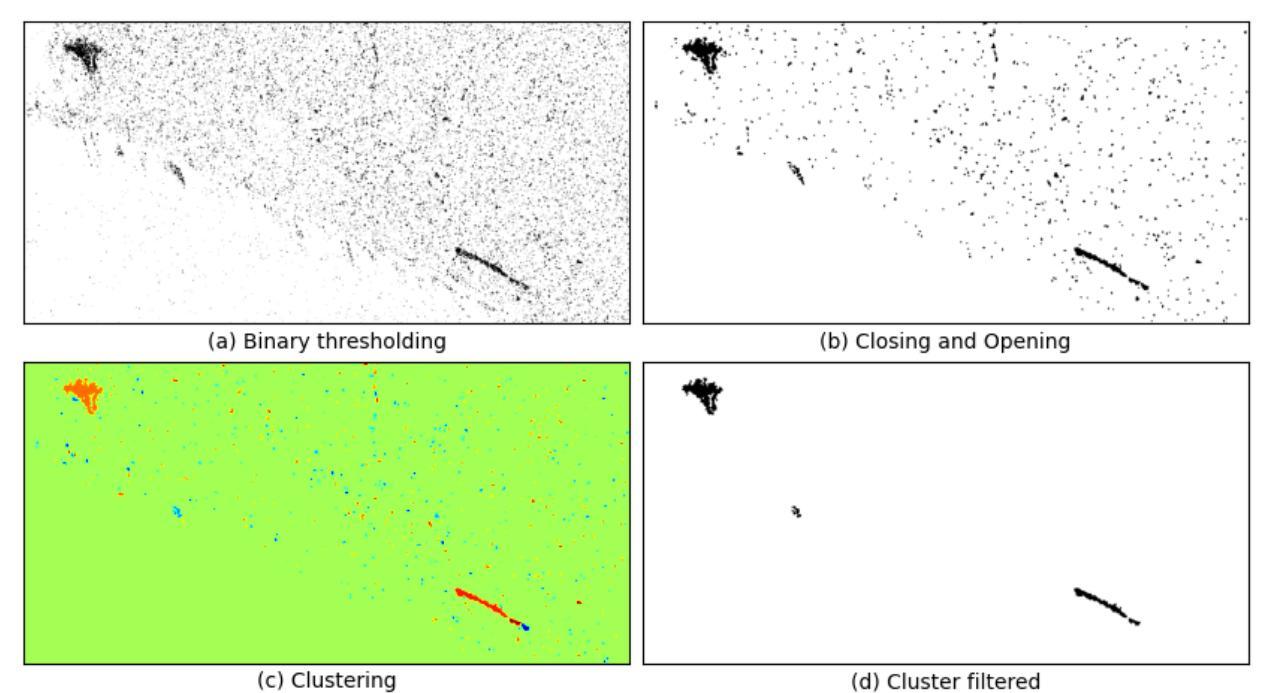
Figure R2. (a) Binary thresholding. (b) Closing and opening operators with kernel-size 5x5. (c) Clustering. (d) Clusters of less than 200 pixels are filtered.

In the updated manuscript, we decided to apply the morphologic operators (opening and closing) with a kernel size of 3x3 (instead of 5x5) to improve the final resolution:

if the backscatter intensity recorded on April 14, 2021, is greater than the threshold, it is assumed that the area is occupied.
95 After thresholding, the morphological operators *closing* and *opening* were applied using a kernel size of 3 × 3. Then, pixel clusters were identified, and those with sizes lower than 200 pixels were filtered out. Figure 3 depicts the extent of the invaded areas in Morro Solar and Lomo de Corvina. The black polygon shown in Figure 3b denotes the extension of the occupied area estimated from visual inspection of images recorded by an unmanned aerial vehicle (UAV). Our results from SAR images identified 84% of the area identified by visual inspection. Furthermore, only 67% of the area identified from SAR images is
100 contained within the black polygon. We believe that the main reason for the discrepancies between SAR images' information and visual inspection lies in the complex geometric distortions in the SAR images.

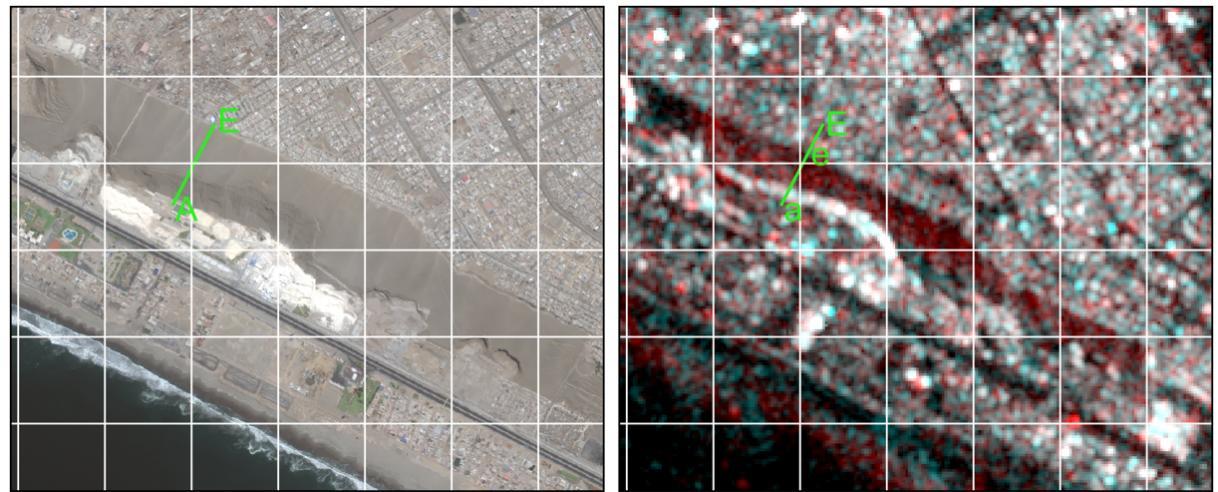
Figure R3. Lomo de Corvina recorded from an optical sensor (left), and from a microwave sensor (right).

The geometric distortions that occur in Lomo de Corvina area is referred as foreshortening/layover. Such distortions are well-known effects in SAR images (See, for instance, section 2.1.4 Geometric **Properties** of book The SAR Handbook: of SAR data the https://servirglobal.net/Global/Articles/Article/2674/sar-handbook-comprehensivemethodologies-for-forest-monitoring-and-biomass-estimation). Figure R3 shows Lomo de Corvina recorded from both an optical sensor and a microwave sensor. Grid lines are drawn for better visualization of the geometric distortions. The bare land, which was recently occupied, seems smaller in the SAR image that that from the optical image. Because the Lomo de Corvina area was shrunk in the SAR images, we stated our results might be underestimated.

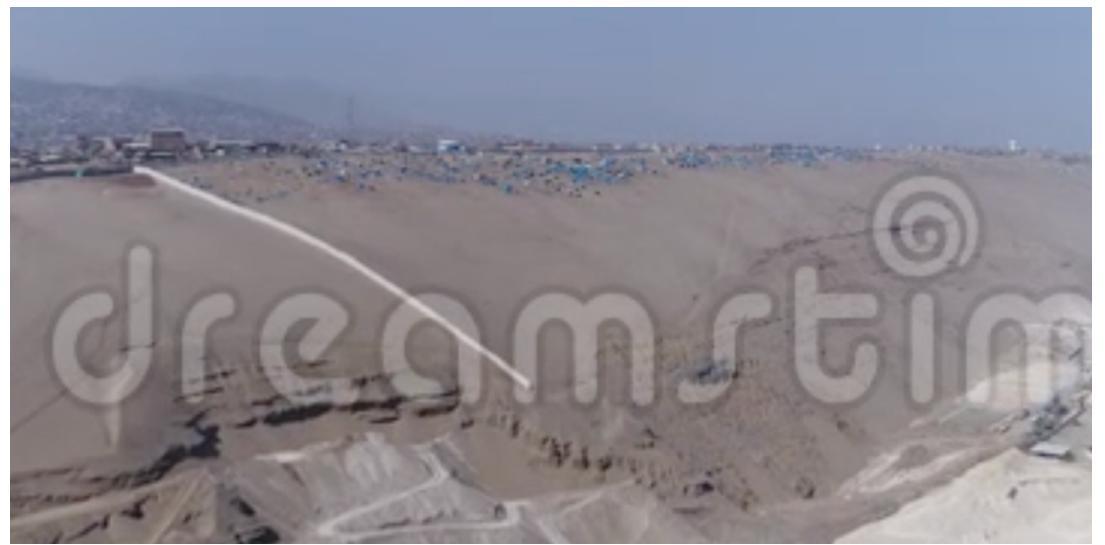
Figure R4. Occupied area in Lomo de Corvina (Source: internet)

Figure R4 shows an image of the northwest side of the occupied area, which is limited by a white wall. A simplified idealization of a cross-section in Lomo de Corvina hill is depicted in Figure R5. The location of the cross-section is depicted in Figure R4 as the segment  $\overline{AE}$ . The cross-section is simplified as four segments  $\overline{AB}$ ,  $\overline{BC}$ ,  $\overline{CD}$ , and  $\overline{DE}$ . We assume that the range direction is parallel to the vertical plane that contains the cross-section to illustrate the geometric distortions in the SAR image. The *slant range* denotes the direction from which the microwave energy travels from the satellite to the ground. The microwave images are presented in *ground-range* format. Note that because the points A and C share about the same distance to the satellite, both segments  $\overline{AB}$  and  $\overline{CB}$  occupy the same geographic position in the ground-range (see  $\overline{ab}$  and  $\overline{cb}$ ). In the ground-range the cross-section is located along the segment  $\overline{AE'}$  in the optical image; on the other hand, the cross-section is located along the segment  $\overline{ae}$  in the microwave image. It is observed that the length of  $\overline{AE'}$  is larger than the length of  $\overline{ae}$ , which is the reason we stated our results might be underestimated. However, the reviewer is right mentioning that our assumption is not conclusive. Note that the length of  $\overline{DE'}$ , the segment that contains the occupied area, is slightly larger than the length of  $\overline{de}$ .

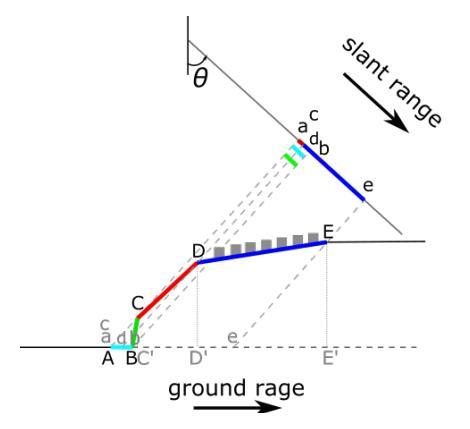
Figure R5. Simplified scheme of the cross-section of the Lomo de Corvina hill. It is assumed that the cross section and the range direction lie on the same vertical plane. Due to the oblique observation of SAR images, surface slopes lead to geometric distortions.

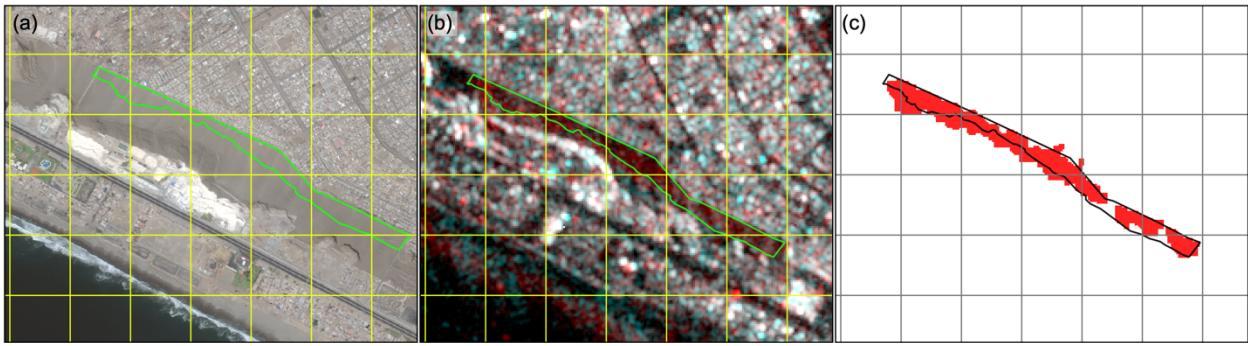
Figure R6. Extent of the occupied area in Lomo de Corvina

Regarding a comparison of our results and field surveys, by georeferencing some images extracted from the videos, and with the aid of a high-resolution optical images, we manually draw the extent of the occupied areas at the Lomo de Corvina (See Figure R6a). Then we shifted the polygon to fit the occupied area in the SAR image, we use as reference the boundary between the existing urban area and the recently occupied area (See Figure R6b).

Figure R6c shows the estimated occupied areas from SAR imagery and that from visual inspection (VI). 84% of VI-based area were identified in the SAR-based results; on the other hand, 67% of the SAR-based results belong to the VI-based area.

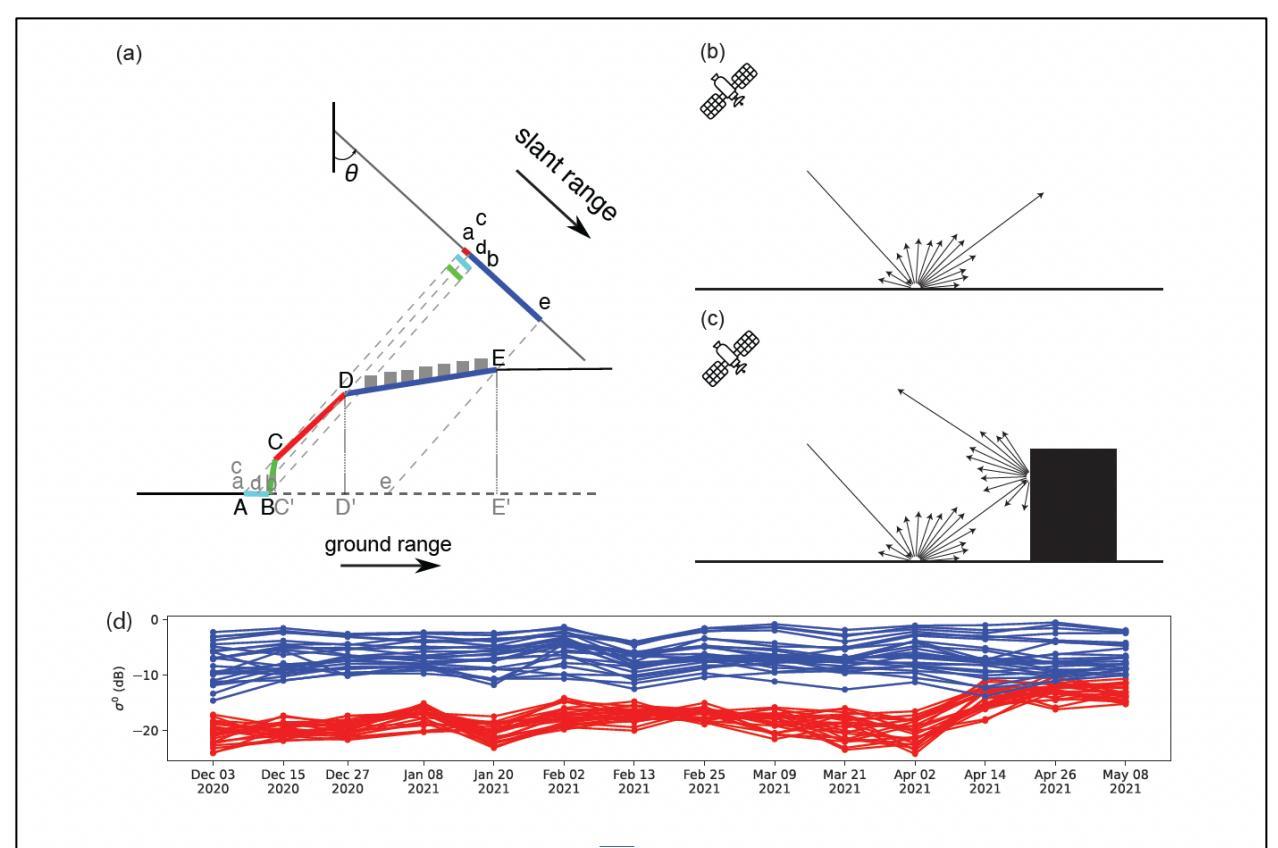
Figure 2. (a) Simplified scheme of the elevation profile at the line  $\overline{AE}$  in Figure 1c, inset (ii). (b) Diagram of the radar pulse,  $I_a$ , backscattered from the ground. (c) Diagram of the radar pulses backscattered from the ground,  $I_a$ , and the makeshift shelter,  $I_b$ . (d) Red lines: SAR backscattering intensity time series at some representative points of the recently invaded land in Morro Solar. The sudden increment from April 14 denotes the change of the backscatter mechanism from the mechanism shown in 2(b) to that shown in 2(c); Blue lines: SAR backscattering intensity time series at some points of an old informal settlement located close to the recently invaded land.

color composite of backscattered intensity recorded on different dates. The red band denotes an image recorded on December 03, 2020, and the green and blue band denote the image recorded on April 14, 2021. Note from inset (ii) in Figures 1c and 1d that the Lomo de Corvina area in the SAR image looks smaller than that from the optical image. Such geometric distortions are because of the oblique observation geometry of SAR images. Figure 2a depicts a scheme of the elevation profile corresponding to the line AE depicted in the inset (ii) of Figure 1. The profile is simplified by four segments, AB, BC, CD, and DE. In order to illustrate the geometric distortions in the SAR images, it is assumed that the range direction is parallel to the vertical plane that contains the profile. The slant range denotes the direction from which the microwave energy travels from the satellite to the ground. The microwave images are presented in ground-range format. Note that because points A and C share about the same distance to the satellite, both segments AB and CB occupy the same geographic position in the ground-range (ab and cb) of the SAR image. In the optical image, the profiling scheme is located over the line AE (Figure 1c); on the other hand, the informal settlement in the optical image, DE, is only slightly larger than the length of de. Note also that there is a shift

between  $\overline{DE}$  and  $\overline{de}$ .

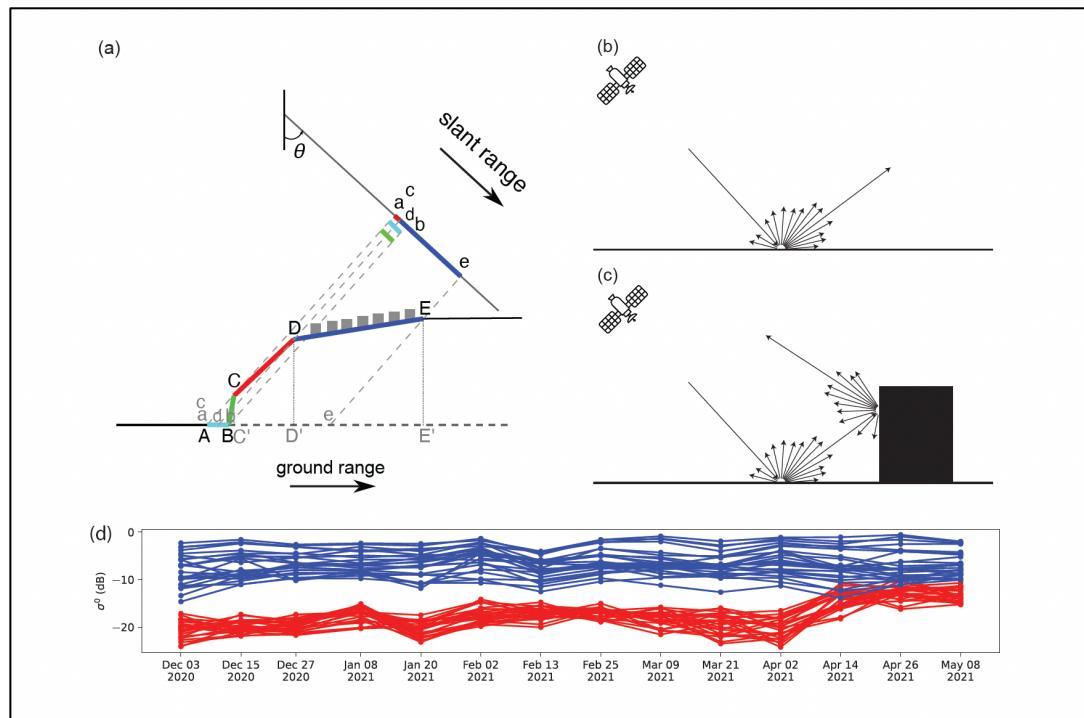
**Figure 2.** (a) Simplified scheme of the elevation profile at the line  $\overline{AE}$  in Figure 1c, inset (ii). (b) Diagram of the radar pulse,  $I_a$ , backscattered from the ground. (c) Diagram of the radar pulses backscattered from the ground,  $I_a$ , and the makeshift shelter,  $I_b$ . (d) Red lines: SAR backscattering intensity time series at some representative points of the recently invaded land in Morro Solar. The sudden increment from April 14 denotes the change of the backscatter mechanism from the mechanism shown in 2(b) to that shown in 2(c); Blue lines: SAR backscattering intensity time series at some points of an old informal settlement located close to the recently invaded land.

Based on the videos, we prepare a simplified scheme of an elevation profile in Lomo de Corvina and discussed the scattering mechanism in the topography of Lomo de Corvina. We already provided common backscattering intensity values and the backscattering mechanism in the occupied areas (Figure 2c of the original manuscript, and Figure 2d of the updated manuscript).

- 70 color composite of backscattered intensity recorded on different dates. The red band denotes an image recorded on December 03, 2020, and the green and blue band denote the image recorded on April 14, 2021. Note from inset (ii) in Figures 1c and 1d that the Lomo de Corvina area in the SAR image looks smaller than that from the optical image. Such geometric distortions are because of the oblique observation geometry of SAR images. Figure 2a depicts a scheme of the elevation profile corresponding to the line  $\overline{AE}$  depicted in the inset (ii) of Figure 1. The profile is simplified by four segments,  $\overline{AB}$ ,  $\overline{BC}$ ,  $\overline{CD}$ , and  $\overline{DE}$ . In

- order to illustrate the geometric distortions in the SAR images, it is assumed that the range direction is parallel to the vertical plane that contains the profile. The slant range denotes the direction from which the microwave energy travels from the satellite to the ground. The microwave images are presented in ground-range format. Note that because points A and C share about the same distance to the satellite, both segments  $\overline{AB}$  and  $\overline{CB}$  occupy the same geographic position in the ground-range ( $\overline{ab}$  and  $\overline{cb}$ ) of the SAR image. In the optical image, the profiling scheme is located over the line  $\overline{AE}$  (Figure 1c); on the other hand, the

- 80 profile is located along the segment  $\overline{ae}$  in the SAR image, which is significantly smaller. However, the segment that contains the informal settlement in the optical image,  $\overline{DE}$ , is only slightly larger than the length of  $\overline{de}$ . Note also that there is a shift between  $\overline{DE}$  and  $\overline{de}$ .

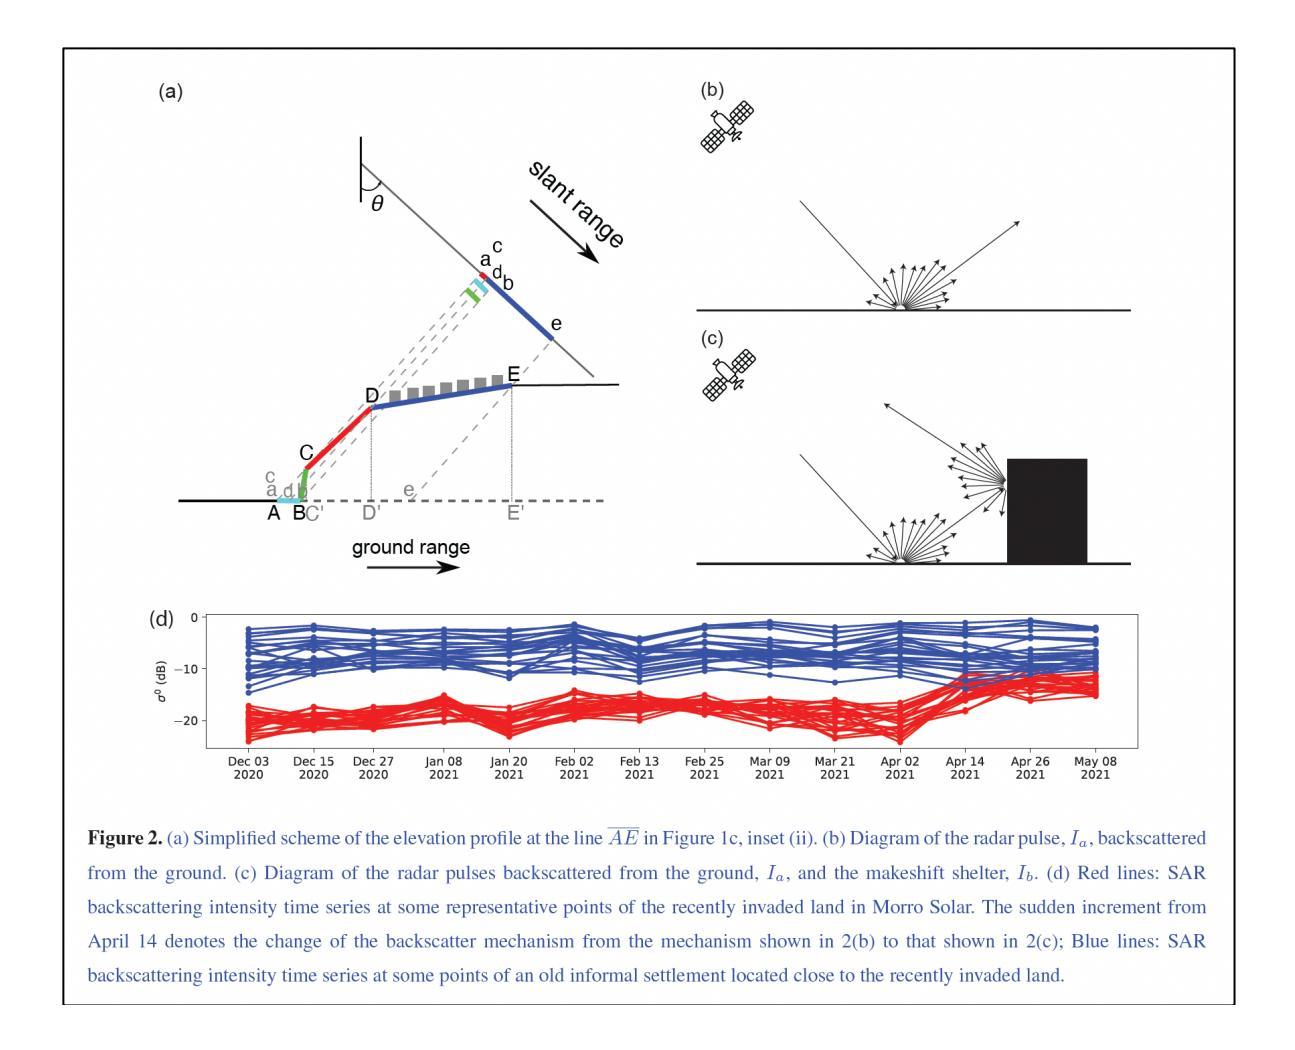
"Figure 2c) must include units on the vertical axis."

Following the reviewer's comment, we have included units on the vertical axis.

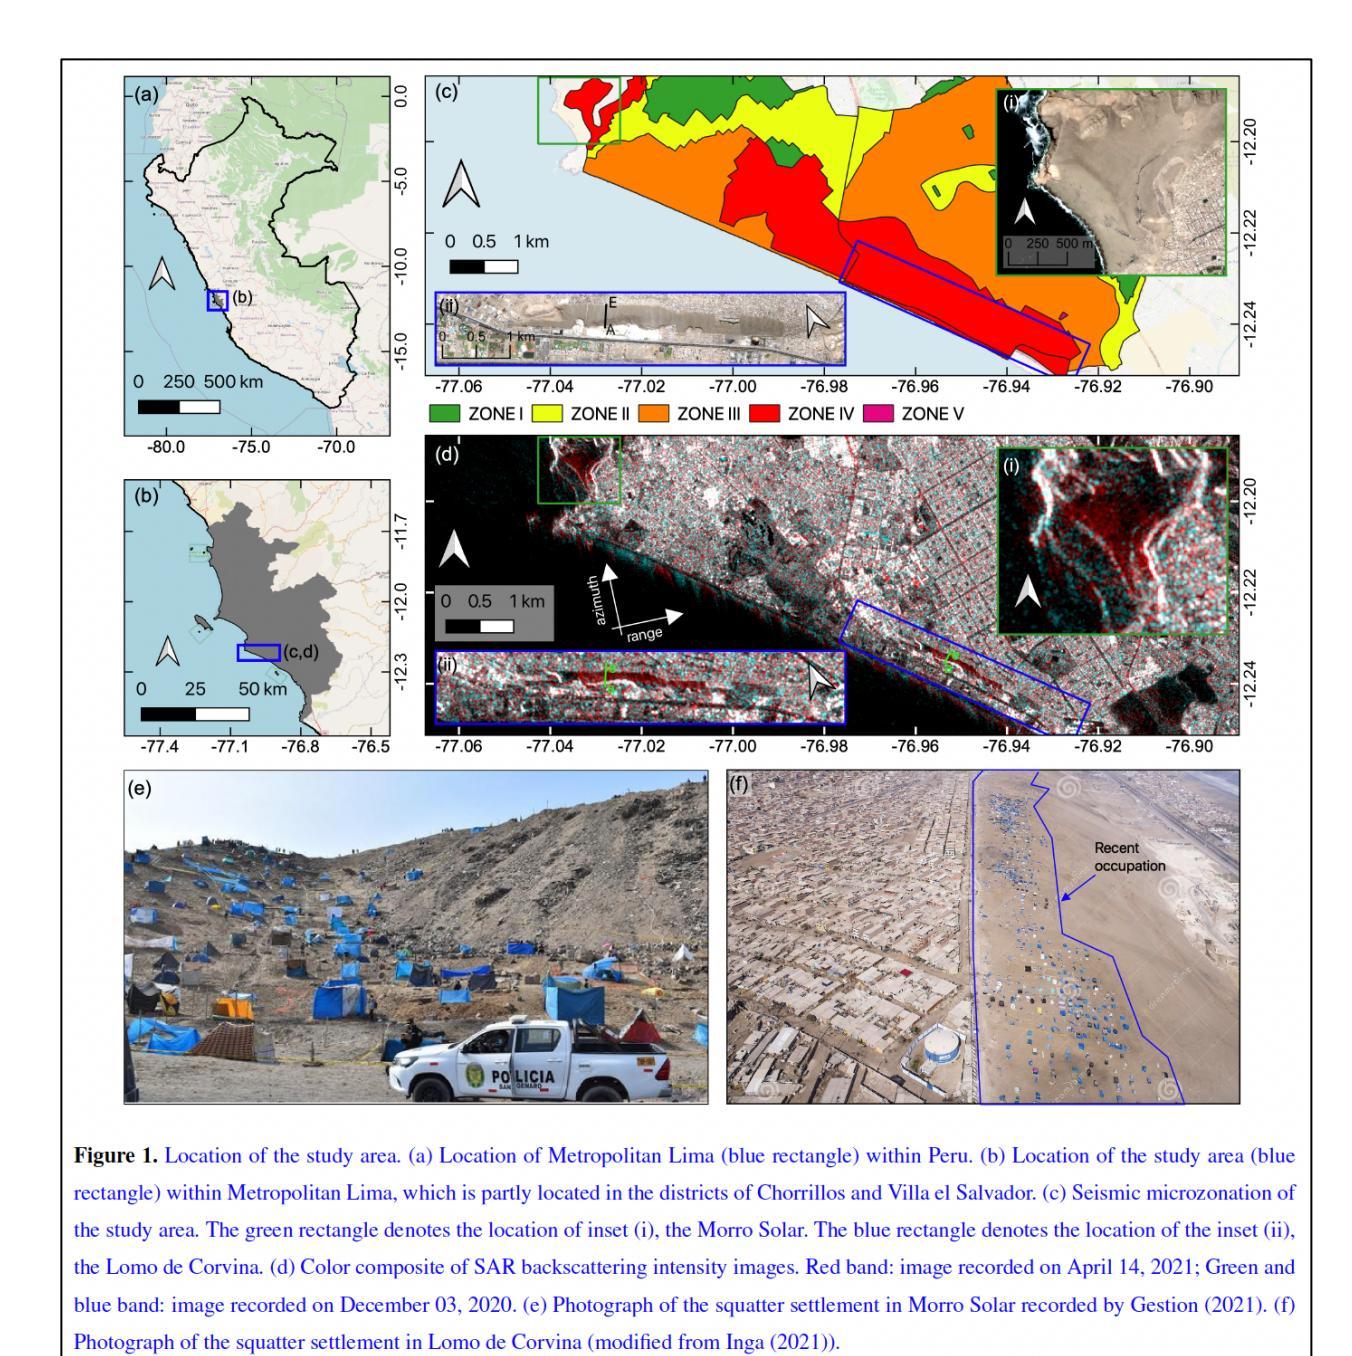
Change in manuscript: Figure 1:

"Given the great relevance of the colors and sharpness of figures, improvements are expected (at least) in Figures 1c), 1d) and 3."

The figures have been modified according to the reviewer's comment.

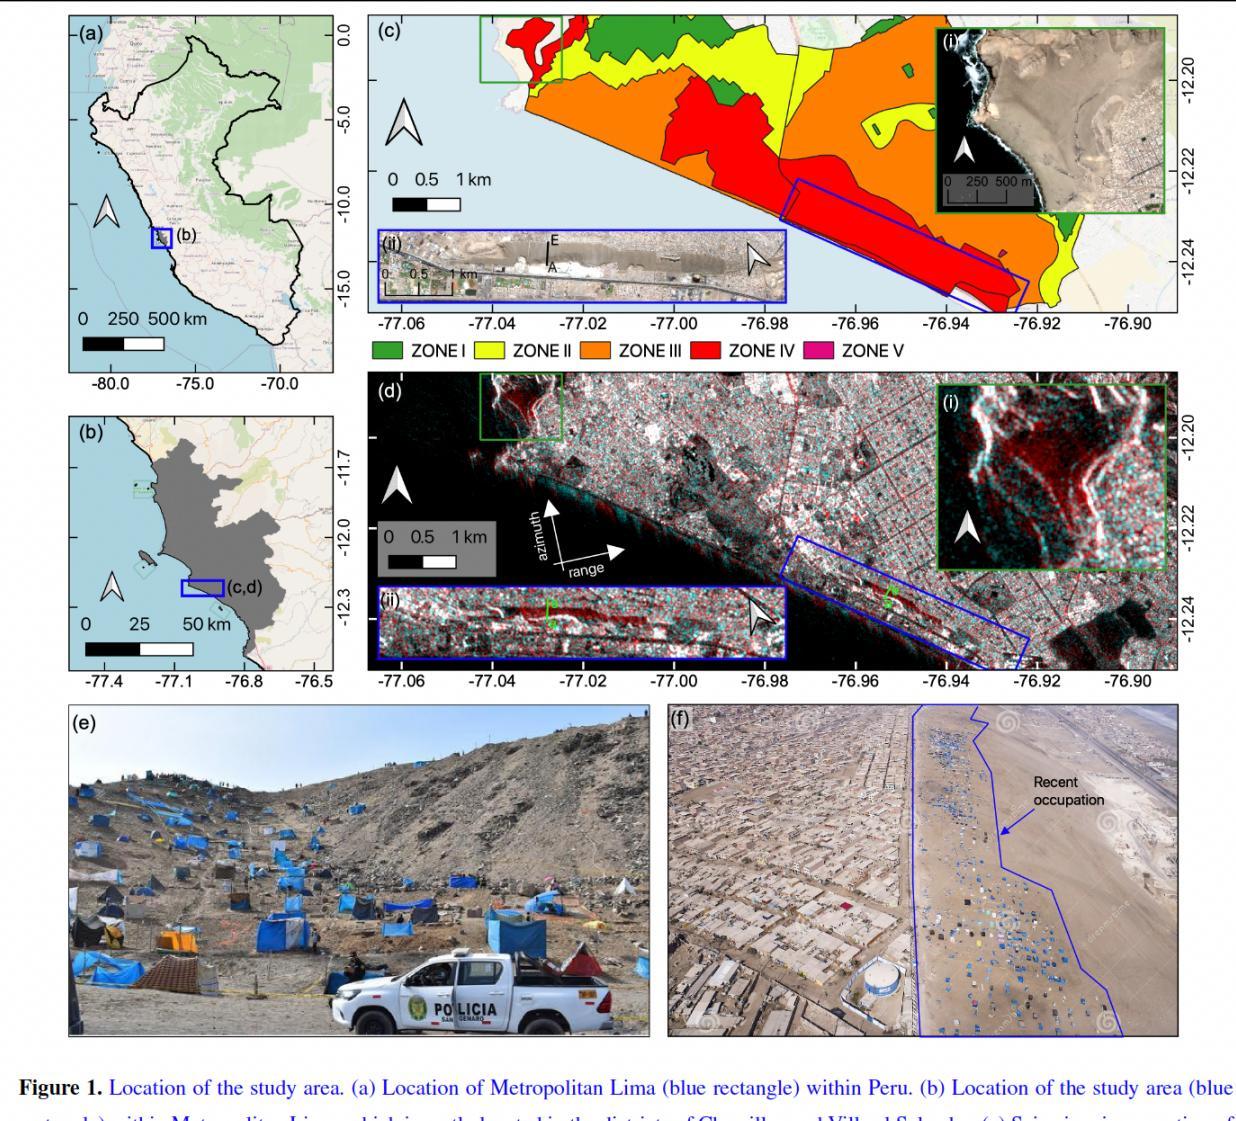
Change in manuscript: Page 3:

rectangle) within Metropolitan Lima, which is partly located in the districts of Chorrillos and Villa el Salvador. (c) Seismic microzonation of the study area. The green rectangle denotes the location of inset (i), the Morro Solar. The blue rectangle denotes the location of the inset (ii), the Lomo de Corvina. (d) Color composite of SAR backscattering intensity images. Red band: image recorded on April 14, 2021; Green and blue band: image recorded on December 03, 2020. (e) Photograph of the squatter settlement in Morro Solar recorded by Gestion (2021). (f) Photograph of the squatter settlement in Lomo de Corvina (modified from Inga (2021)).

We agree with the reviewer. Figure 1c (iii) has been enlarged and moved to Figure 1e. We have also included another photo of Lomo de Corvina as Figure 1f. Regarding Figures 1a and 1b, it was a request from the editorial team.

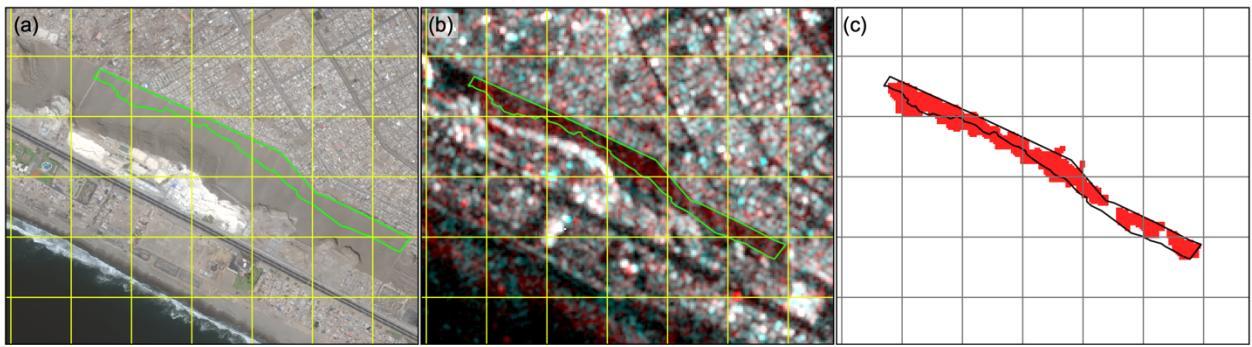
Figure R6. Extent of the occupied area in Lomo de Corvina

by georeferencing some images extracted from the videos, and with the aid of a high-resolution optical images, we manually draw the extent of the occupied areas at the Lomo de Corvina (See Figure R1a). Then we shifted the polygon to fit the occupied area in the SAR image, we use as reference the boundary between the existing urban area and the recently occupied area (See Figure R1b).

Figure R6c shows the estimated occupied areas from SAR imagery and that from visual inspection (VI). 84% of VI-based area were identified in the SAR-based results; on the other hand, 67% of the SAR-based results belong to the VI-based area.
